2022 Annual Facility Performance Report for Turnbull Tailings Storage Facility

Teck Coal Limited, Fording River Operations

WSP Canada Inc.

24 March 2023

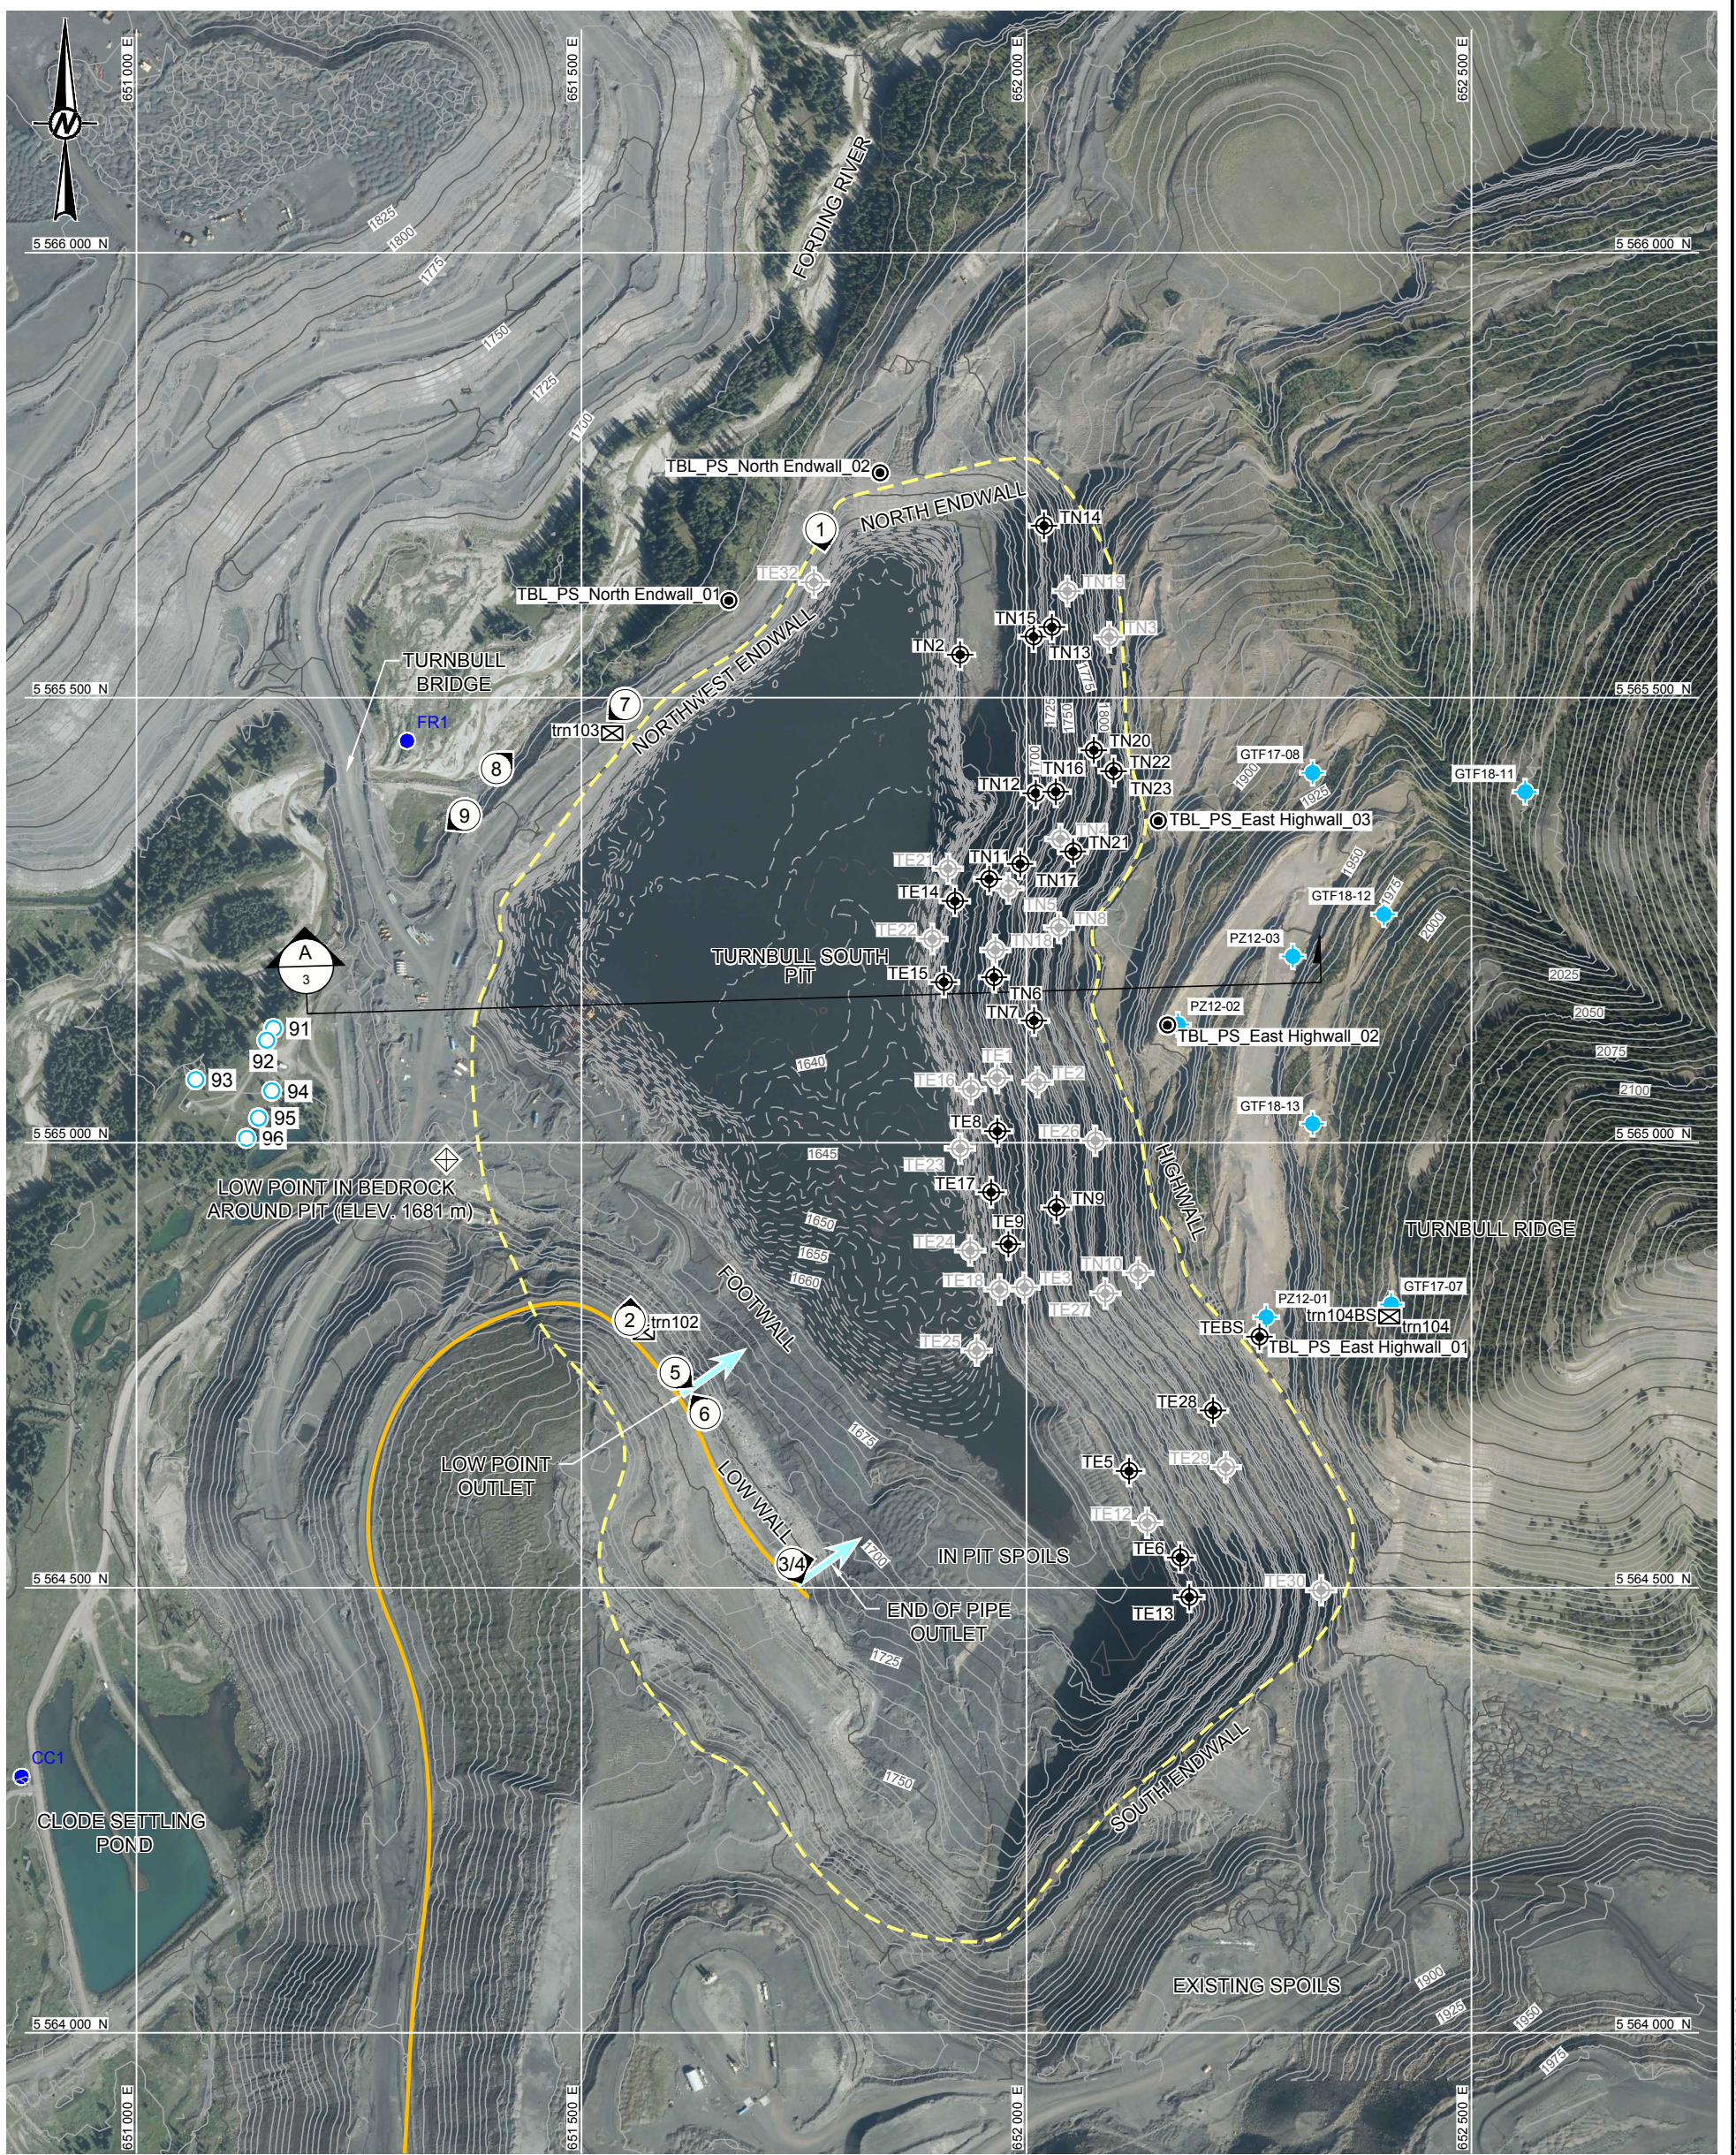
PROJECT	2022 ANNUAL FACILITY PERFORMANCE REPORT FOR TURNBULL TAILINGS STORAGE FACILITY		
TITLE	2022 SITE INSPECTION PHOTOGRAPH AND MONITORING LOCATIONS		
PROJECT NO.	22516328	PHASE/TASK/DOC.	1000/1400/2022-119
REV.	0	REV.	0
FIGURE	2

Appendix A presents a summary of photographs of the Turnbull TSF from the site inspection. The location, direction, and number for each photograph are noted in Figure 2.

There are 26 active prisms installed on the highwall of the TBS Pit. There are five GPS units on the highwall and endwalls of the TBS Pit. The spoils and highwall are monitored due to the potential for a failure to create a subaerial landslide that could result in a wave overtopping the facility via the low point on the west side of the pit. Instrumentation locations are shown in Figure 2.

There are 21 prisms that did not have location data collected over the past year and they are shown in grey in Figure 2. Prisms along the lower portions of the highwall will become inactive as the TSF pond elevation rises.
