**REPORT**

**2022 Annual Facility Performance Report**  
*Greenhills Operations Tailings Storage Facility*

**Teck Coal Limited**

Reference No. 22516234-2022-137-R-Rev0-2000

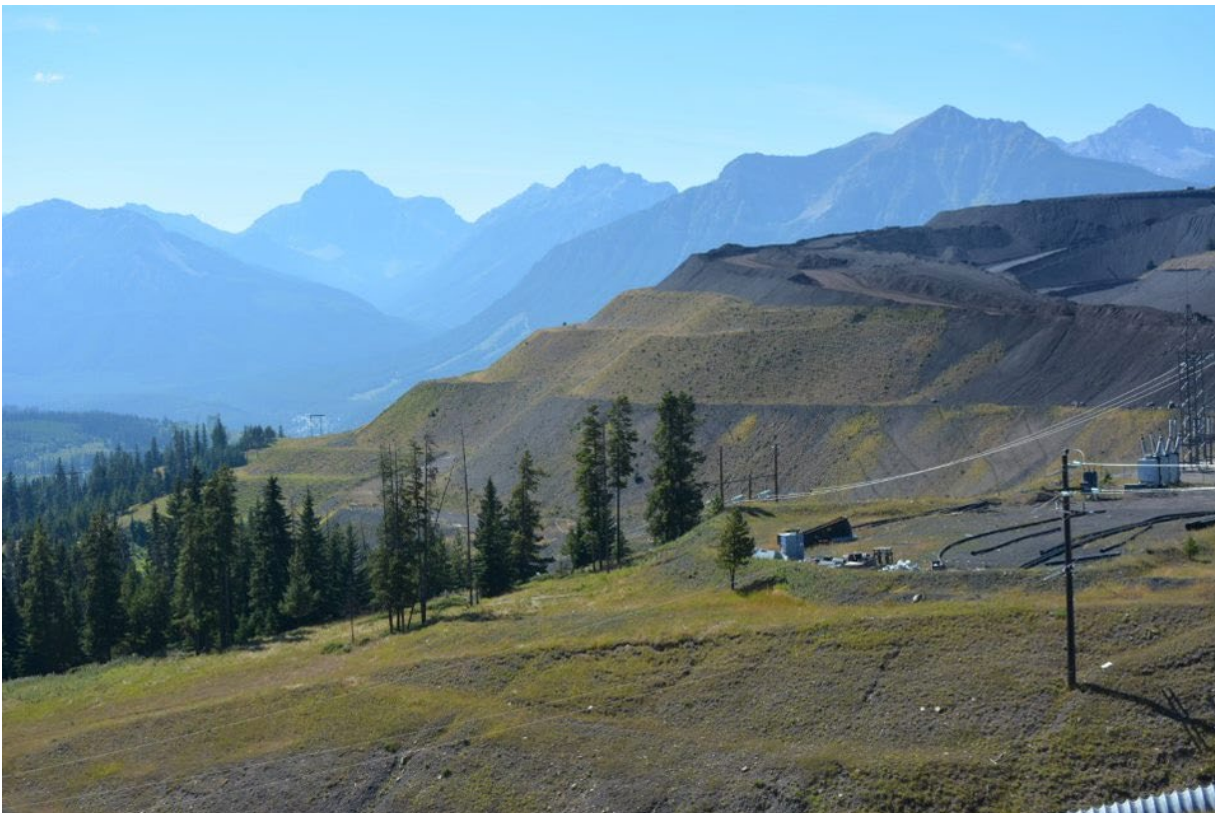
**Photograph 26: Site C CCR Facility – Downstream Slope, Looking Southwest, 30 August 2022**

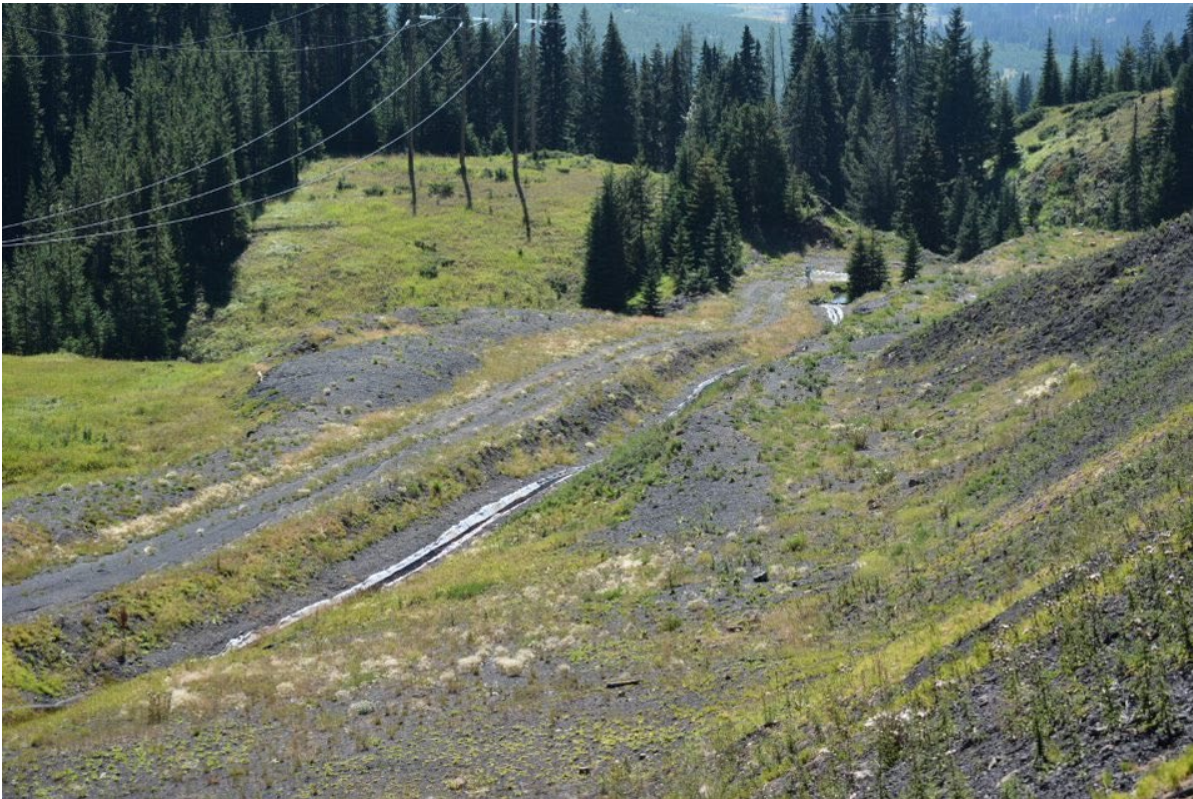
**Photograph 27: Site C CCR Facility – Smart Drain at Toe, Looking Southwest, 30 August 2022**

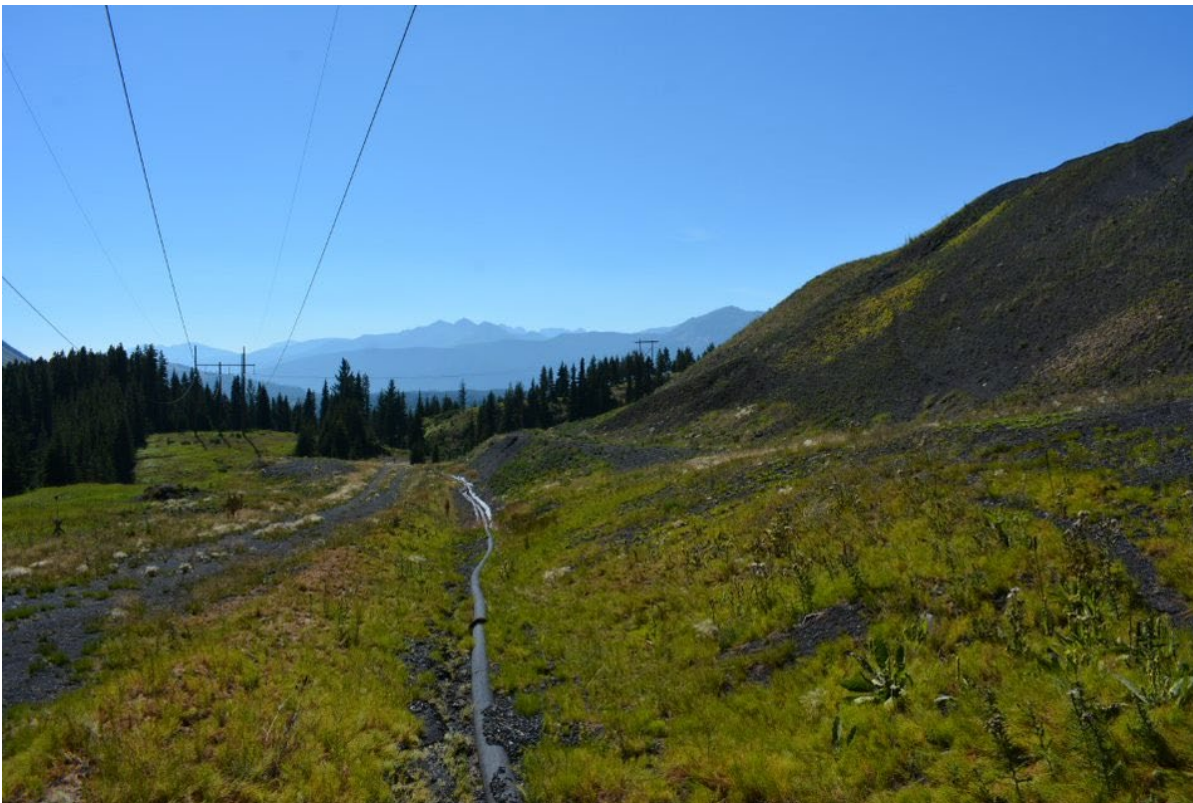
A high-density polyethylene pipe collects surface water from the lower bench at Site C and conveys the water to the seepage collection channel at the toe of the Site C CCR stockpile (Photo 28 and Photo 29, Appendix A). This flow reports to the Site C Weir and is not measured separately. It is therefore not possible to distinguish whether flow at the Site C Weir is due to increased seepage or surface runoff from the lower bench at Site C. It would be preferable to convey the flow from the high-density polyethylene pipe away from the seepage collection channel to allow for more accurate monitoring of seepage from the MTD.

**Photograph 28: Site C CCR Facility – Toe area and surface water pipe, Looking South, 30 August 2022**

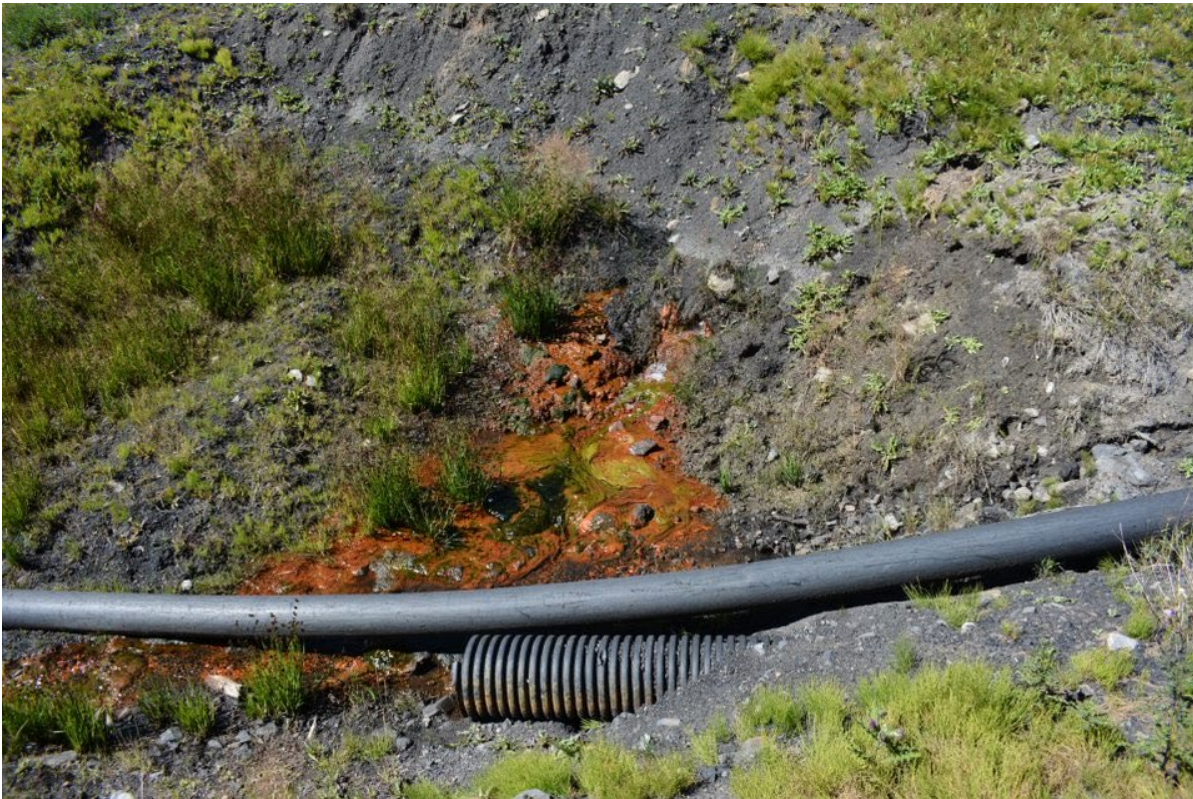
**Photograph 29: Site C CCR Facility – Underdrain Seepage Flow, Looking Northwest, 30 August 2022**

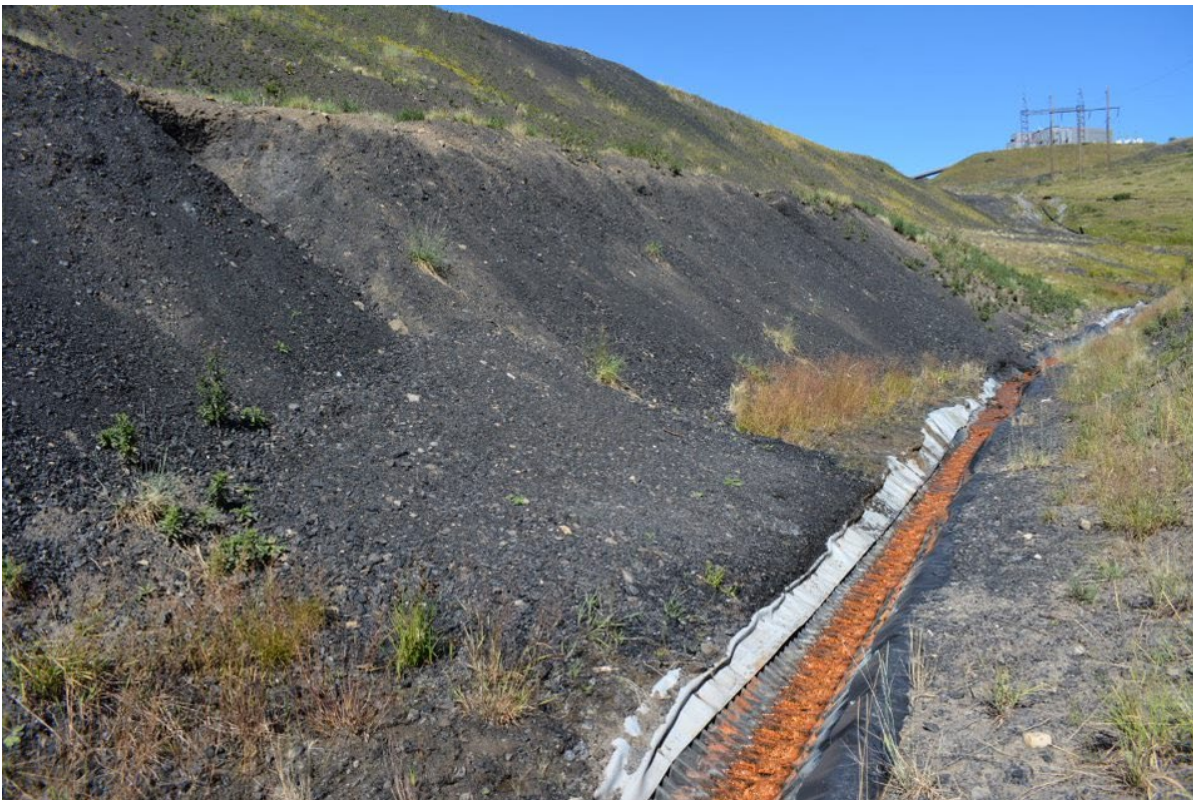
**Photograph 30: Site C CCR Facility – Smart Drain at Toe, Looking Northeast, 30 August 2022**

4.1 Seepage from Dam	Seepage/surface water runoff observed from Site C rockdrain and in Smart Ditch channel.	29, 30, 31	
4.2 Signs of Erosion	Erosion of natural ground downstream of Site C from surface water runoff reactivating movement of active landslide on natural ground east of Site C.

4.3 Signs of Turbidity in Seepage Water	None observed.		
4.4 Discoloration/Staining	Iron staining in seepage.	29, 30, 31	
4.5 Outlet Operating Problem (if applicable)	Sloughing into Smart Ditch.	31	Remove sediment from collection channel as part of routine maintenance.

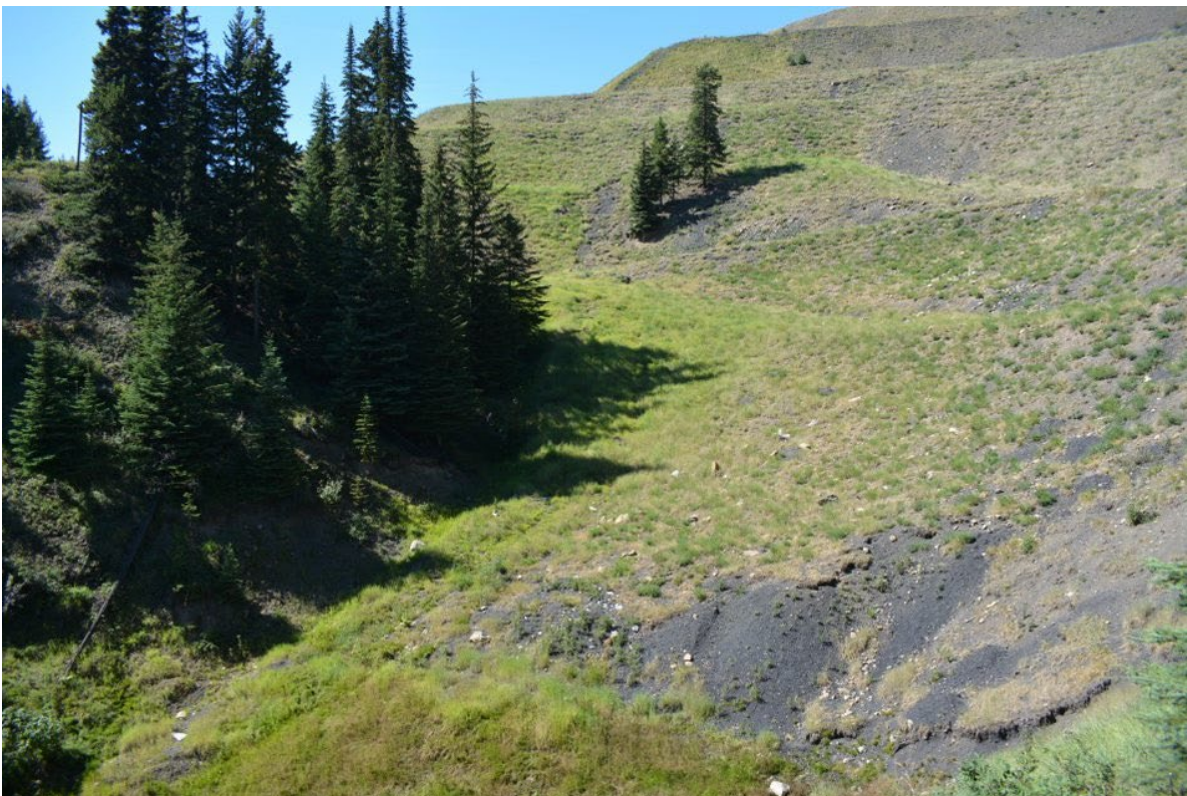
**Photograph 32: Site C CCR Facility – Toe Area and Weir Discharge, Looking west, 30 August 2022**

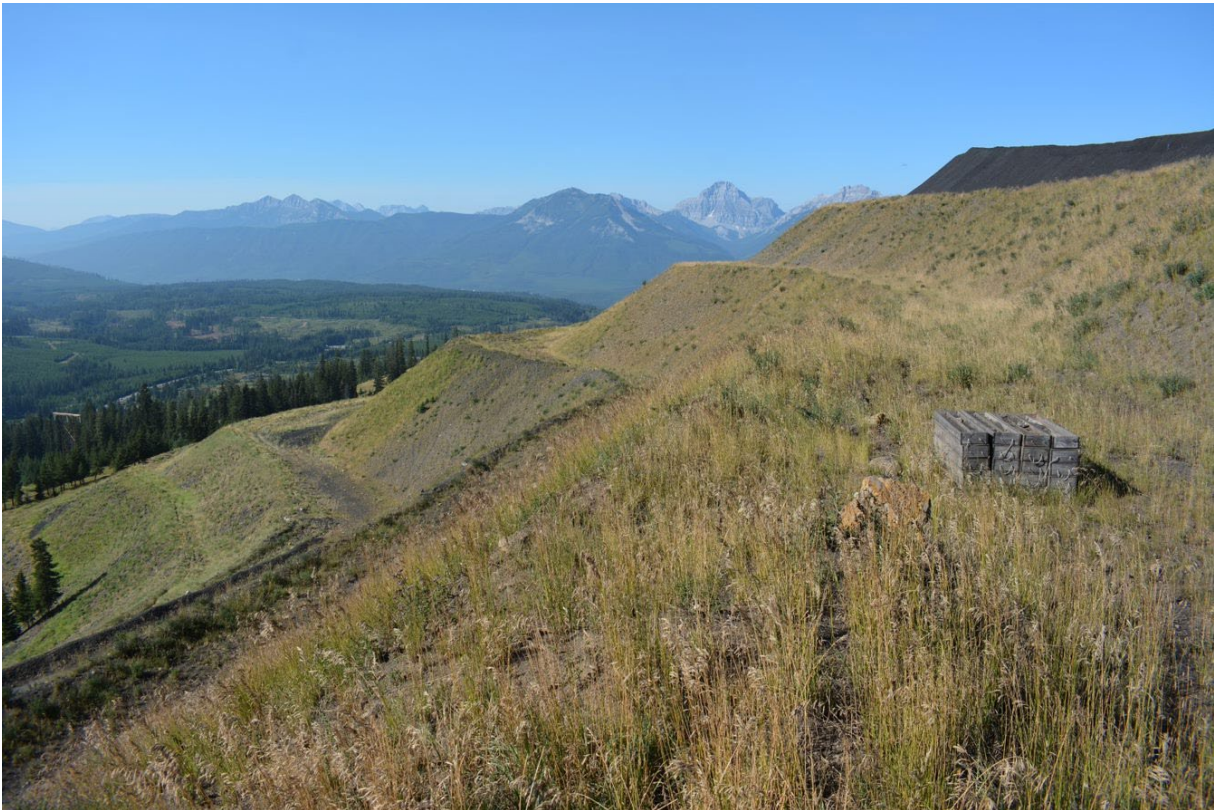
**Photograph 33: Site C/D CCR Facility – Downstream Slopes, Looking southwest, 30 August 2022**

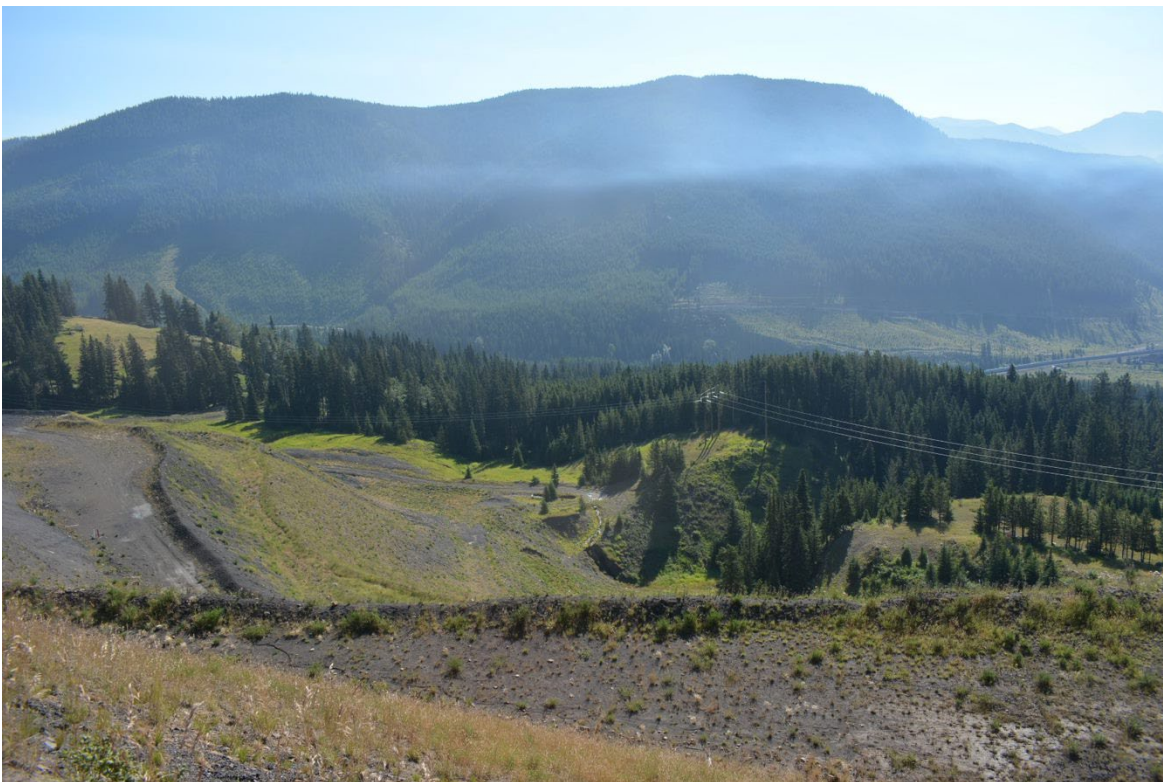
**Photograph 36: Site D CCR Facility – Downstream Slope and Toe Area, Looking southeast, 30 August 2022**

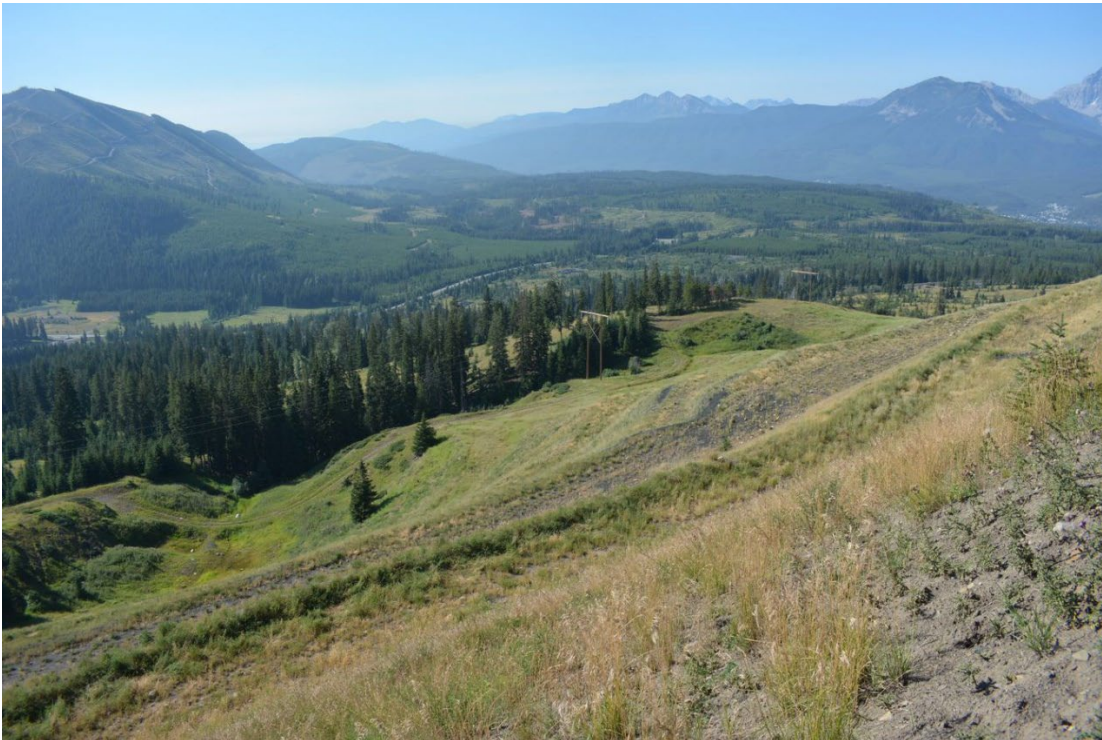
**Photograph 37: Site D CCR Facility – Downstream Slope and Toe Area, Looking southwest, 30 August 2022**
