Teck Highland Valley Copper Partnership

2022 Annual Facility Performance Report

Bethlehem No.1 Tailings Storage Facility

March 2023

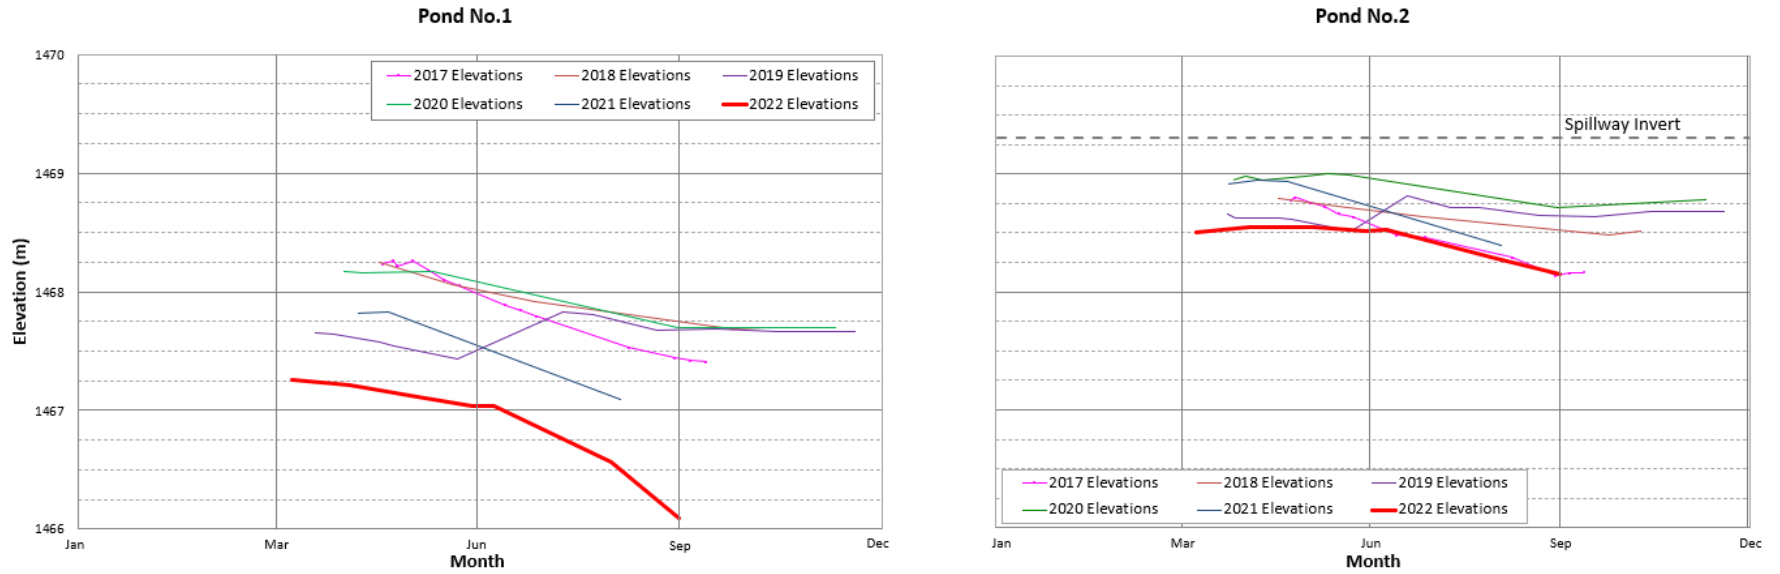
Figure 5.1 Bethlehem TSF Pond No. 1 and Bethlehem TSF Pond No. 2 Pond Levels – 2017 to 2022

- During 2022, the pond level followed the established seasonal pattern (Figure 5.1), reaching the peak early in the year, related to freshet, and then dissipating during the remainder of the year. One exception was the levelling of the pond from June to July, which coincides with the above-average precipitation during those months (Section 4.2).
- Since the end of 2019, the pond level has shown a steady decrease, approximately 1.1 m, when comparing pond levels from September 2019 to 2022. This pattern has been observed in the past as the pond level has fluctuated since operations were suspended (Table 5.2).

- During 2022, the pond level followed the established seasonal pattern (Figure 5.1), reaching the peak early in the year, related to freshet, and then dissipating during the remainder of the year.
- The peak pond level during the review period was about 0.4 m lower than the previous year, but that gap reduced to 0.1 m by the end of the review period; refer to Figure 5.1 and Table 5.3. This is attributed to the above-average rainfall in June and July (Section 4.2), which delayed pond drain down over that period.

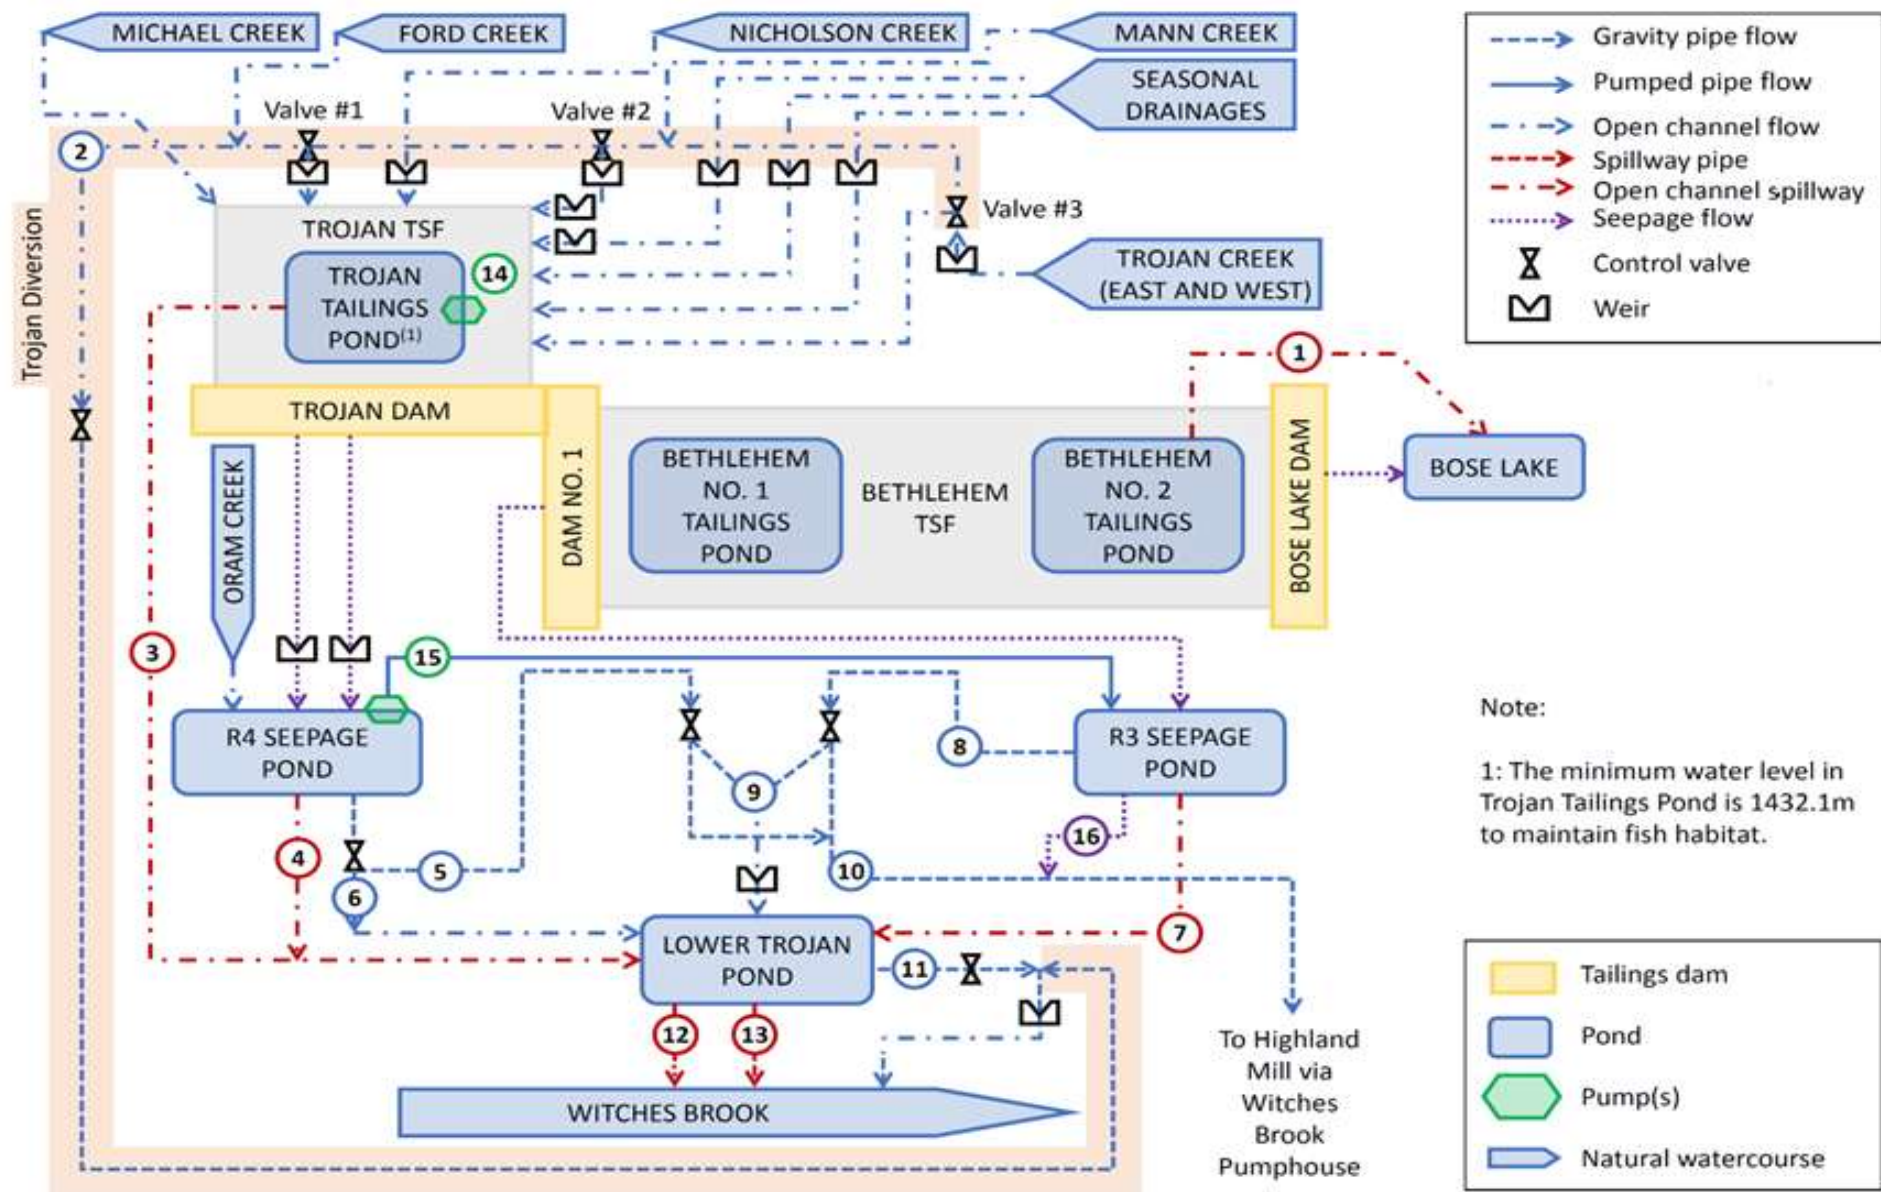
PROJECT BETHLEHEM NO.1 TAILINGS STORAGE FACILITY 2022 ANNUAL FACILITY PERFORMANCE REPORT	
	TITLE FLOW SCHEMATIC FOR BETHLEHEM No. 1 AND TROJAN TAILINGS STORAGE FACILITIES	
	SCALE	FIG. No.
	NTS	M02341C42

On June 29, 2022, water from the R3 Seepage Pond was discharged through the spillway. This was caused by a blockage in the Low-Level Outlet (LLO) upstream of the junction where outflows from the R3 Seepage Pond and from the R4 Seepage Pond mix (Item 9 on Figure 6). The spillway performed as intended, which is to release water from the basin before it approaches the crest and prevent overtopping. However, based on the conditions under which this occurred, HVC reported the event to the regulator as an unauthorized discharge.

While HVC worked to remove the obstruction from the LLO, they mobilized a pump to the R3 Seepage Pond that pumped water to the R4 Seepage Pond to maintain the pond level below the spillway invert. HVC was able to partially clear the obstruction from the LLO sufficient to manage the pond level without the aid of pumping. HVC is planning additional works to restore full functionality of the LLO pipe (i.e., clear remaining obstructions and modify the pipe grade to prevent a recurrence). Until this work is completed, KCB recommends HVC maintain standby pumping at the R3 Seepage Pond during freshet to prevent the likelihood of a similar event.

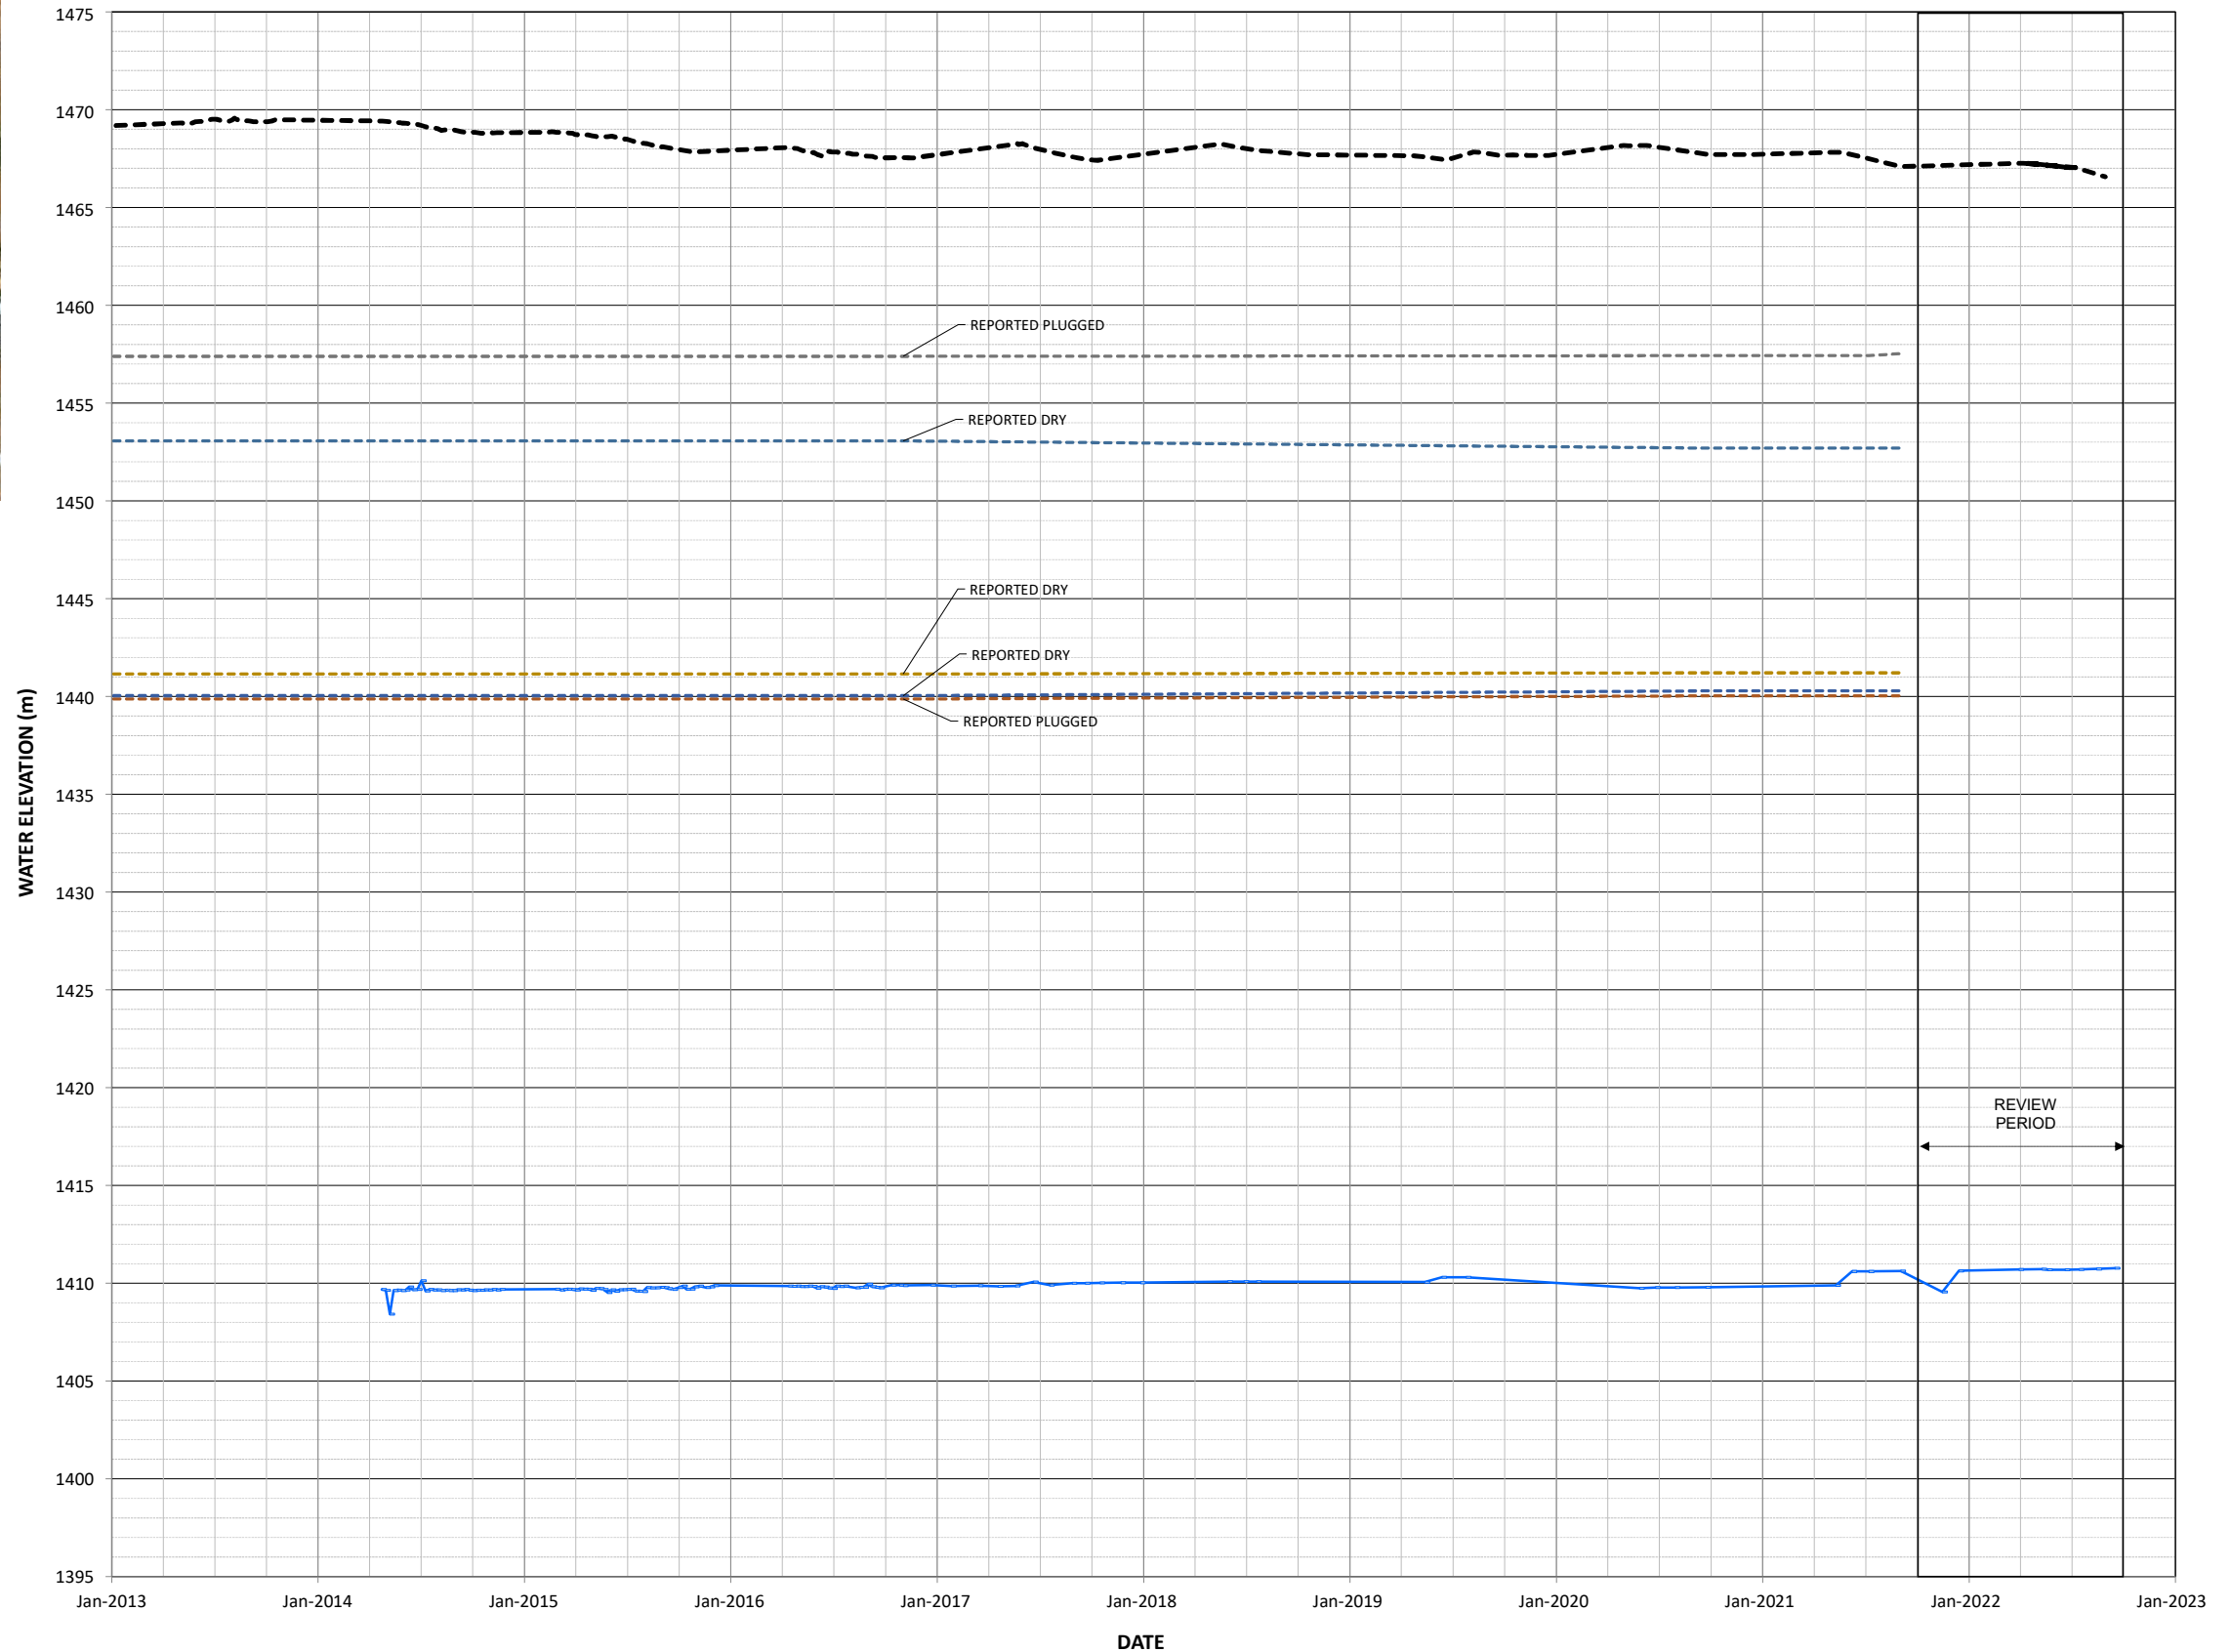
PROJECT: BETHLEHEM NO. 1 TAILINGS STORAGE FACILITY 2022 ANNUAL FACILITY PERFORMANCE REPORT TITLE: DAM No. 1 PIEZOMETRIC DATA YEARS 2013 TO 2022 CREST PROJECT No. M02341C42 FIG No. 9

- Crest Area Piezometers (Figure 9): Of the six piezometers installed near the crest (all of which are in dam fill or cycloned sand beach), only one is below the water table. Although the other piezometers have been measured as “dry” for 10 years, they provide value in demonstrating that the piezometric level in the cycloned sand beach remains low and is not rising.

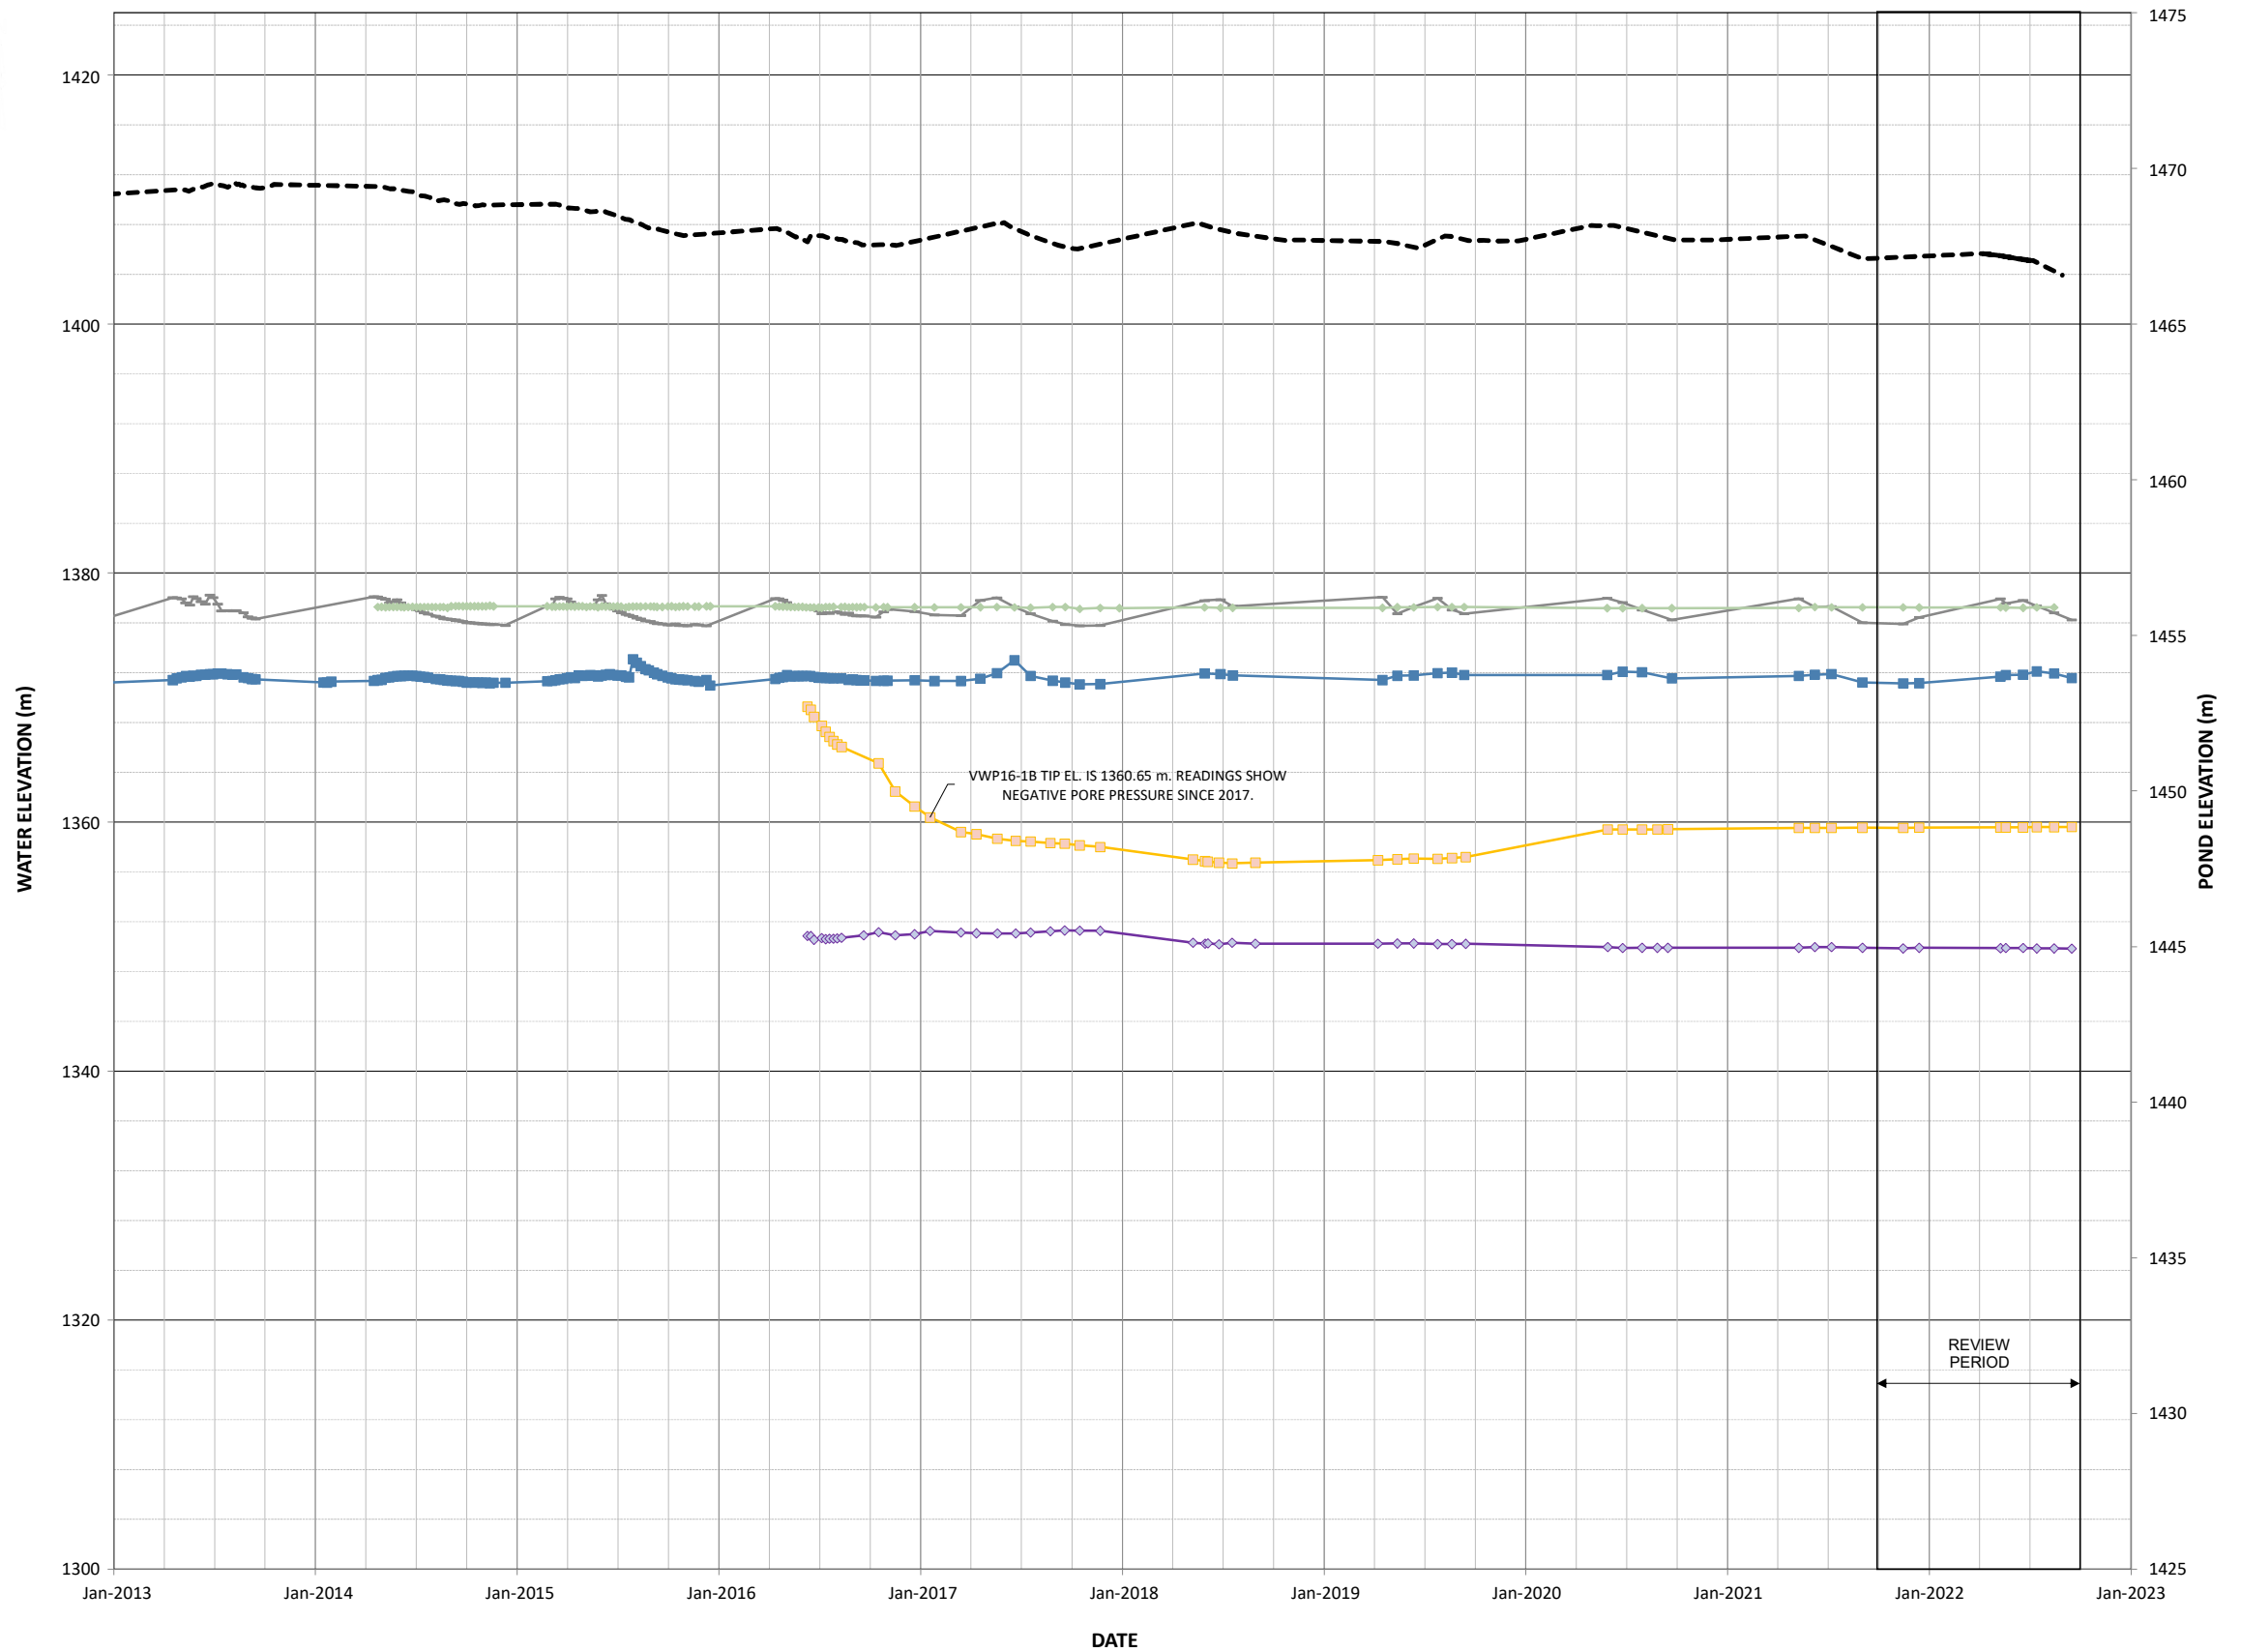
- Downstream Slope Piezometers (Figure 10): Levels and trends are consistent with previous years and continue to indicate a downward gradient through the foundation.

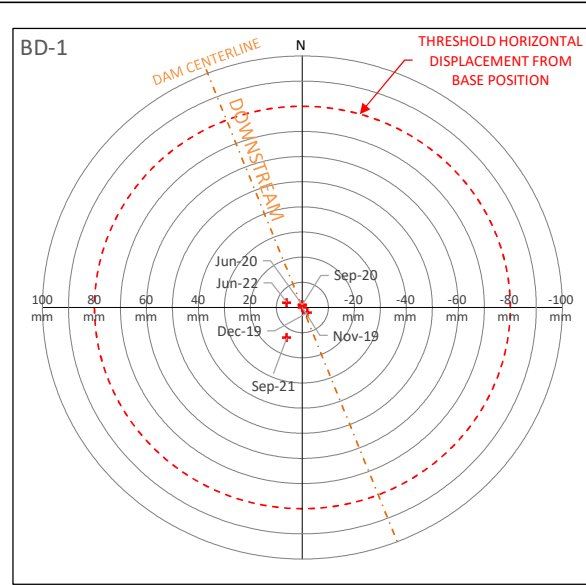
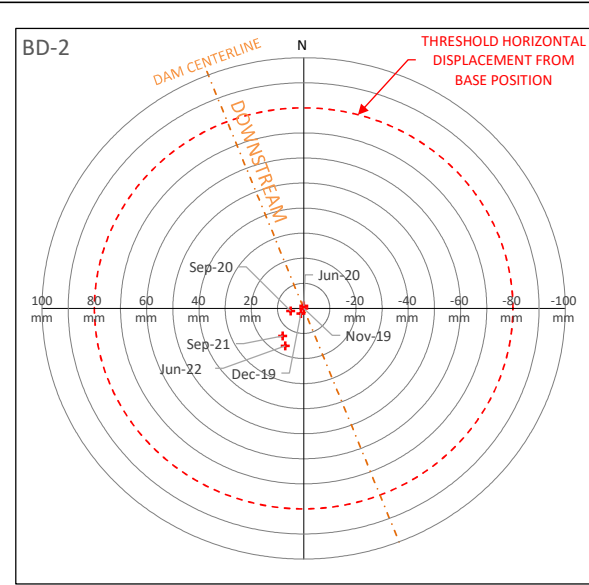
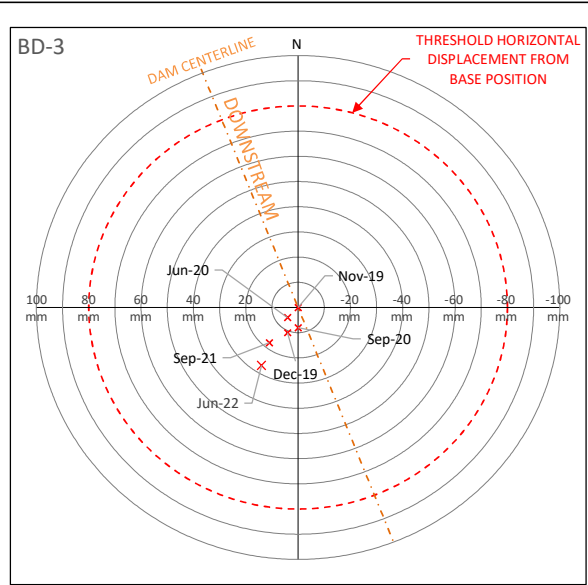
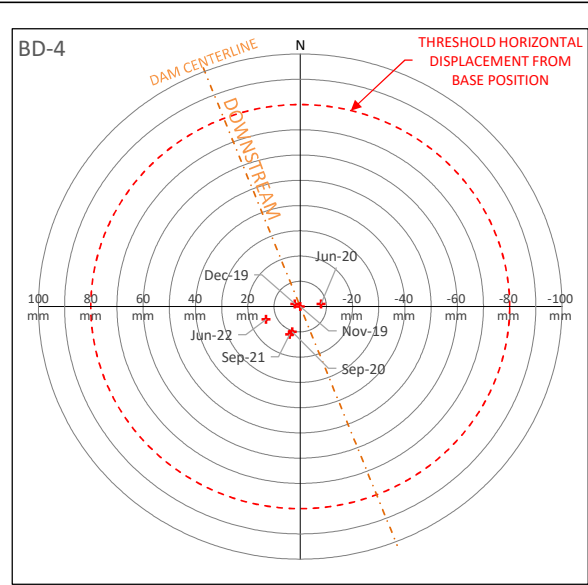
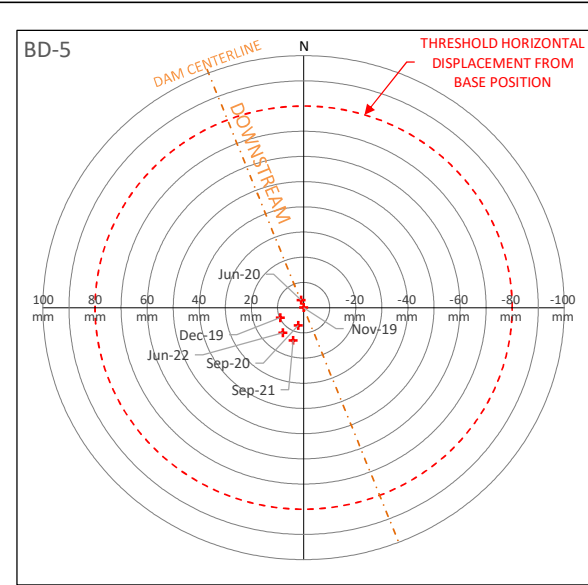
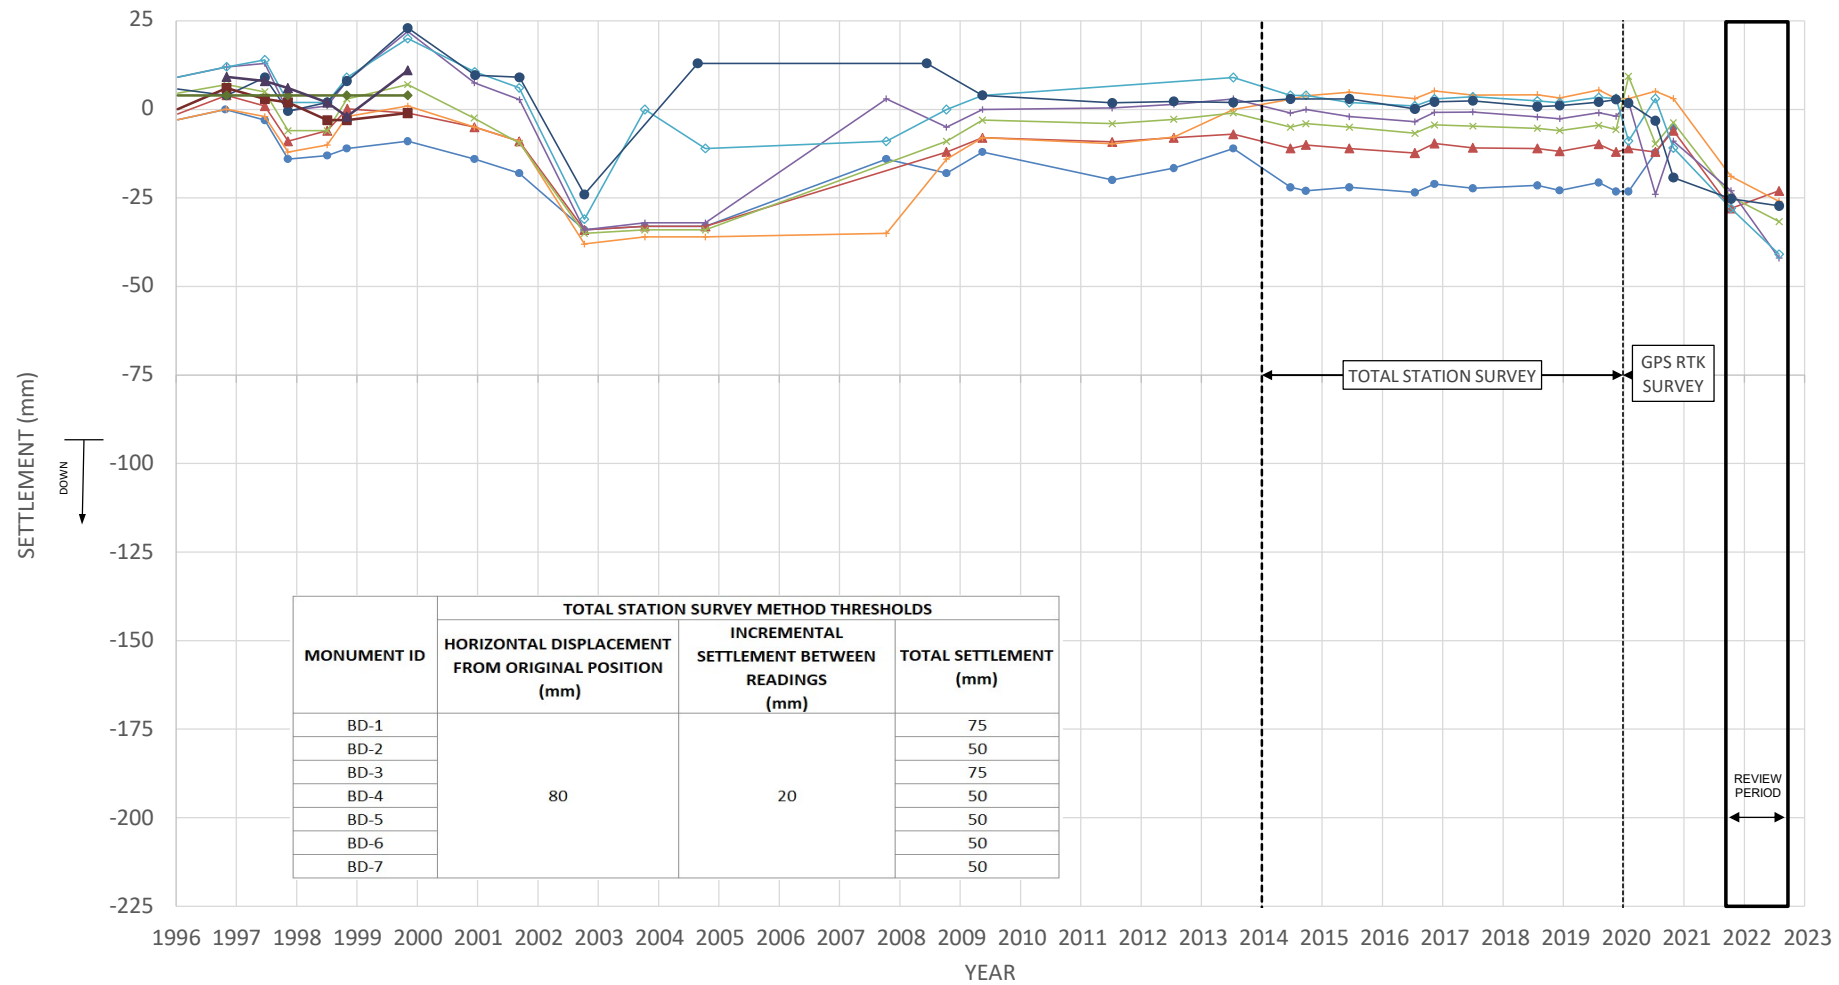
January 13, 2023
\\int.klbn.com\ProData\MV\CR\0234\C42-HVC-2022 AFPR\300 Design\340 Dam Movement Monitoring\343 Survey Monuments\Bethlehem\220908 BoseLakeDamMonitoring.xlam\Fig 18

The RTK surveys have shown an improvement (i.e., less variance between readings) over the previous method with respect to horizontal location (i.e., northing/easting) but show higher variance in elevation. This pattern is evident when reviewing readings since 2020 (Figure 11 and Figure 18). For example, the Bose Lake Dam is a compacted fill dam on a competent foundation. Survey monitoring for 10 years, prior to 2020, showed very little elevation change. However, with the new survey method, all monuments are showing a settlement trend since 2020. KCB interprets this as being related to the survey method and not actual movement. There has been no change in loading or other observation at the structure that would explain this change in behaviour.

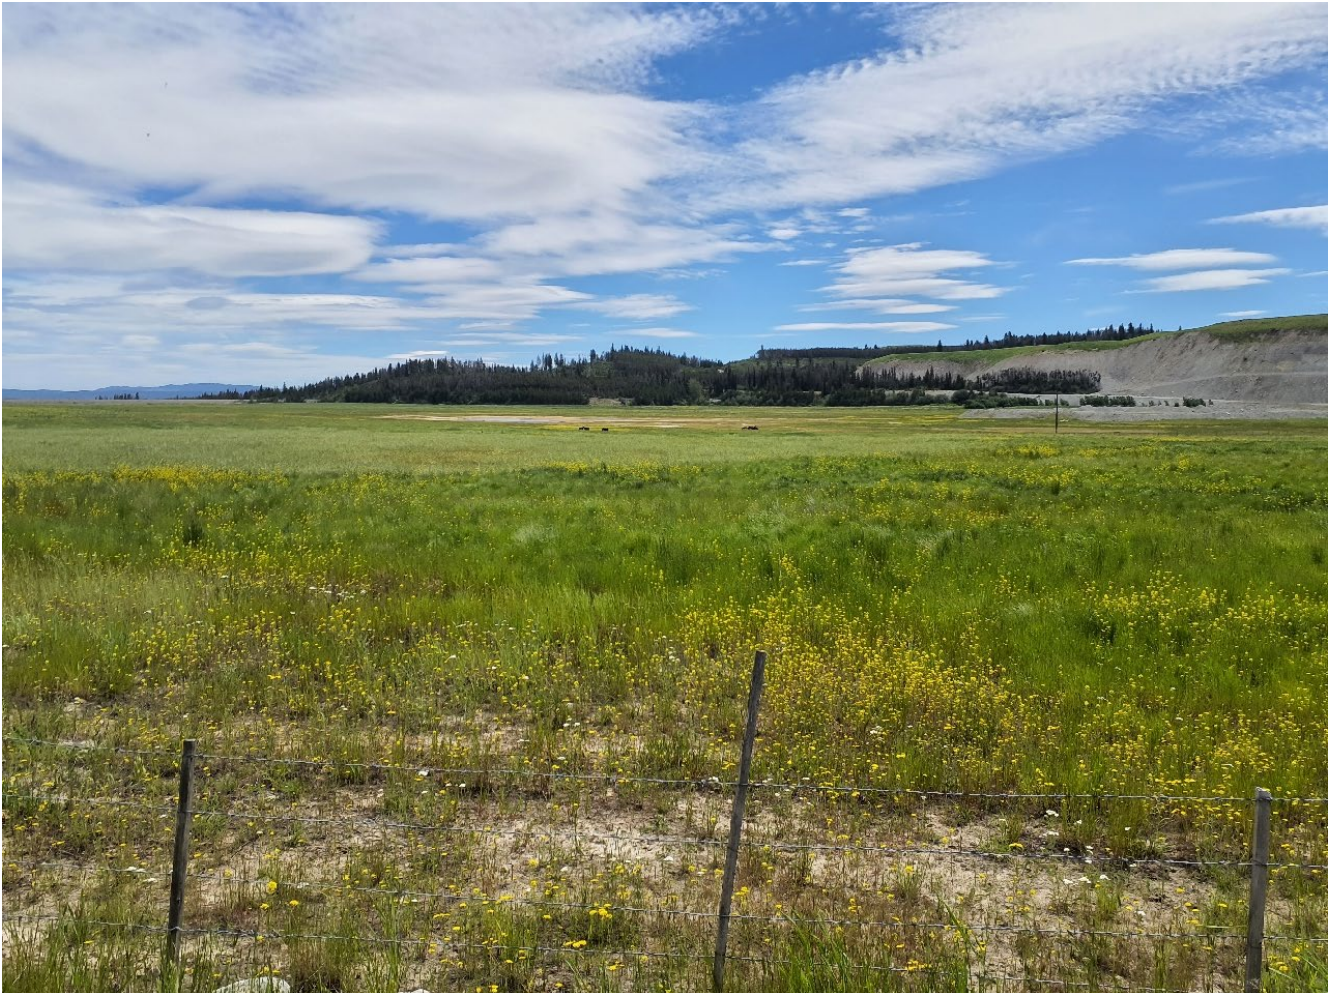
Good physical condition. There is a highpoint between the pond and the downstream slope which is upstream of the crest. The tailings beach is well vegetated. No observations of concern were noted (Photo I-A-1).

Photo I-A-1 Dam No. 1 cycloned beach and impoundment (central pond) (BTH-2022-01)

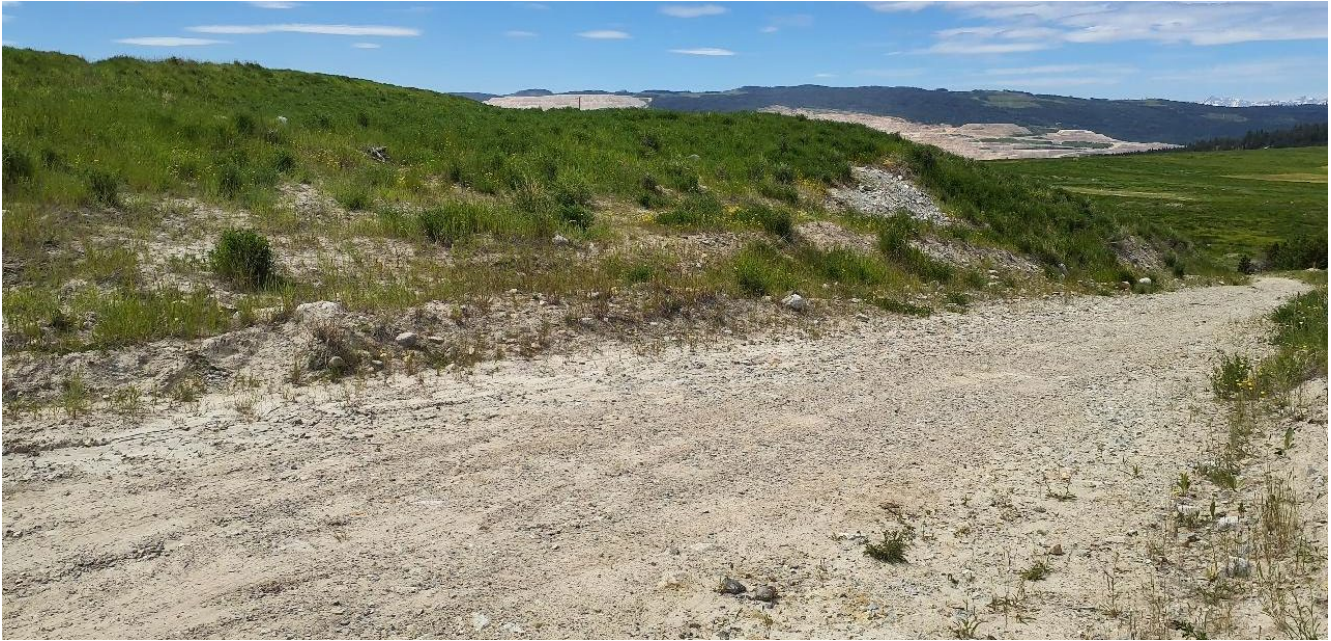
Photo I-A-2 Dam No. 1 west abutment road and transition from rockfill to elevated cyclone beach (BTH-2022-02)

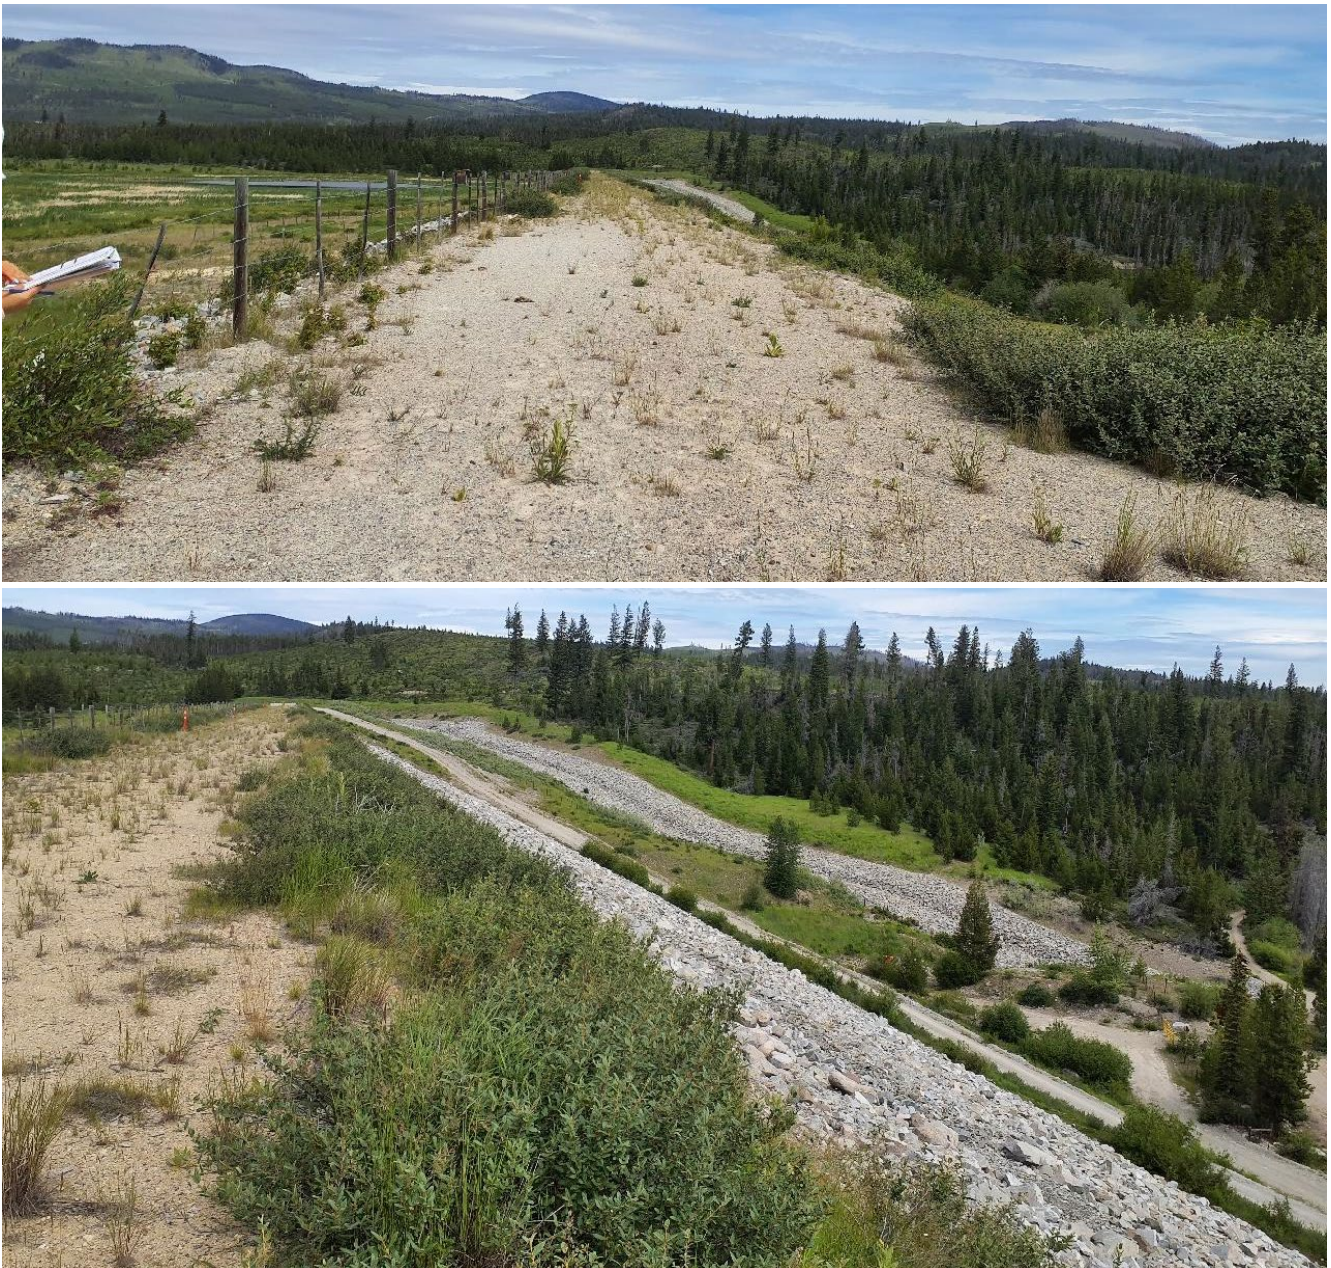
Photo I-B-1 Overview of dam crest from right abutment (top photo) and from middle of the dam (bottom photo) (BTH-2022-07 and BTH-2022-08)

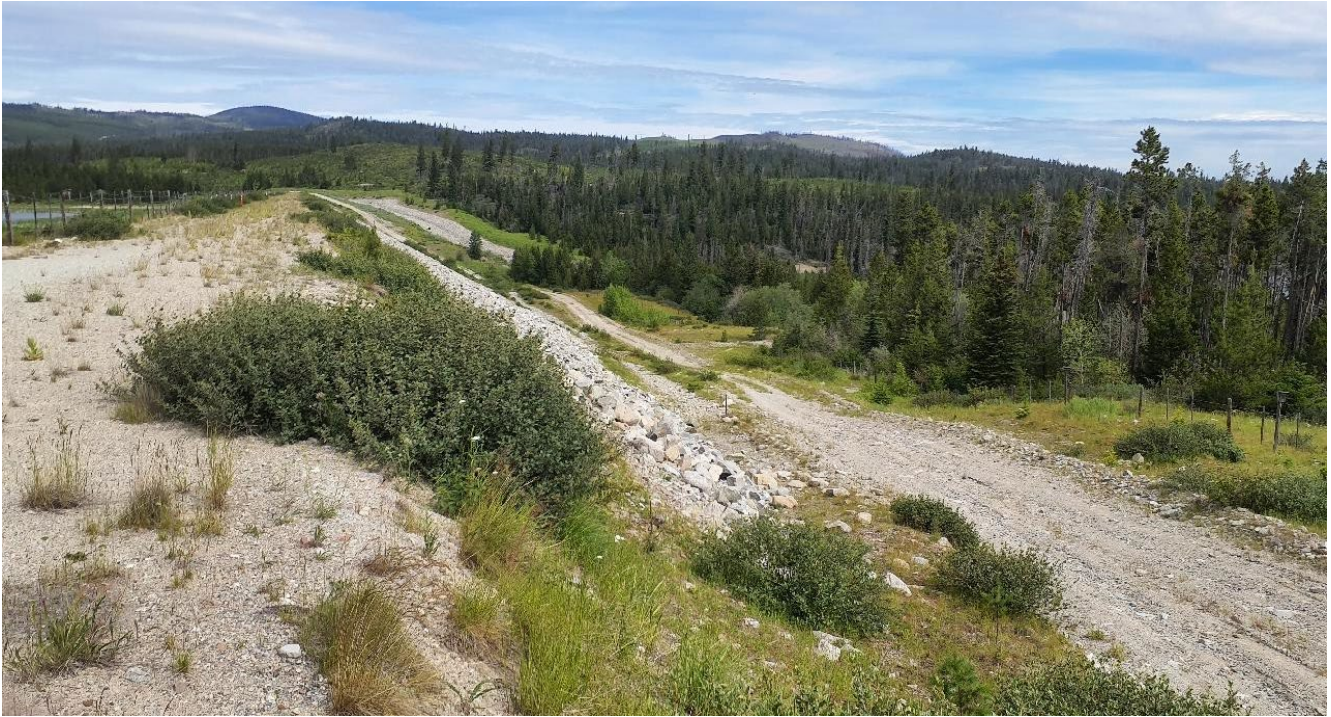
Photo I-B-2 Overview of dam crest and downstream slope from approximately the right abutment (BTH-2022-07)

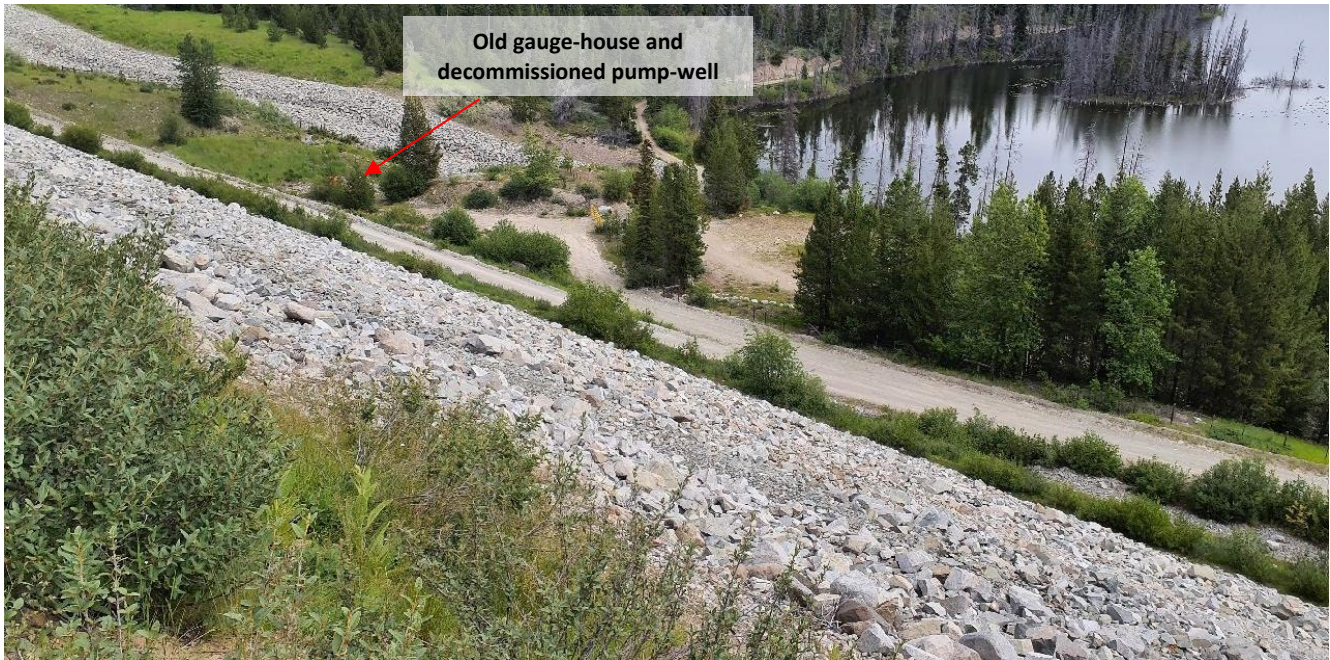
Photo I-B-4 View of downstream slope and toe area from crest looking downstream from approximately middle of dam crest (BTH-2022-08)

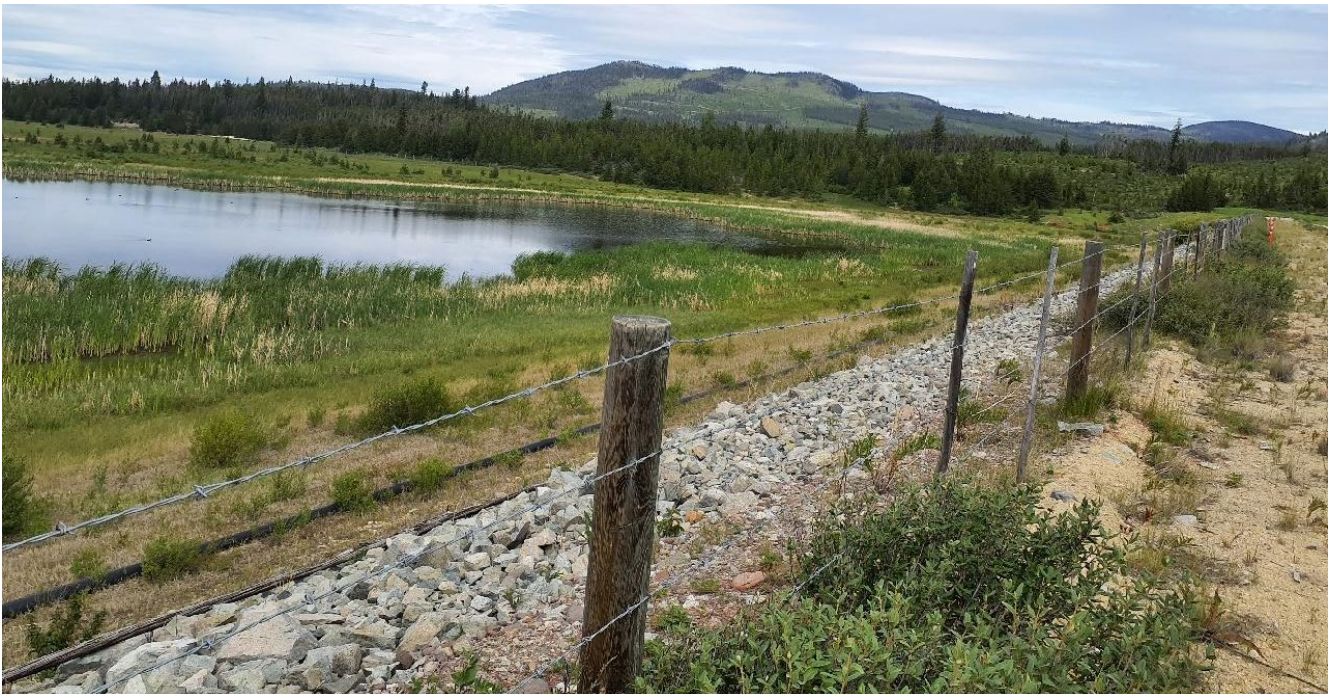
Photo I-B-7 Overview of Bethlehem No. 2 Tailings Pond and tailings beach (BTH-2022-08)

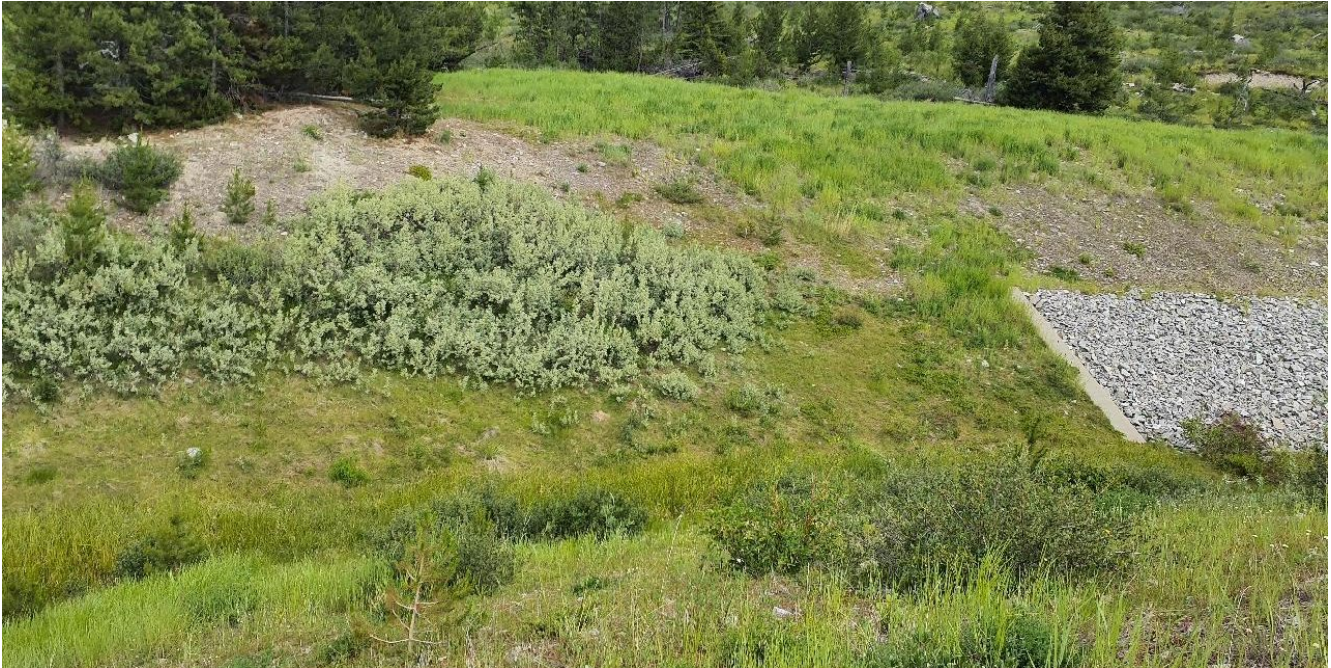
Photo I-B-10 Spillway channel at transition point between inlet and riprap-lined segment, looking towards north (BTH-2022-11)
