Teck Highland Valley Copper Partnership

2022 Annual Facility Performance Report

Bethlehem No.1 Tailings Storage Facility

March 2023

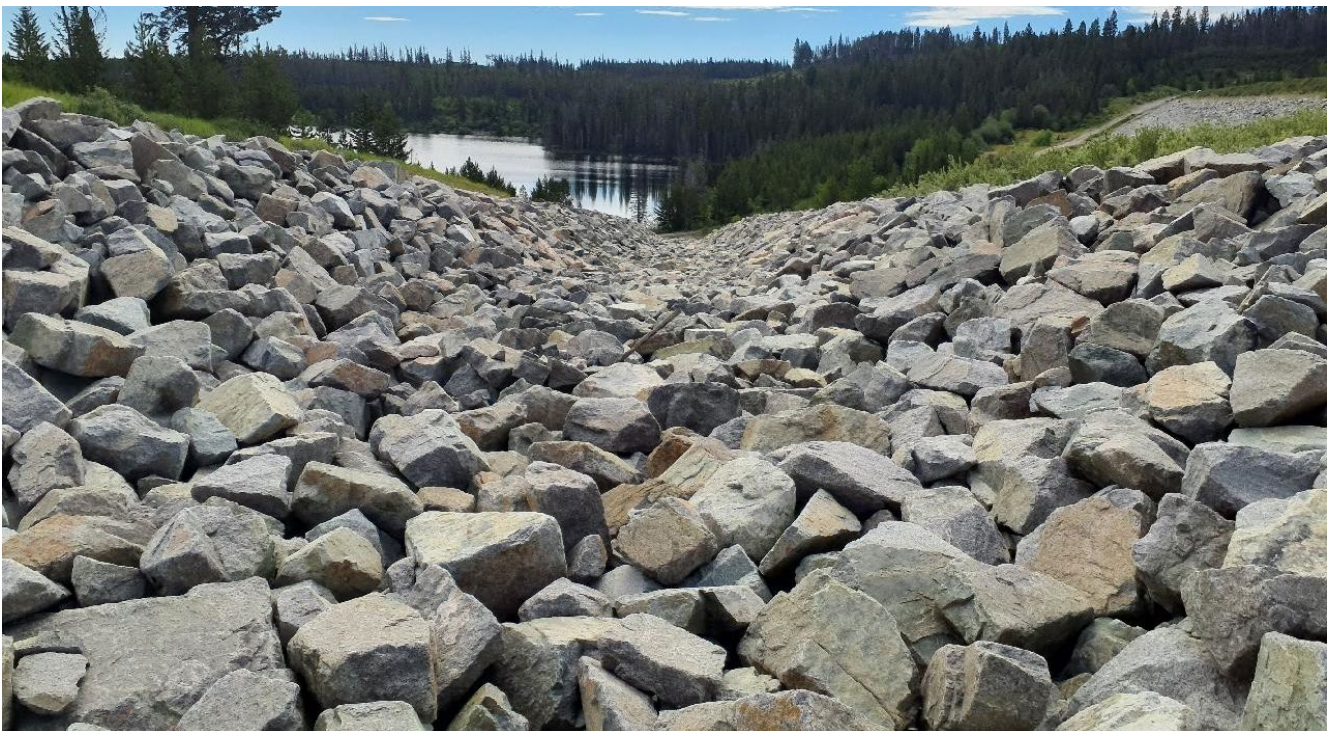
Photo I-B-11 Riprap lined portion of spillway channel looking towards Bose Lake (BTH-2022-12)

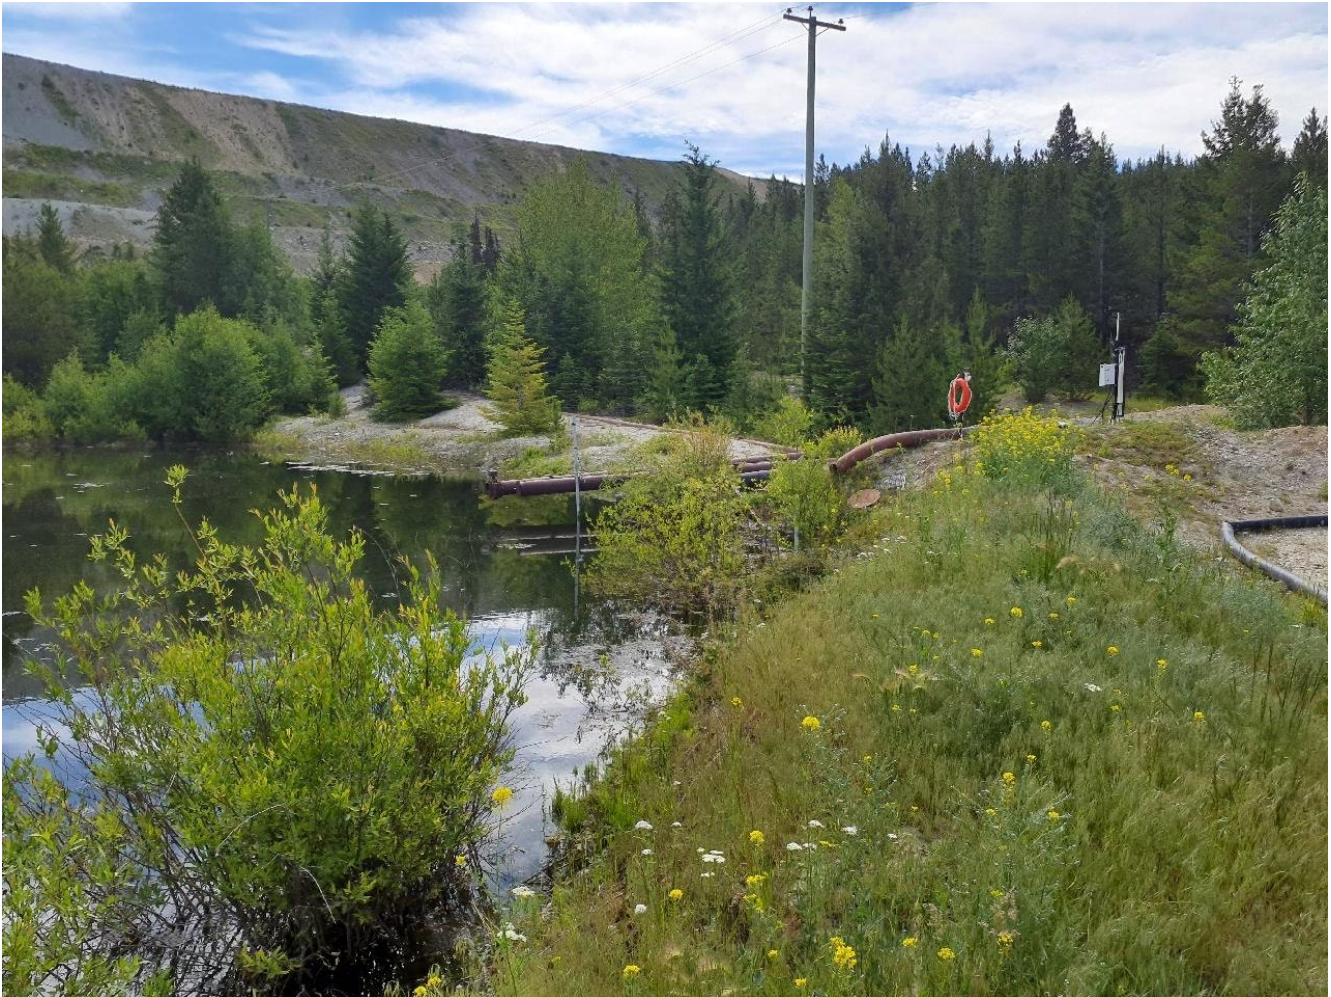
Photo I-C-1 Overview of R3 Seepage Pond (BTH-2022-13)

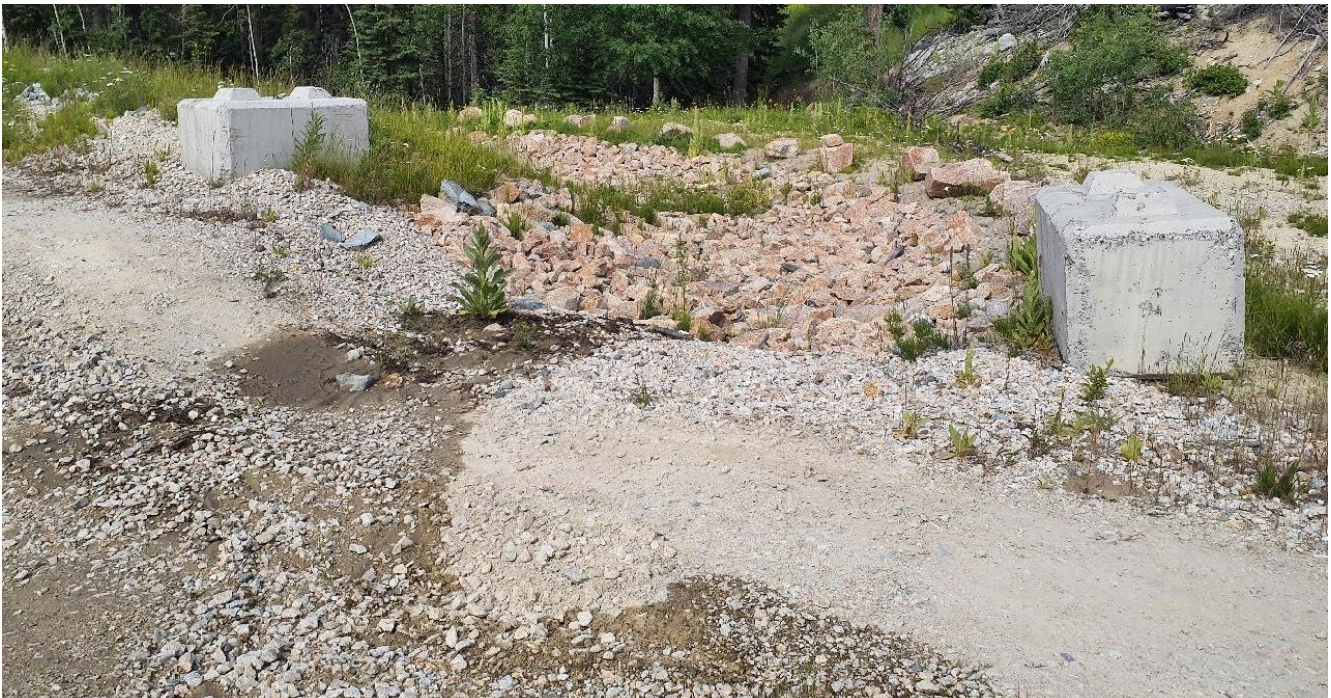
Photo I-C-5 Spillway channel and road crossing at right abutment, looking downstream (BTH-2022-15)

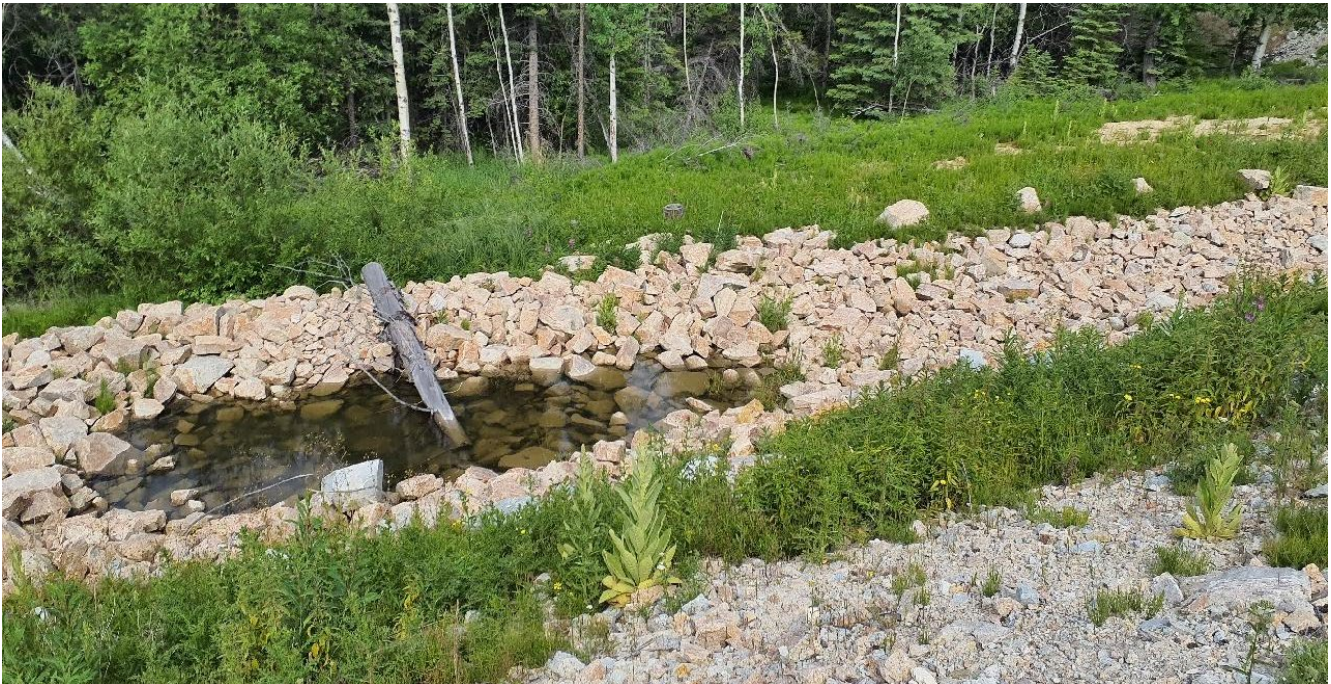
Photo I-C-6 Spillway channel at midpoint, looking downstream (BTH-2022-13)
