# **Teck Highland Valley Copper Partnership**

## **2022 Annual Facility Performance Report**

*Highland Tailings Storage Facility*

March 2023

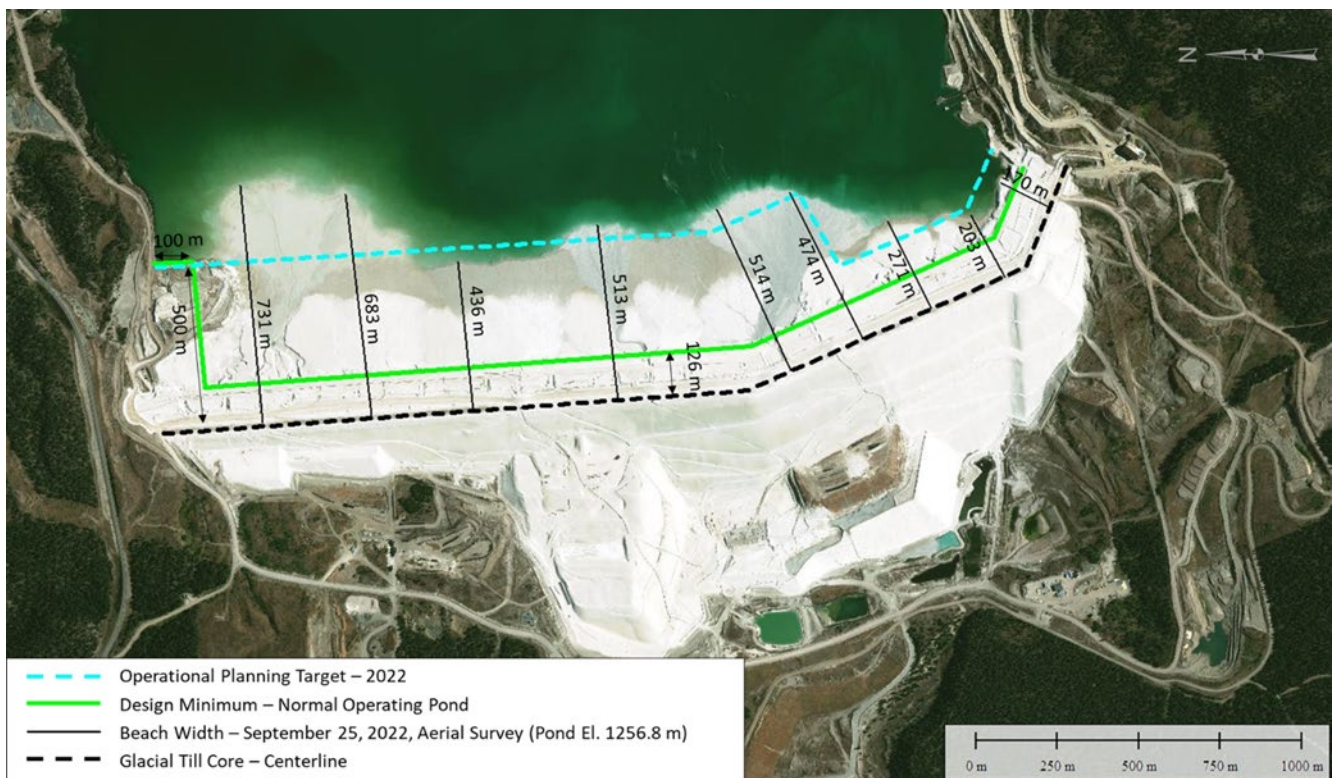
**Figure 5.3 Status of the L-L Dam Beach as of September 2022**

During September 2022 (Figure 5.3), the beach width along all the dam segments, except the South Dam, was near the 500 m target. Beach development at the South Dam met design requirements but was less than the target for the year. This was due to a delay in upgrade works to the tailings distribution works, which are required to allow beach building upstream of the South Dam without impacting the reclaim barge. These works are to be commissioned for 2023, and HVC expects to reach target widths next year and is still on track to establish the target 500 m width across the dam during 2025.

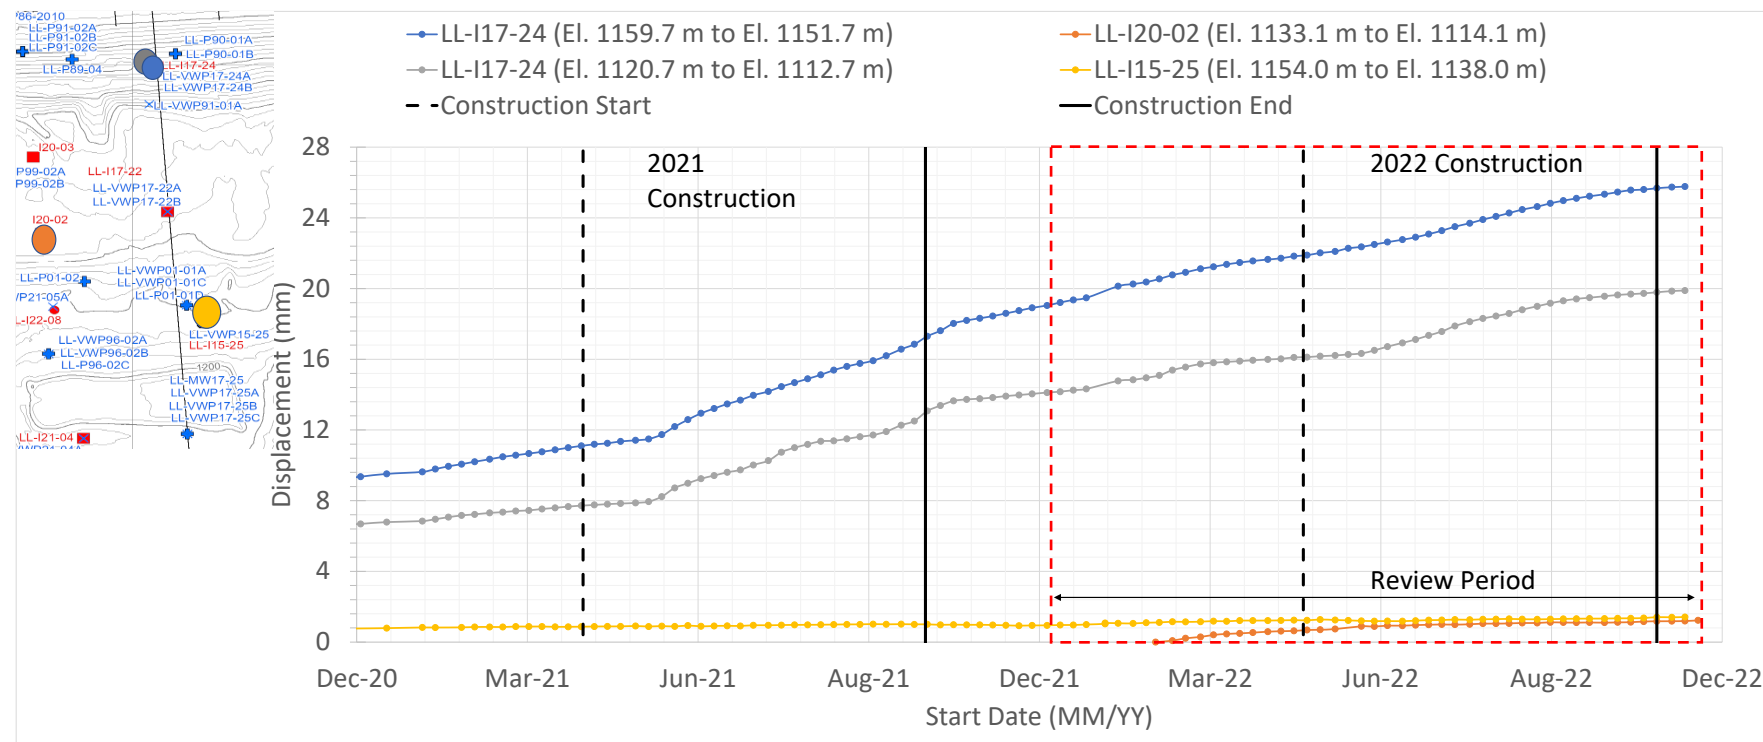
**Figure 5.11 NBB Inclinometers Deformation Along Mudstone Layers: December 2020 to November 2022**

Deformation rates are expected to increase during periods of loading, and then attenuate, which is also consistent with monitoring during the review period (Table 5.7).

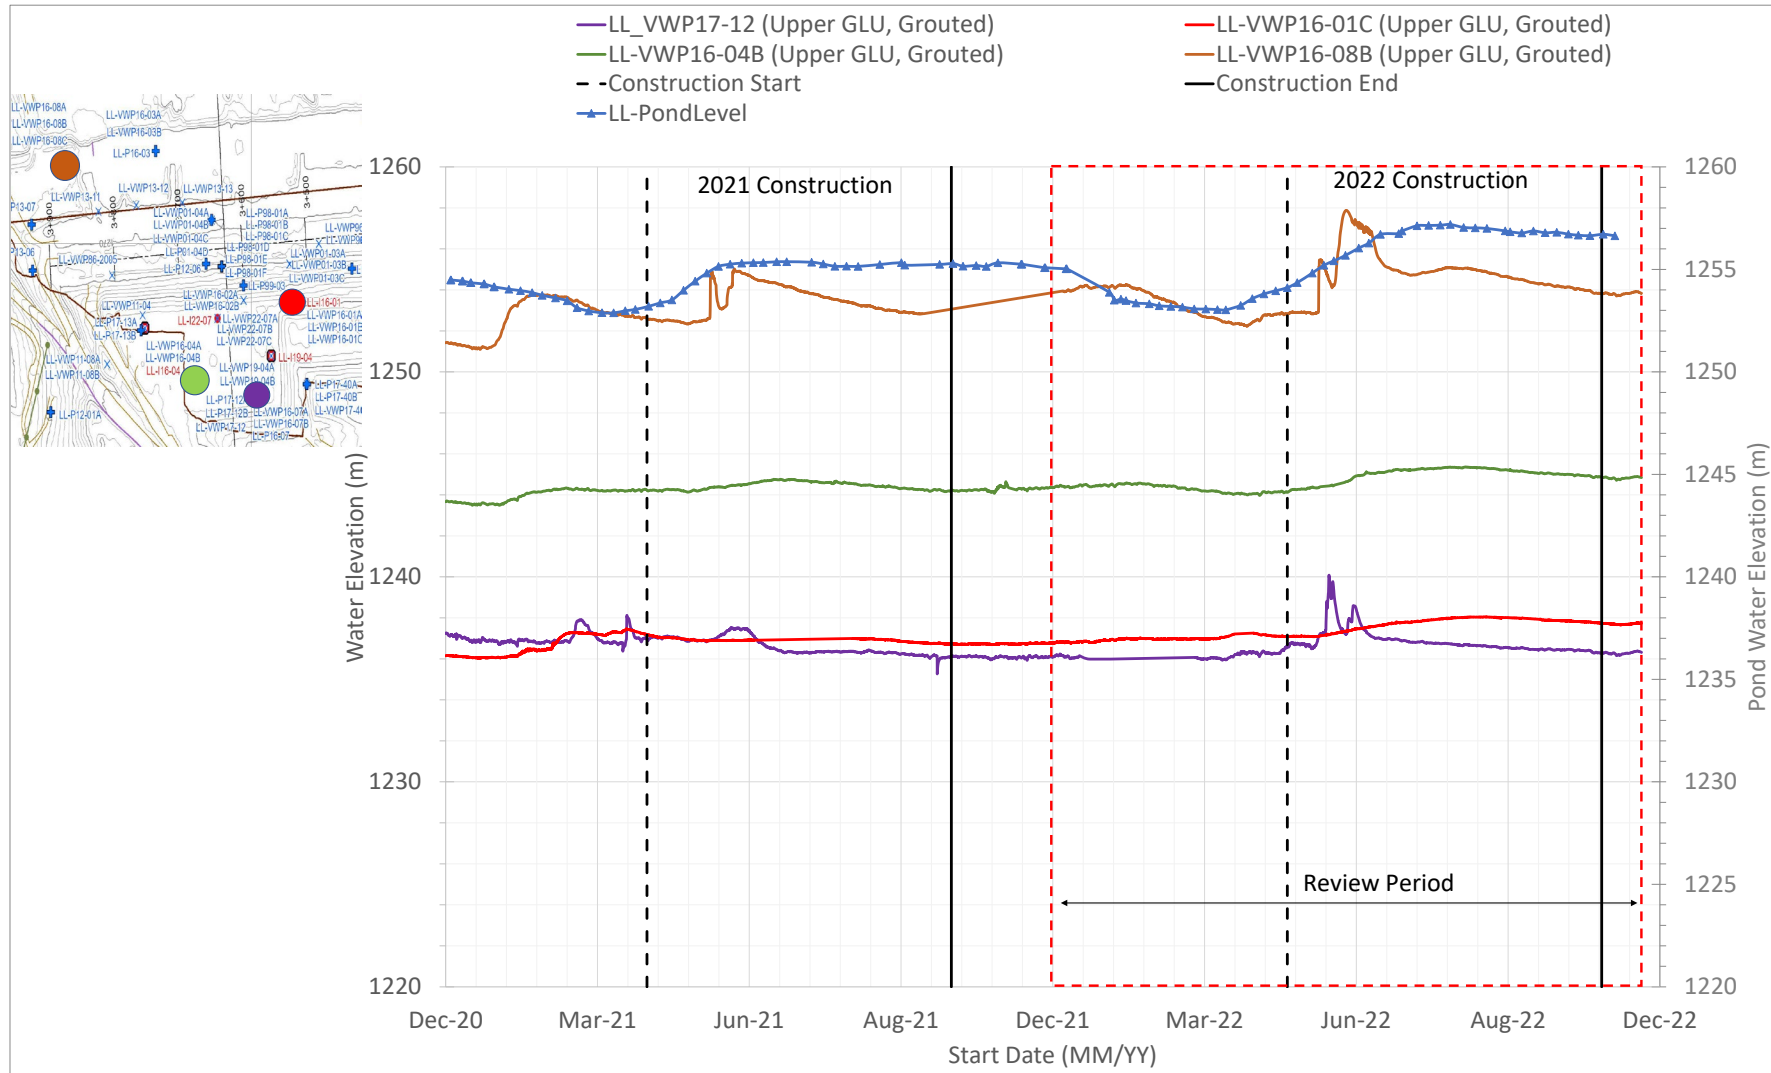
**Figure 5.14 Measured Piezometric Response in the U-GLU Near the North Abutment: December 2020 to November 2022**

- LL-VWP17-12 (U-GLU) directly below the North Dam Buttress exceeded the Notification Level threshold during hydraulic placement. The response was likely related to both loading and increased seepage related to hydraulic placement. The peak piezometric level did not exceed the level assumed in the design analysis and dissipated relatively quickly (Figure 5.14) after loading was suspended or completed. Similar response to construction activity has been observed at this instrument since 2018.
- Similar to the exceedance described at the NBB (Section 5.2.3.6), a positive piezometric pressure was measured at a standpipe piezometer LL-P99-02A (Glacial Till) previously reported as “dry.” KCB defined a new Notification Level threshold consistent with nearby instruments.

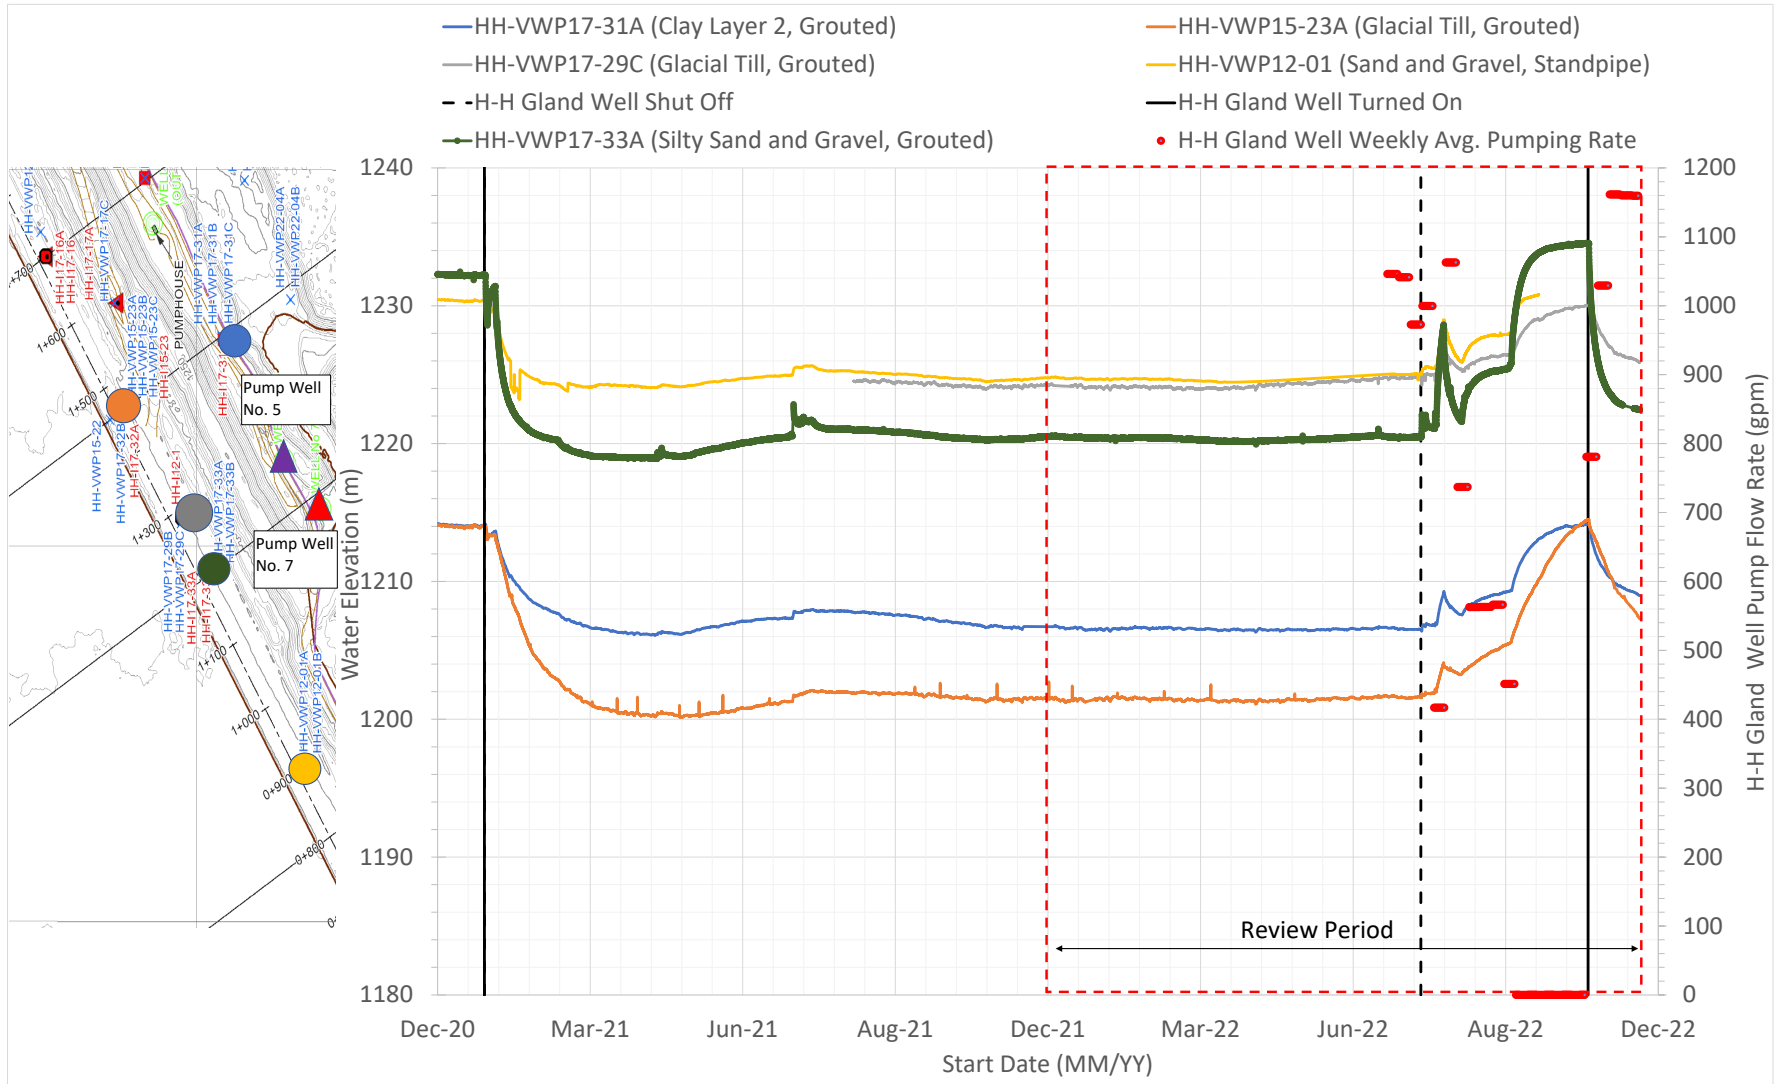
**Figure 5.17 H-H Dam Piezometric Response in Glacial Till and Underlying Units: December 2020 to November 2022**

As mentioned in Section 5.3.2.1, between July 2022 and October 2022, there was intermittent pumping from the H-H Gland Wells. This triggered a sudden rise in the piezometric levels measured in the Glacial Till and underlying foundation units (Figure 5.17). A similar disruption in pumping occurred between mid-2020 and January 2021. The corresponding drawdown from that event, after pumping was resumed, is also shown in Figure 5.17. The behaviour during both pumping disruptions was similar.

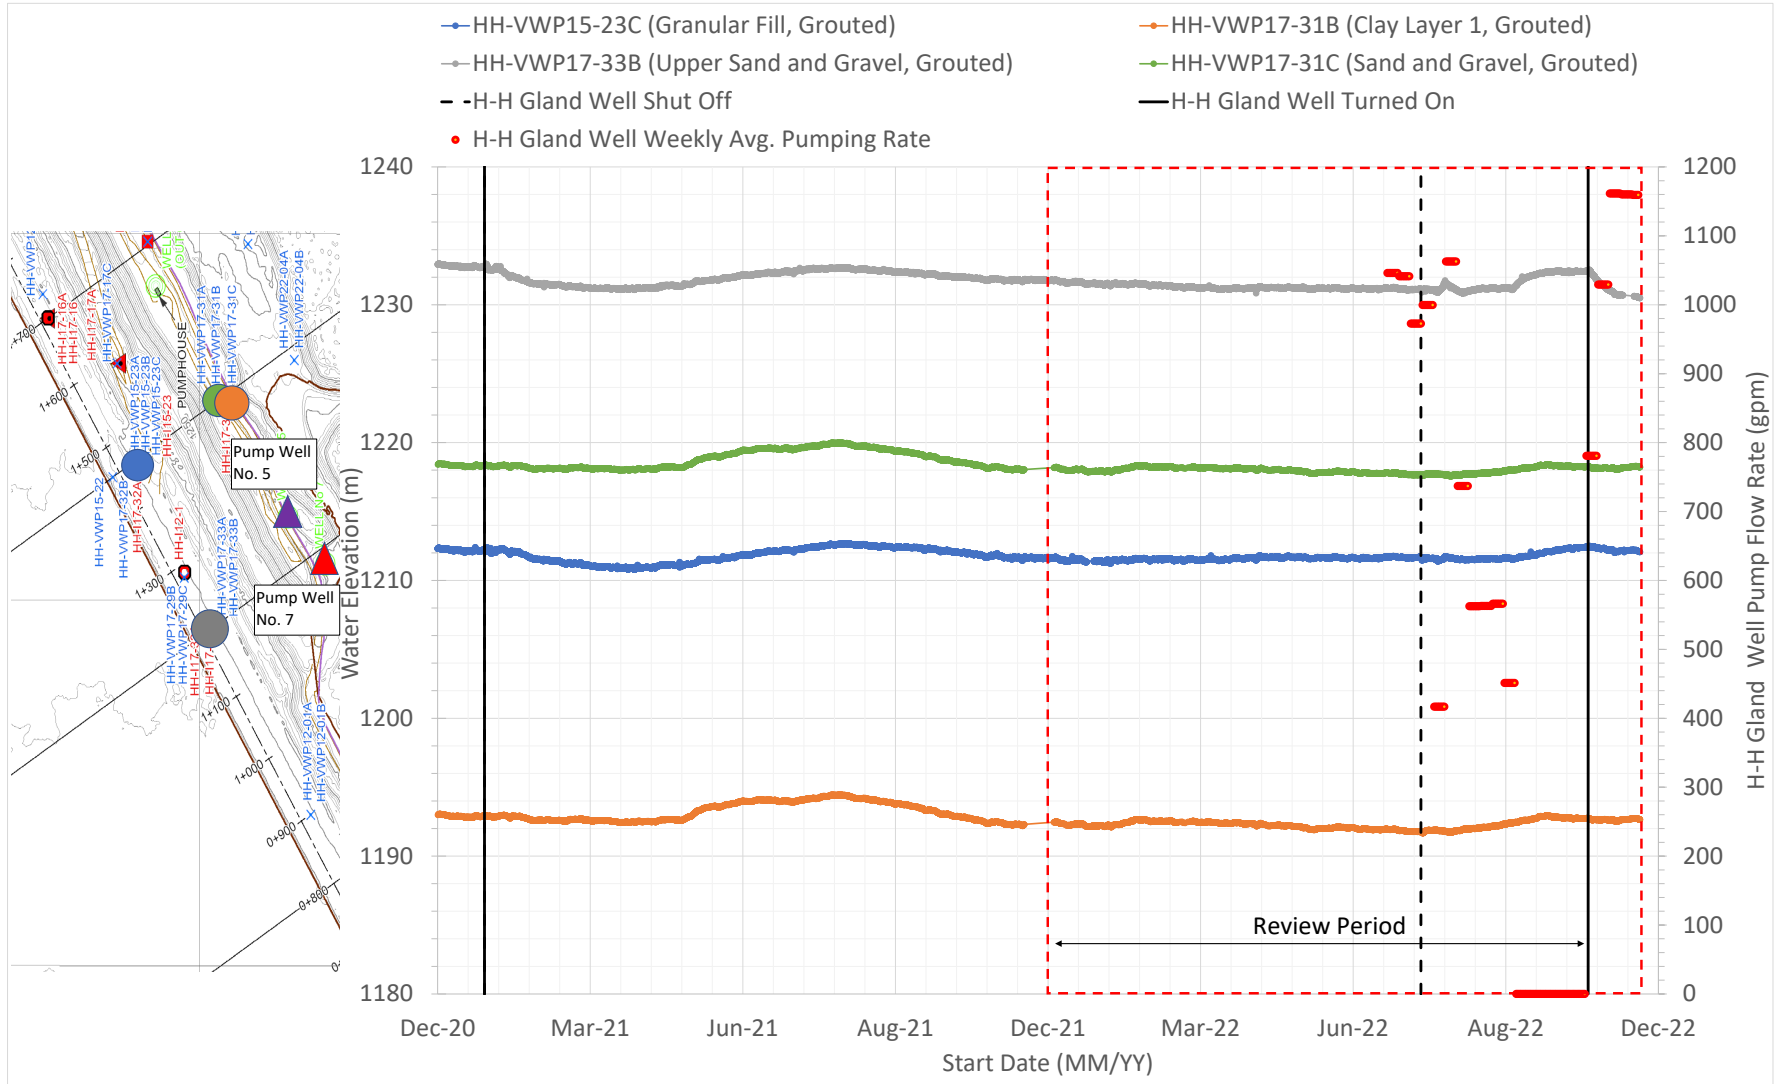
**Figure 5.18 H-H Dam Piezometric Response in the Dam Fill and Foundation Above Glacial Till: December 2020 to November 2022**

Piezometers in the dam fill or foundation units above the Glacial Till (Figure 5.18) did not measure a response to the pumping disruption, as expected. A piezometric rise was measured during this period but was related to a rise in the 24 Mile TSF pond level (Figure 5.19). During the pumping disruption, HVC sourced gland water from the 24 Mile TSF. To accommodate the increased reclaim from the facility, HVC raised the operating pond level. Prior to raising the 24 Mile TSF pond level, these piezometers were relatively steady throughout the review period.

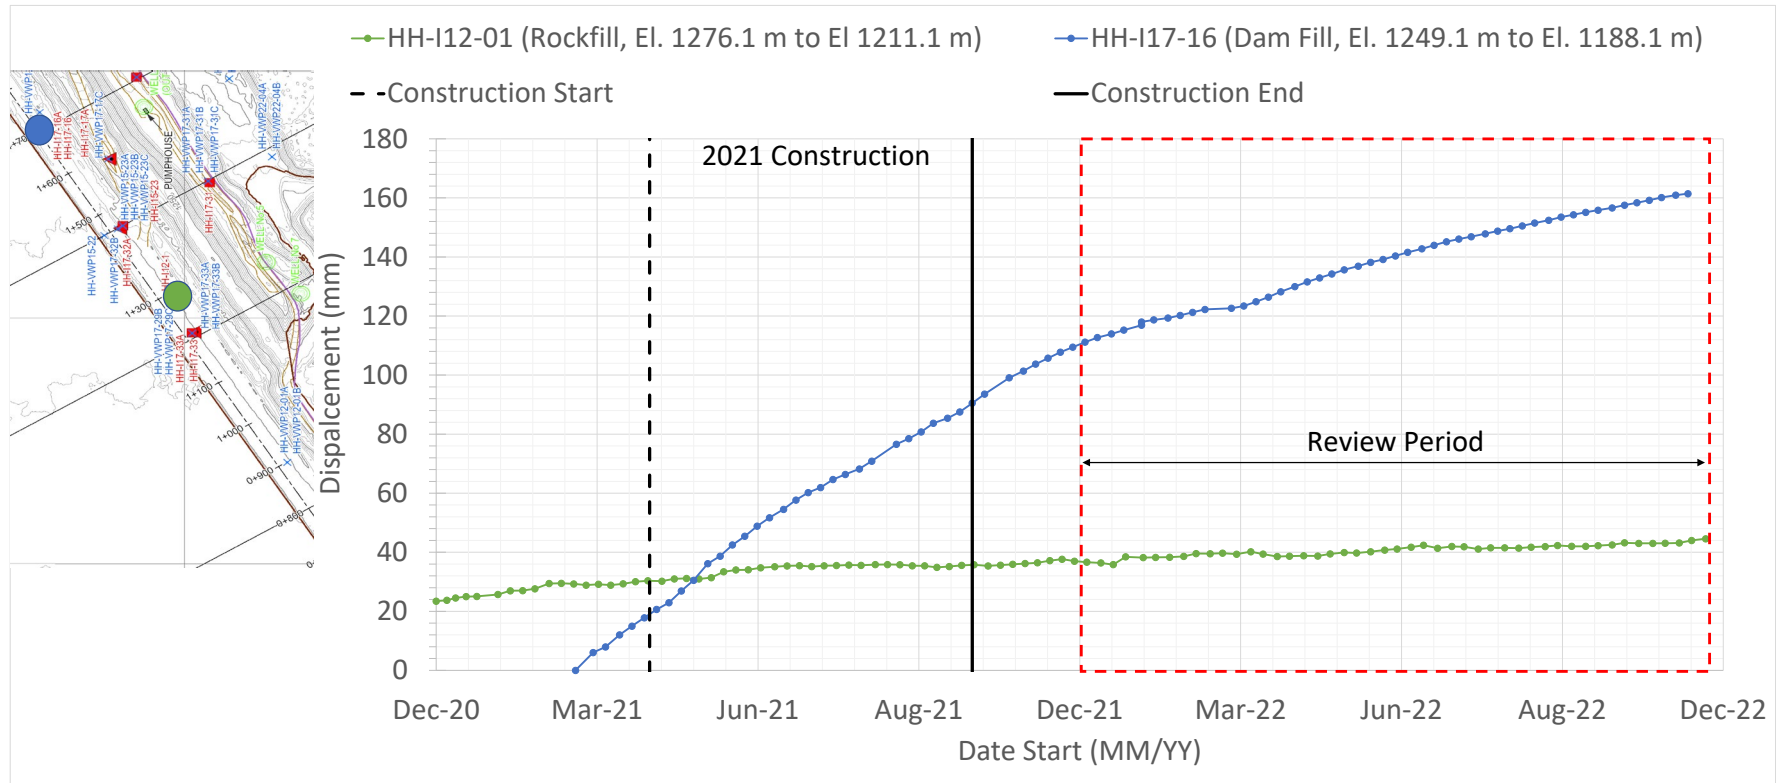
**Figure 5.20 Measured Horizontal Deformation Within Downstream Fill: HH-I17-16 and HH-I12-01**

The measured horizontal deformations (<0.7 mm/month to 4.2 mm/month) and settlement (<100 mm) in the fill during the review period were within the range of those observed since the instruments were installed. The settlement measured during the review period was a continued response to the fill placement during 2020 and 2021. Figure 5.20 shows the horizontal deformations measured in the dam fill at two typical inclinometers: HH-I17-16 and HH-I12-01. Relative to 2021, deformation rates were notably less (Table 5.10), which was expected since there was no fill placed on the downstream slope during 2022. This magnitude of deformation can be accommodated by the structure without compromising design function. There were no visual observations of significant cracking or deformation of the fill over the crest area.

No shear deformation zones within the natural foundation were measured along the dam, which is consistent with historic and expected future behaviour.

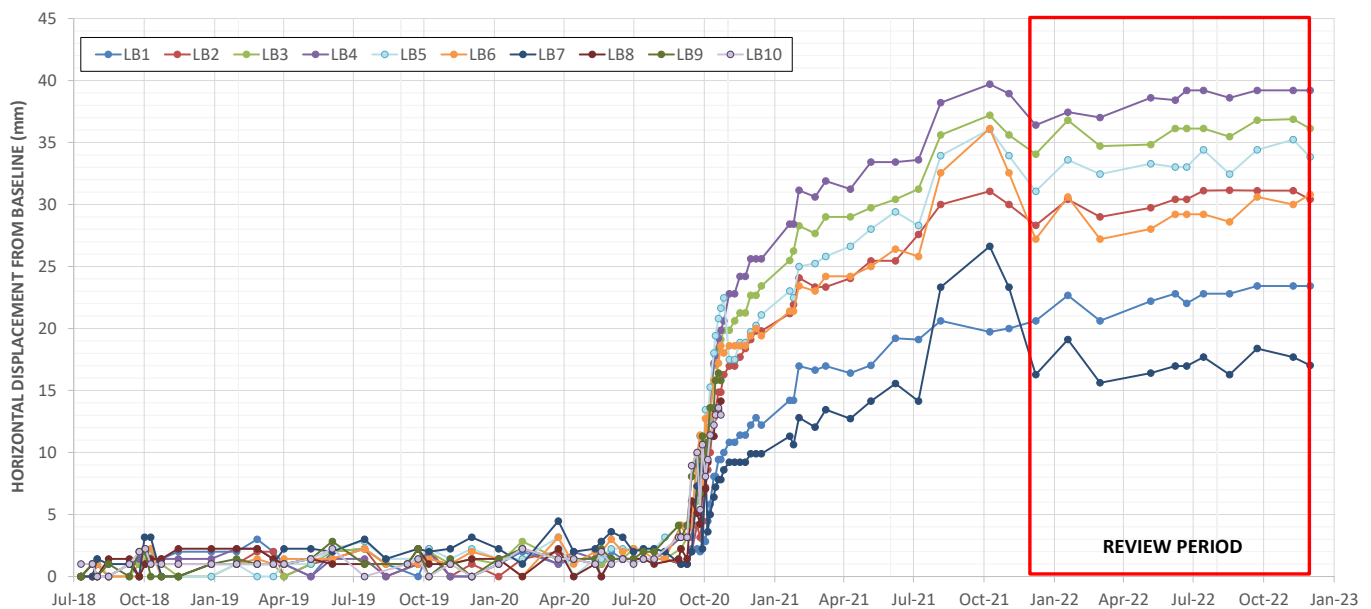
**Figure 5.21 Lock-Block Wall Monuments: Horizontal Displacement from Baseline (2018 to 2022)**

During 2020, deflection of the lock-block wall increased in response to fill placement immediately upstream of the wall by the HVC mining fleet. Although no issues of wall instability were observed, HVC took the precautionary step of placing fill downstream to support the lower half of the wall, which had an immediate impact on reducing the deformation rates. The lower three monuments (LB8, LB9, and LB10) were buried by the fill.

No fill was placed upslope of the lock-block wall during the review period. As expected, wall deflections from 2020 and 2021 construction have attenuated and levelled off (Figure 5.21). In addition, no issues of instability were observed during visual inspections.

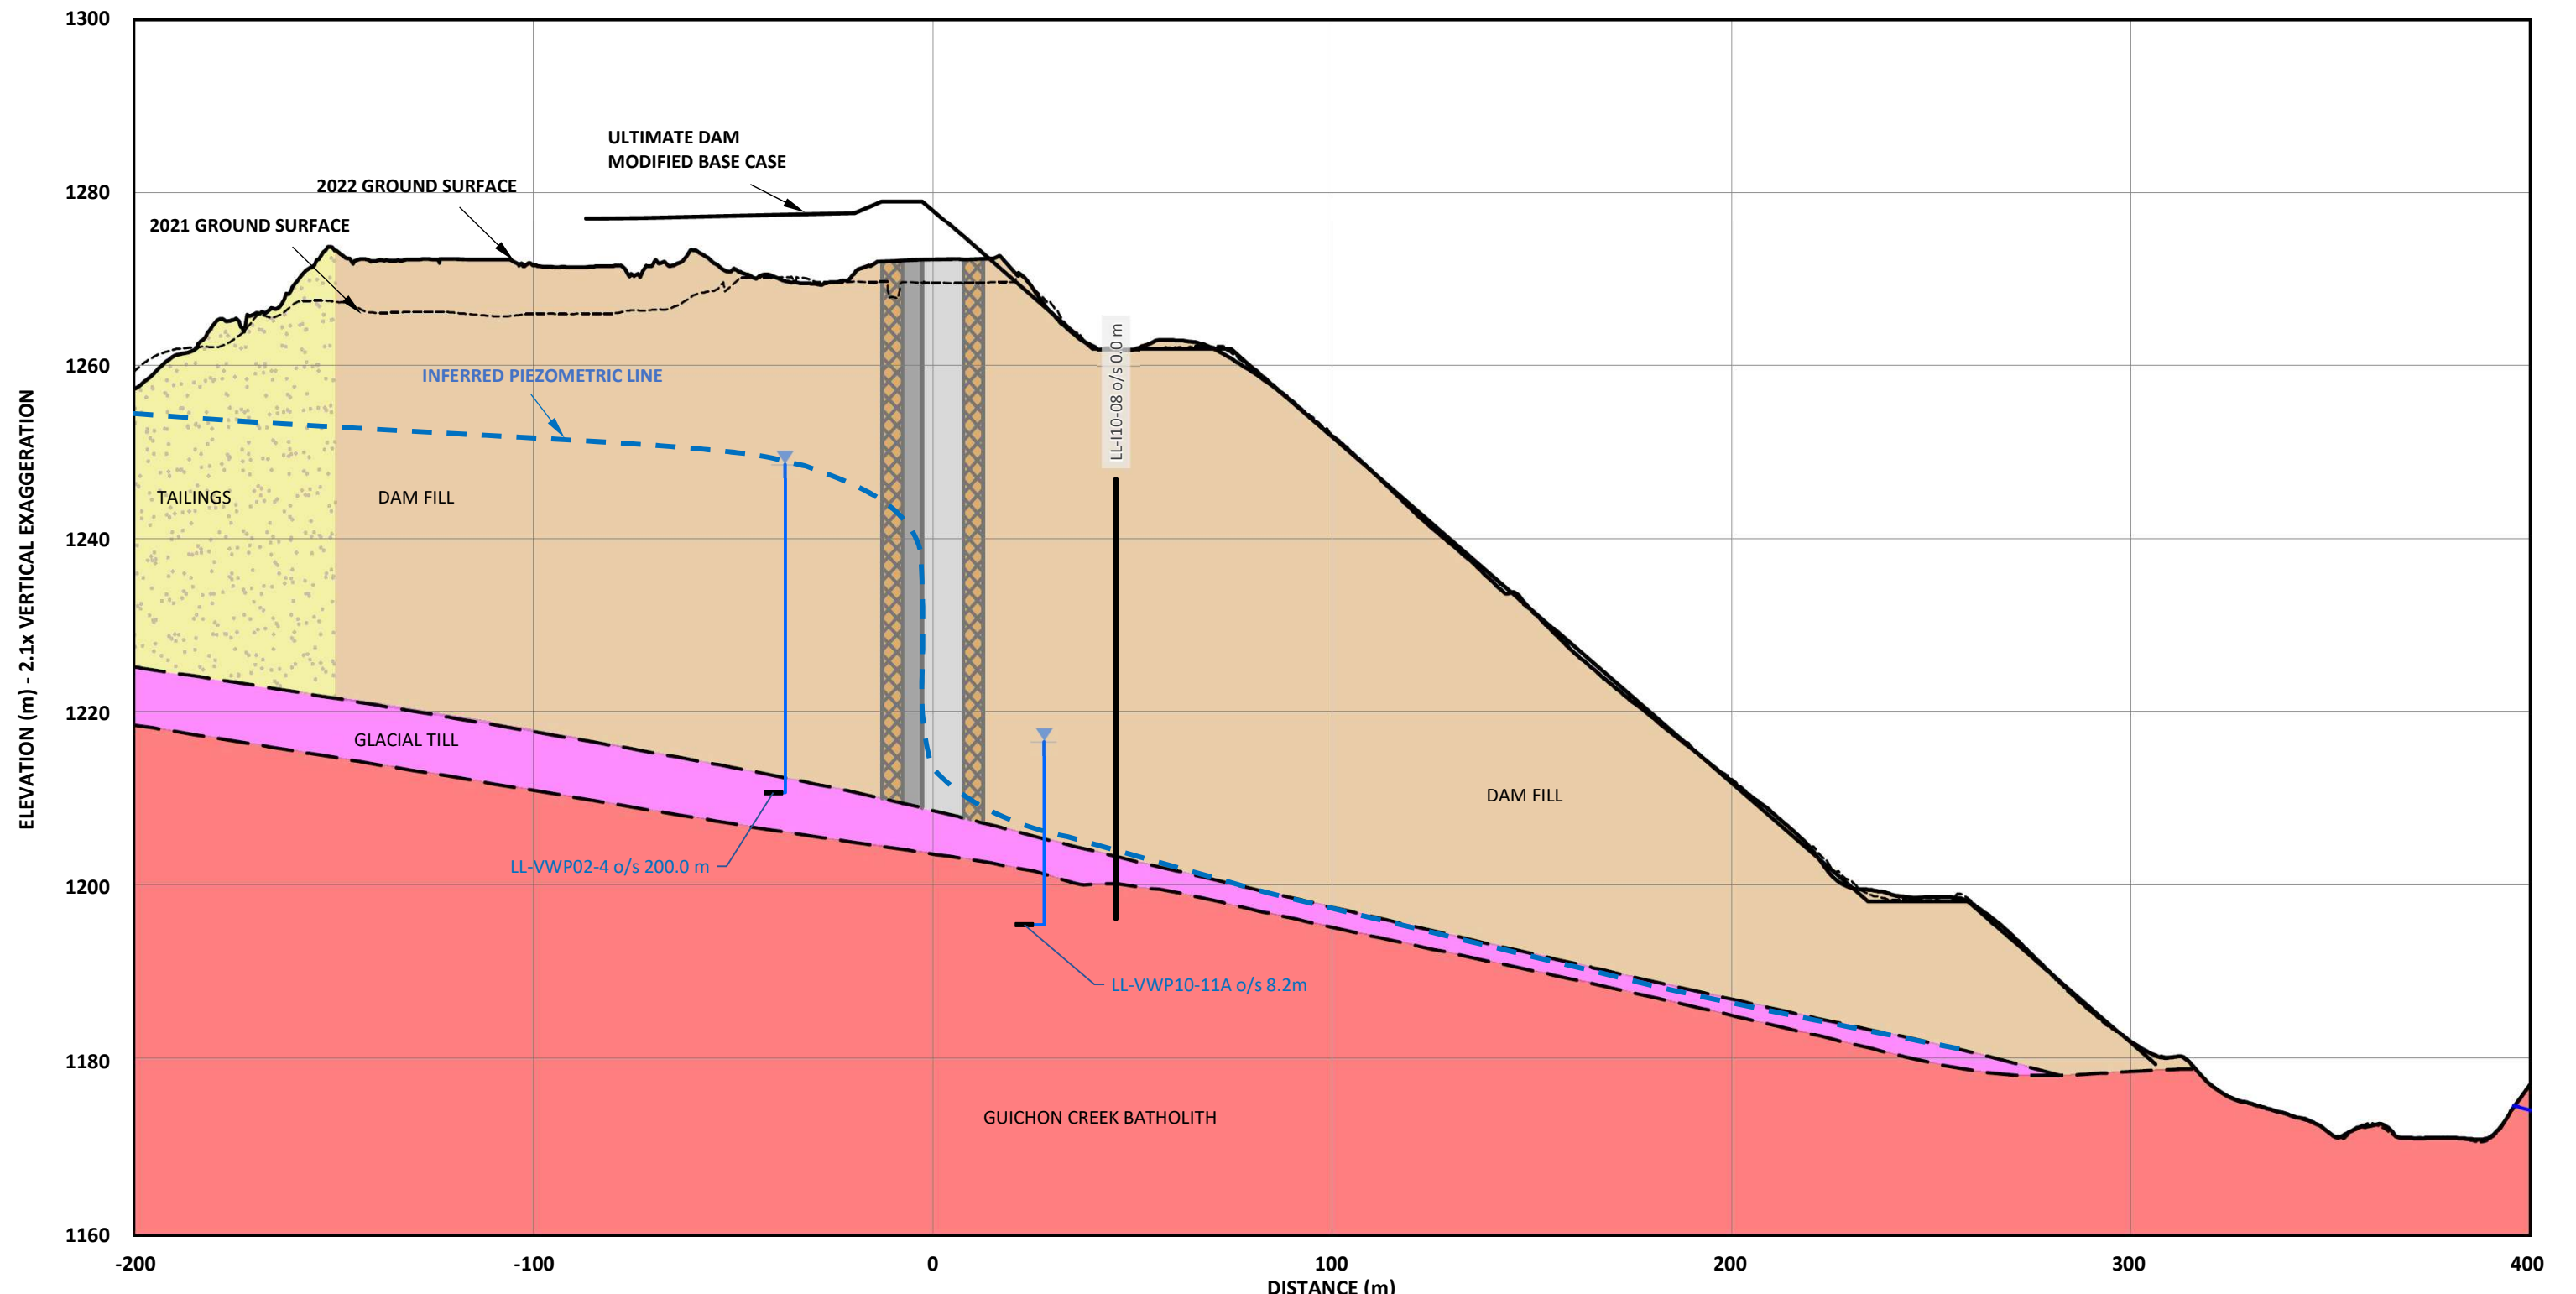
CLIENT 	PROJECT HIGHLAND TAILINGS STORAGE FACILITY 2022 ANNUAL FACILITY PERFORMANCE REPORT
	TITLE L-L DAM INSTRUMENTATION SECTION Sta. 1+200 - SOUTH DAM INSTRUMENT STATUS IN NOVEMBER 2022
SCALE NTS	PROJECT No. M02341C42
FIG. No. 11

November 2022 instrumentation readings from the south abutment near Sta. 1+200 are projected onto a dam cross section (Figure 11). Instrument behaviour shown in Figure 11 is representative of behaviour north of Sta. 1+100. As shown in Figure 8, the only construction activity in the South Dam segment during the review period was a crest raise. The downstream slope has been built to ultimate configuration.

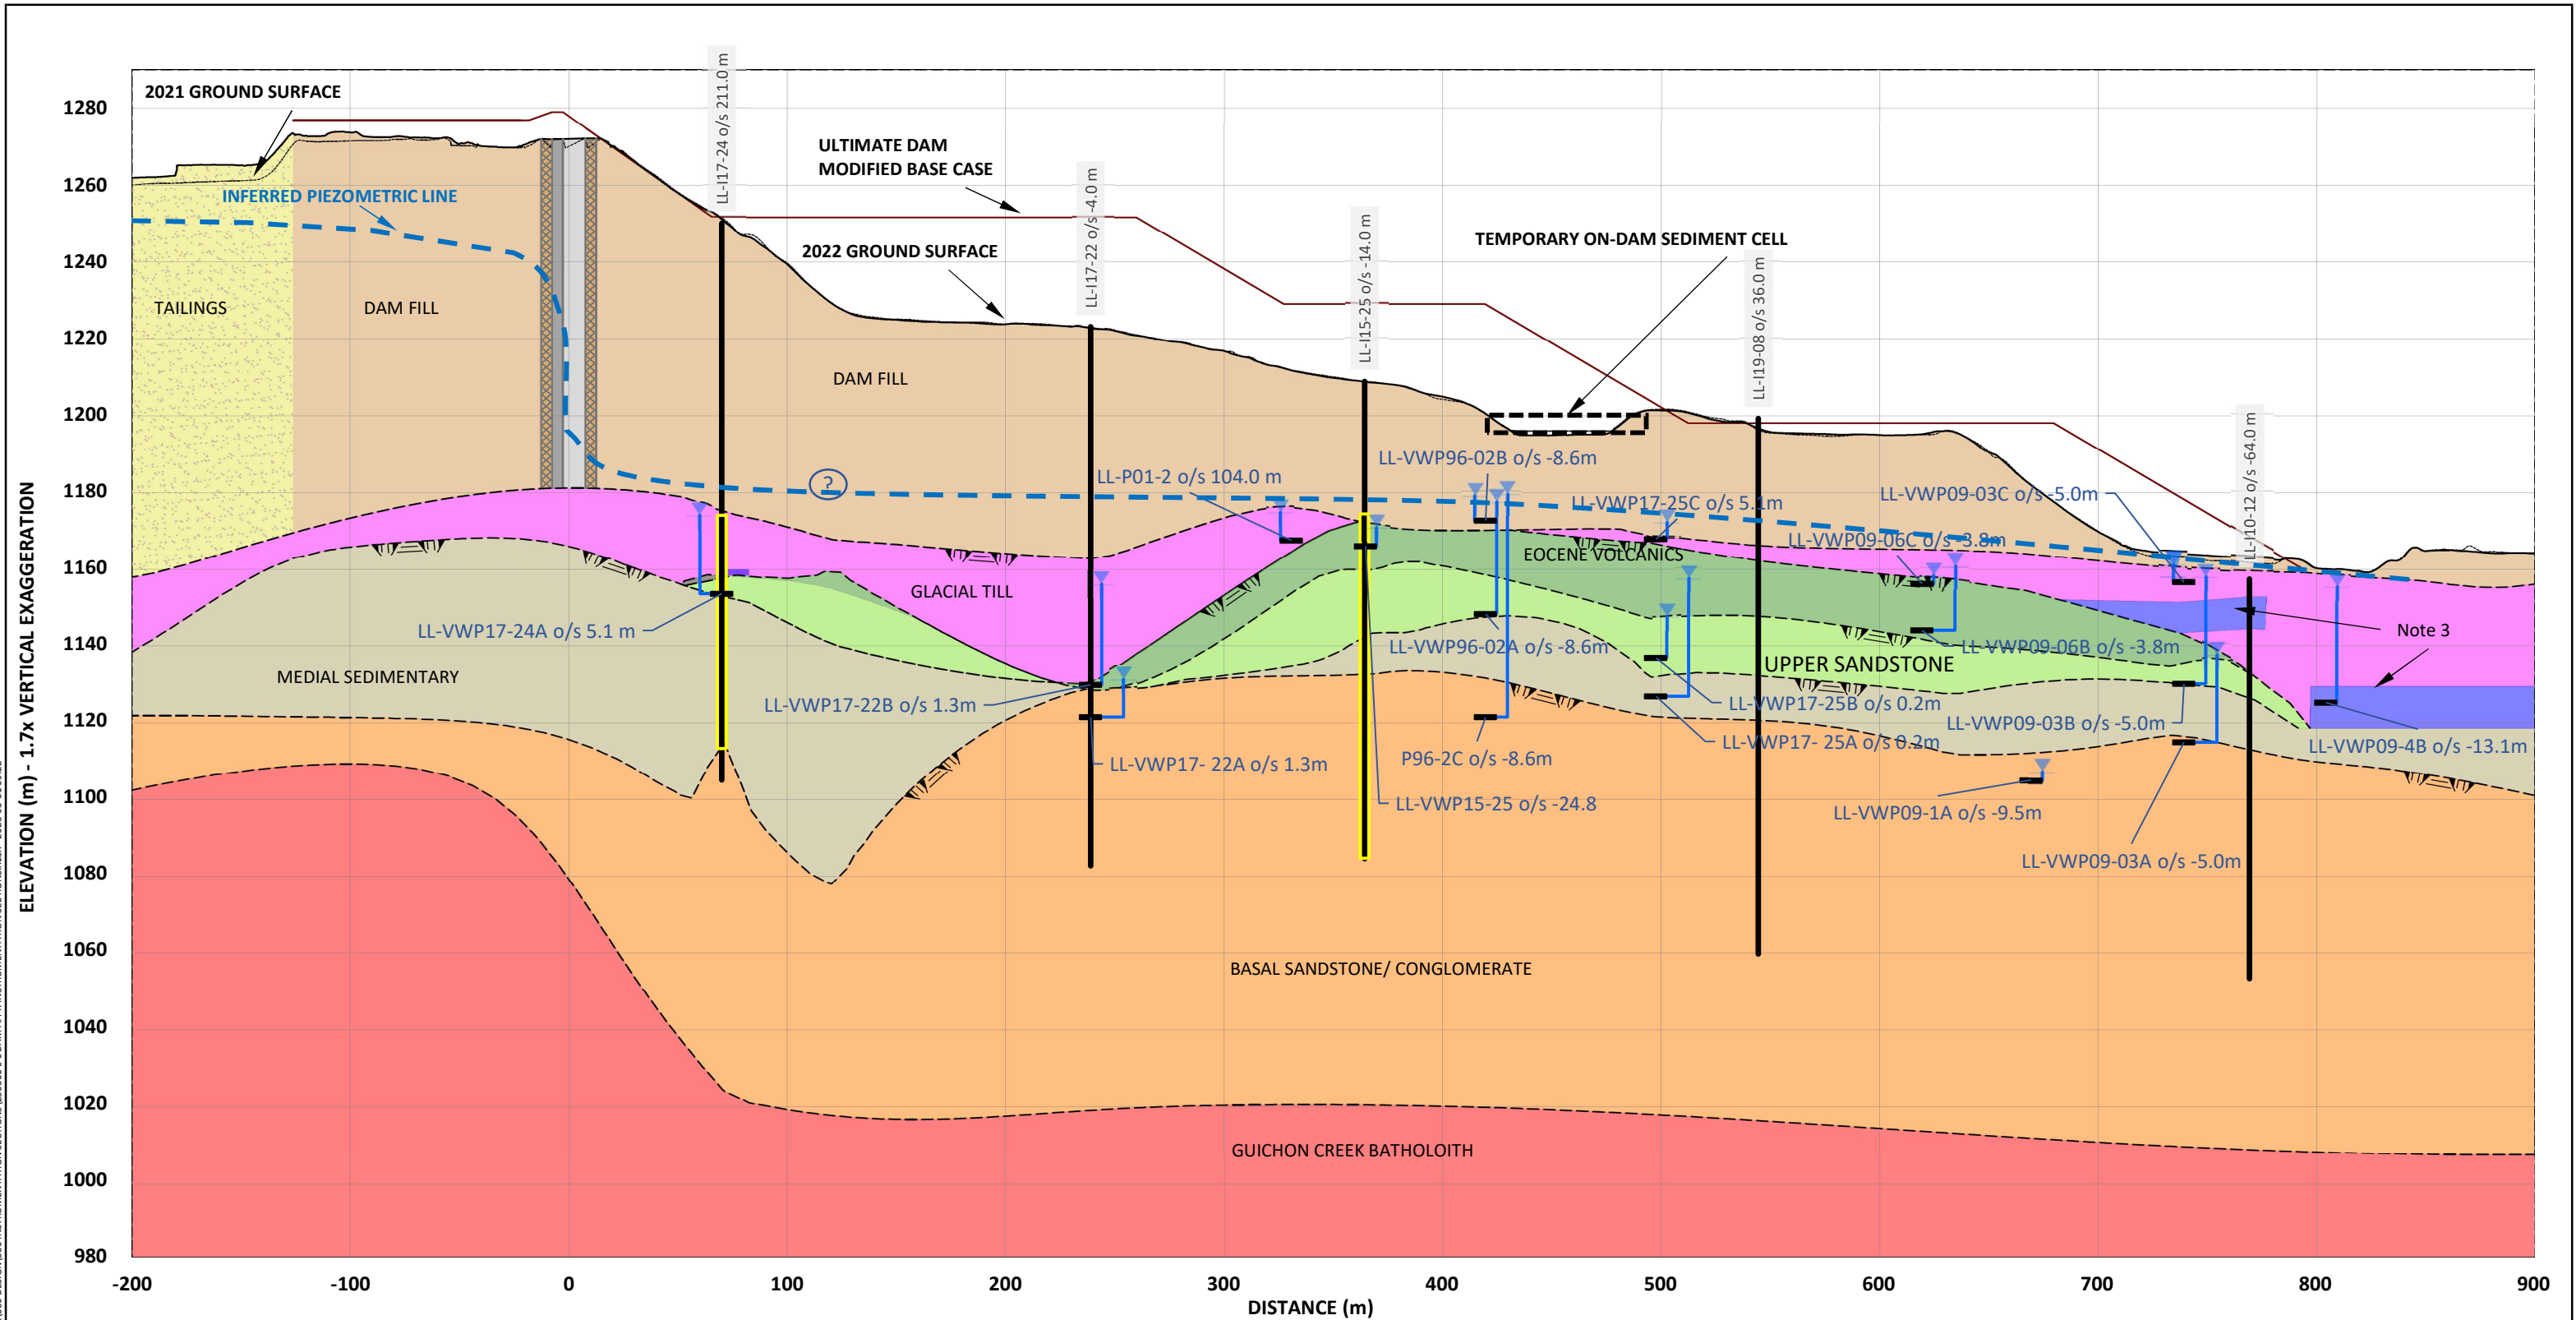
November 2022 instrumentation readings near Sta. 2+564 and Sta. 2+690 are projected onto a dam cross section (Figure 14 and Figure 15). As shown in Figure 8, construction activity in the NBB area during 2022 included a crest raise, placement along the south side toe, and operation of the temporary on-dam sediment storage cell.

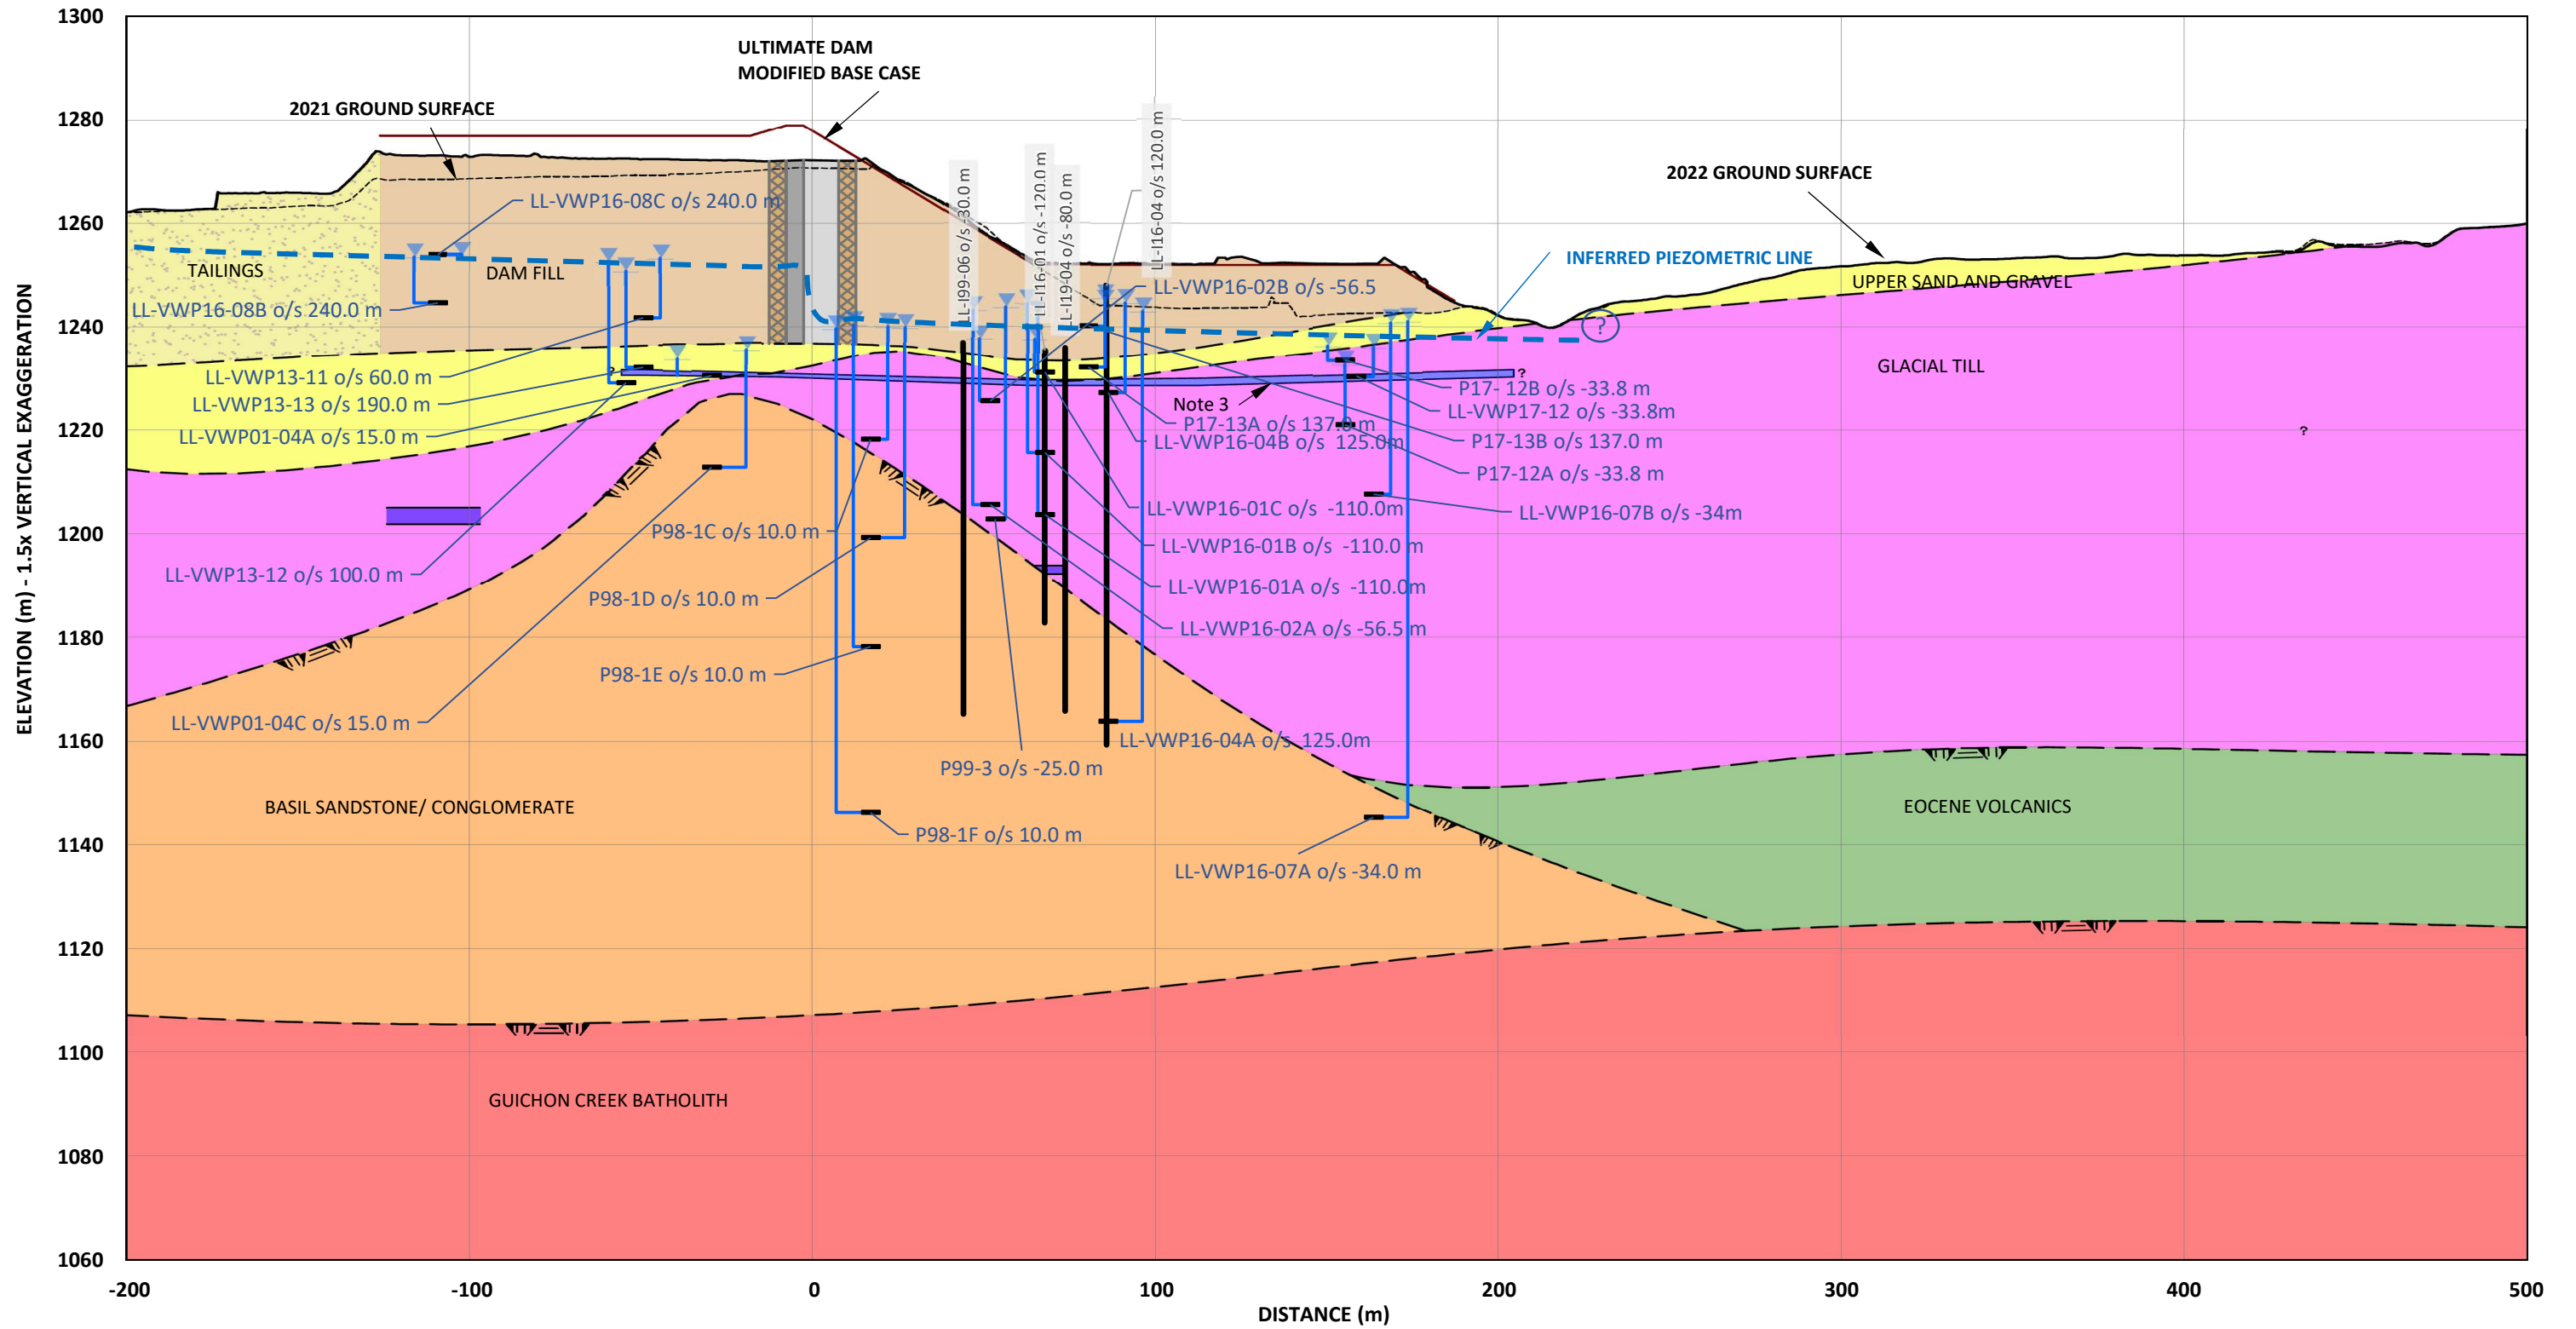
CLIENT <b>Highland Valley / Teck Copper</b>	PROJECT	HIGHLAND TAILINGS STORAGE FACILITY 2022 ANNUAL FACILITY PERFORMANCE REPORT
	TITLE	L-L DAM INSTRUMENTATION SECTION Sta. 3+630 - NORTH DAM U-GLU SEGMENT INSTRUMENT STATUS IN NOVEMBER 2022
	SCALE	NTS
	PROJECT No.	M02341C42
	FIG. No.	18

November 2022 instrumentation readings near Sta. 3+630 are projected onto a dam cross section (Figure 18). As shown in Figure 8, construction activity in the North Dam U-GLU area during 2022 included a crest raise and completion of the North Dam Buttress. Following 2022 construction, the downstream slope of this segment has been built to the ultimate configuration.
