# **Teck Highland Valley Copper Partnership**

## **2022 Annual Facility Performance Report**

*Highland Tailings Storage Facility*

March 2023

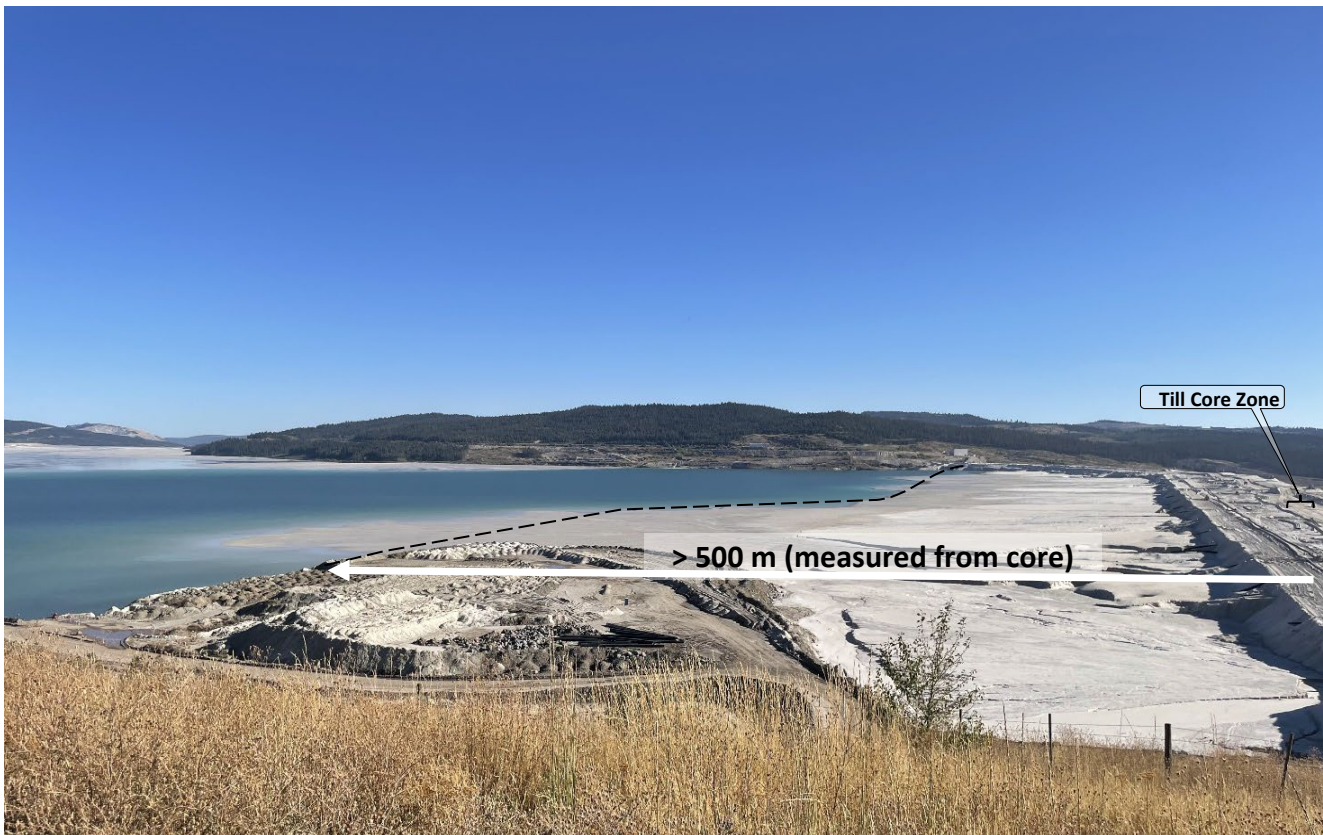
**Photo I-A-1 Tailings beach at north abutment was >500 m wide during the site visit as required by design. (LL-2022-01)**

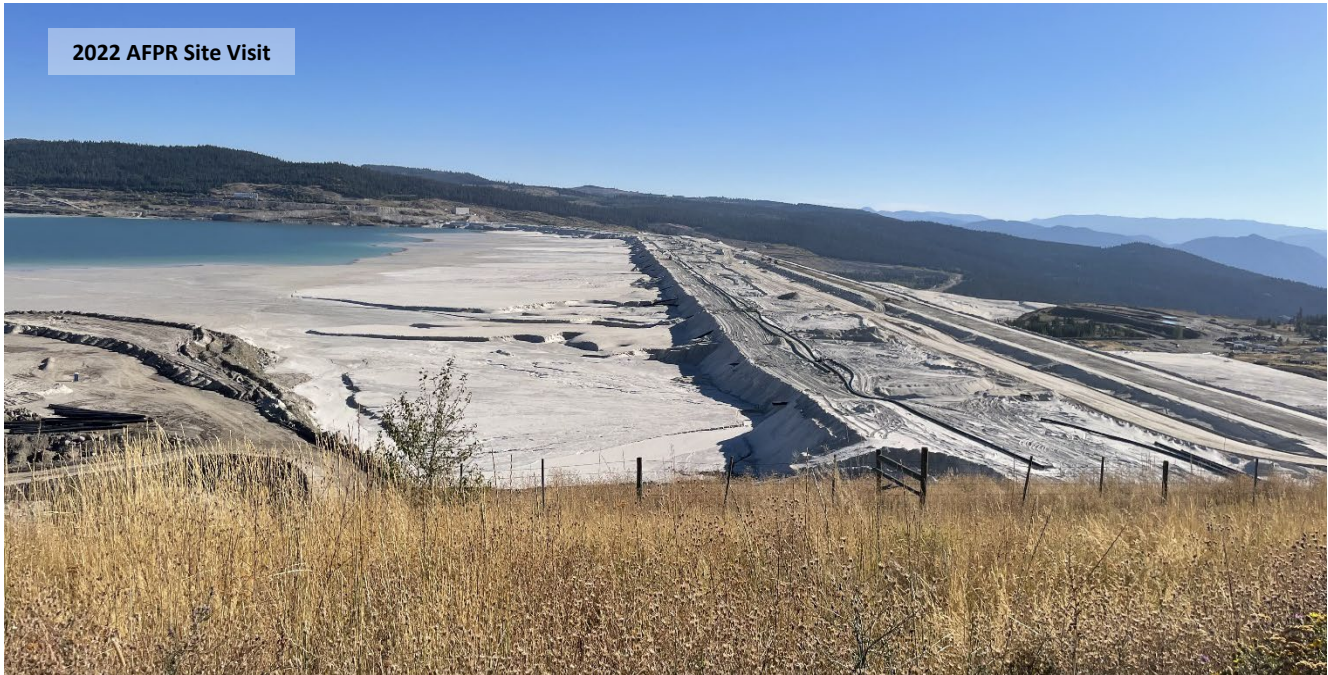
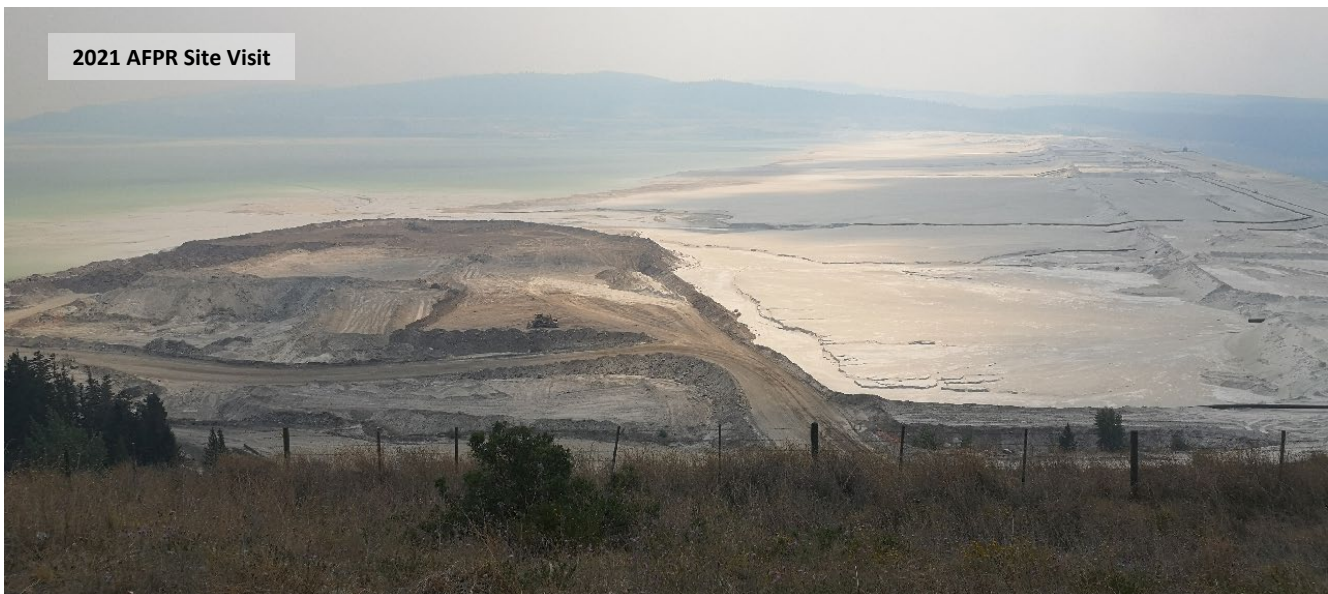
**Photo I-A-2 Tailings beach and upstream cycloned sand hydraulic placement cells along North Dam U-GLU and North Dam Bedrock segments during 2021 and 2022 AFPR site visits. (LL-2022-01)**

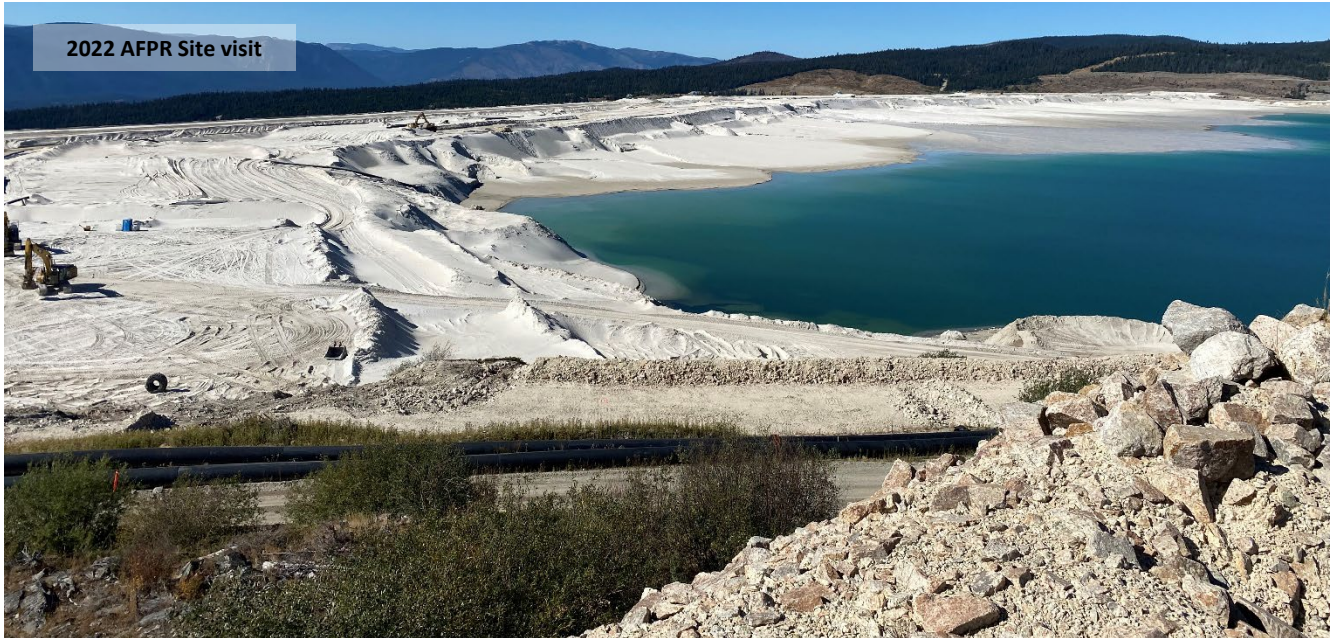
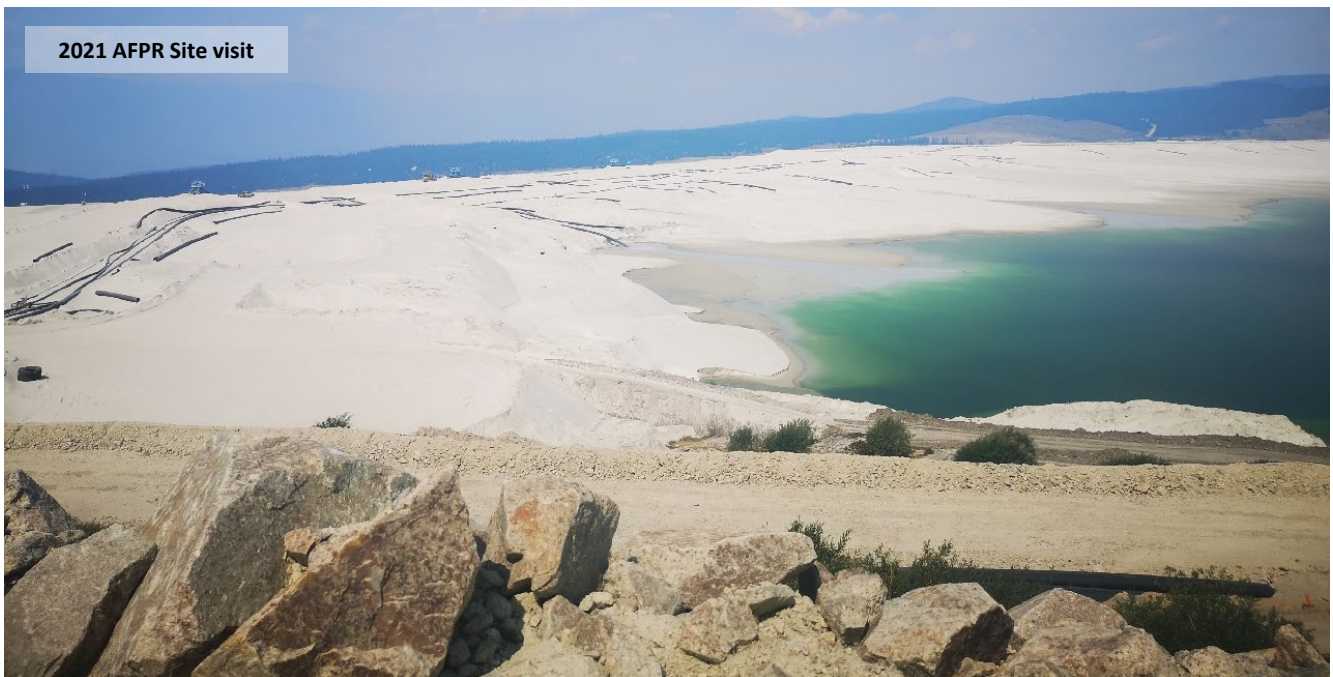
Near the south abutment (Photo I-A-3), where the pond is nearest to the upstream fill zone, the upstream slope was stepped, and a portion of the slope shallowed to reduce risk of localized instability of the slope. Both controls were effective and no signs of cracking or slumping into the impoundment was observed.

**Photo I-A-3 Tailings beach and upstream cycloned sand hydraulic placement cells along South Dam and VBB segments during 2021 and 2022 AFPR site visits. (LL-2022-02)**

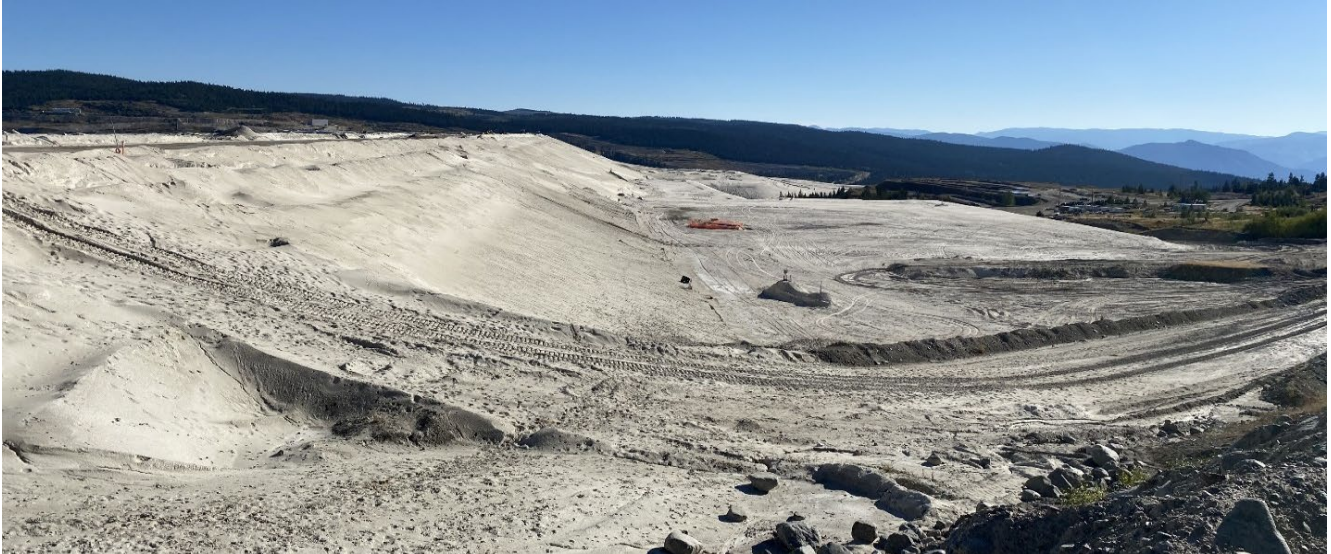
**Photo I-A-4 North Dam U-GLU downstream slope (looking south) including North Dam Buttress which was built to ultimate configuration during 2022 construction. (LL-2022-03)**

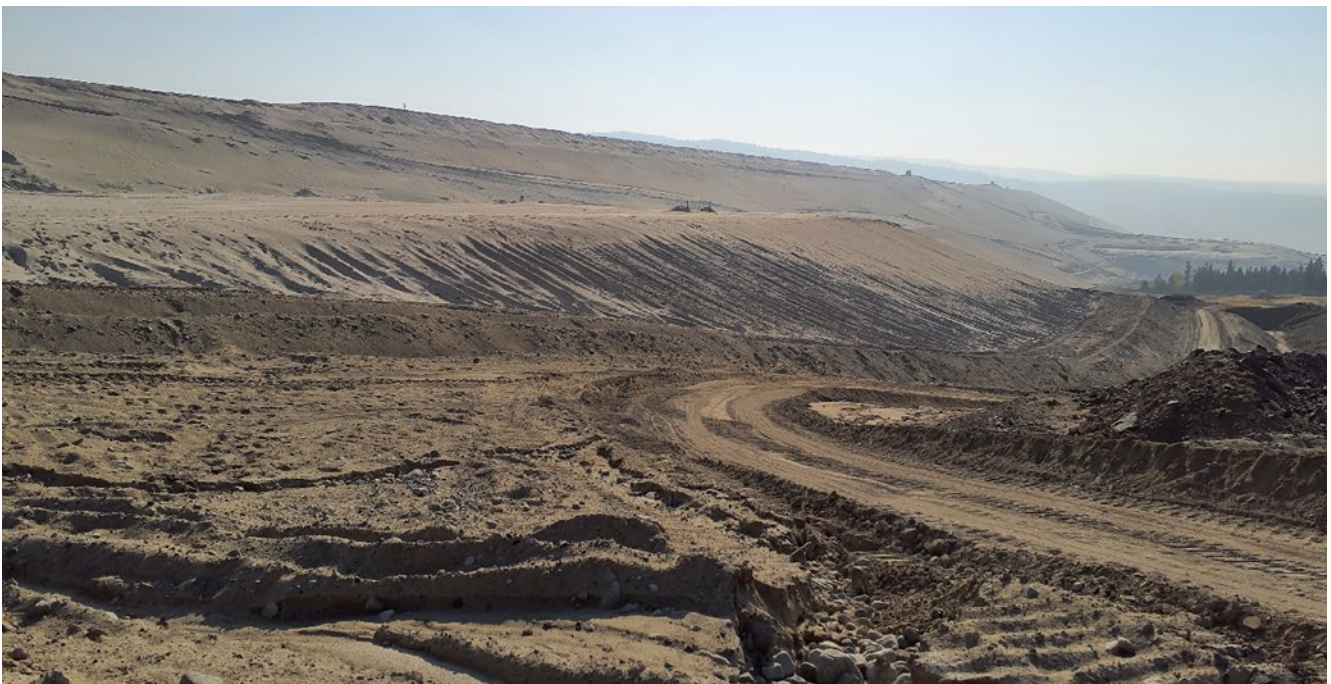
**Photo I-A-5 North Dam U-GLU downstream slope (looking southeast). (LL-2022-10)**

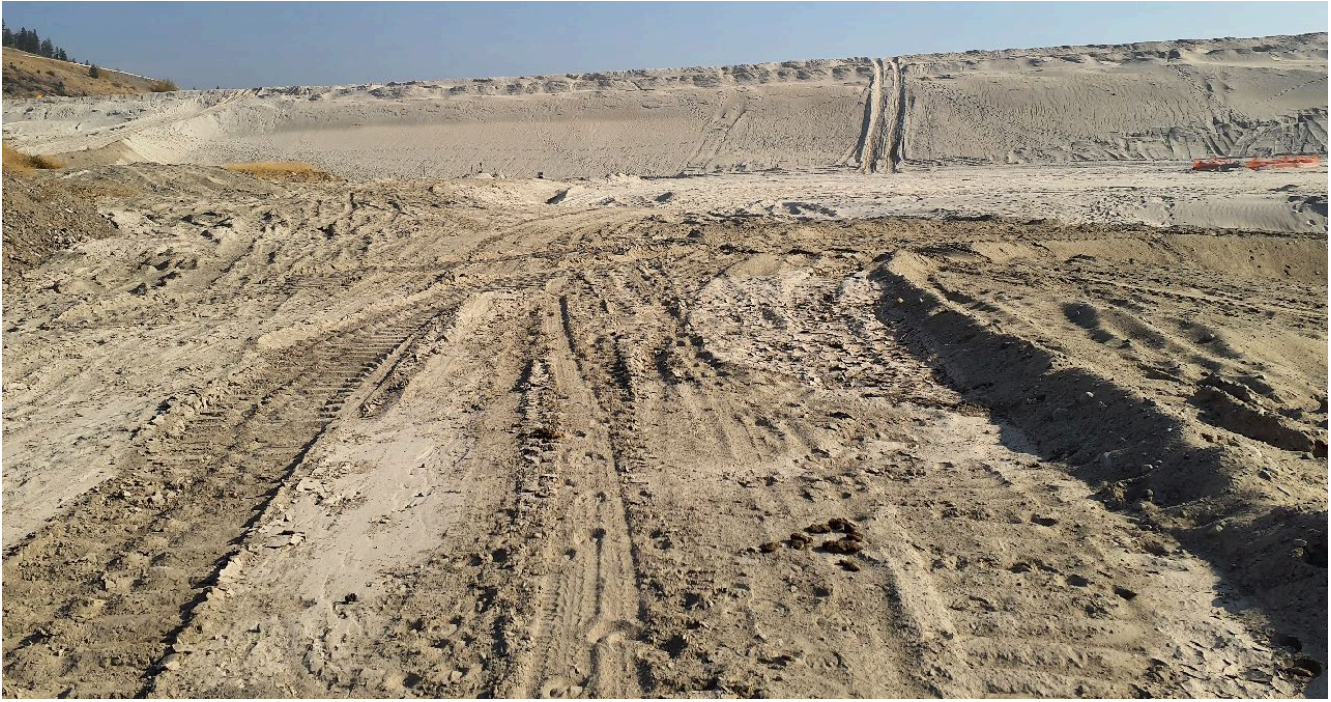
**Photo I-A-6 North Dam Bedrock downstream slope (looking northeast). (LL-2022-11)**

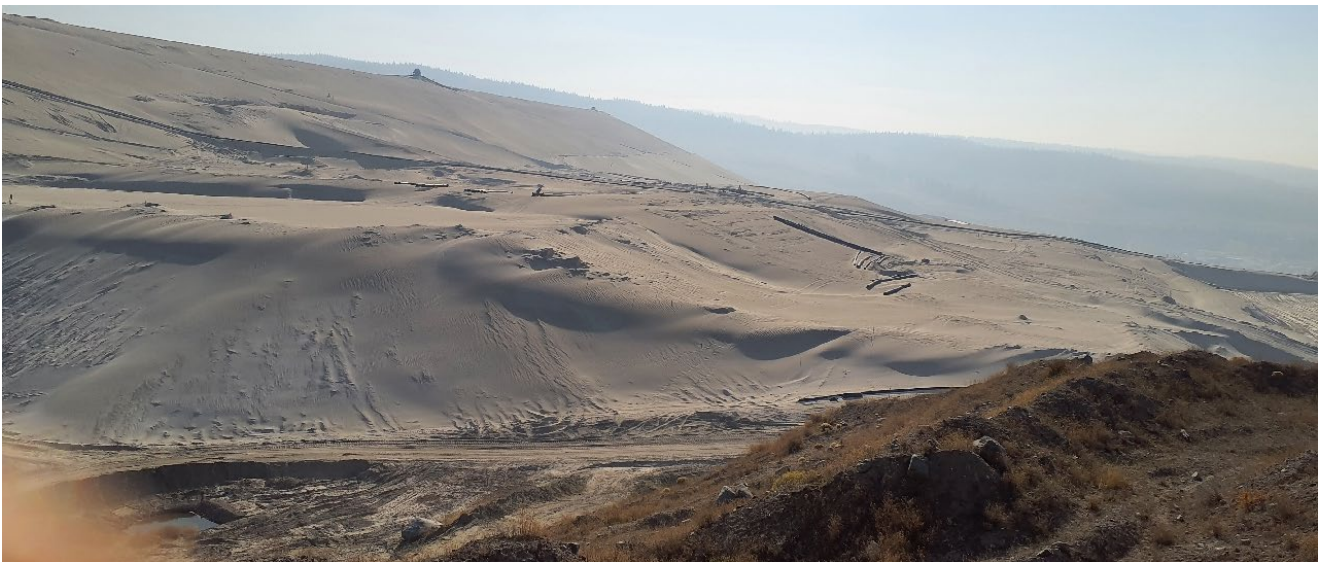
**Photo I-A-7 NBB downstream slope, upper slope and mid bench area (looking south). (LL-2022-09)**

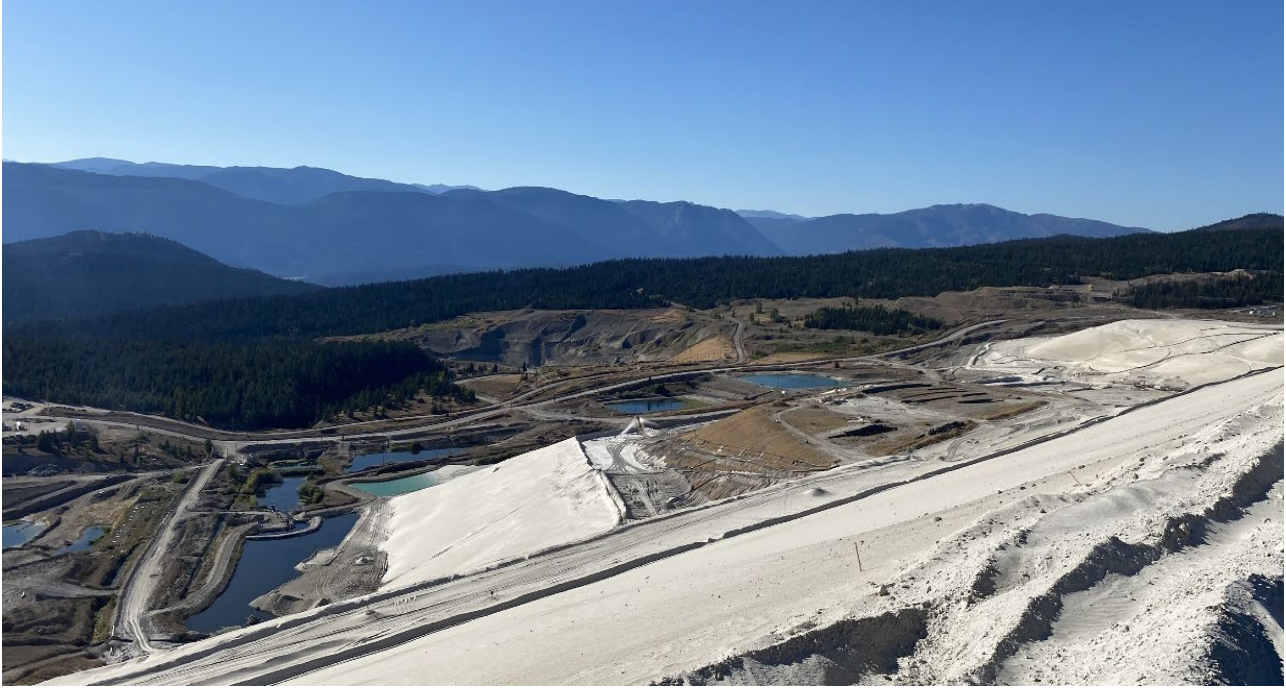
**Photo I-A-8 Overview of VBB and downstream sediment and seepage ponds looking northwest from dam crest. (LL-2022-04)**

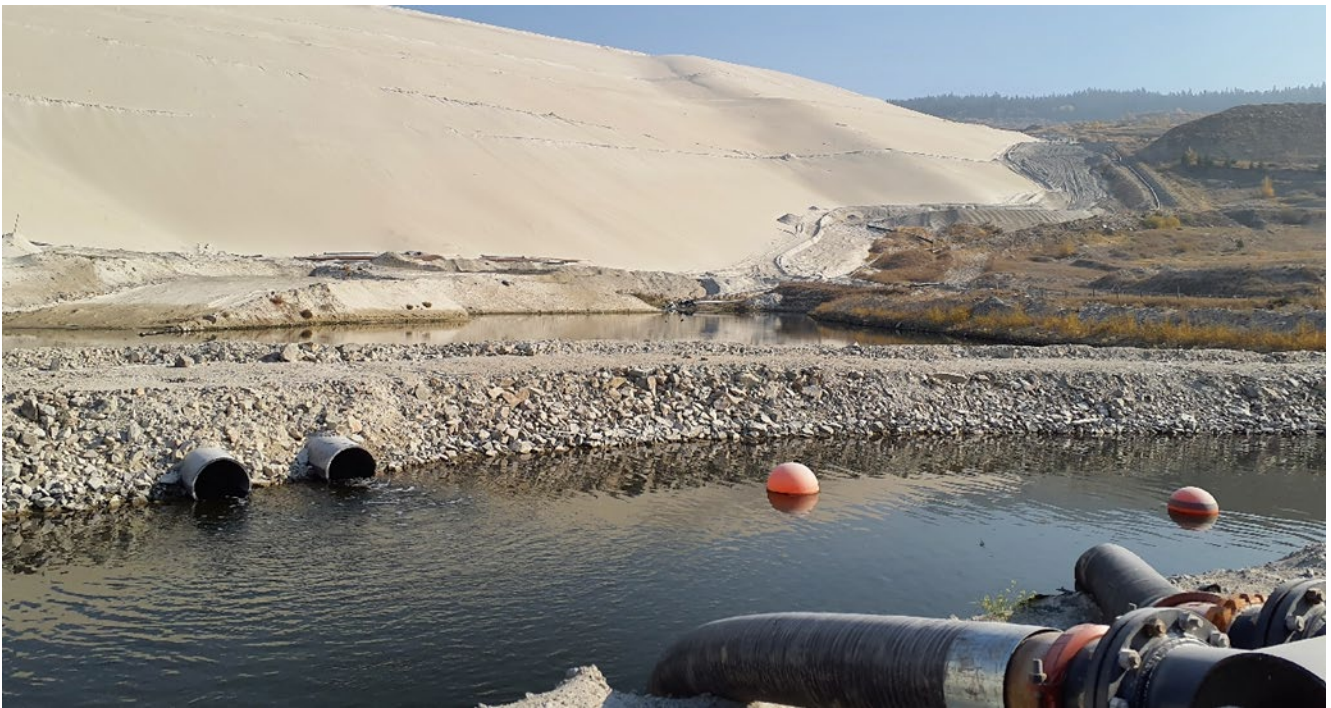
**Photo I-A-11 Sediment Pond 1 South Cell and the internal rockfill berm which keeps retained sediments away from pump intakes and Seepage Water Reclaim Pond. (LL-2022-06)**

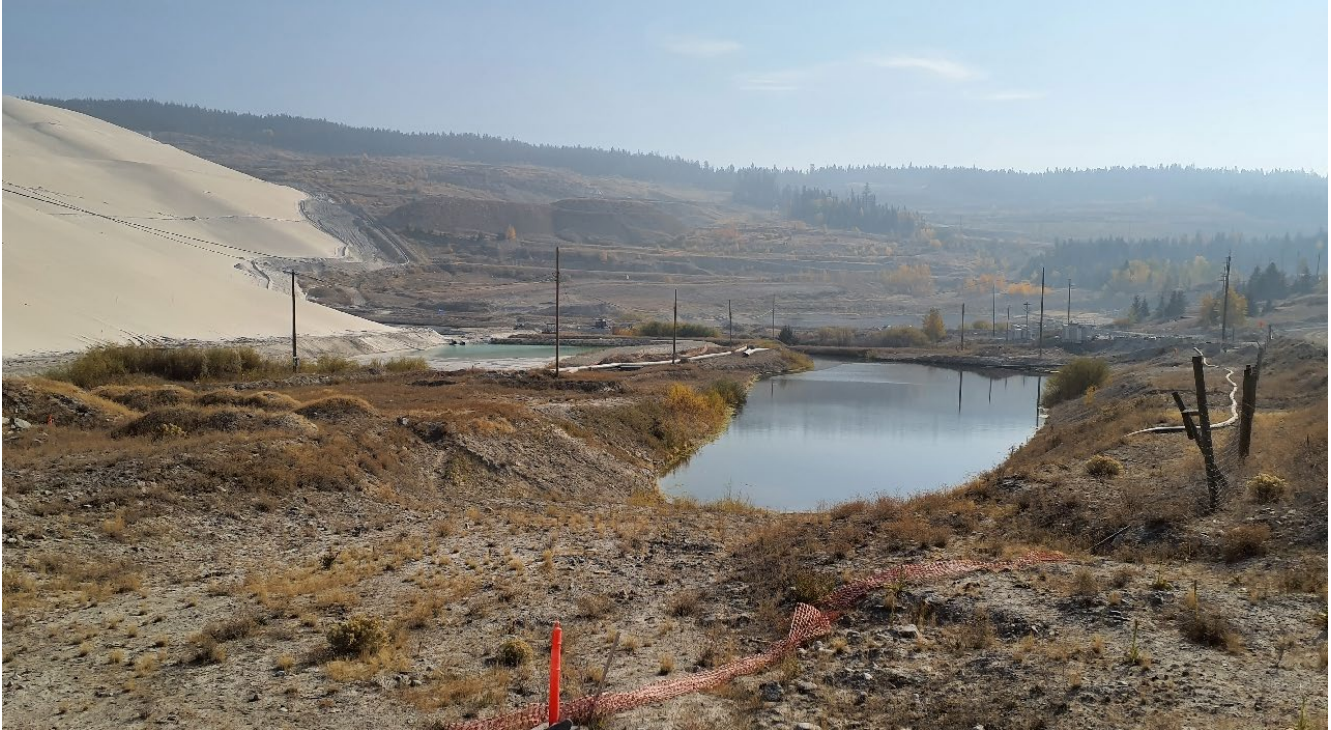
**Photo I-A-12 Overview of Sediment Pond 1 North Cell (left) and Sediment Pond 4 (right) which stores local surface runoff but is not used as an active sediment pond. (LL-2022-07)**

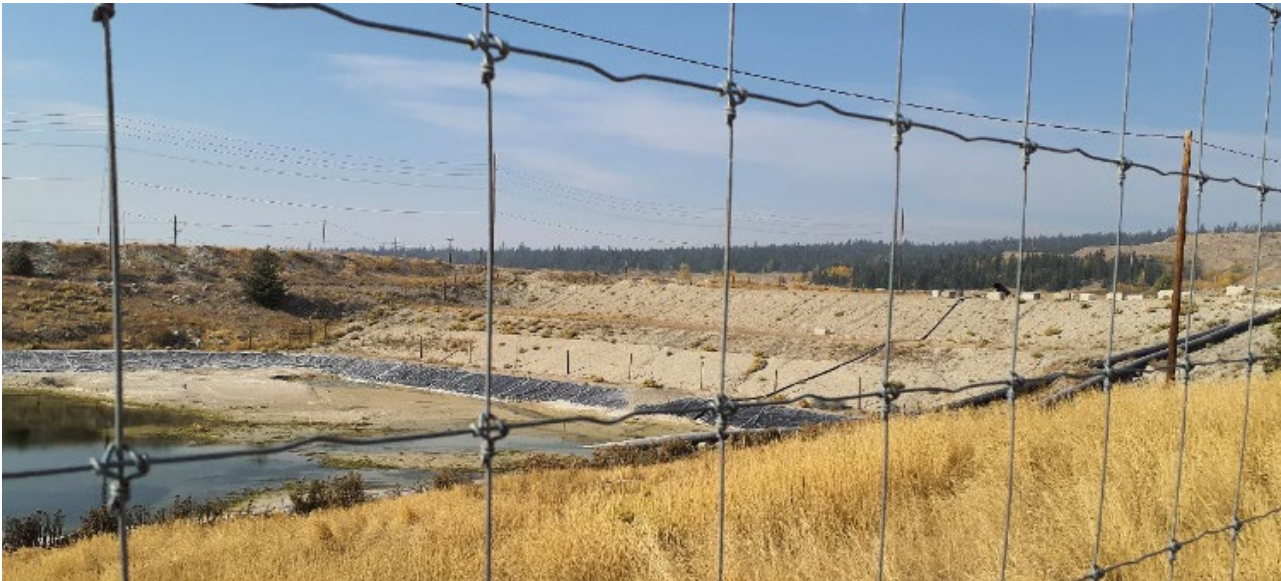
**Photo I-A-13 Seepage Pond 2, northern half, and downstream slope of Sediment Pond 2 which is immediately north. (LL-2022-08)**

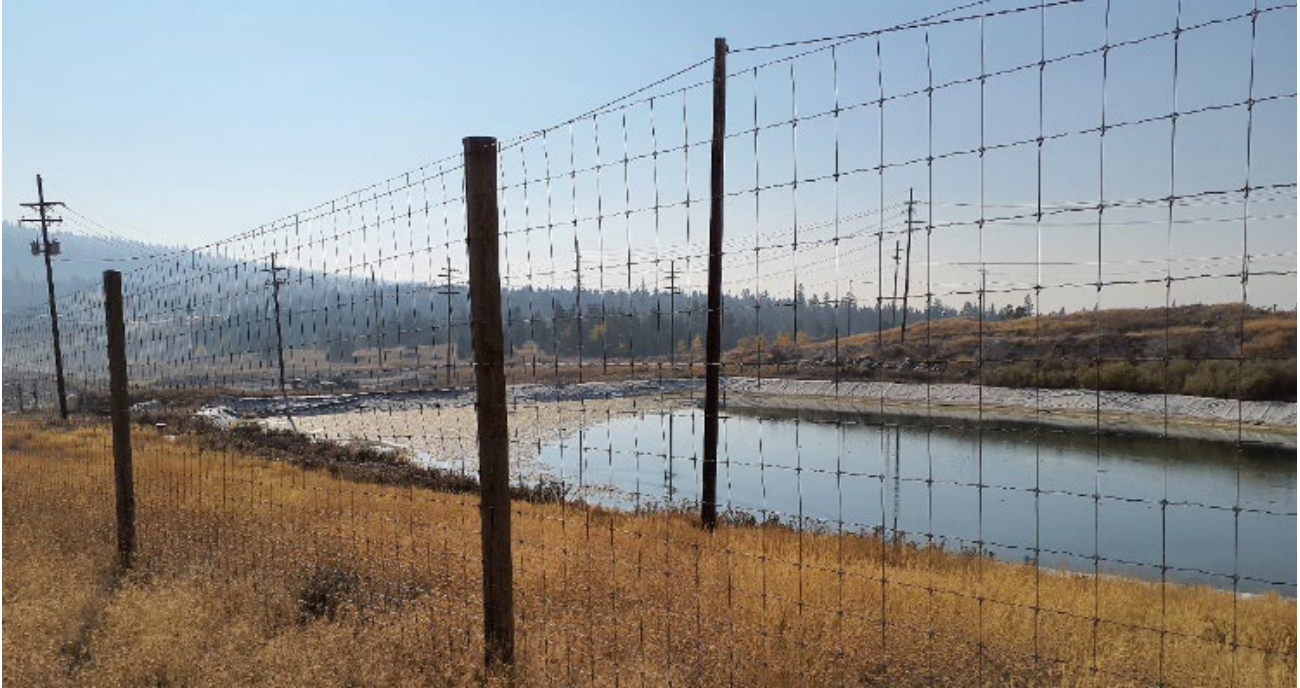
**Photo I-A-14 Seepage Pond 2, southern half. Outlet to Seepage Pond 2 was not obstructed during site visit. (LL-2022-08)**

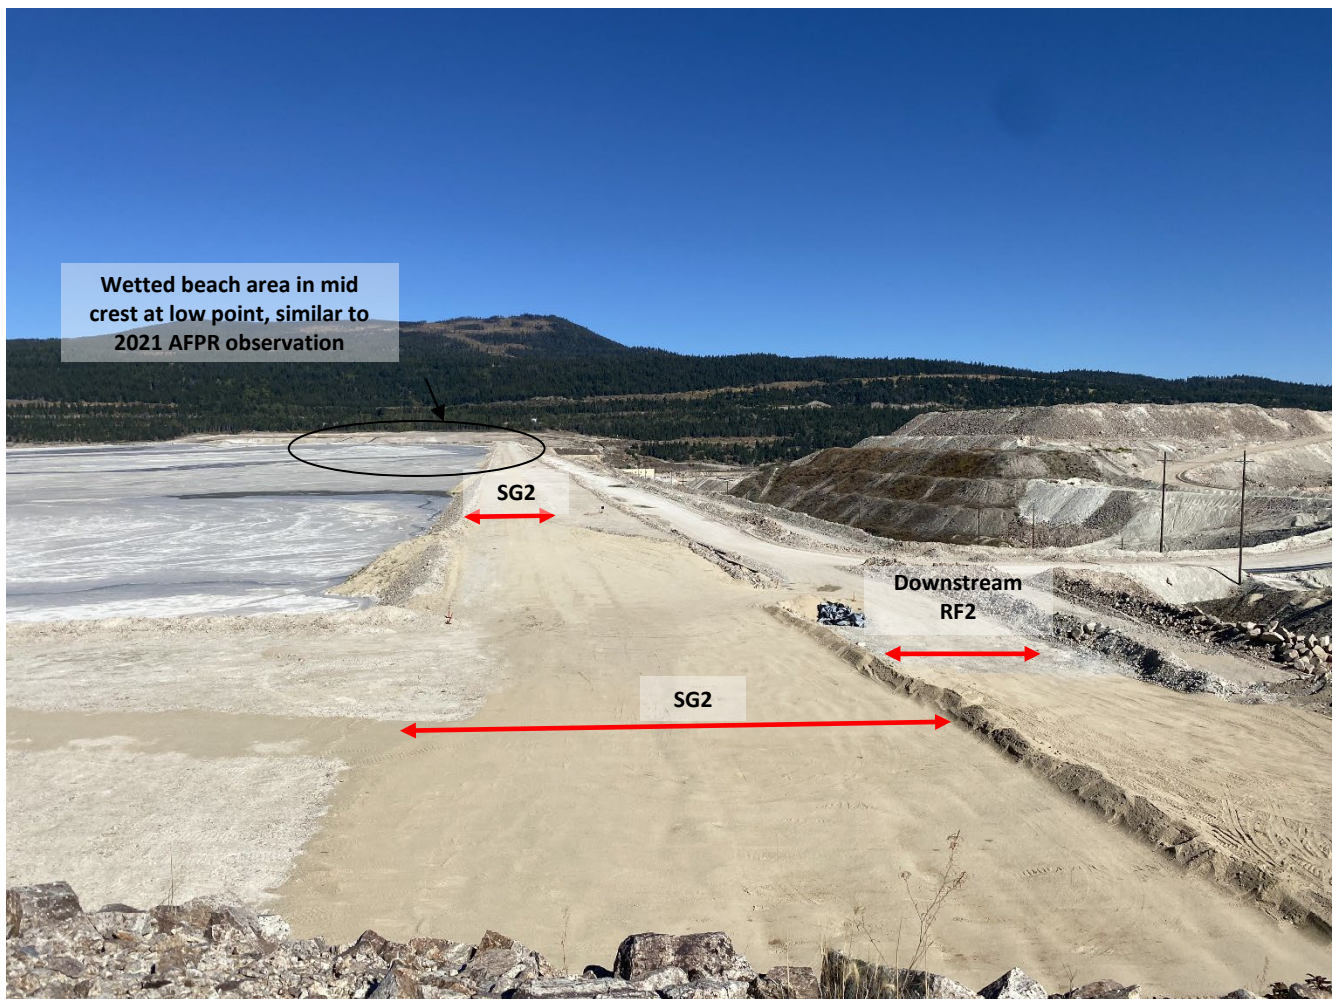
**Photo I-B-1 Overview of H-H Dam crest looking northeast from west abutment. The surface of the crest is the sand and gravel filter zone (SG2) and downstream rockfill (RF2). There was no crest raise during 2022. (HH-2022-01)**

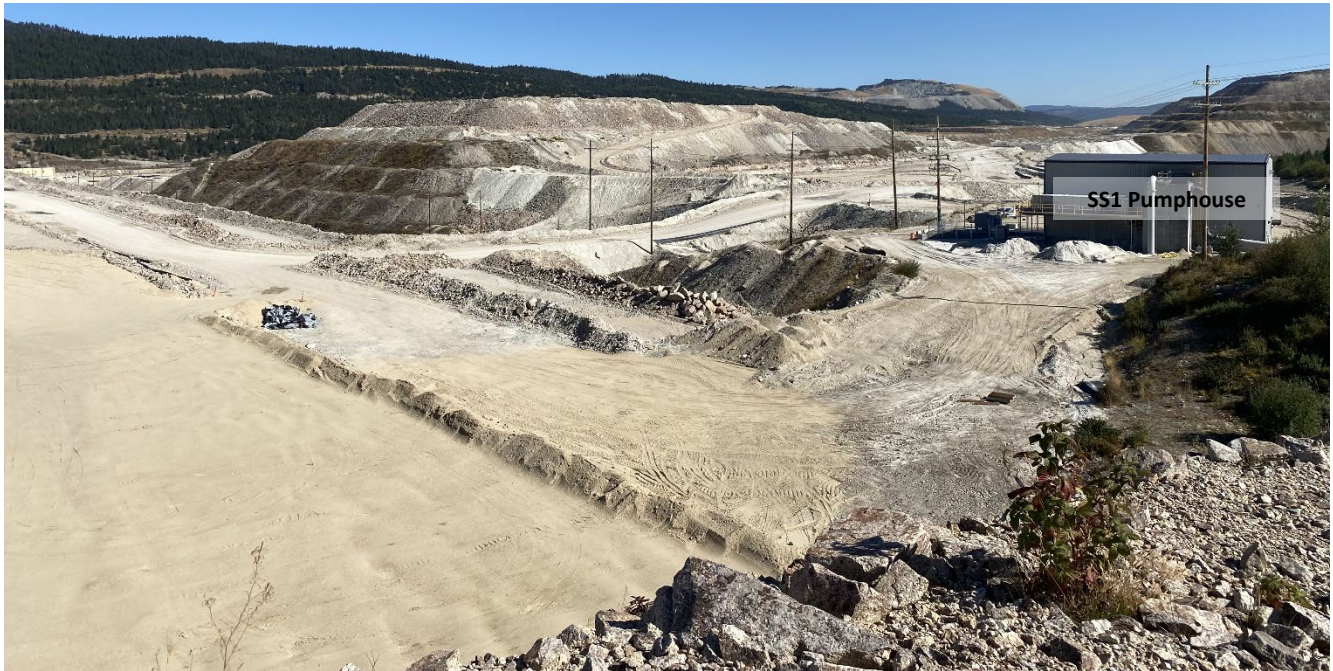
**Photo I-B-2** Downstream slope area looking east, from west abutment. Decommissioning of the Mystery Creek culvert outlet was completed during 2022, including backfilling the area. (HH-2022-01)

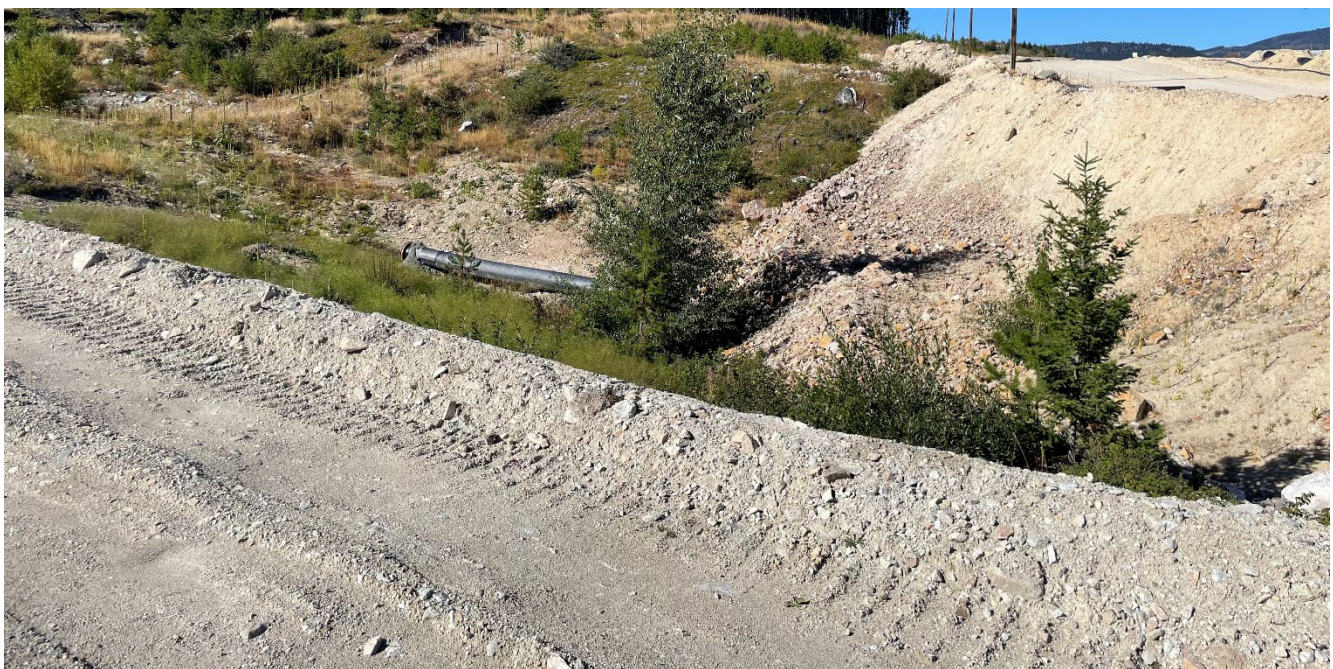
**Photo I-B-3** The inlet of the Mystery Creek culvert that extends west of the south side mine road. The pipe was grouted and inlet capped during decommissioning. (HH-2022-11)

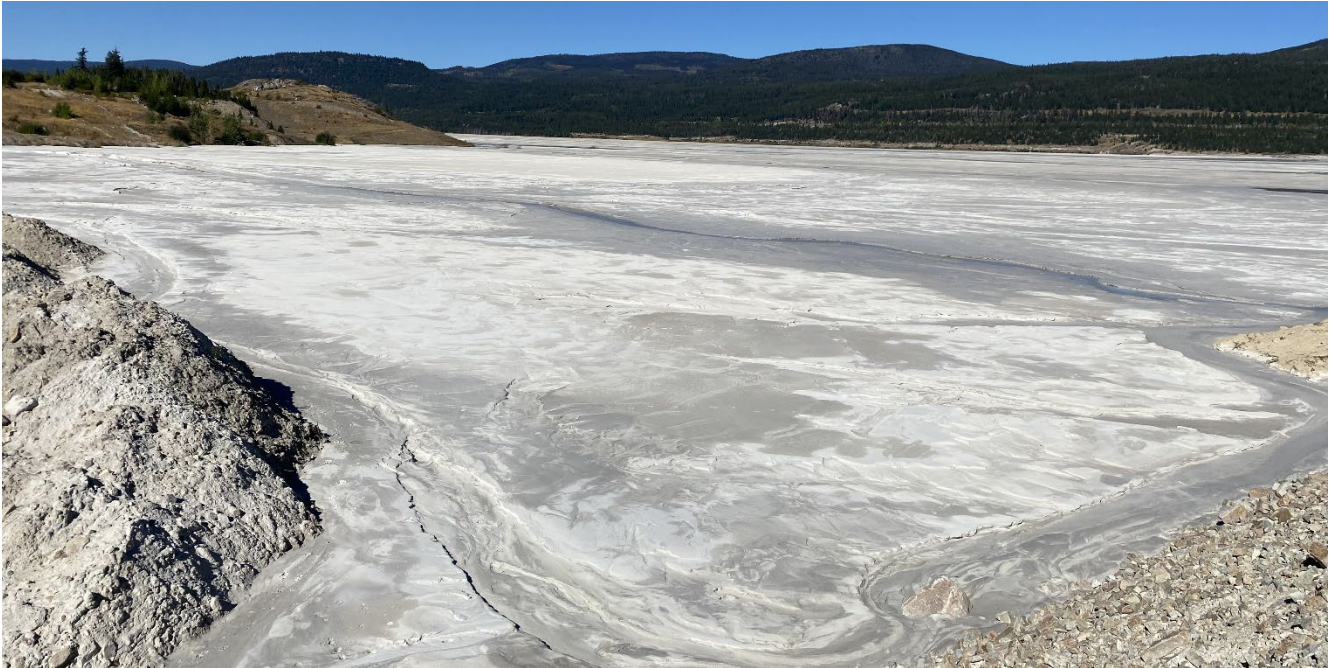
**Photo I-B-4 Tailings beach upstream of west abutment. (HH-2022-02)**

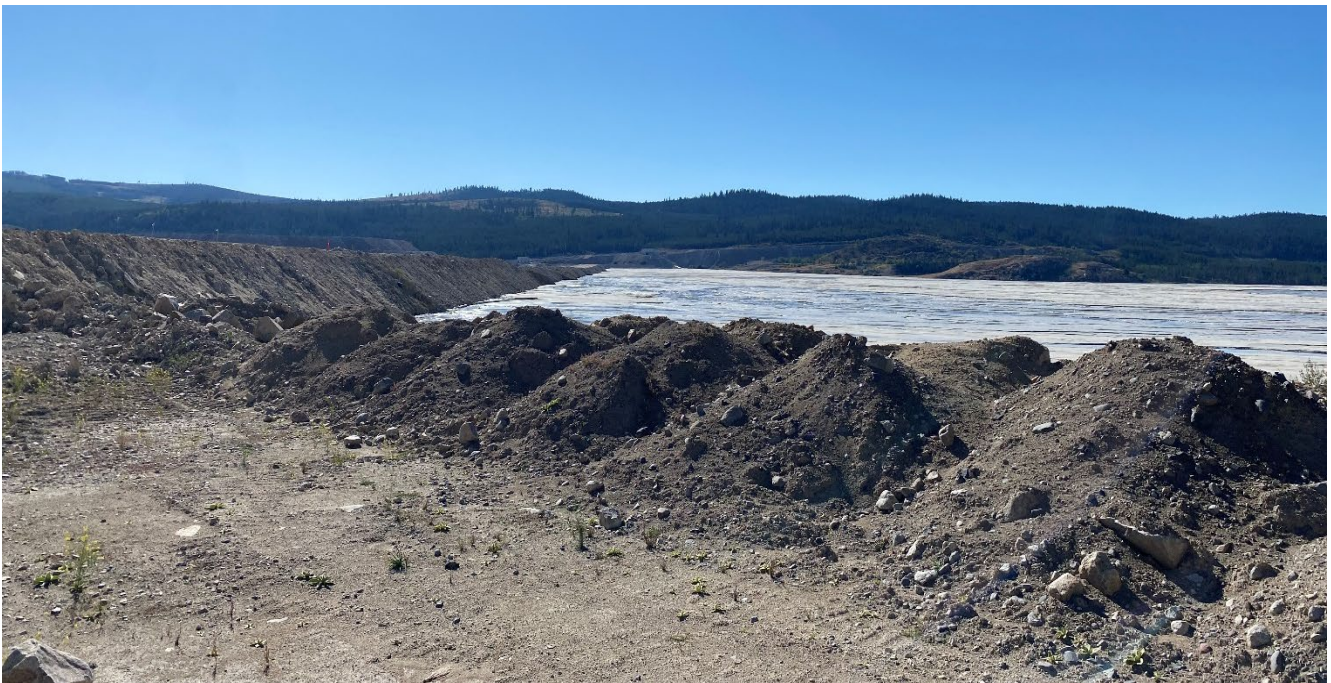
**Photo I-B-5 View of upstream slope face and beach from east abutment, looking southwest. (HH-2022-05)**

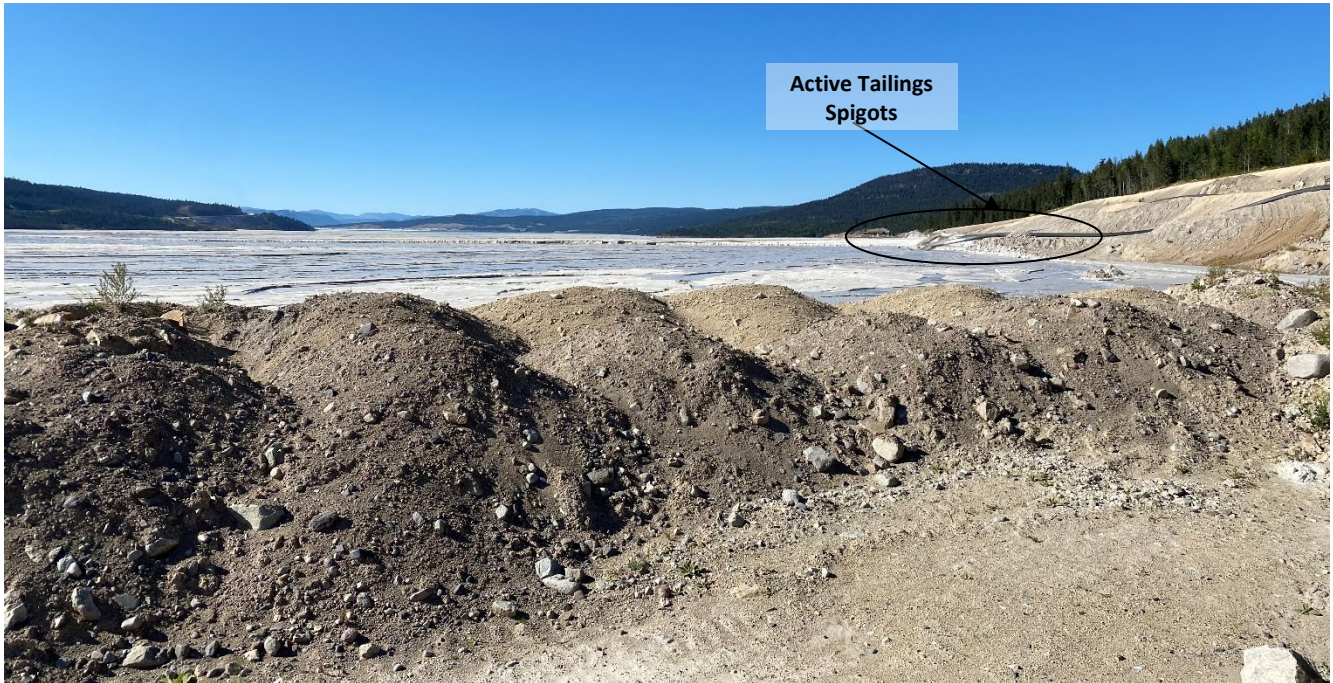
**Photo I-B-6 Active tailings spigots ~250 m upstream of west abutment. (HH-2022-05)**

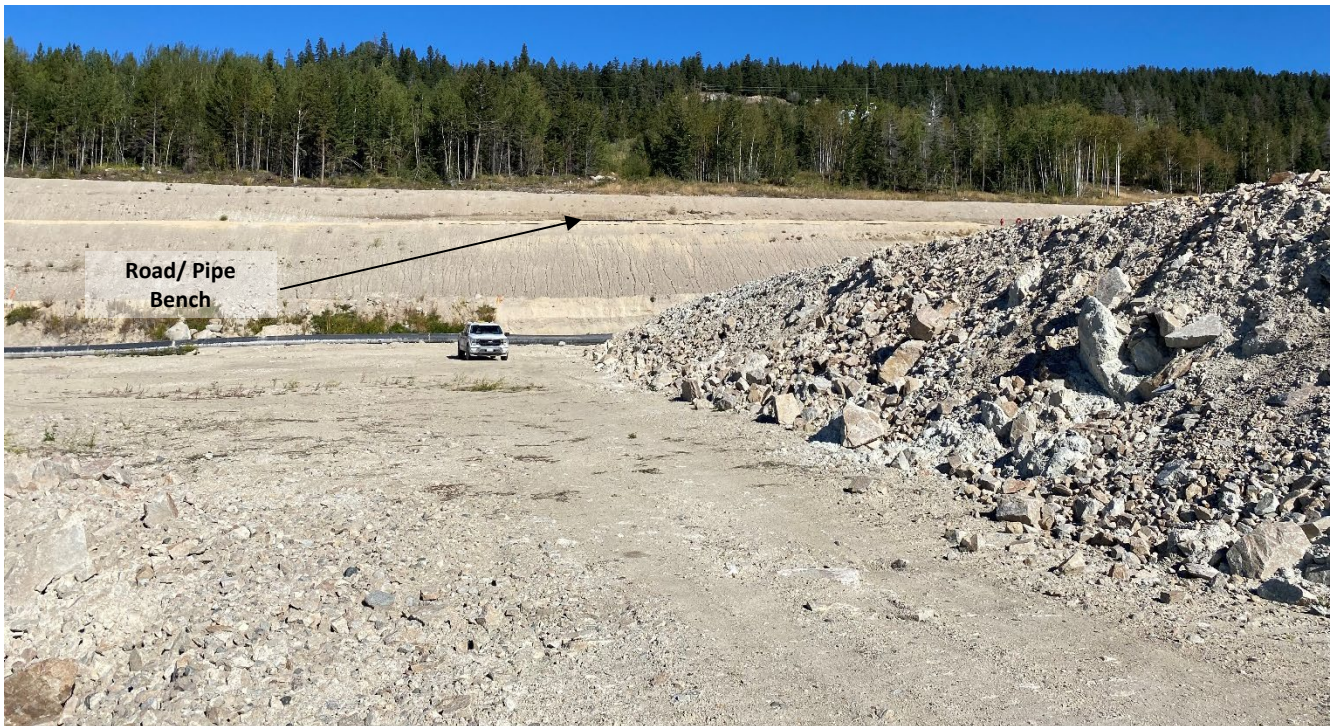
No visual indicators of concern or unusual behavior. Seepage from the excavation face of the H-H Pipe Bench and access road, upslope of H-H Dam and tailings, was observed but not causing excessive erosion or damage. (Photo-I-B-7)

**Photo I-B-7 H-H Pipe Bench and access road which crosses dam crest and waste fill platform extended onto tailings beach immediately upstream of west abutment. (HH-2022-05)**

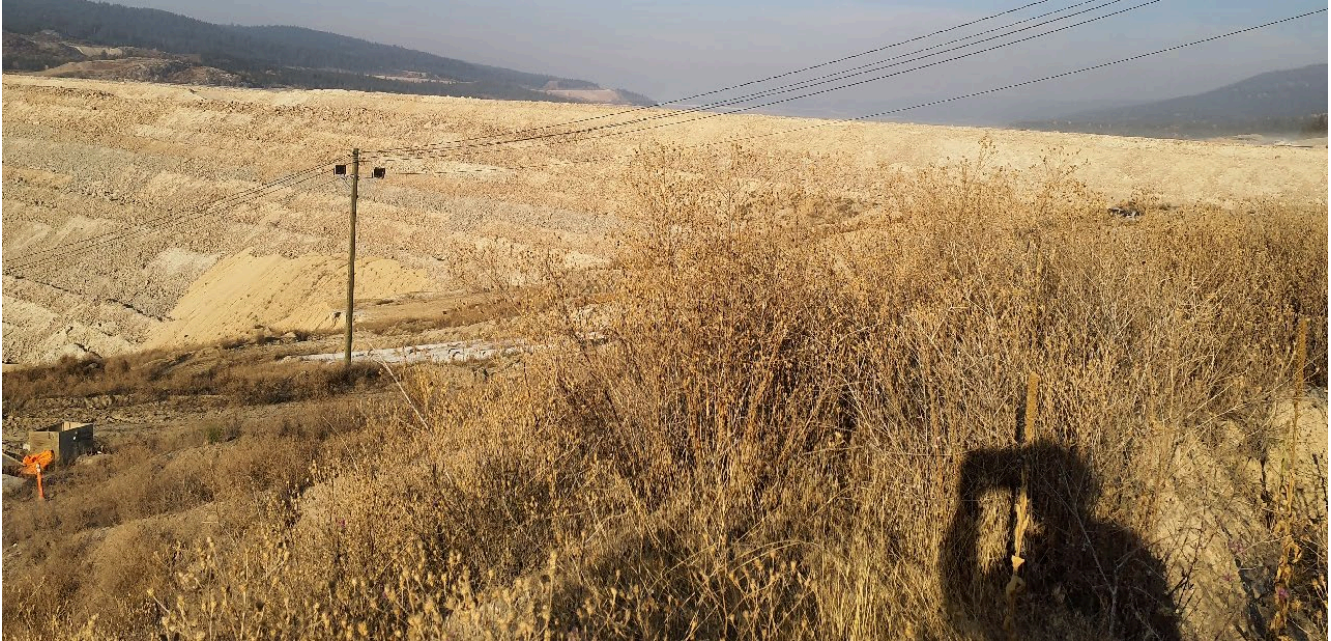
**Photo I-B-10 H-H Dam downstream slope near east abutment looking west from north side haul road. (HH-2022-10)**

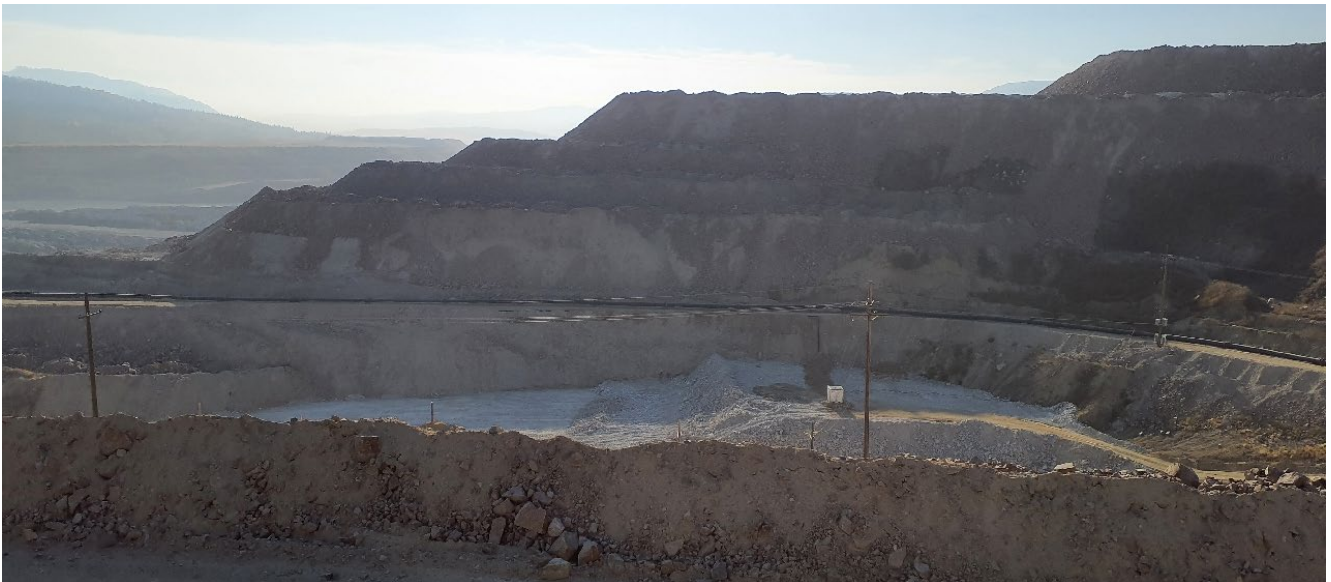
**Photo I-B-11 H-H Gland Well casings (No. 5 and No. 7) and surrounding fill are being raised in preparation for 2023 buttress fill placement. (HH-2022-09)**

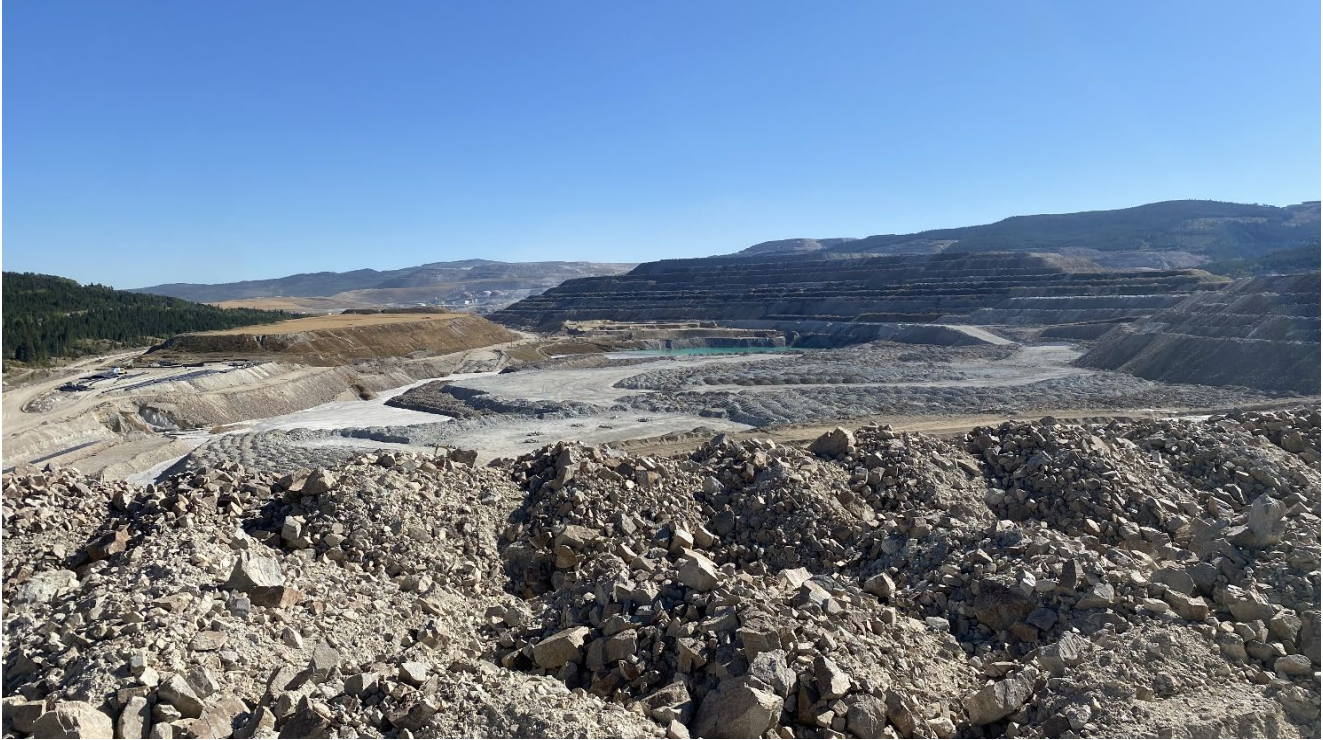
**Photo I-B-12 24 Mile Waste Dump and 24 Mile TSF downstream of H-H Dam, looking south near Sta. 1+850. (HH-2022-04)**
