# **Teck Highland Valley Copper Partnership**

## **2022 Annual Facility Performance Report**

*Trojan Tailings Storage Facility*

March 2023

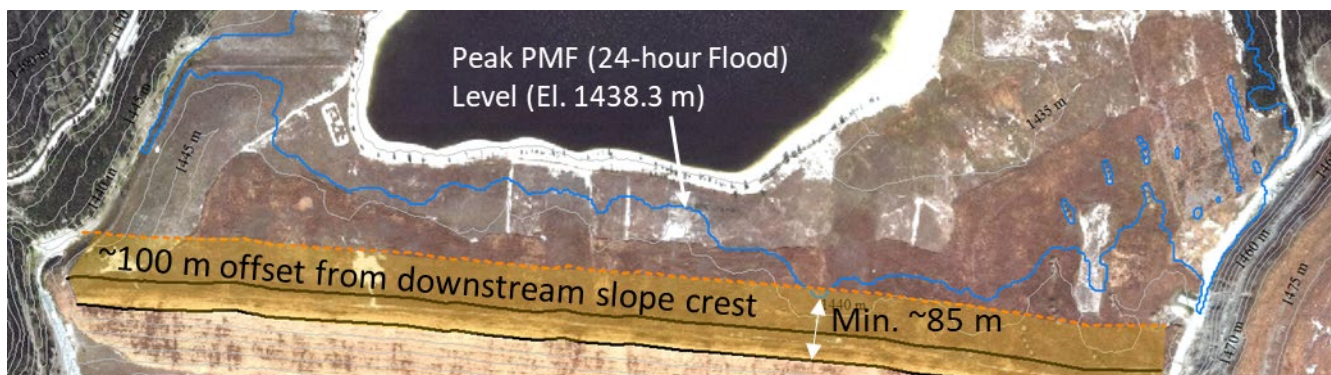
**Figure 4.4 Beach Width at Peak PMF 24-Hour Flood Level**

- The Trojan TSF spillway can route, with adequate freeboard, the PMF (24-hour) flood event, which is greater than the IDF (Table 4.2) required under the HSRC (EMCLI 2021b).
- With one exception, the minimum beach width at peak flood level during the spillway design event (PMF 24-hour) exceeds the 100 m minimum requirement specified in the design (KL 1987). Over a ~40 m segment the beach width is between 85 m to 100 m, as shown on Figure 4.4. KCB considers this acceptable and has recommended a review to confirm minimum beach width performance criteria for the existing condition; refer to Section 7.2.1 for further discussion.
- The R4 Seepage Pond can safely route, with adequate freeboard, the IDF (Table 4.2) required under the HSRC (EMCLI 2021b).

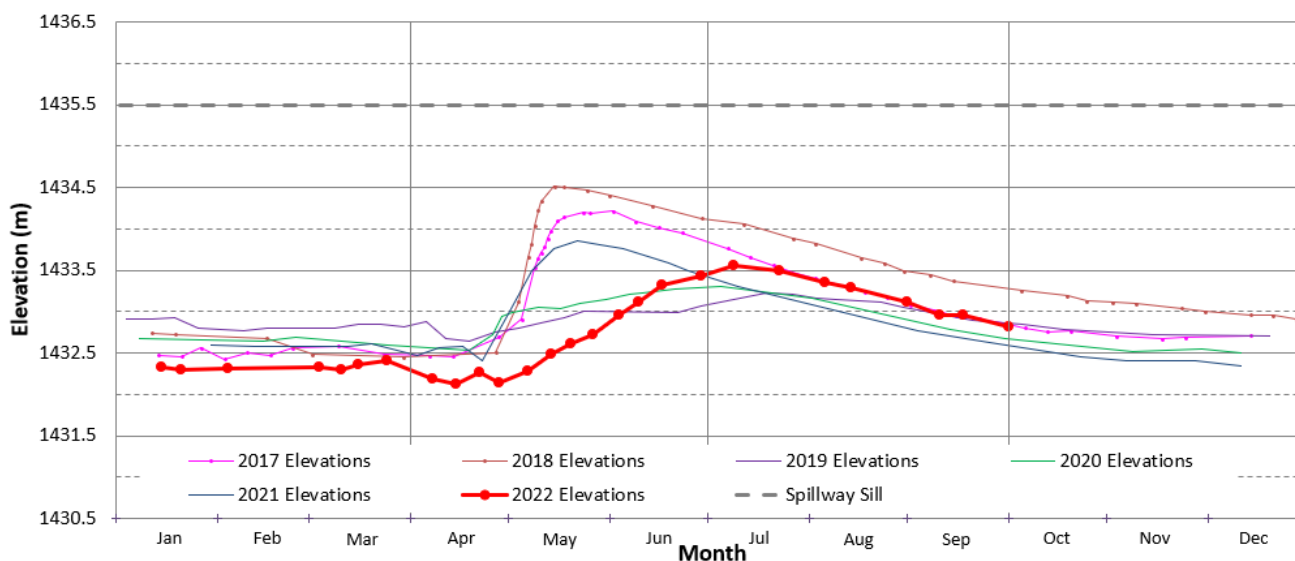
**Figure 5.1 Trojan Pond Water Elevations – 2017 to 2022**

The peak pond level during the review period was less than the previous year (-0.3 m), but the pond level at the end of the review period was higher (0.3 m); refer to Figure 5.1 and Table 5.2. Both of these are consistent with climate observations (Section 4.2), which suggests that limited rain during snowmelt (March and April) contributed to a mild freshet, but above-average rains in June and July resulted in seasonal pond rise extending later into the year and an overall net increase in pond volume over the past year. However, as shown on Figure 5.1, pond levels at the end of the review period are within the typical range for the existing conditions.

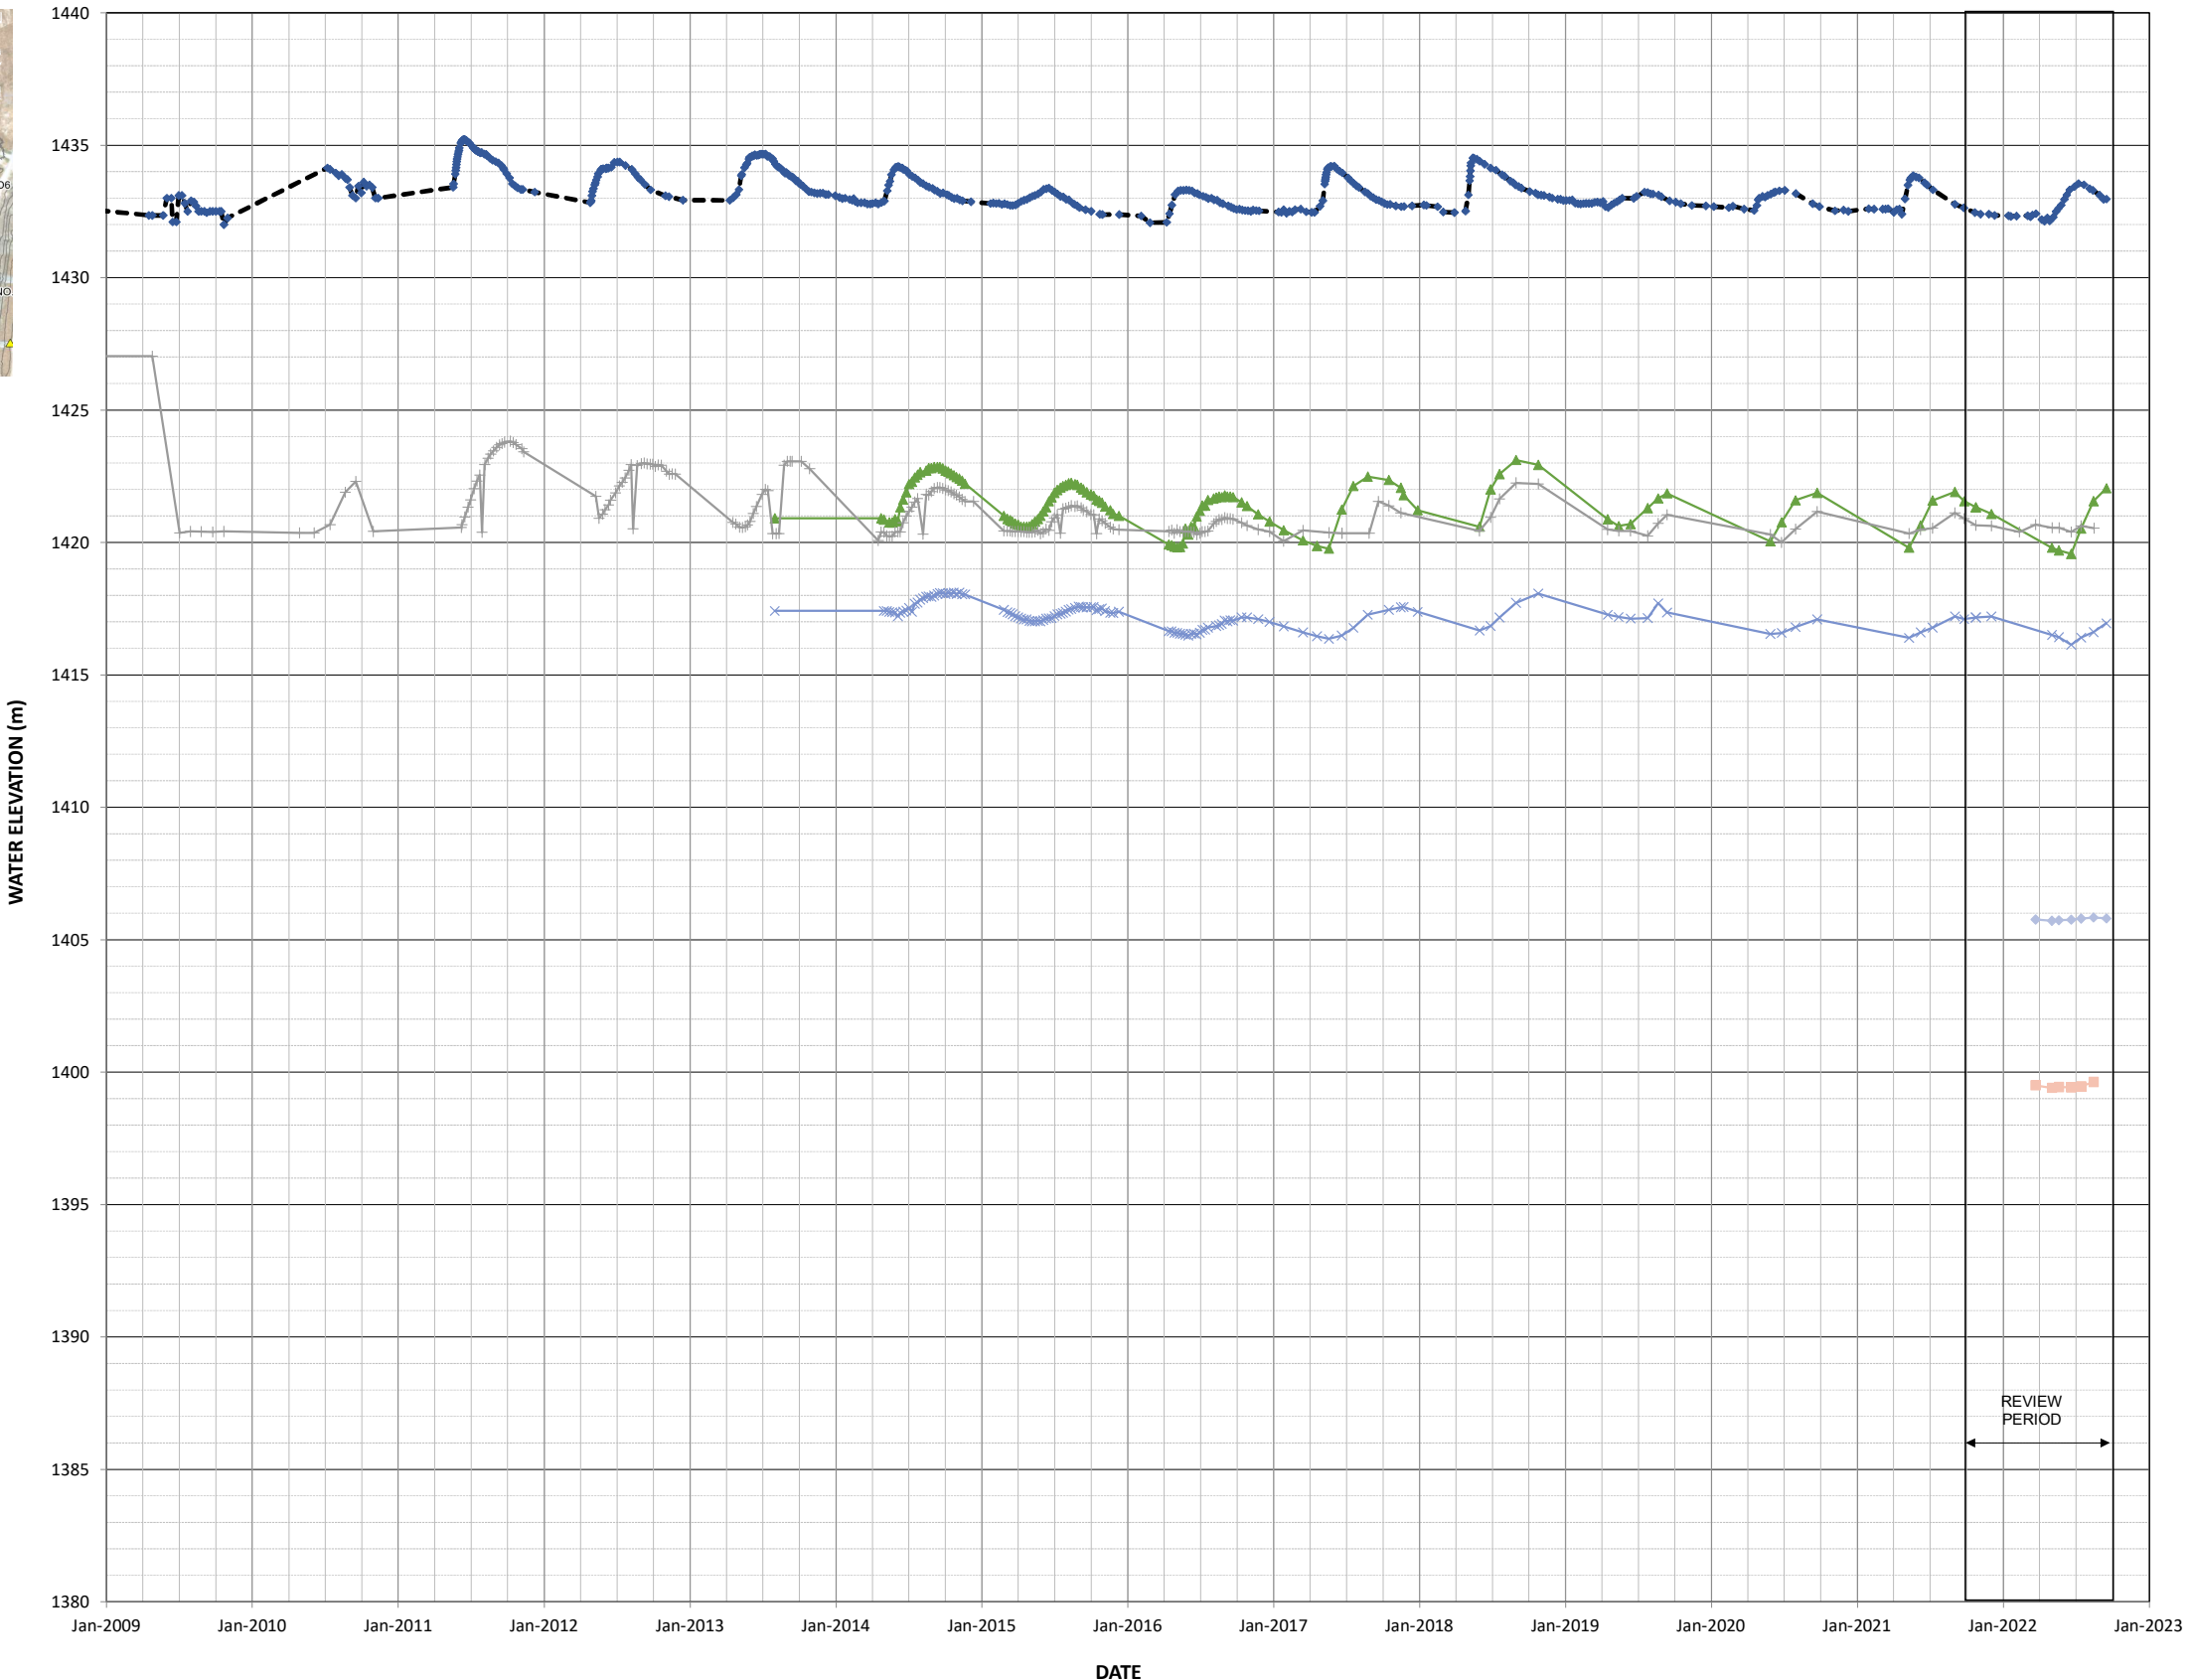
CLIENT <b>Highland Valley Copper</b> / <b>Teck</b>	PROJECT TROJAN TAILINGS STORAGE FACILITY 2022 ANNUAL FACILITY PERFORMANCE REPORT
TITLE TROJAN DAM PIEZOMETRIC DATA YEARS 2009 TO 2022 IMPOUNDMENT	
PROJECT No. M02341C42	FIG No. 7

- Cycloned Sand (Impoundment and Near Crest) (Figure 7 and Figure 8): Piezometric readings and trends during the review period were consistent with readings over the past 12 years.

**NOTES:**  
 1. THRESHOLDS WILL BE ESTABLISHED FOR TRJ-VWP19-06 AND TRJ-VWP19-07 AFTER A MINIMUM OF 18 MONTHS OF DATA HAS BEEN COLLECTED SO THAT EXPECTED CONDITIONS ARE ESTABLISHED.  
 2. SECTIONS A AND B ARE SHOWN ON FIGURE 12.

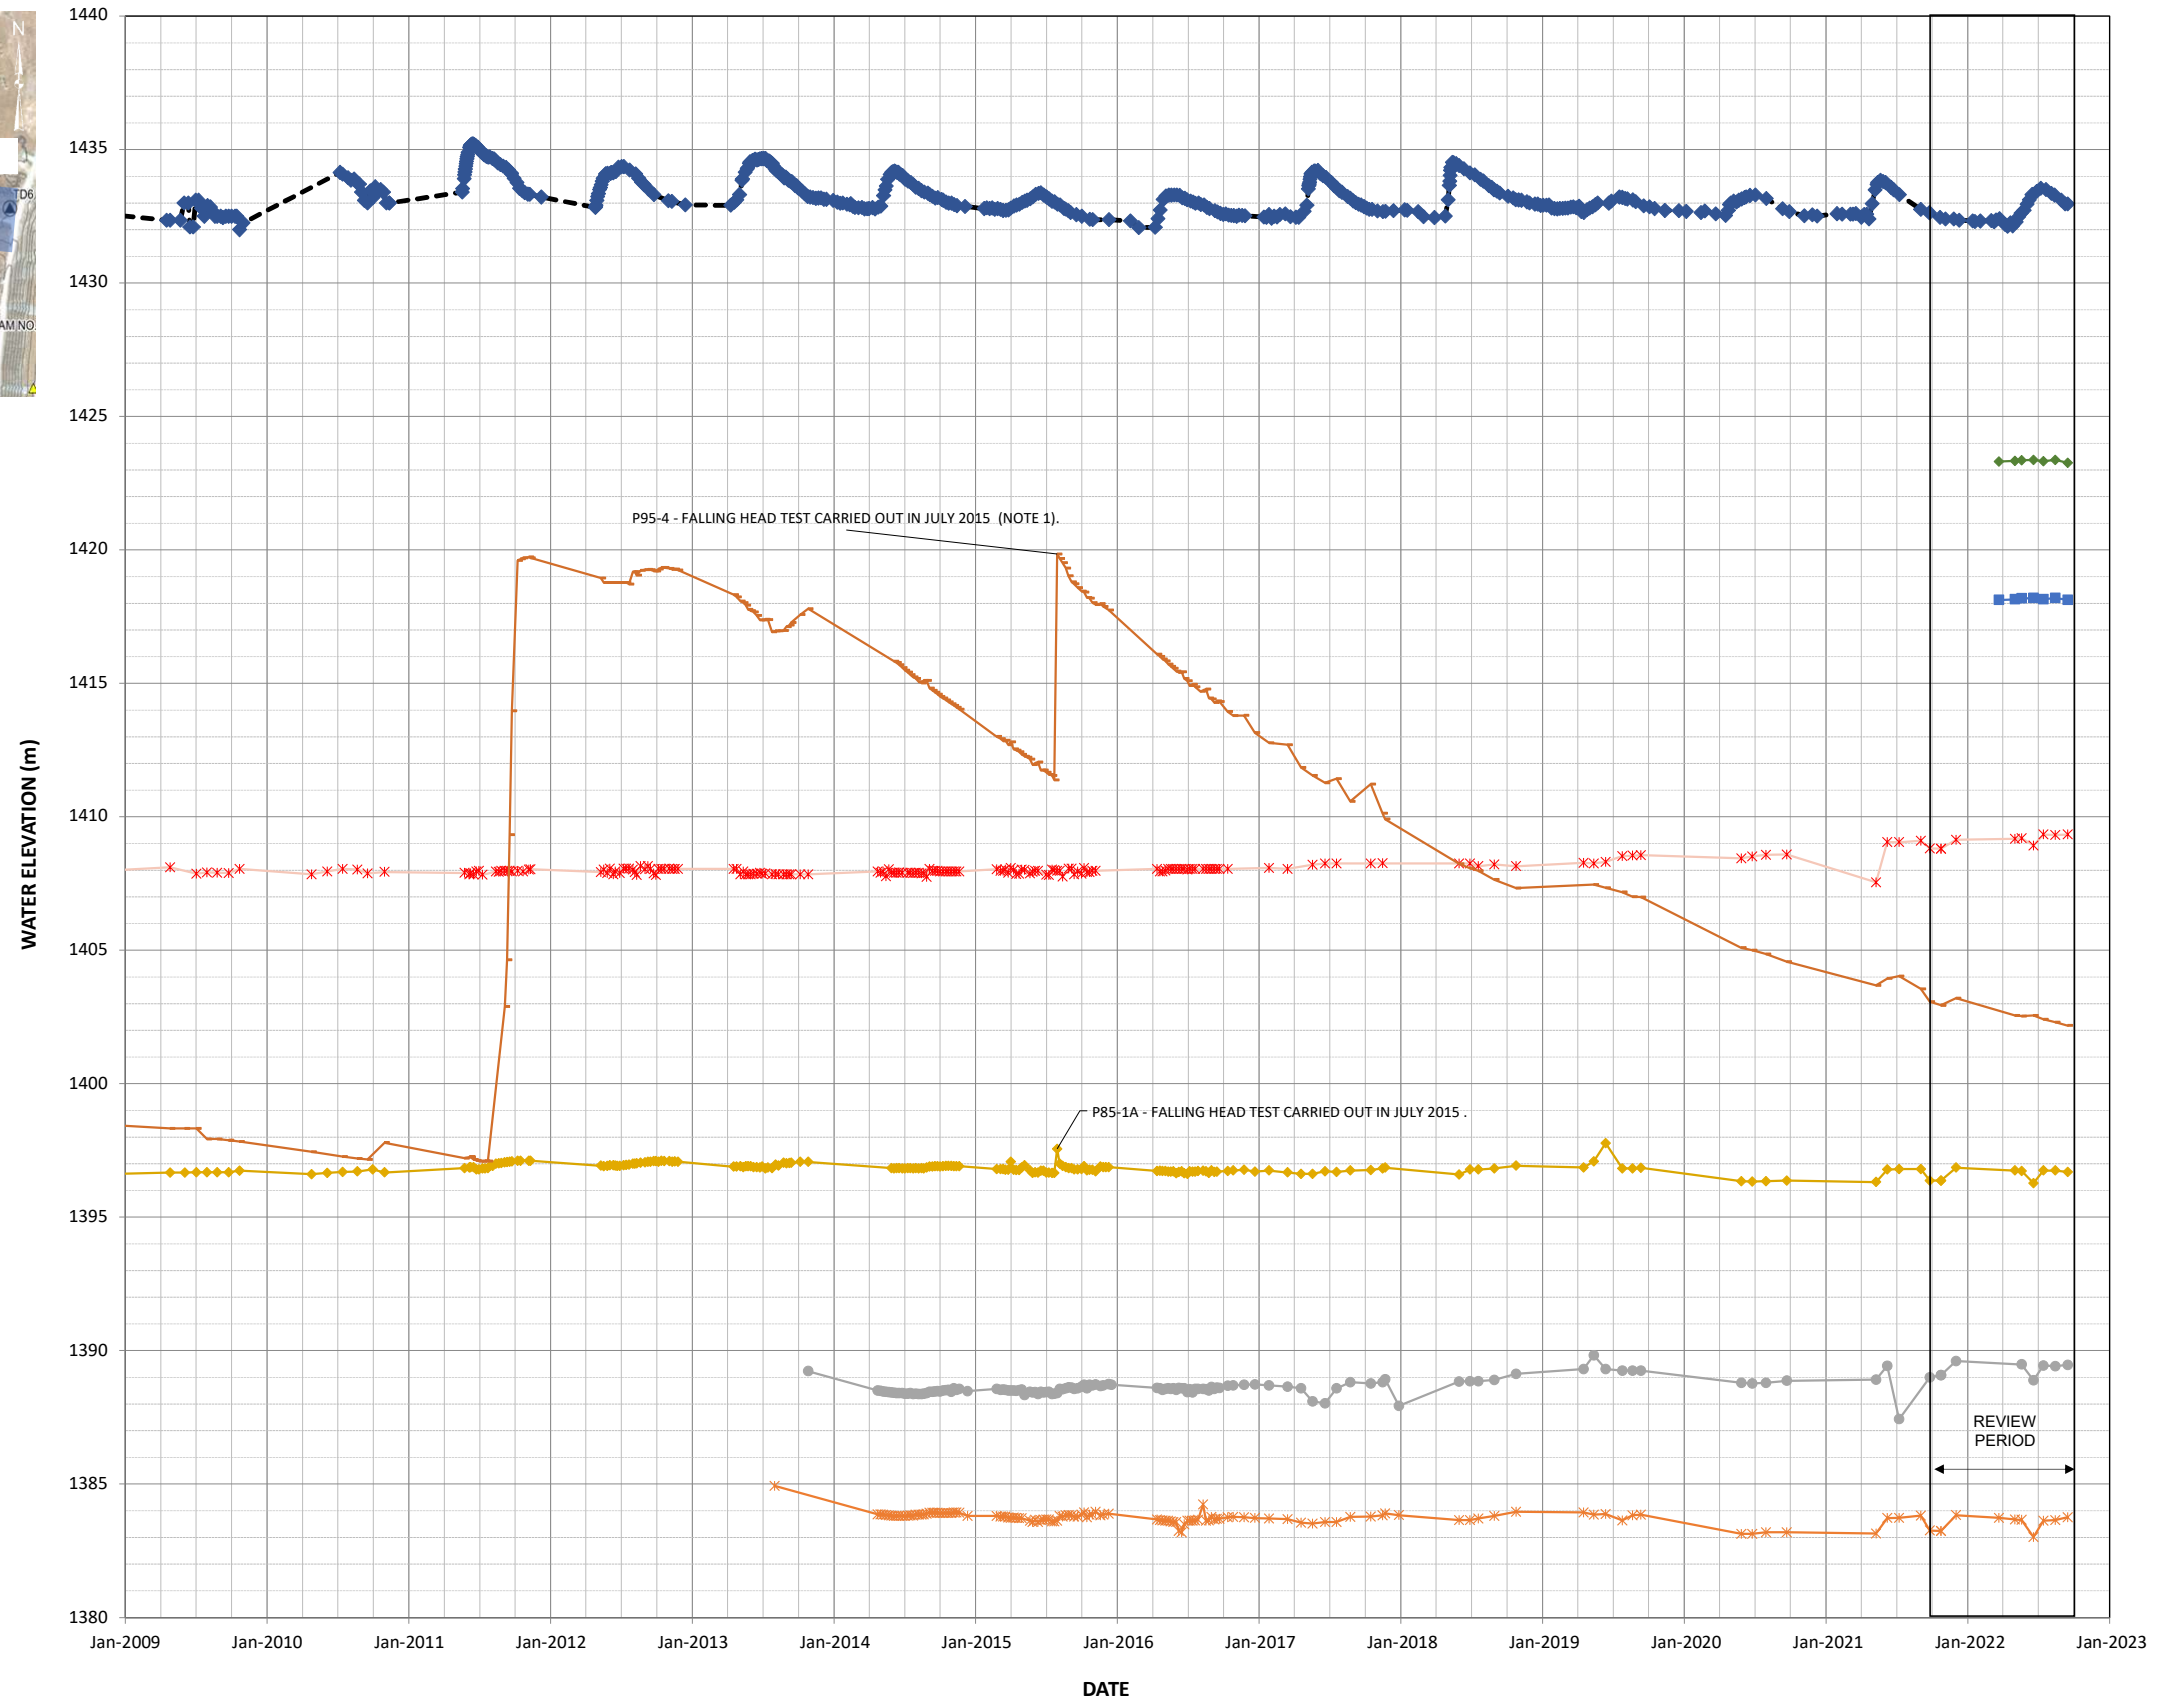
PROJECT No. M02341C42 | FIG No. 8

- ◆ As shown on Figure 12, piezometric levels are showing drain down from the pond through the cycloned sand beach. P95-4 continues to show drain down from the falling head test completed in 2015 and remains above the piezometric level measured in other nearby piezometers. Such a prolonged drain down period suggests the piezometer casing may be plugged. Similar to P86-1, KCB recommends HVC also investigate this instrument to confirm whether this is the case.

- Starter Dam Fill (Figure 8): Piezometers installed in sand-and-gravel fill zones of the starter dam (TB-PS-04/P13-3 and TB-PS-03/P13-4) measure low piezometric levels (Figure 8). This also supports that the starter dam continues to act as an effective drain for the cycloned sand beach.
- Starter Dam Foundation (Figure 9): Piezometers installed in the glacial till foundation at the starter dam upstream toe, near the low point of the valley, and beneath the downstream slope, measured low piezometric heads with little variance throughout the year.
  - ◆ VWP16-2A is interpreted as undergoing a prolonged equilibration after installation. Readings during the review period suggest it is reaching a steady level.

1. P95-4 IS STILL EQUILIBRATING FROM 2015 FALLING HEAD TEST SO NO THRESHOLD HAS BEEN APPLIED. ONCE IT EQUILIBRATES THE INSTRUMENT WILL BE REVIEWED TO CONFIRM WHETHER IT PROVIDES VALUE AND SHOULD BE RETAINED AS SUCH A LONG DRAINAGE PERIOD IS NOT A EXPECTED FOR CYCLONED SAND PIEZOMETER.

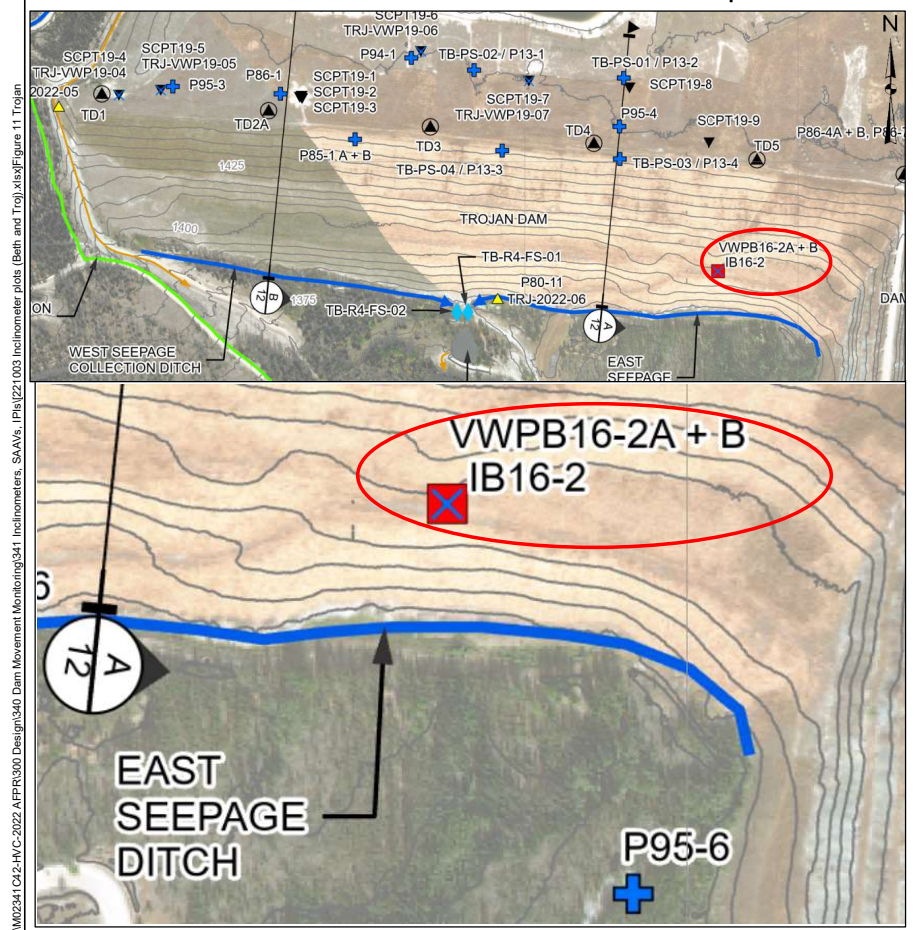
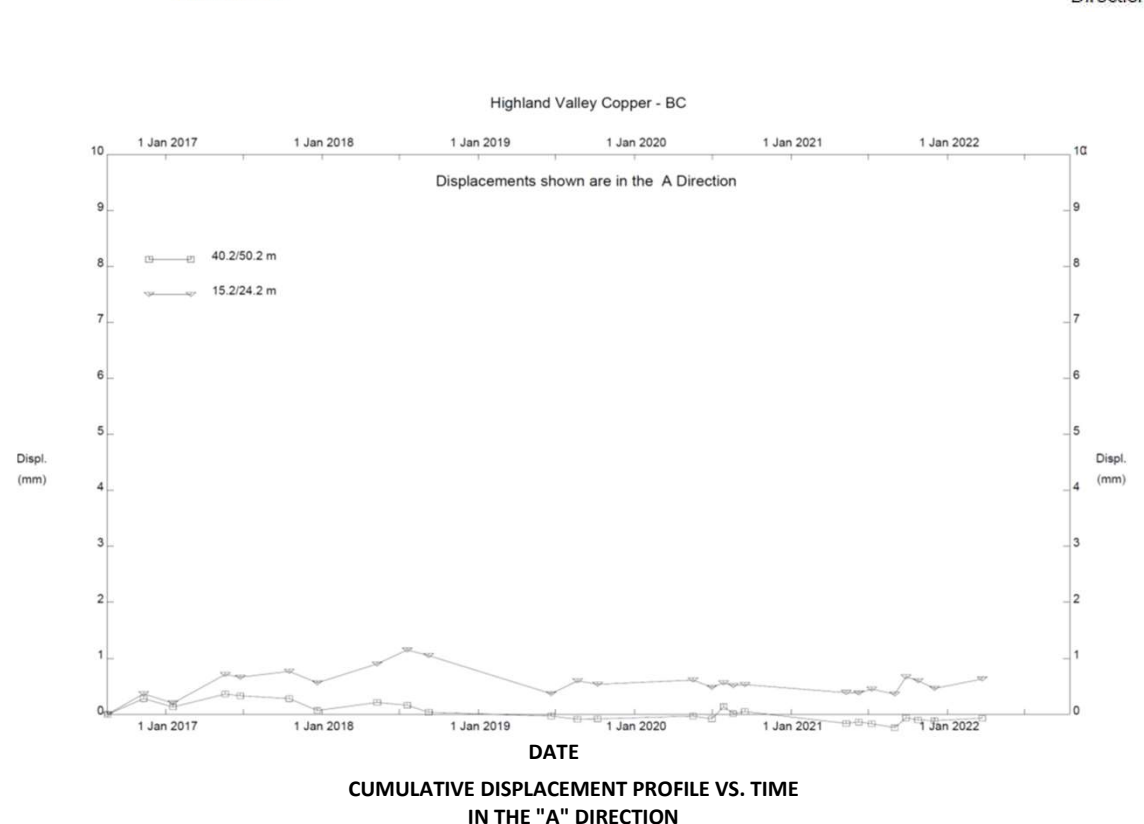
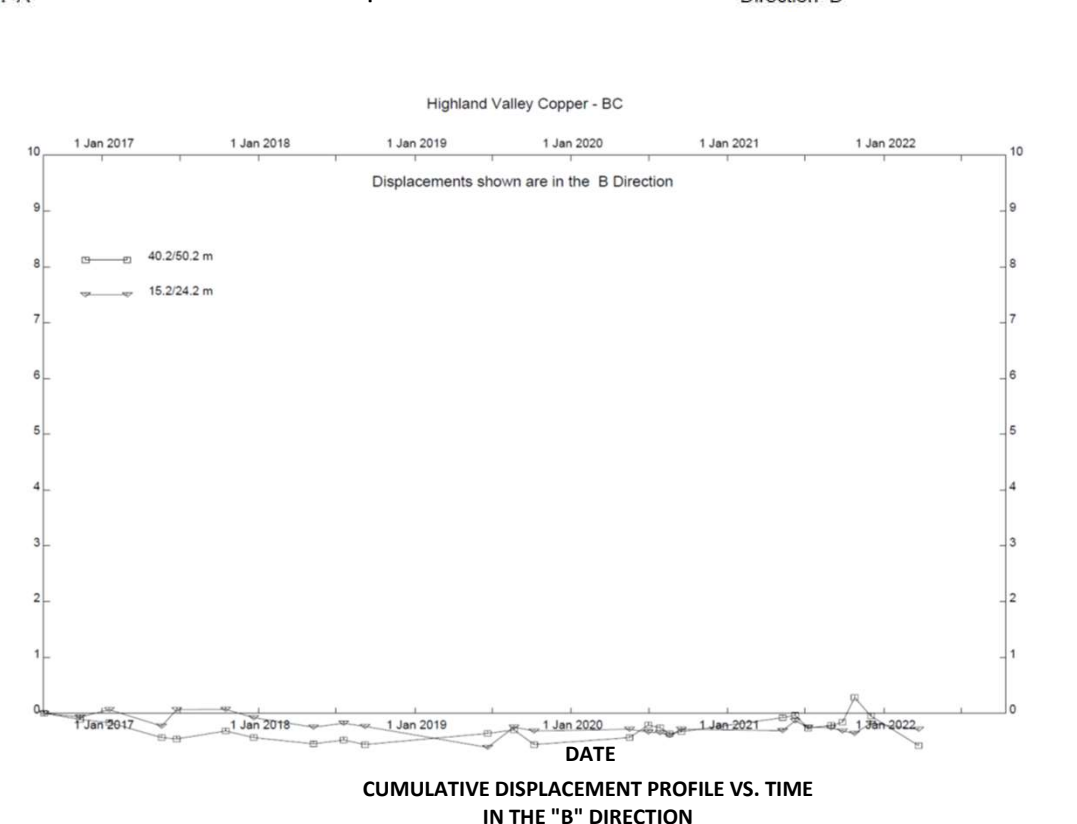
CLIENT Highland Valley Copper / Teck	PROJECT TROJAN TAILINGS STORAGE FACILITY 2022 ANNUAL FACILITY PERFORMANCE REPORT
	TITLE TROJAN DAM INCLINOMETER DISPLACEMENT PROFILE IB16-2
PROJECT No. M02341C42	FIG No. 11

A single inclinometer (IB16-2) is installed at the Trojan Dam. IB16-2 was read twice during 2022, as per the OMS Manual (HVC 2022), but only one reading (March) was taken during the review period. No significant deformations in the downstream direction have been observed (Figure 11).

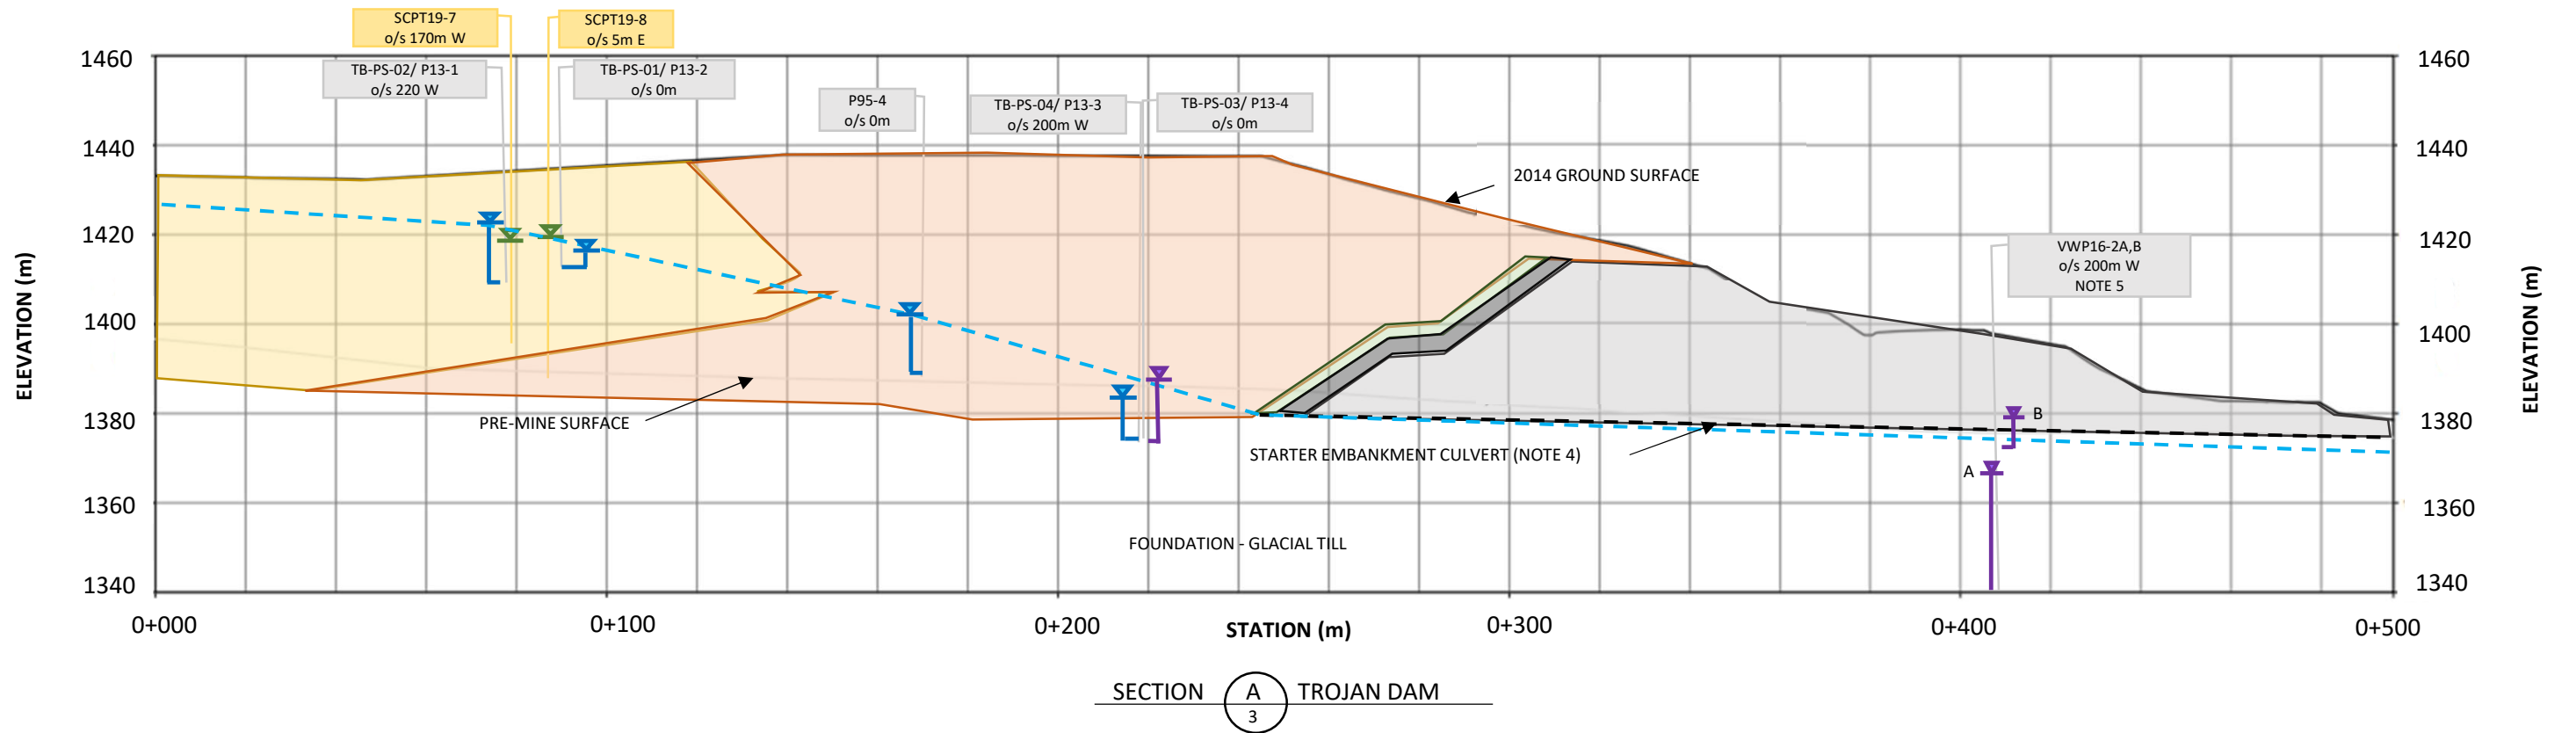
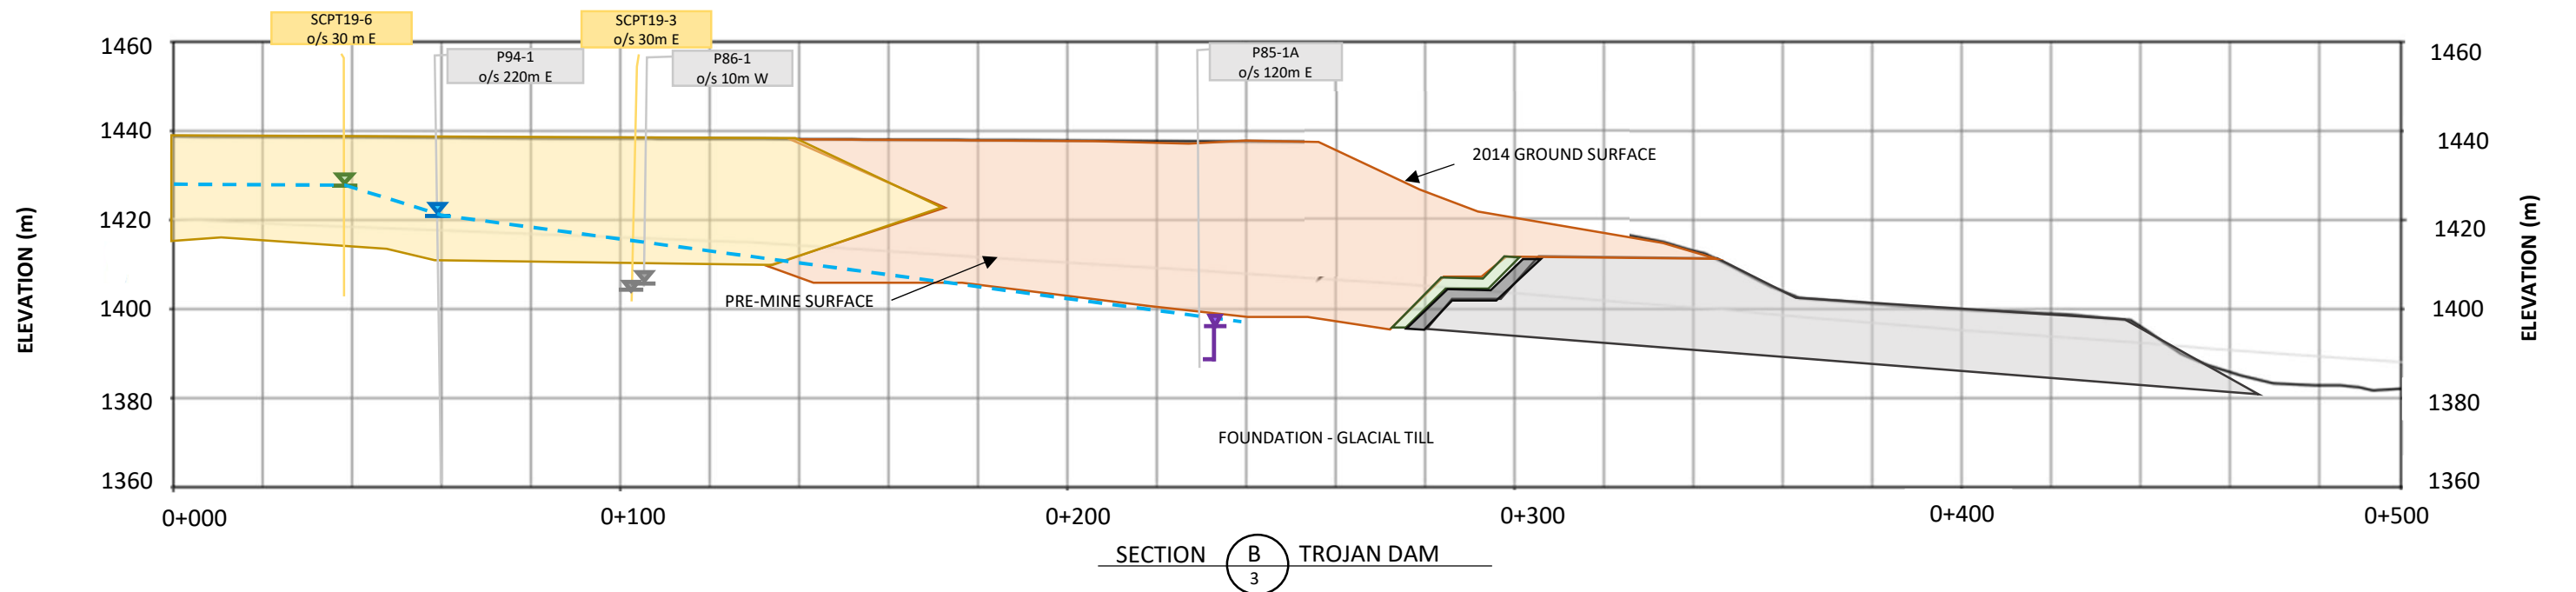
- no piezometers are showing a rising trend over time; and
    - below the crest, piezometric levels are well below the starter dam crest and, in the centre of the valley (Section A, Figure 12), are more than 10 m below the levels measured during operations.

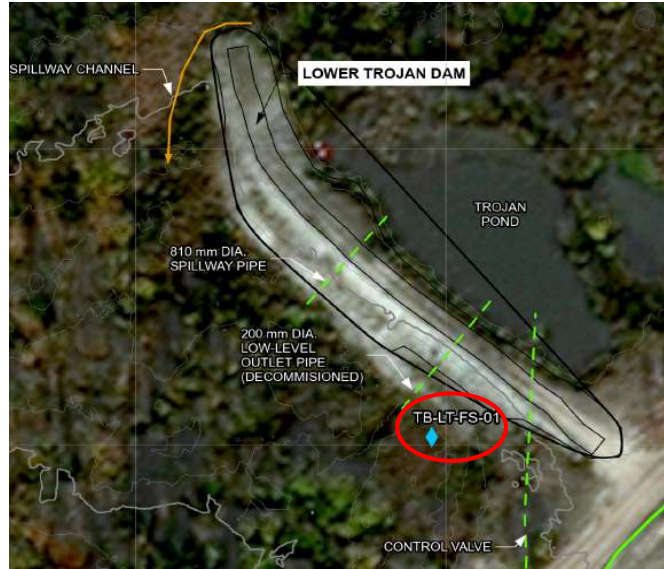
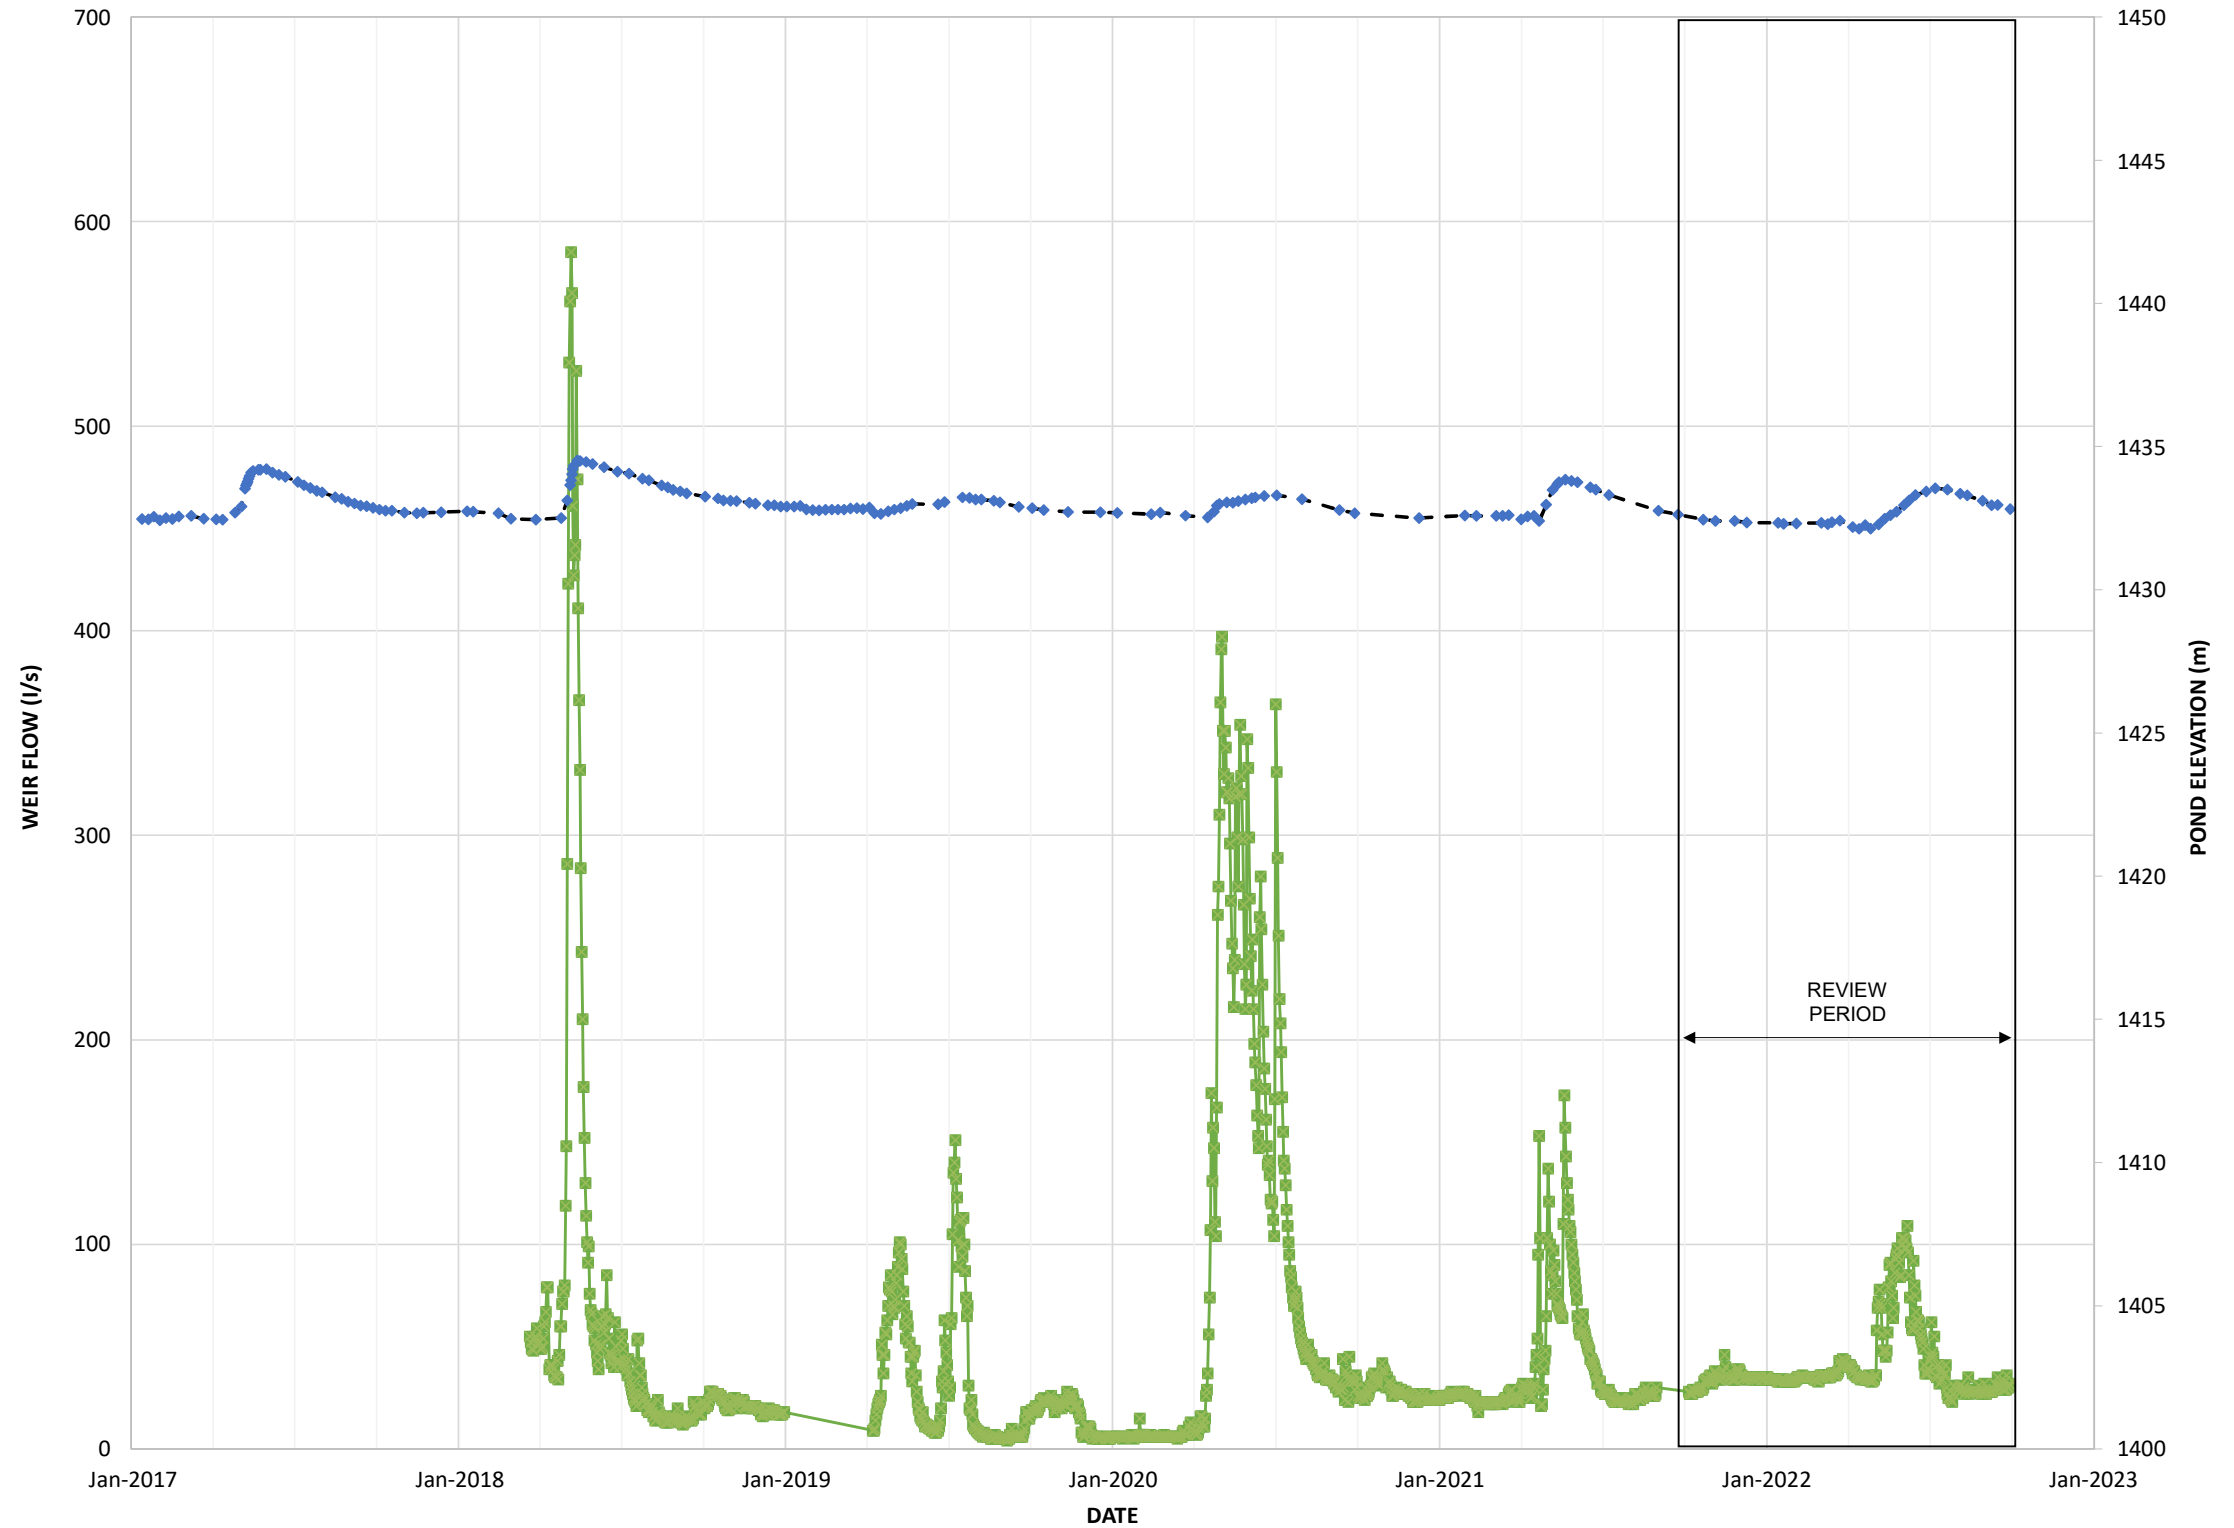
NOT FOR CONSTRUCTION	
TO BE READ WITH KLOHN CRIPPEN BERGER REPORT DATED: March 2023	
CLIENT 	PROJECT TROJAN TAILINGS STORAGE FACILITY 2022 ANNUAL FACILITY PERFORMANCE REPORT
TITLE LOWER TROJAN DAM WEIR FLOWS	
	PROJECT No. M02341C42      FIG No. 14

Seepage flows measured at weirs installed downstream of the Trojan TSF are plotted on Figure 14 and Figure 15. The number and relative locations of the active weirs are listed below:

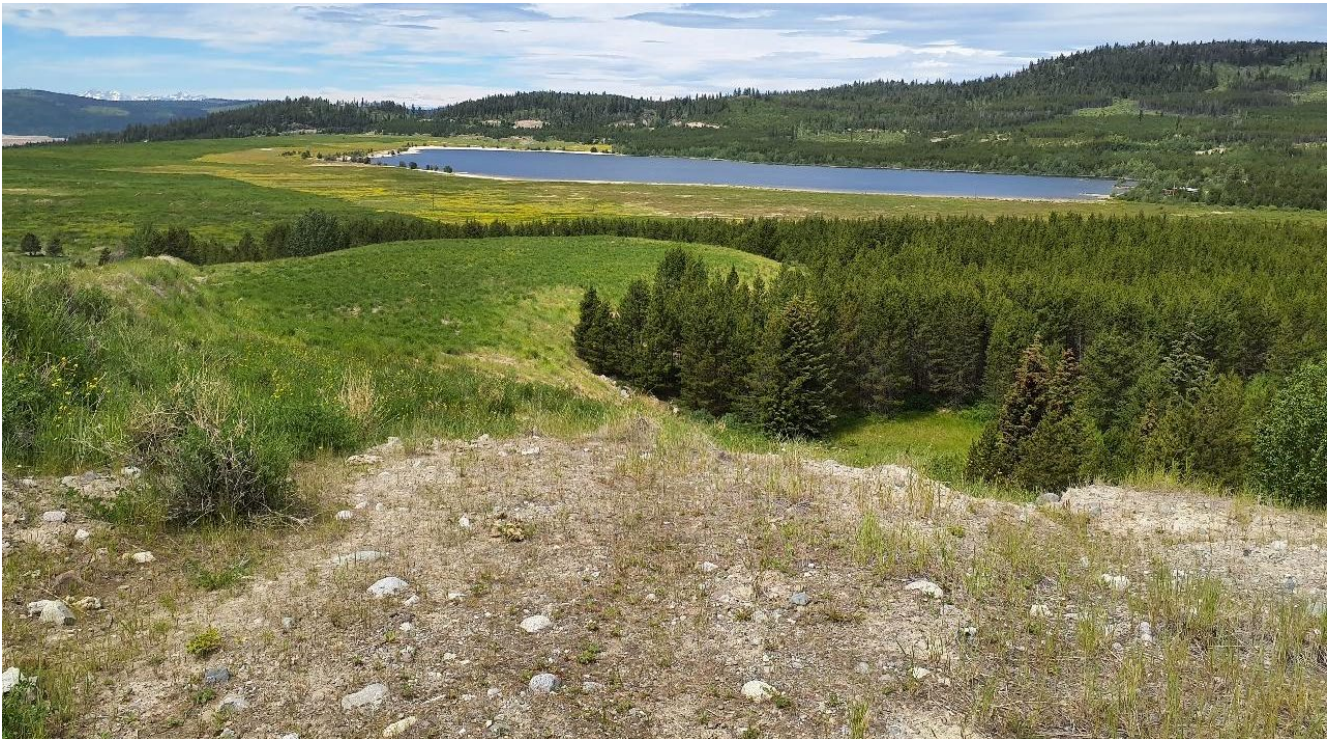
**Photo I-A-3 Overview of Trojan Tailings Pond and vegetation-free perimeter beach (TRJ-2022-03)**

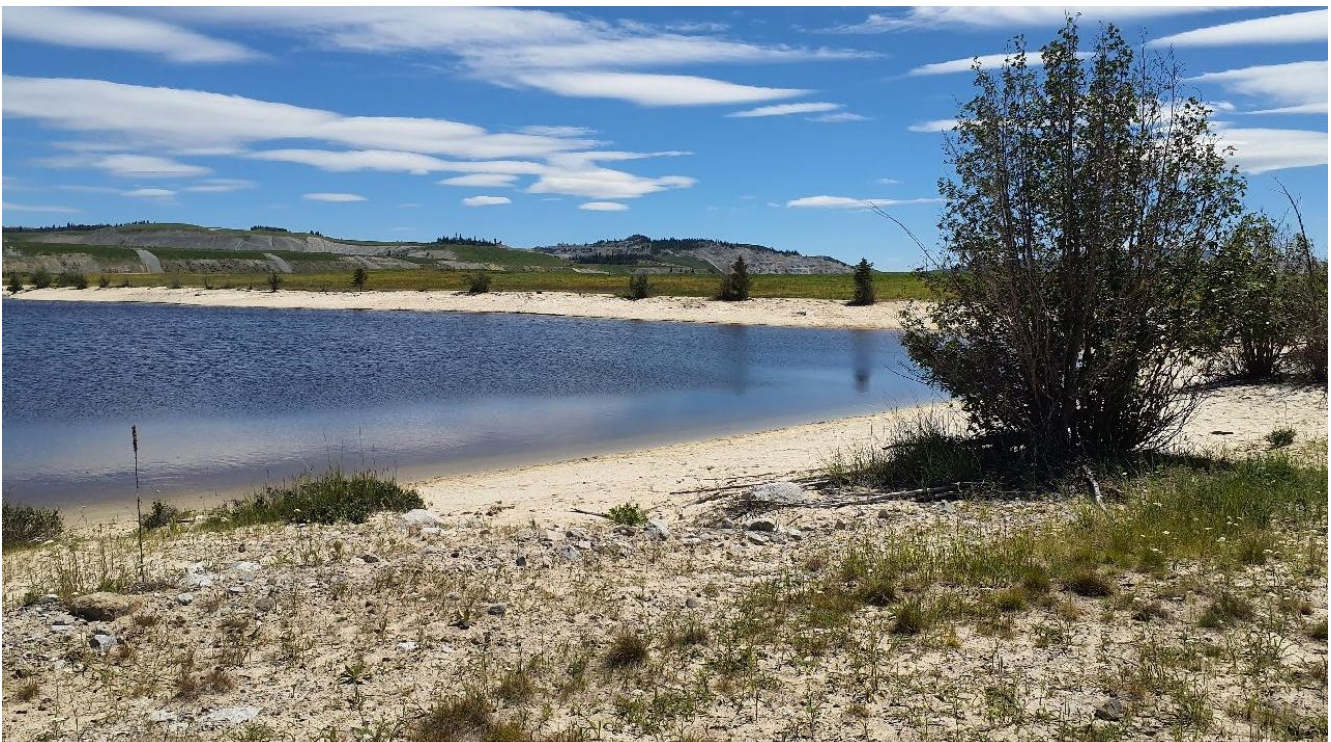
**Photo I-A-4 View of Trojan spillway inlet. KCB observed that the approach channel was clear and debris boom was secured (TRJ-2022-03)**

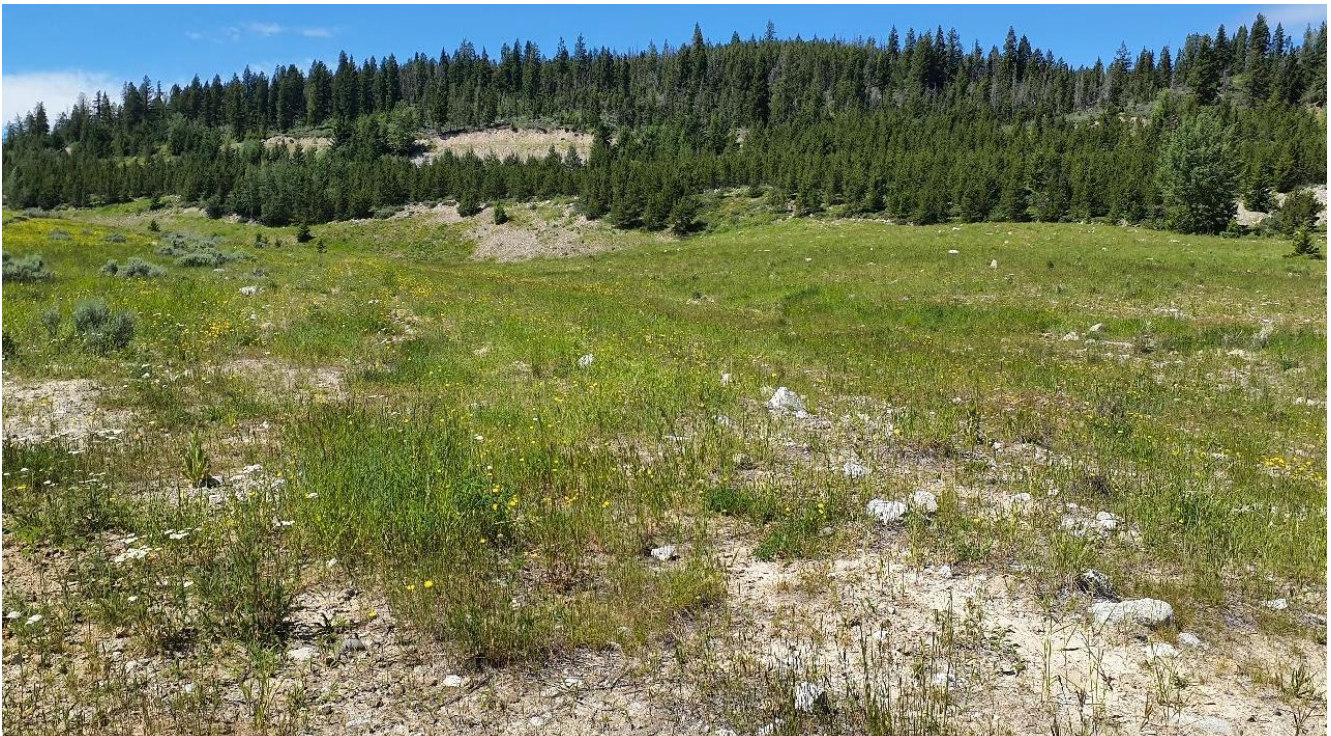
**Photo I-A-6** Upper segment of spillway downstream of approach channel, looking toward southwest (top) and looking toward northeast (bottom). HVC provided a photograph to show that vegetation was cleared after site visit. (TRJ-2022-04)

- No dam safety deficiencies were observed.
- Vegetation growth in spillway channel upstream of bedrock chute which was observed during the AFPR site visit includes seasonal growth. HVC scrubbed the bushes and cut the grass along the base of the spillway channel as part of routine maintenance after the site visit.
