# **Teck Highland Valley Copper Partnership**

## **2022 Annual Facility Performance Report**

*Trojan Tailings Storage Facility*

March 2023

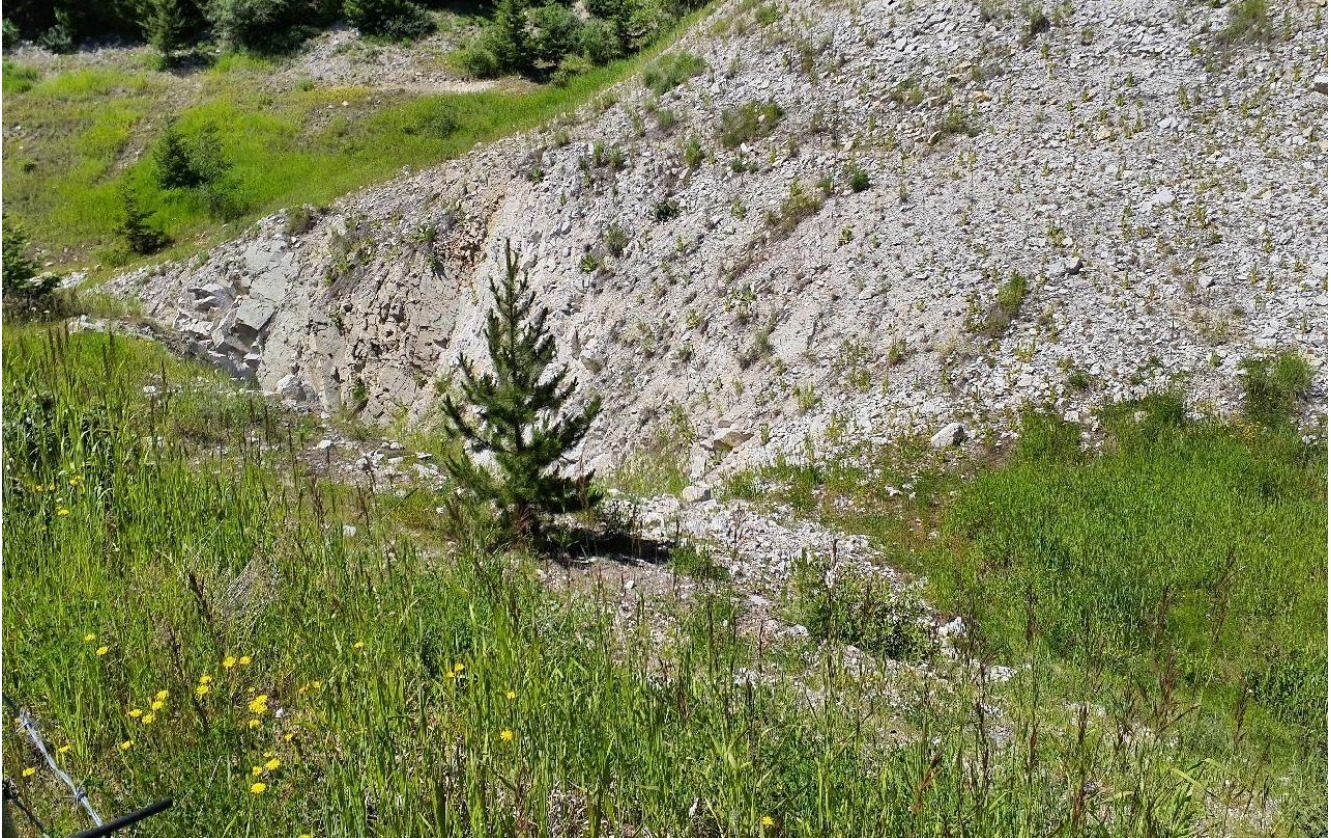
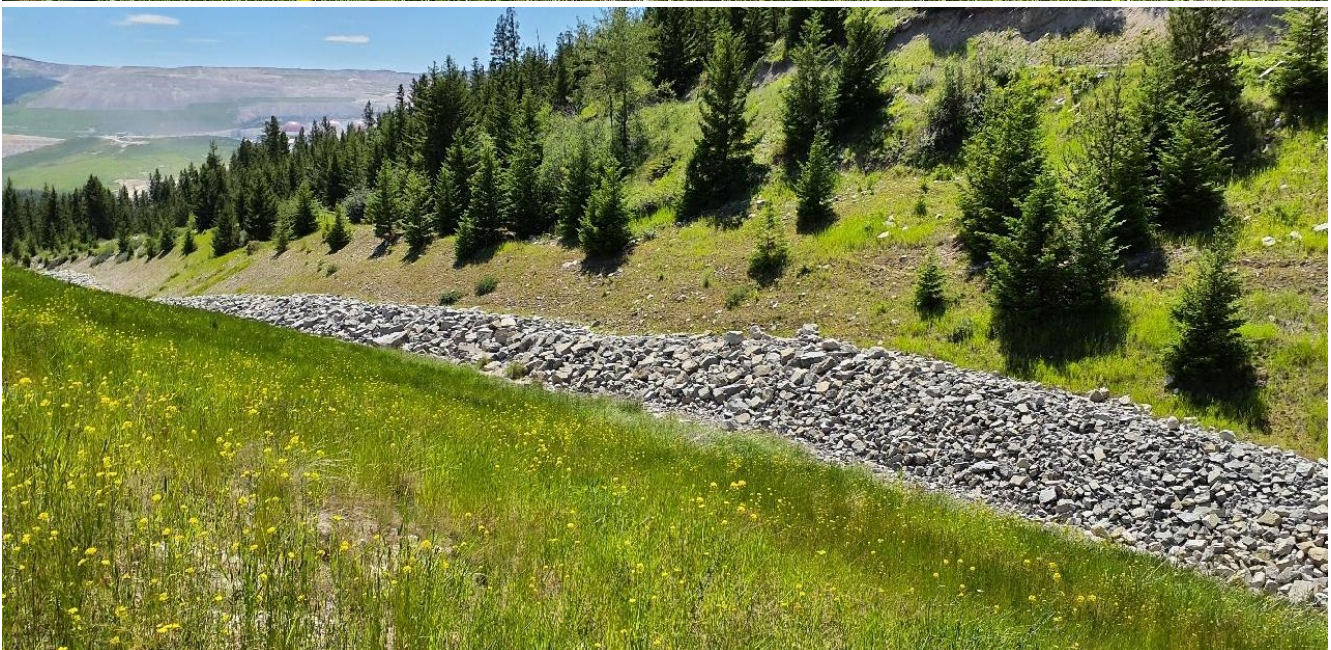
**Photo I-A-7 Overview of spillway channel downstream of rock chute, near transition to riprap segment, looking toward south (top) and looking north (bottom). (TRJ-2022-05)**

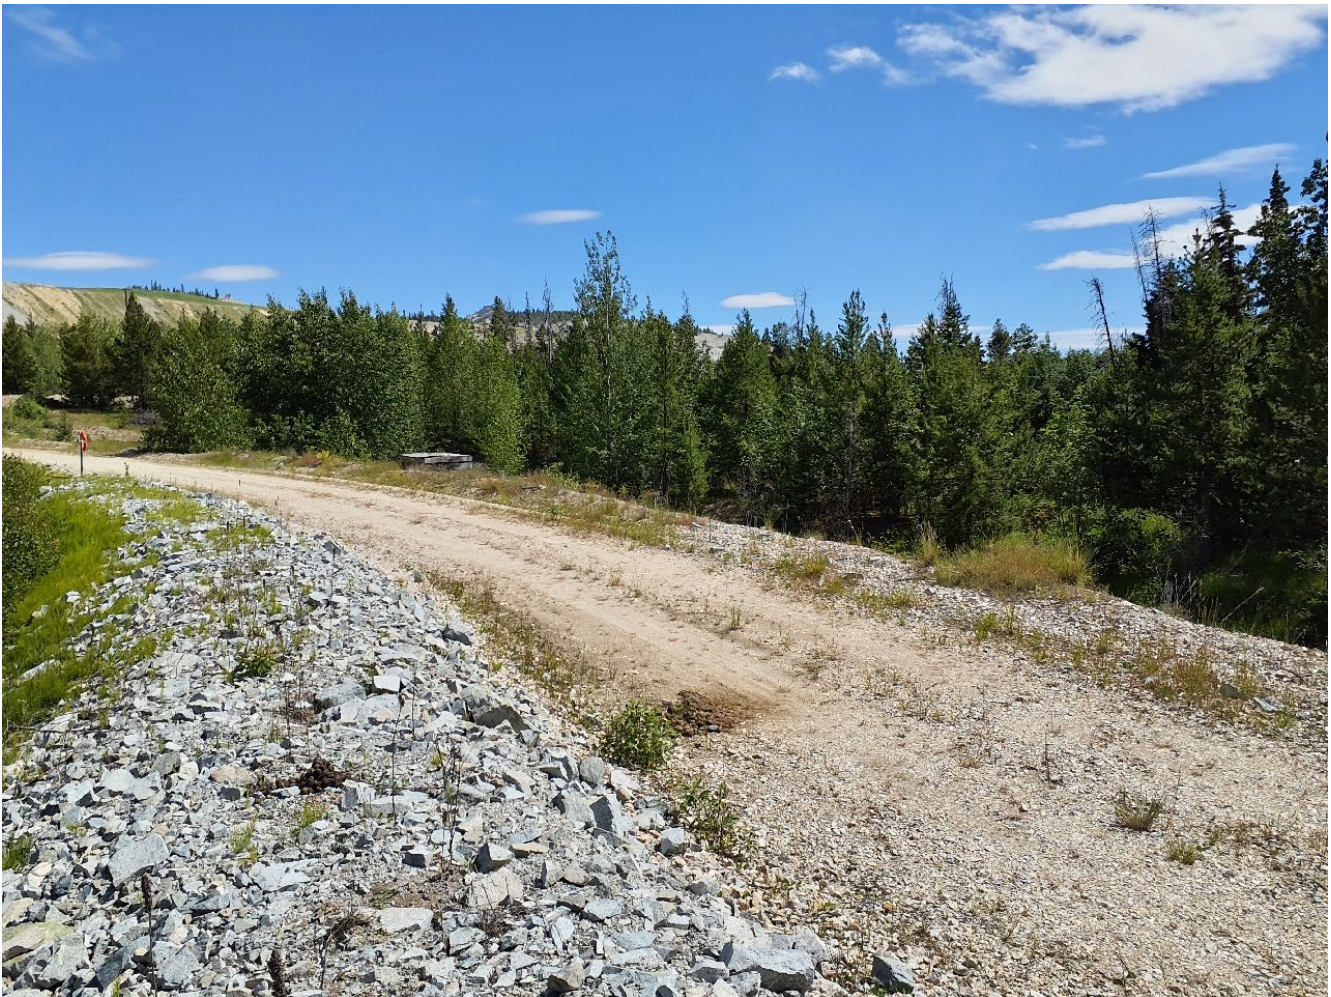
**Photo I-B-1 Overview of R4 Seepage Pond Dam crest and downstream slope looking towards left abutment (TRJ-2022-07)**

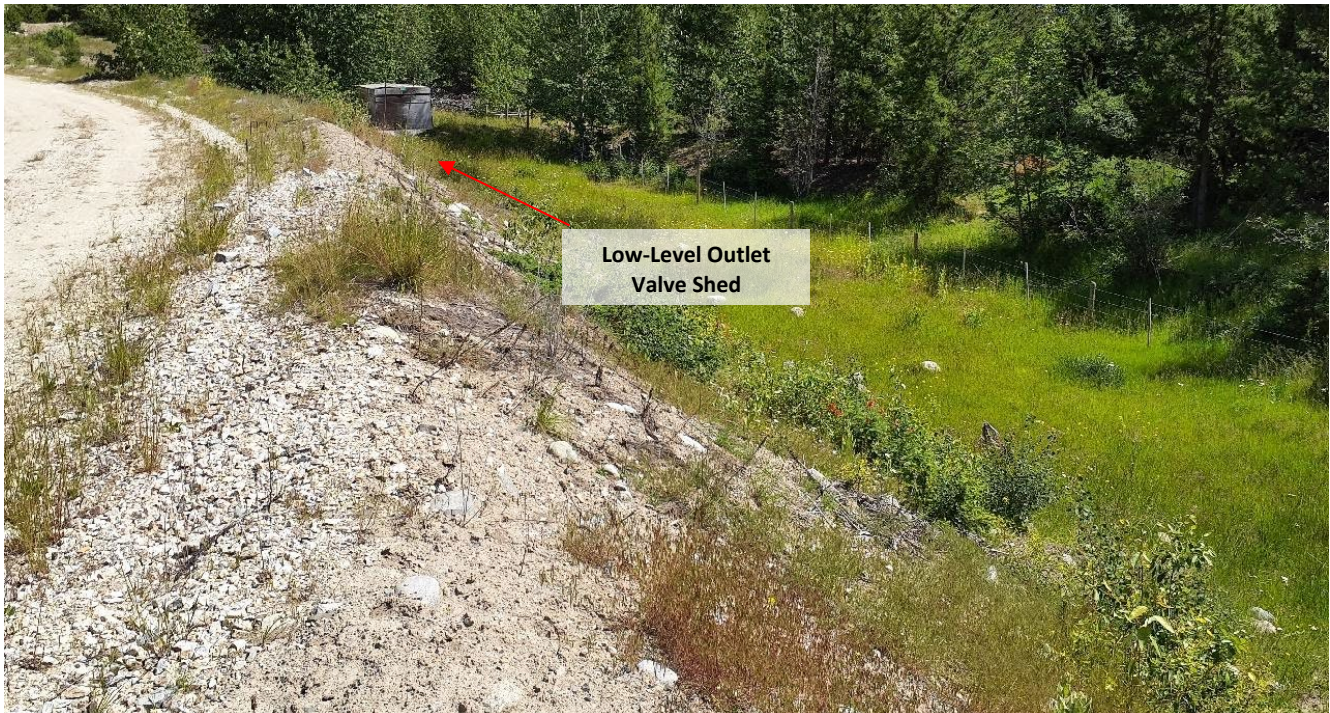
**Photo I-B-2 Overview of downstream slope looking towards left abutment (TRJ-2022-07)**

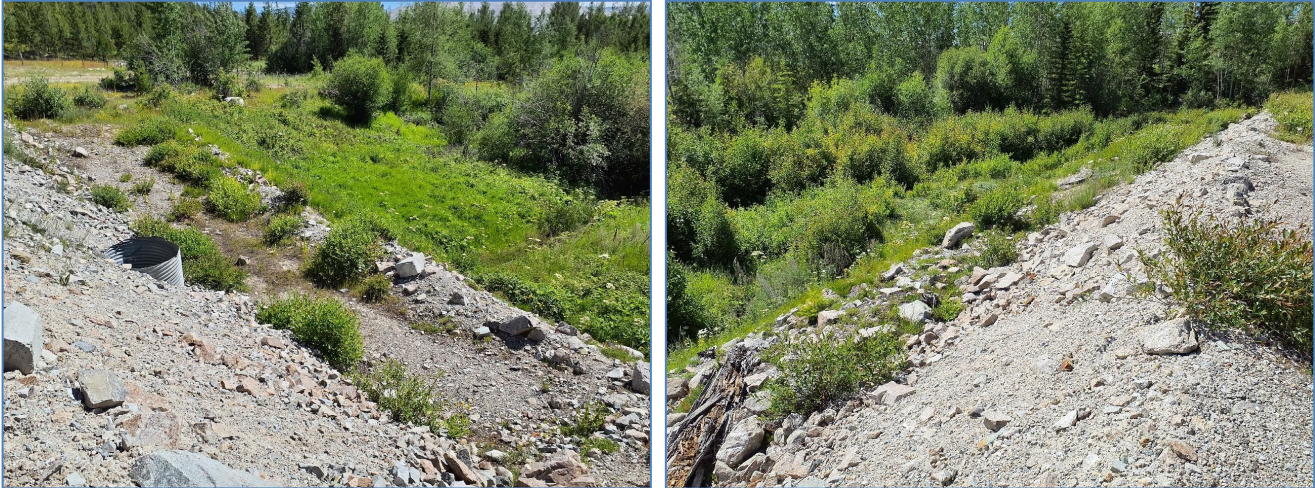
**Photo I-C-2 View of downstream slope. The outlet of decommissioned Low-level Outlet pipe is visible in the left photo (TRJ-2022-11)**

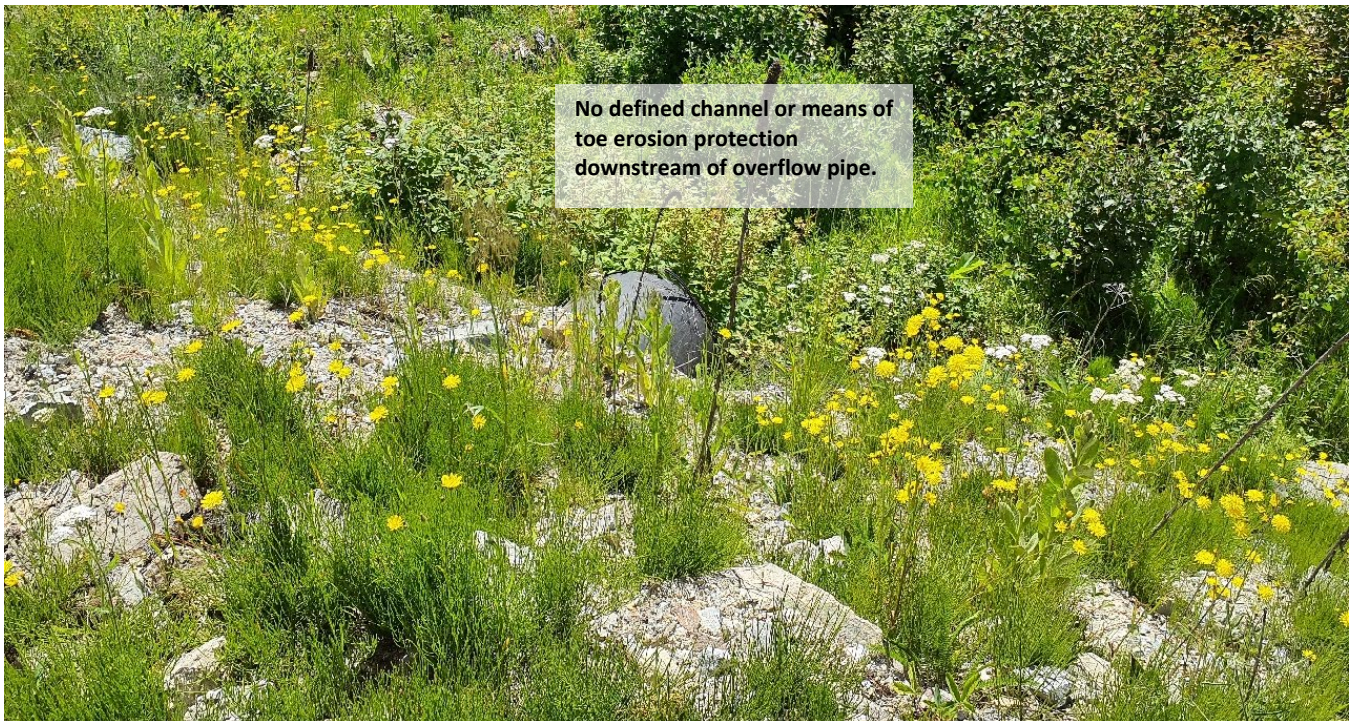
**Photo I-C-3 View of downstream slope and outlet of spillway overflow pipe through the dam (TRJ-2022-10)**
