**THURBER ENGINEERING LTD.**

**LINE CREEK OPERATIONS  
TAILINGS STORAGE FACILITIES  
2022 ANNUAL FACILITY PERFORMANCE REPORT**

**Final Report**

Date: March 20, 2023  
File: 31397-3002

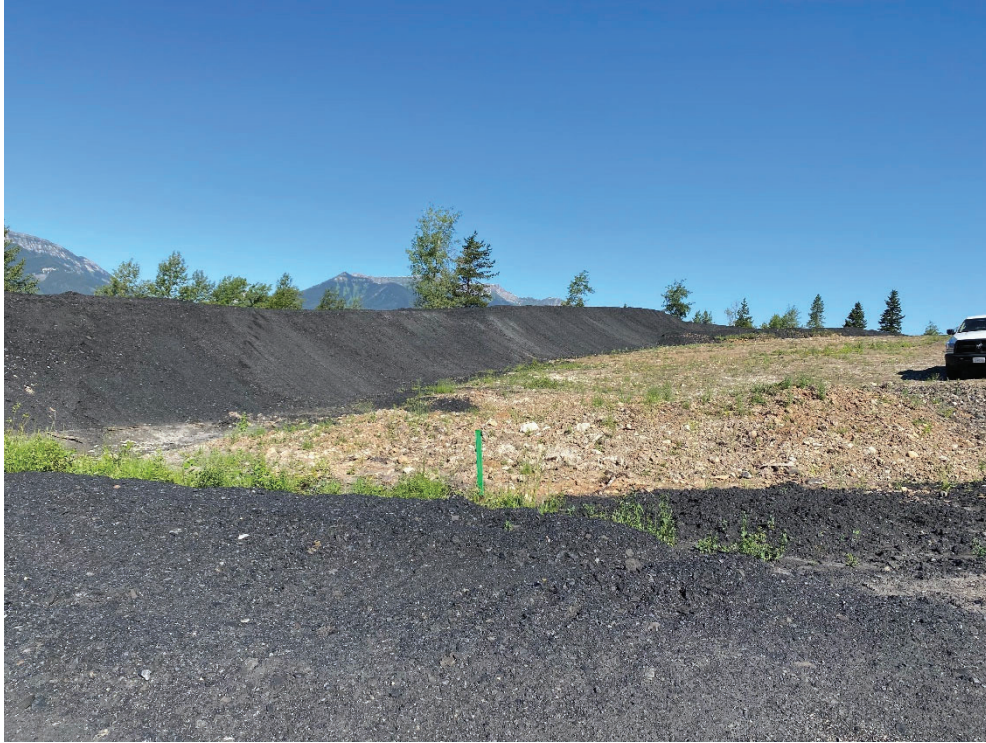
**Photo 1. West runout berm constructed out of CCR, looking northwest**

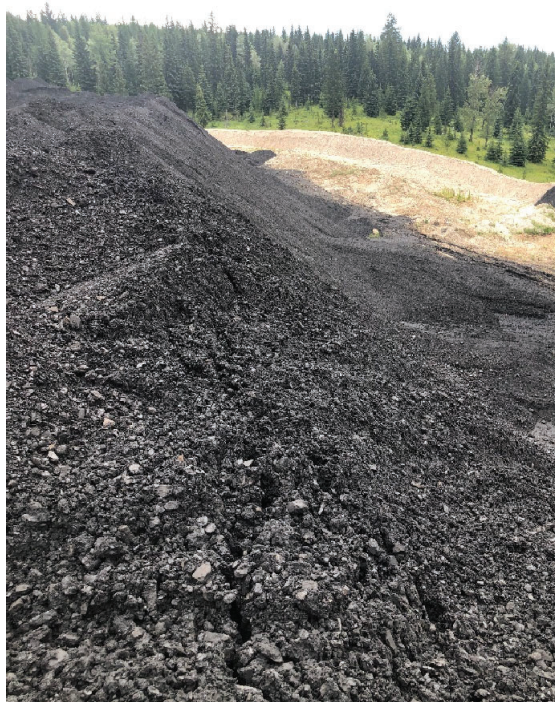
**Photo 4. Crest of the 1270 m bench, looking east**

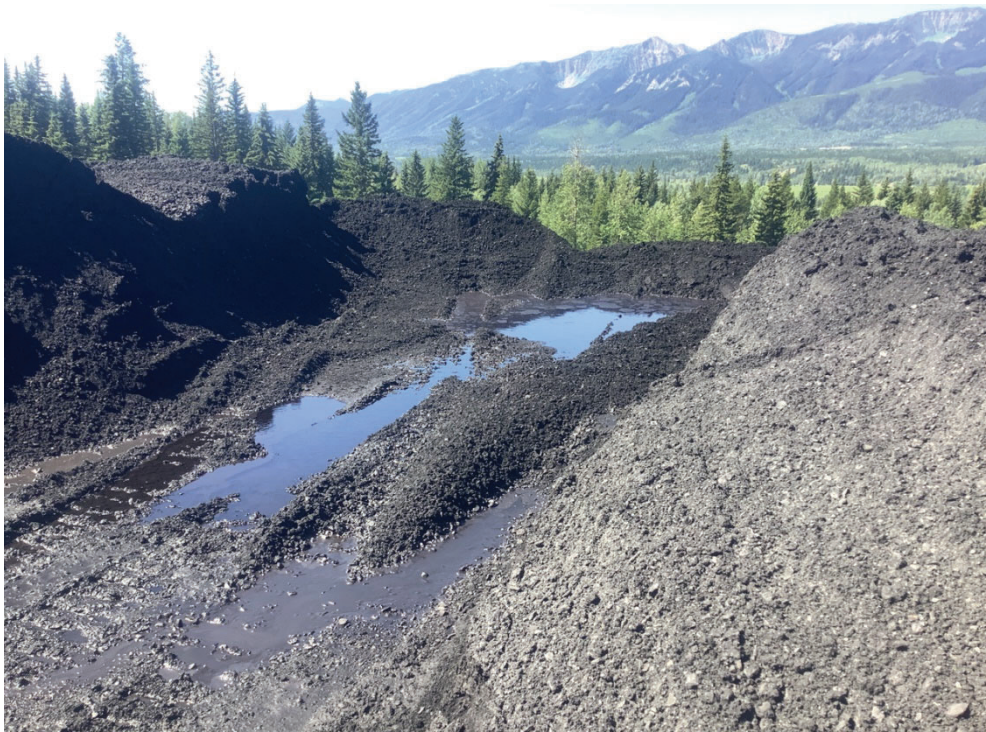
- Standing water was observed near the southern crest of the 1285 m bench (Photos 17 and 18). As stated in the water management plan, the TSF should be sufficiently graded so that drainage from freshly deposited CCR and precipitation runoff is directed away from the crests to prevent washout gullies.
- The location of the washout gullies described in Section 6.1.1 along the southern end of the lower bench was observed during the AFPR site inspection. The wet CCR material could be seen along the downstream toe at the runout locations (Photos 2, 12, 15, and

**Photo 18. Water pooling near crest of the 1270 m bench, looking south**

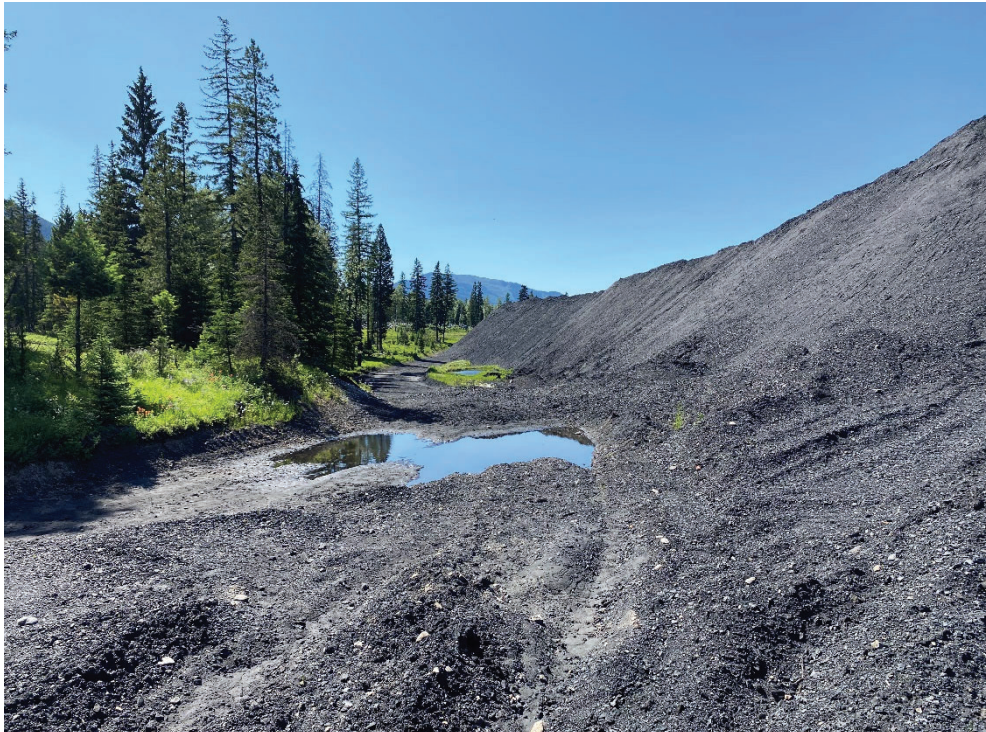
- Ponding water was observed along a section of the east toe (Photos 37 and 38). The surface water management should be modified to divert water away from the toe.

Photo 38. Water pooling along the downstream toe along eastern extents of the ERX, looking south

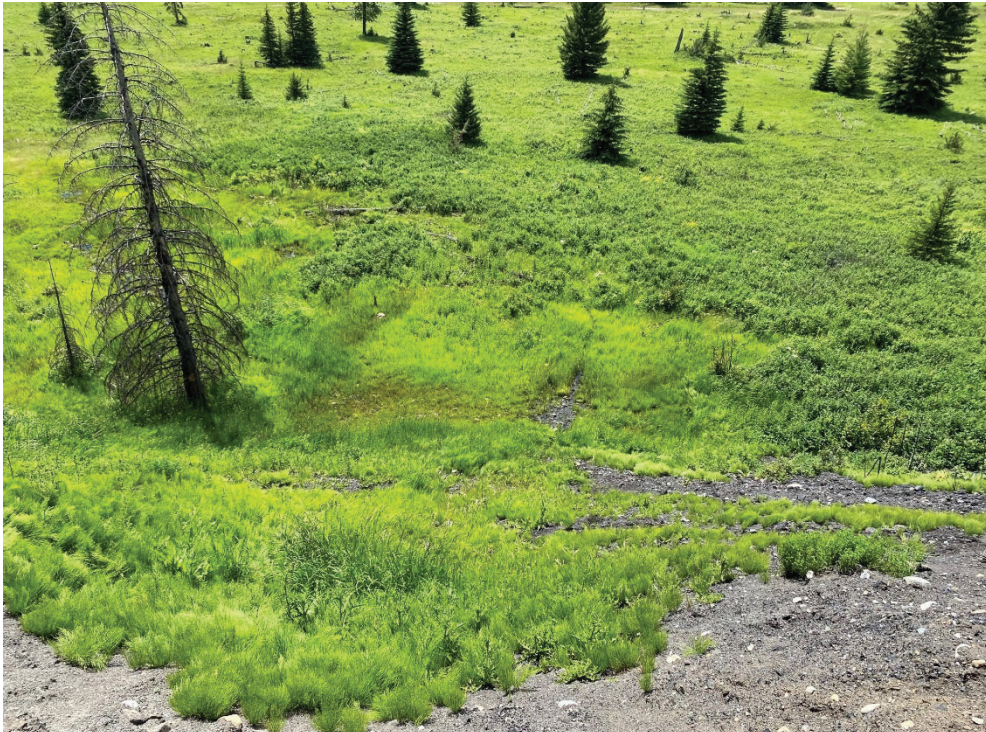
- Seepage and flow through the culvert were observed along the downstream slope of the decommissioned mine road at the base of the PFD (Photos 41 and 44). The seepage daylighted at the same elevation as the outlet culvert installed in the decommissioned road. As the decommissioned mine road is considered to be a tailings embankment the seepage should continue to be monitored and an assessment of the road materials susceptibility to internal erosion should be considered.

Photo 41. Downstream slope of the abandoned mine access road, looking southwest

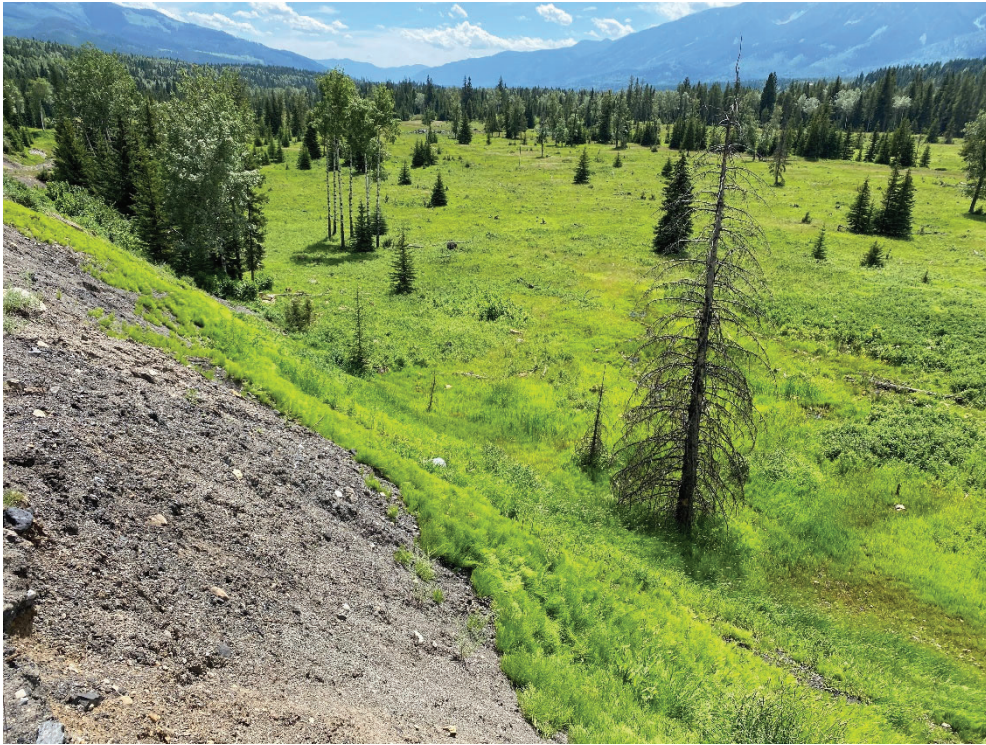
**Photo 44. Downstream slope and culvert of the abandoned mine access road, looking south**

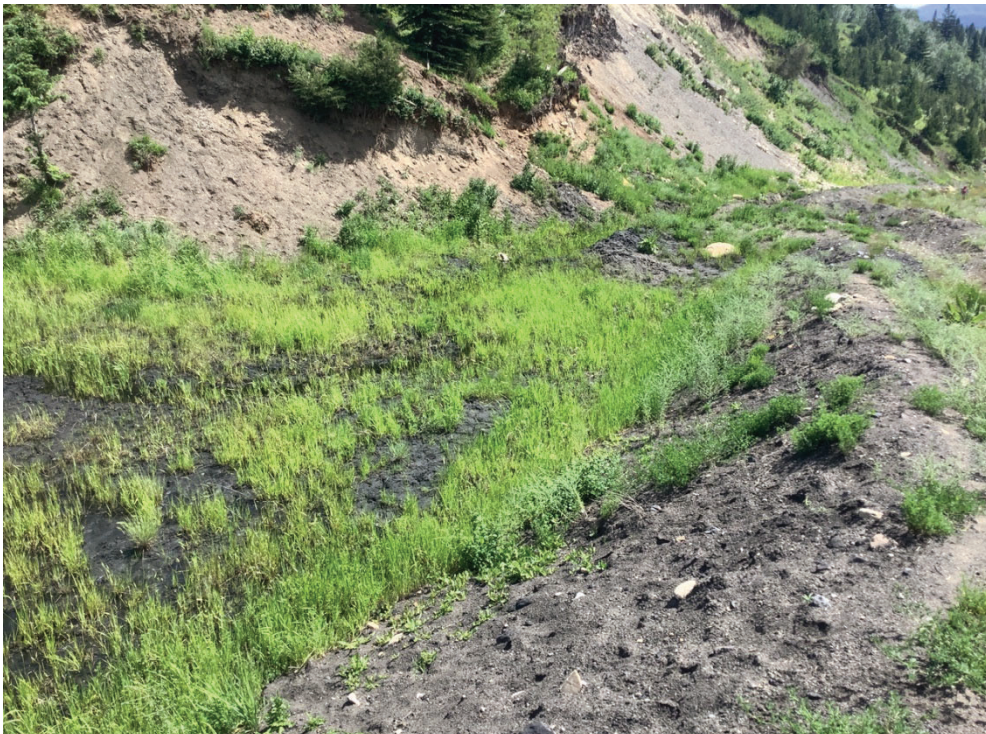
**Photo 45. Inlet to ditch on upstream side of the abandoned mine access road, looking southeast**

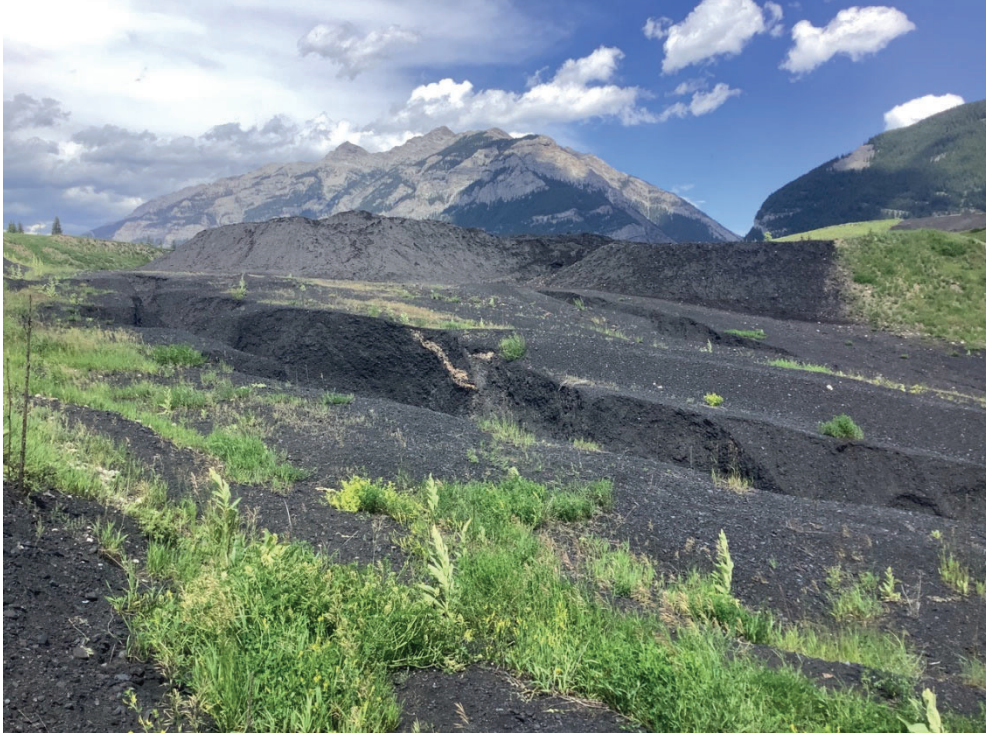
**Photo 46. Downstream slope of the Lower Bench, looking northeast**

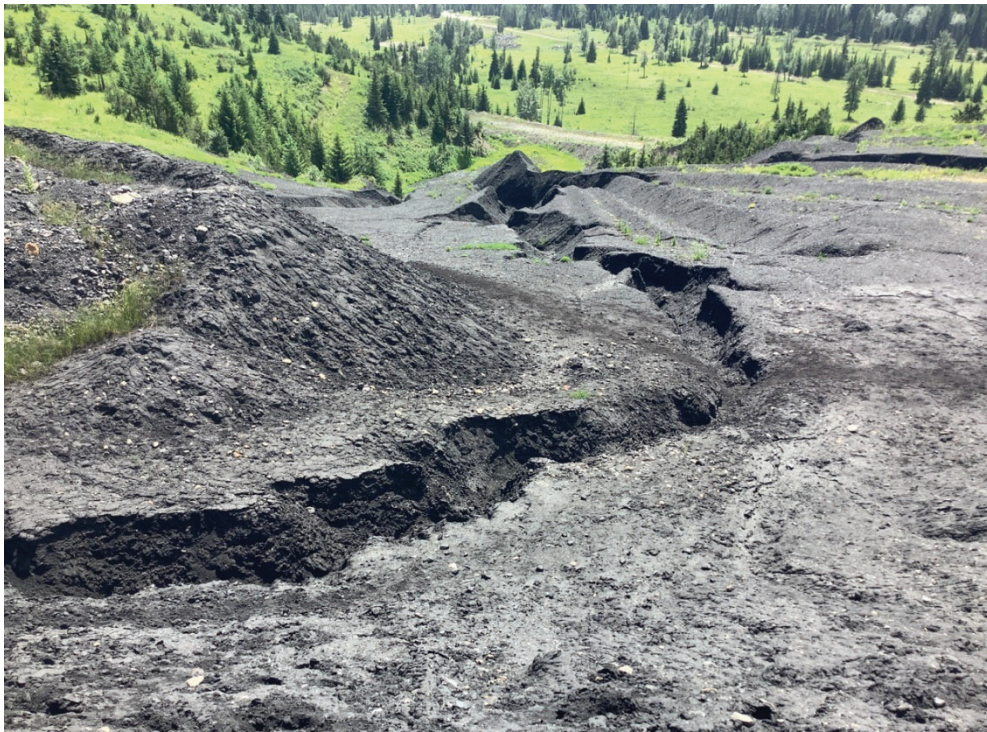
**Photo 49. Erosion gullies at the toe of the Lower Bench, looking southwest**

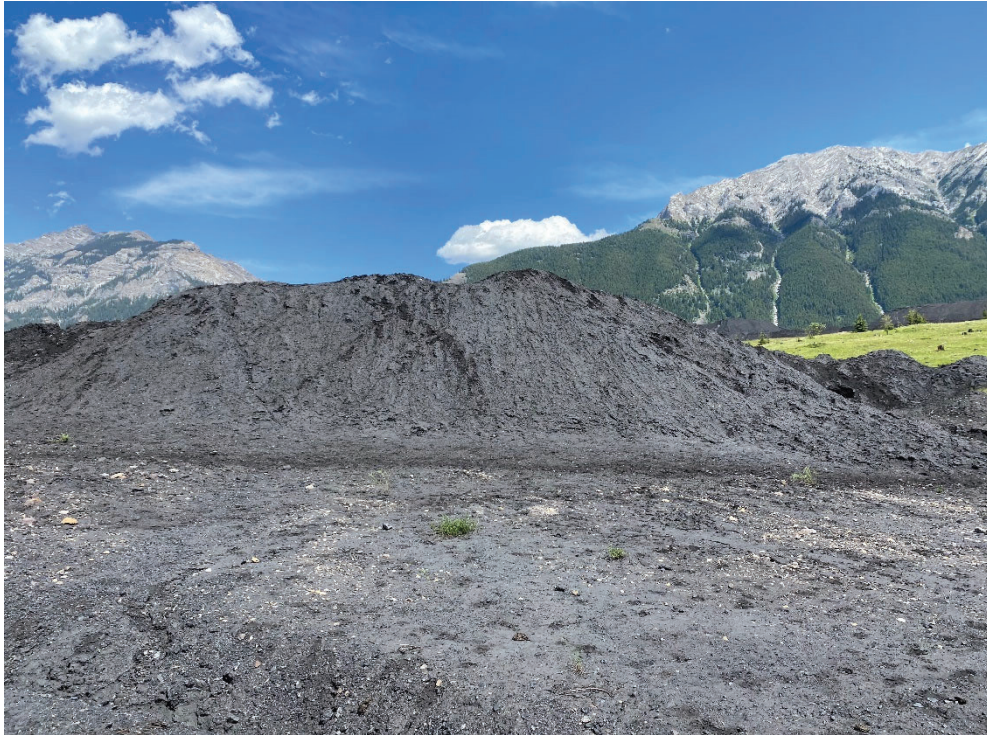
- Deposits of pond fines from the cleanout of the RLP Pond B cleanout in March 2022 were observed to have been dumped on the 1300 m bench. The pond fines were arrayed in standing dump piles and appeared to have dewatered since deposition (Photos 50 to 60). No post dump handling or compaction efforts were evident. It is recommended that no additional material be deposited in the PFD until a stability analysis and design are developed and approved by the EoR.

**Photo 50. Pond fines pile deposited on the Lower Bench, looking northeast**

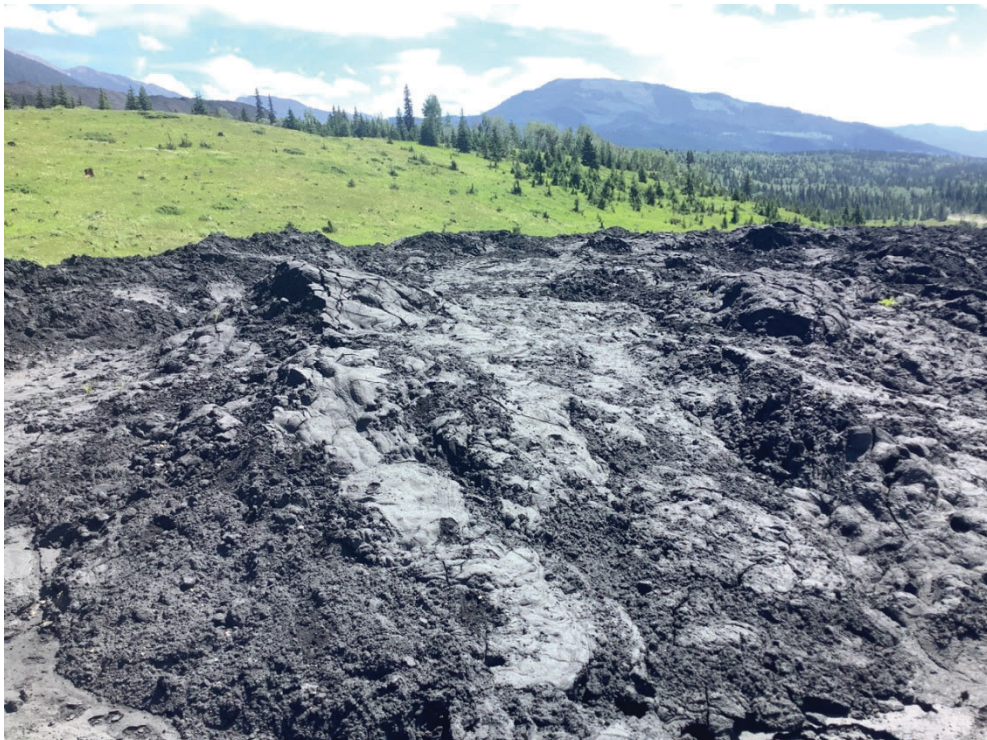
**Photo 51. Pond fines deposited on the Upper Bench, looking southeast**

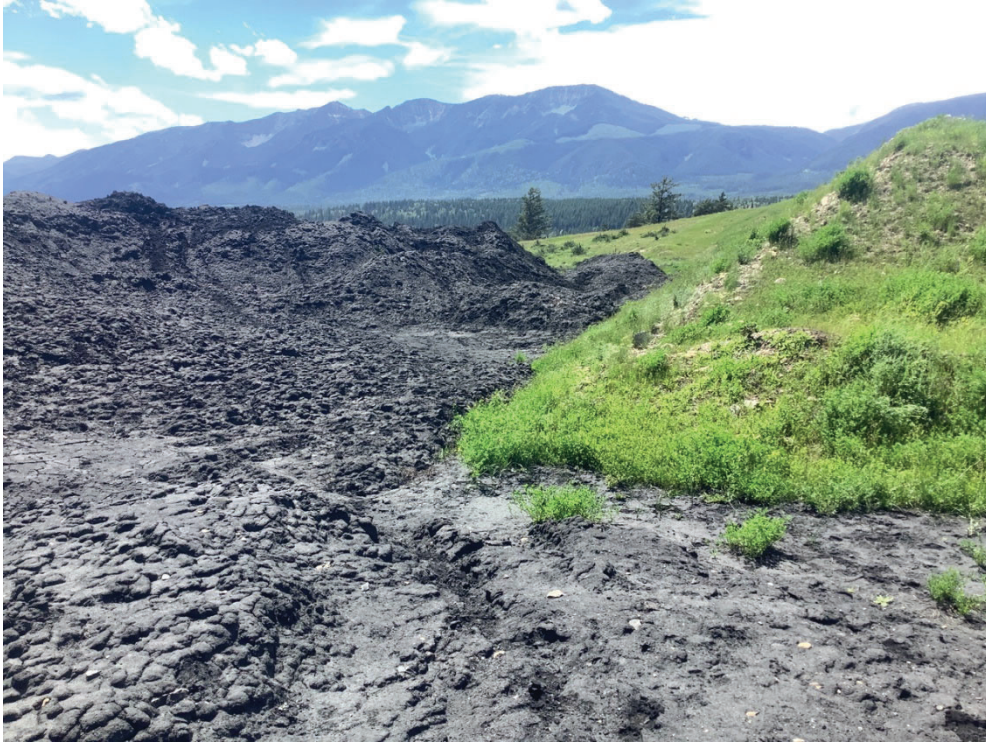
**Photo 52. Pond fines deposited along the Lower Exfiltration Basin downstream slope of the Upper Bench, looking southwest**

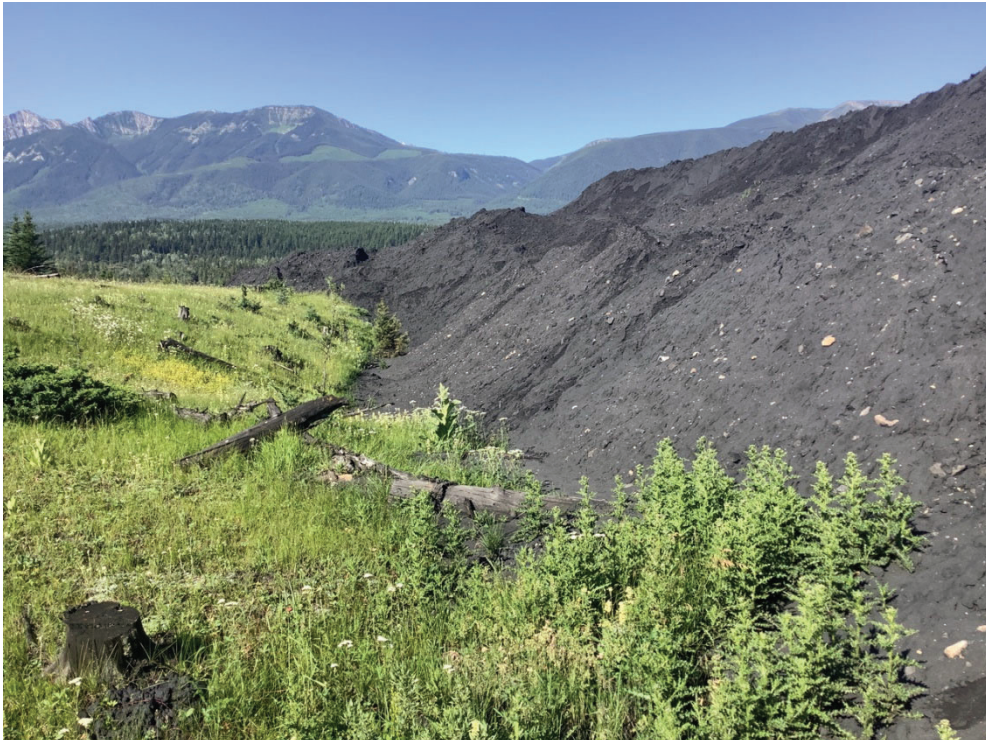
**Photo 53. Pond fines deposited on the Upper Bench, adjacent to the archeological sites, looking southwest**

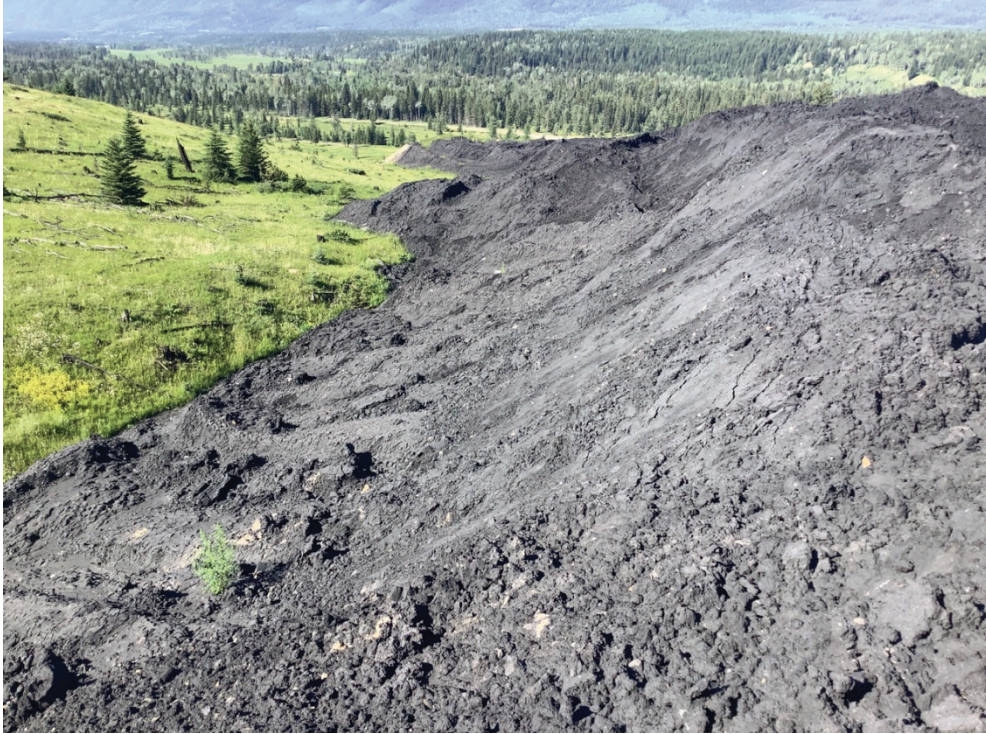
**Photo 54. Pond fines deposited on the Upper Bench, adjacent to the archeological sites, looking south**

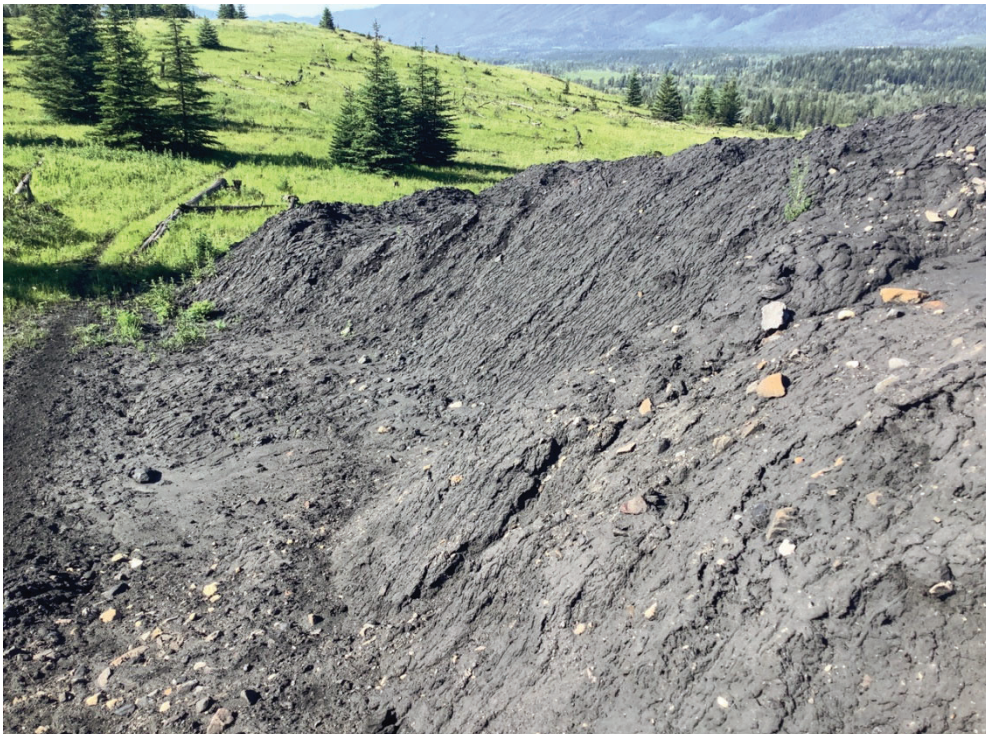
**Photo 55. Pond fines deposited on the Upper Bench, looking southeast**

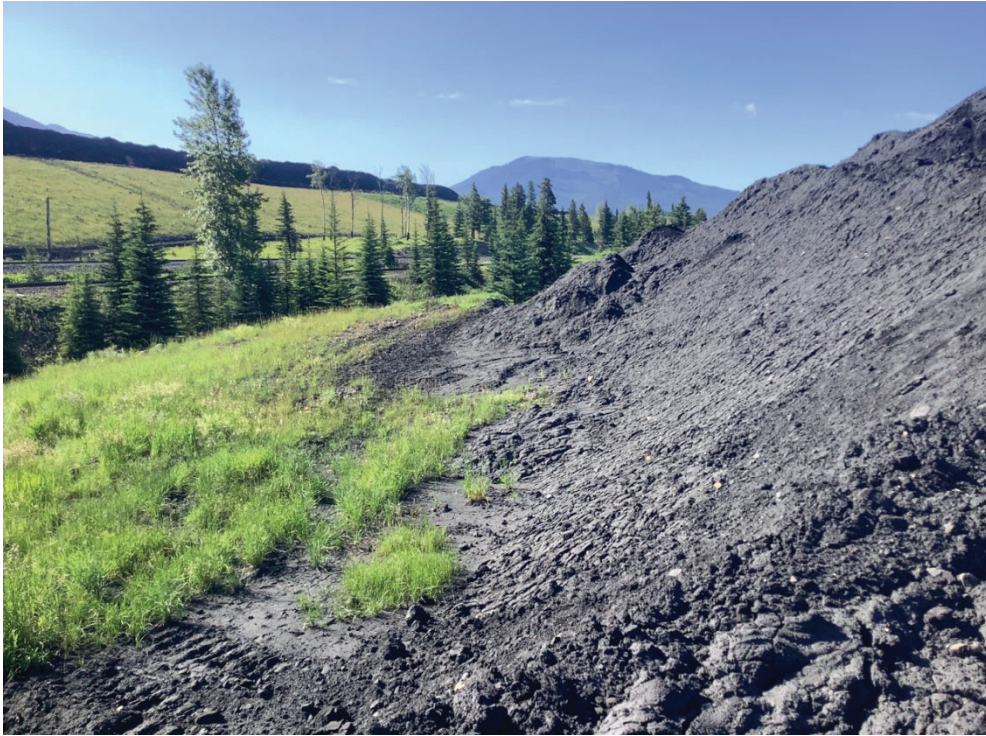
**Photo 56. Pond fines deposited on the Upper Bench, looking southwest**

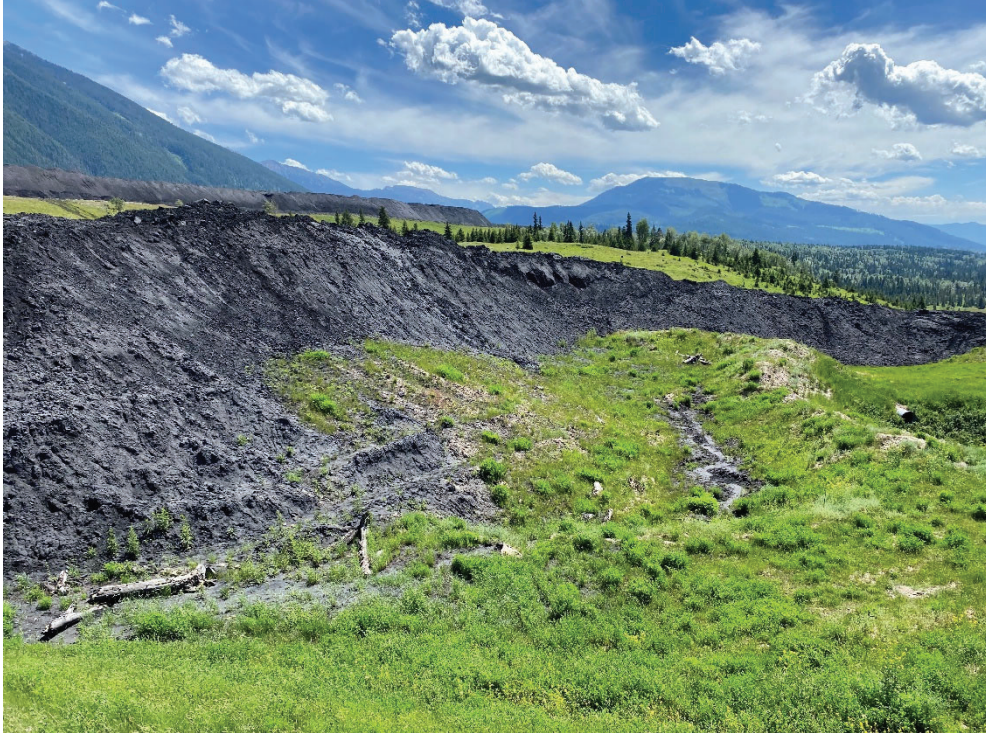
**Photo 60. Pond fines deposited on the along the Upper Bench adjacent to the Lower Exfiltration Basin, looking south**

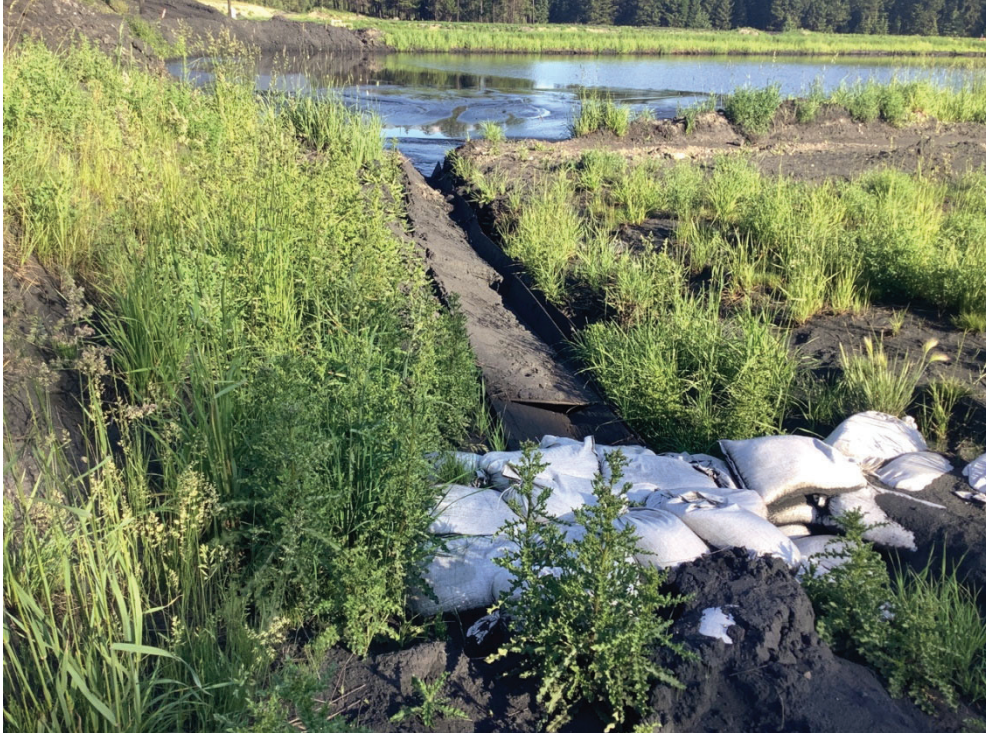
- The erosion along the discharge pipe box between Pond A and Pond B resulting from the events described in Section 2.3.3.1 was observed (Photos 63 and 66). The erosion should be repaired, and consideration should be given to the installation of passive, erosion protected, flow conveyance (i.e., spillways) between the ponds. Repairs were scheduled to be completed in Q4 of 2022.

- The discharge pipe crossing of the Pond A/B internal berm limits equipment access to the berm to the northeast (Photos 62 and 63). If the discharge piping were to be relocated, equipment would have multiple point of access and egress along the berm to facilitate maintenance and response to emergencies.

**Photo 63. Box culvert containing discharge pipe between Pond A and Pond B, looking west**

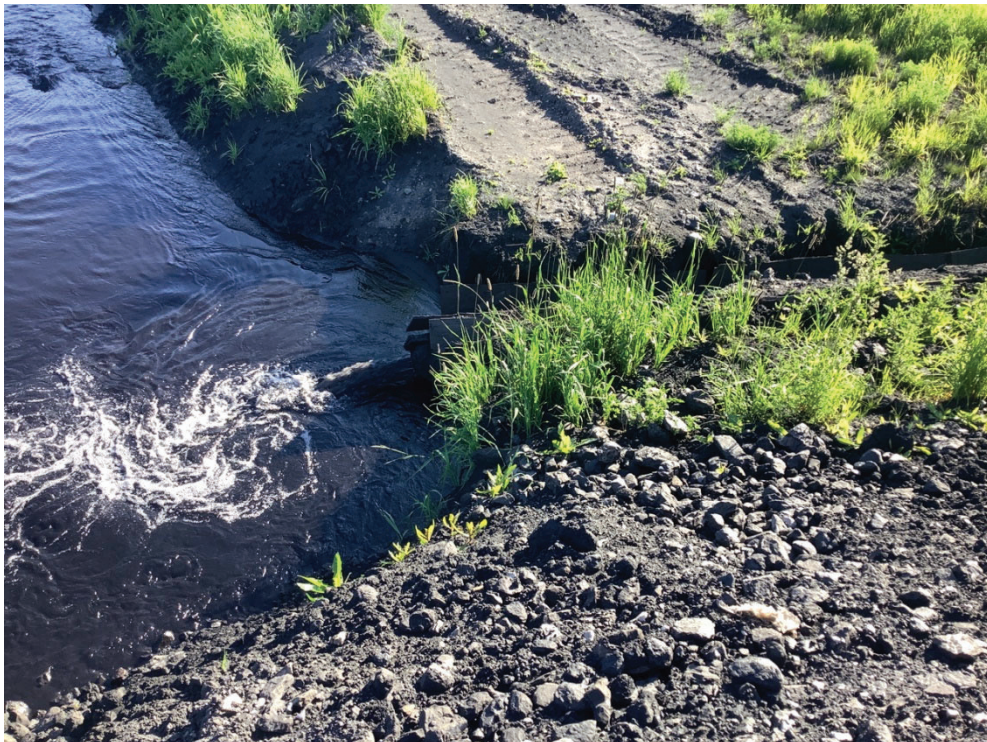
Photo 66. Pond B discharge spigot location, looking northwest

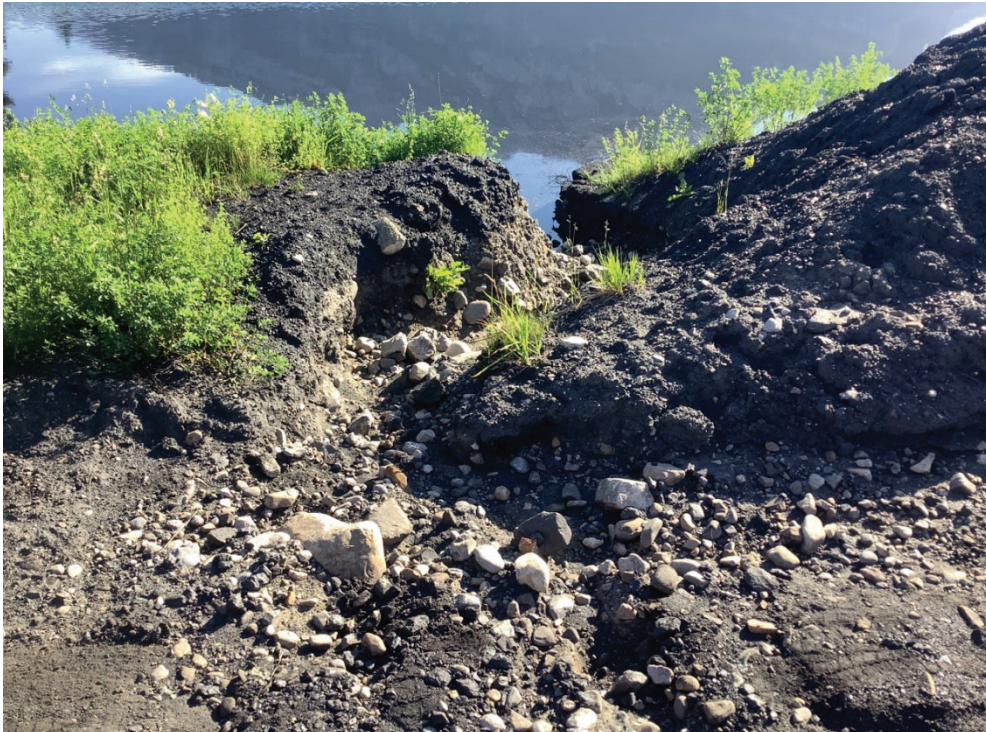
- Ponding water and upstream erosion were observed on the access road along the southwest of the RLP (Photos 69, 70, and 78). Regrading of the road should be conducted more regularly and the erosion on the Pond C upstream slope should be repaired, and erosion protection installed.

**Photo 70. Erosion along the upstream slope of the Pond C, looking northwest**

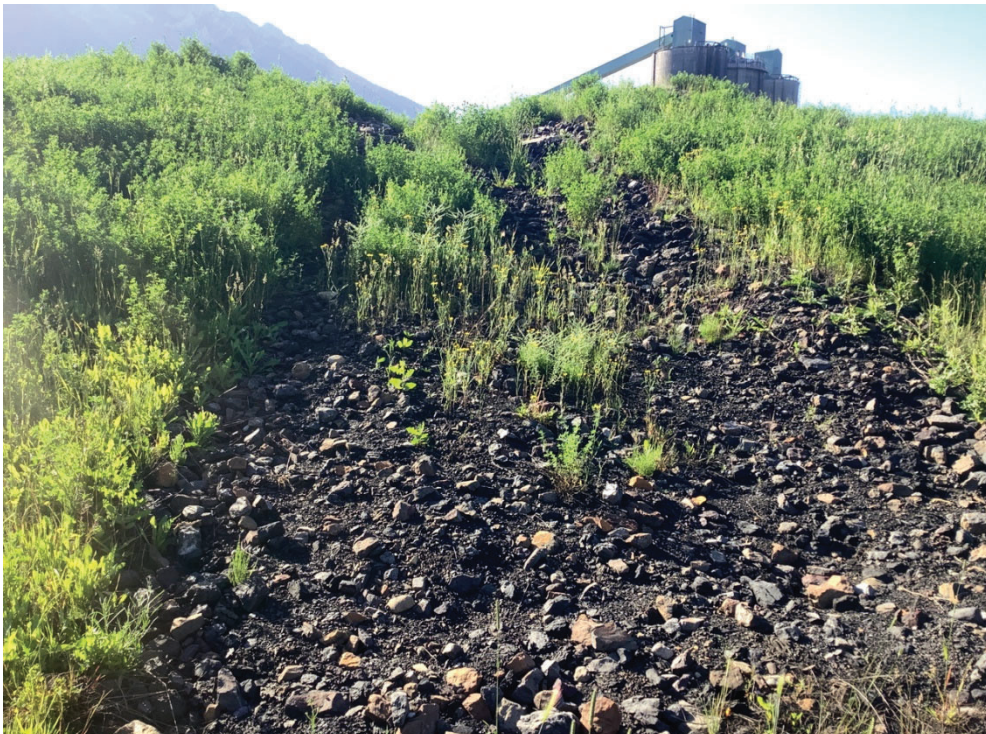
- The riprap erosion protection installed at the Pond C/D spillway appeared to be undersized (Photos 74 and 75). An analysis of the adequacy of the spillway should be performed as part of a hydrotechnical analysis for the RLP to ensure that the flow can be safely conveyed over the spillway in the case of an emergency.

**Photo 74. Pond C spillway downstream slope, looking southwest**

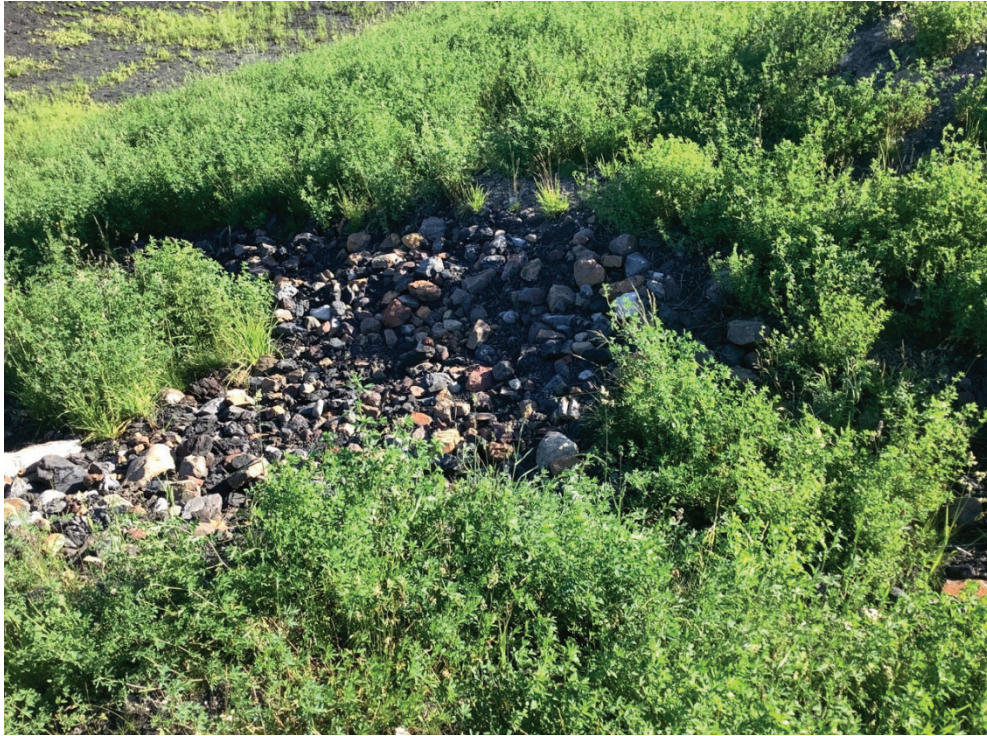
**Photo 75. Pond C spillway crest, looking north**

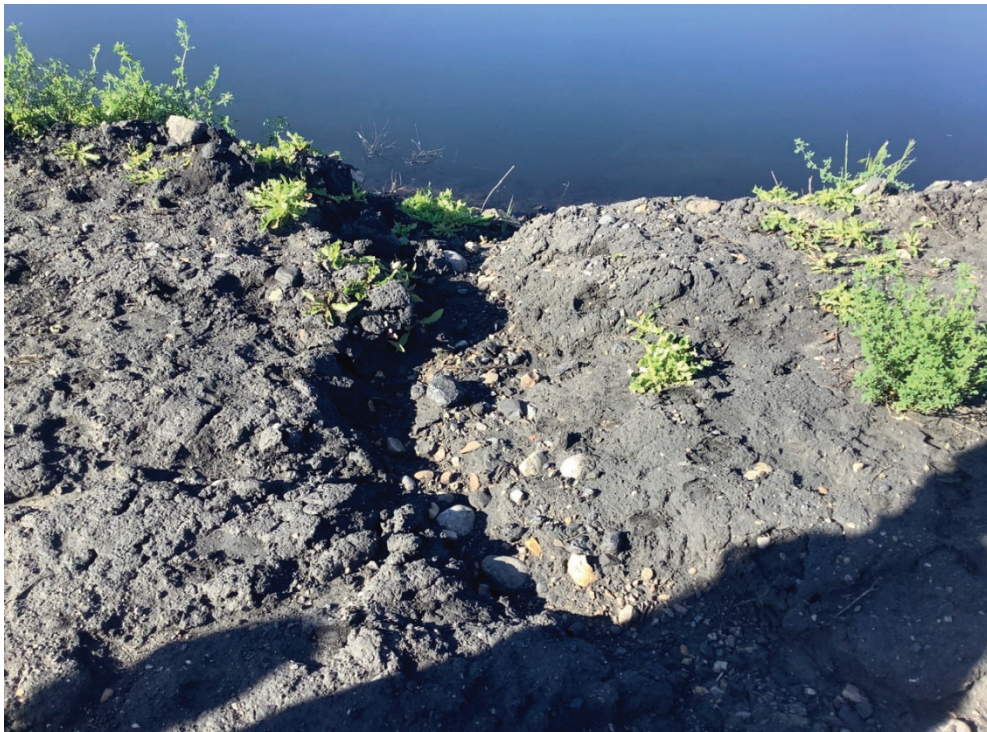
Photo 78. Erosion along the upstream slope of the Pond C, looking southwest
