2022 ANNUAL FACILITY PERFORMANCE REPORT - LOUVICOURT

TECK RESOURCES LTD.

001-22521237-2000-RA-Rev0-TSF Inspection 2022

27 March 2023

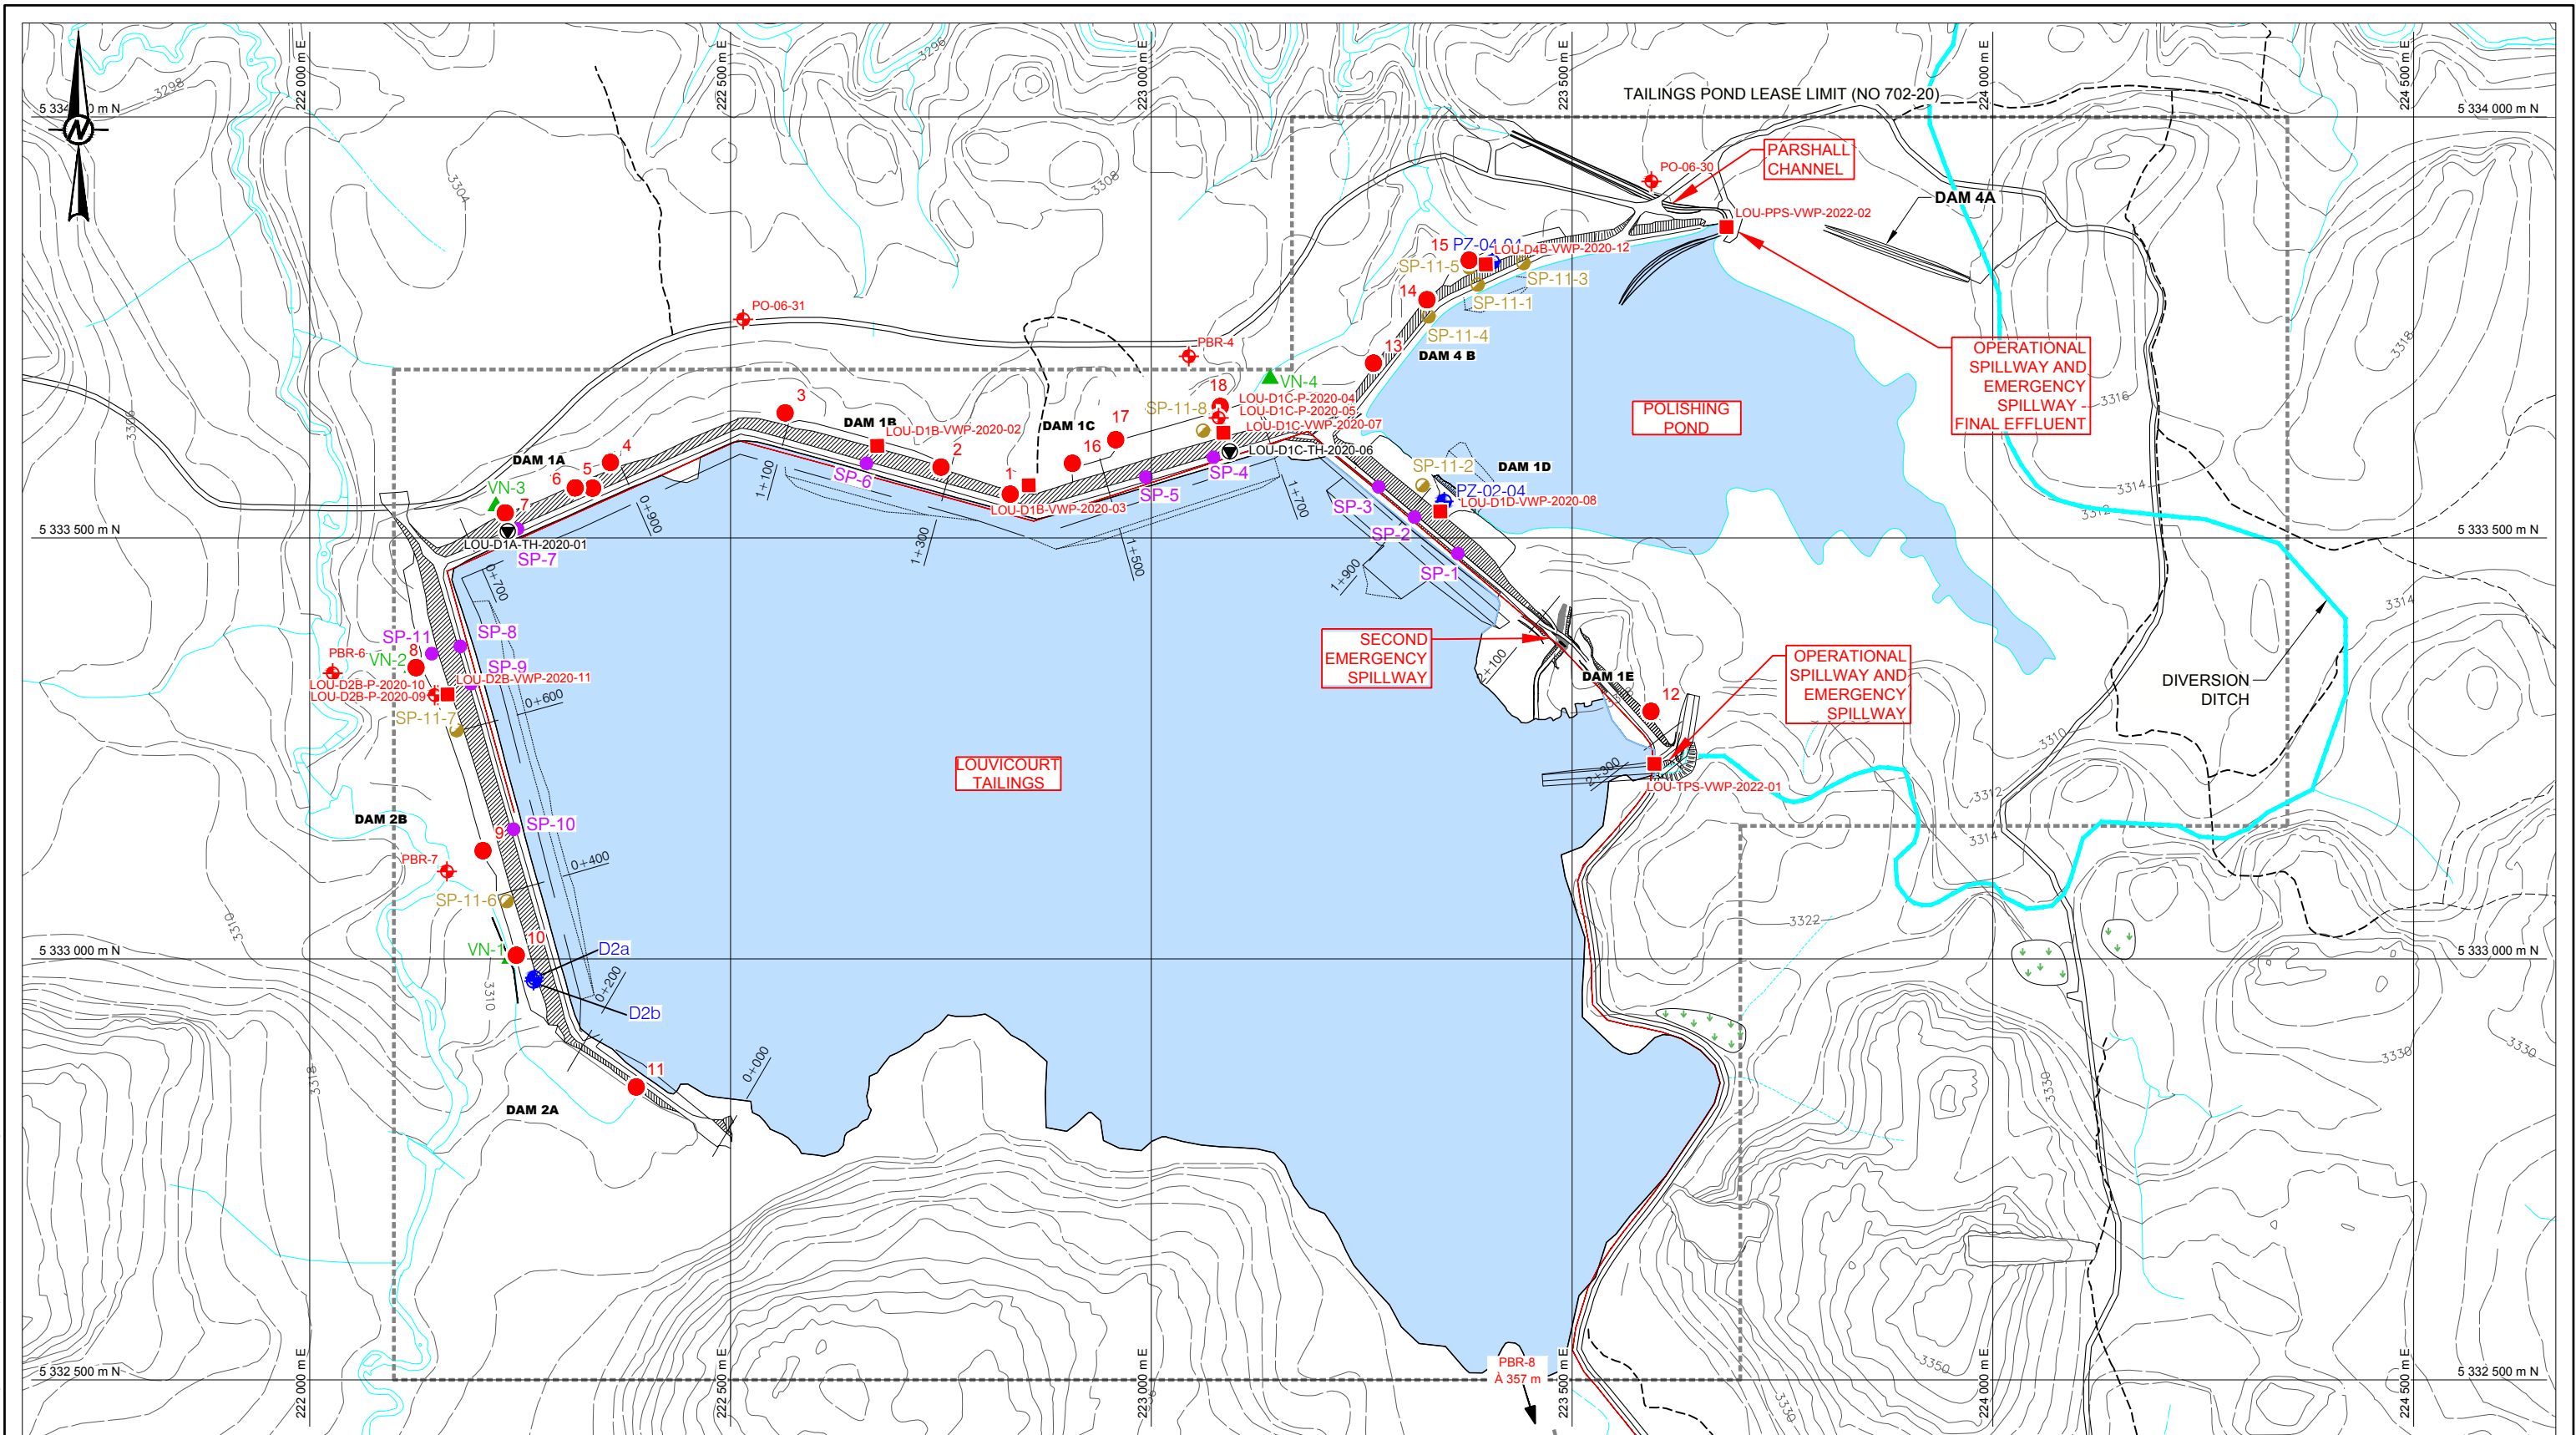
Figure 1 shows a plan view of the Louvicourt TSF and polishing pond facilities. Figure 2 shows a typical dam cross-section of the facilities.

- The riprap on Dams 1A and 1C was replaced in 2022, with the addition of traffic gravel on the crest (Photograph 2).
- Ponding water was observed at the toe of Dams 1A to 1E at the same locations as last year. At several locations, flowing water was either visible or audible near the toe of Dams 1A to 1C and 2B (Photograph 3). The apparent increase of seepage at the toe areas is attributed to a significant rainfall event which occurred on September 19 2022. The locations of current and historic seepage points are presented on Figure 1.

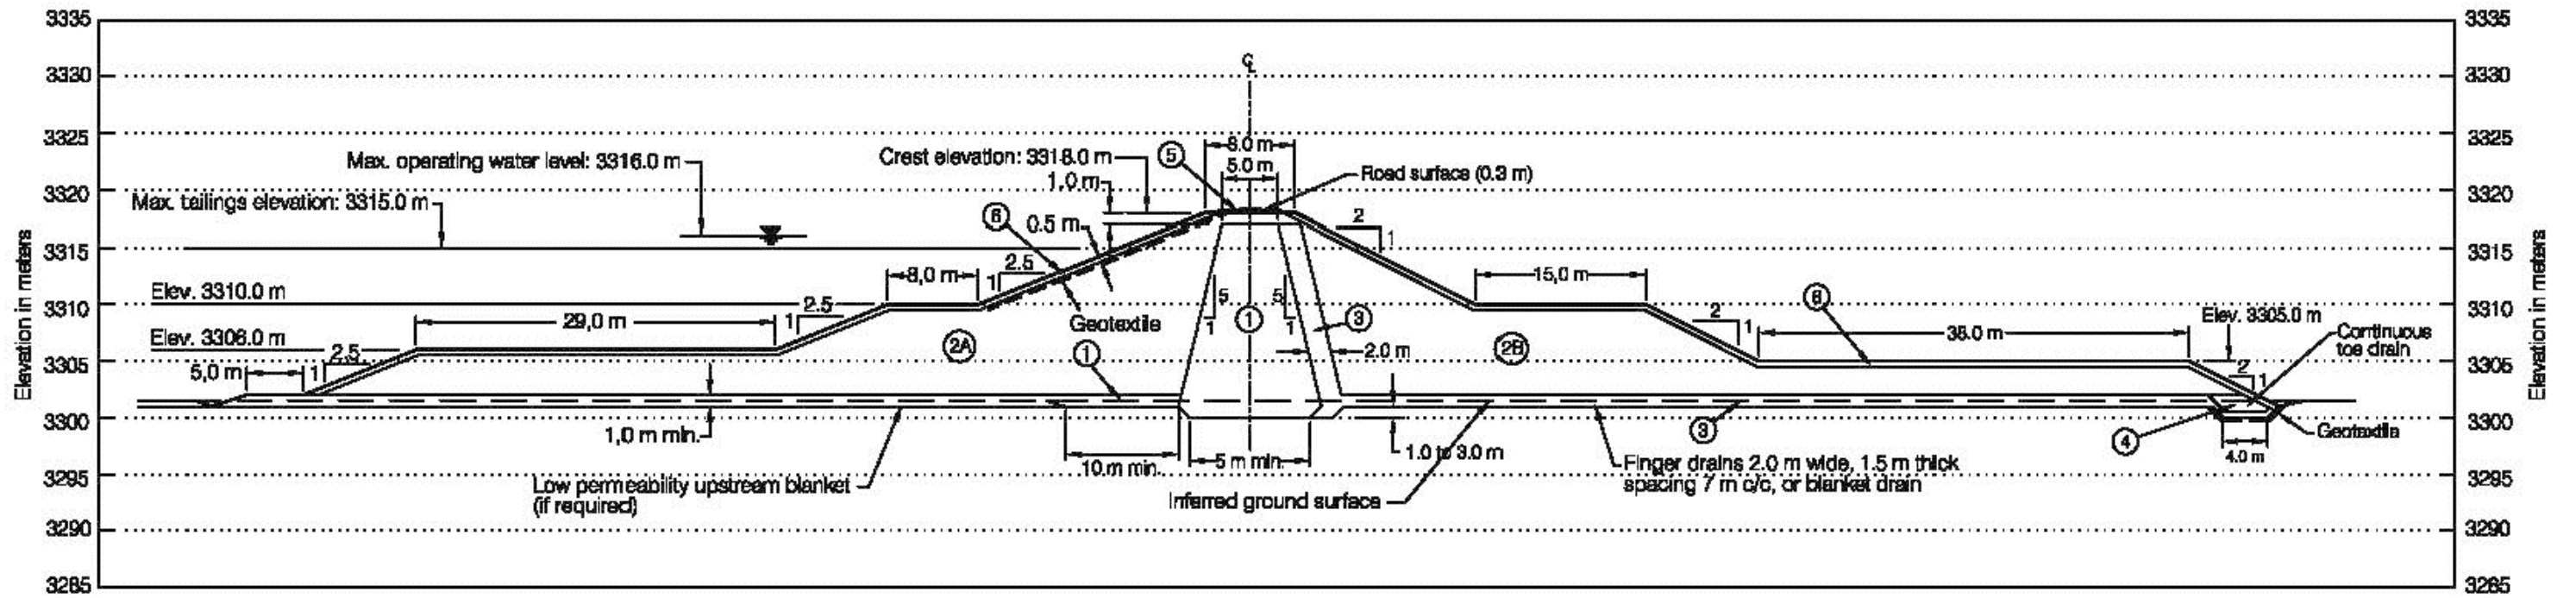
FIGURE
2

The tailings dams and polishing pond dam are zoned earth fill embankment structures, constructed of compacted till core with a filter zone along the downstream face of the core and a drain along the base of the dams and rockfill/sand and gravel shoulders, as shown in the typical section presented in Figure 2.

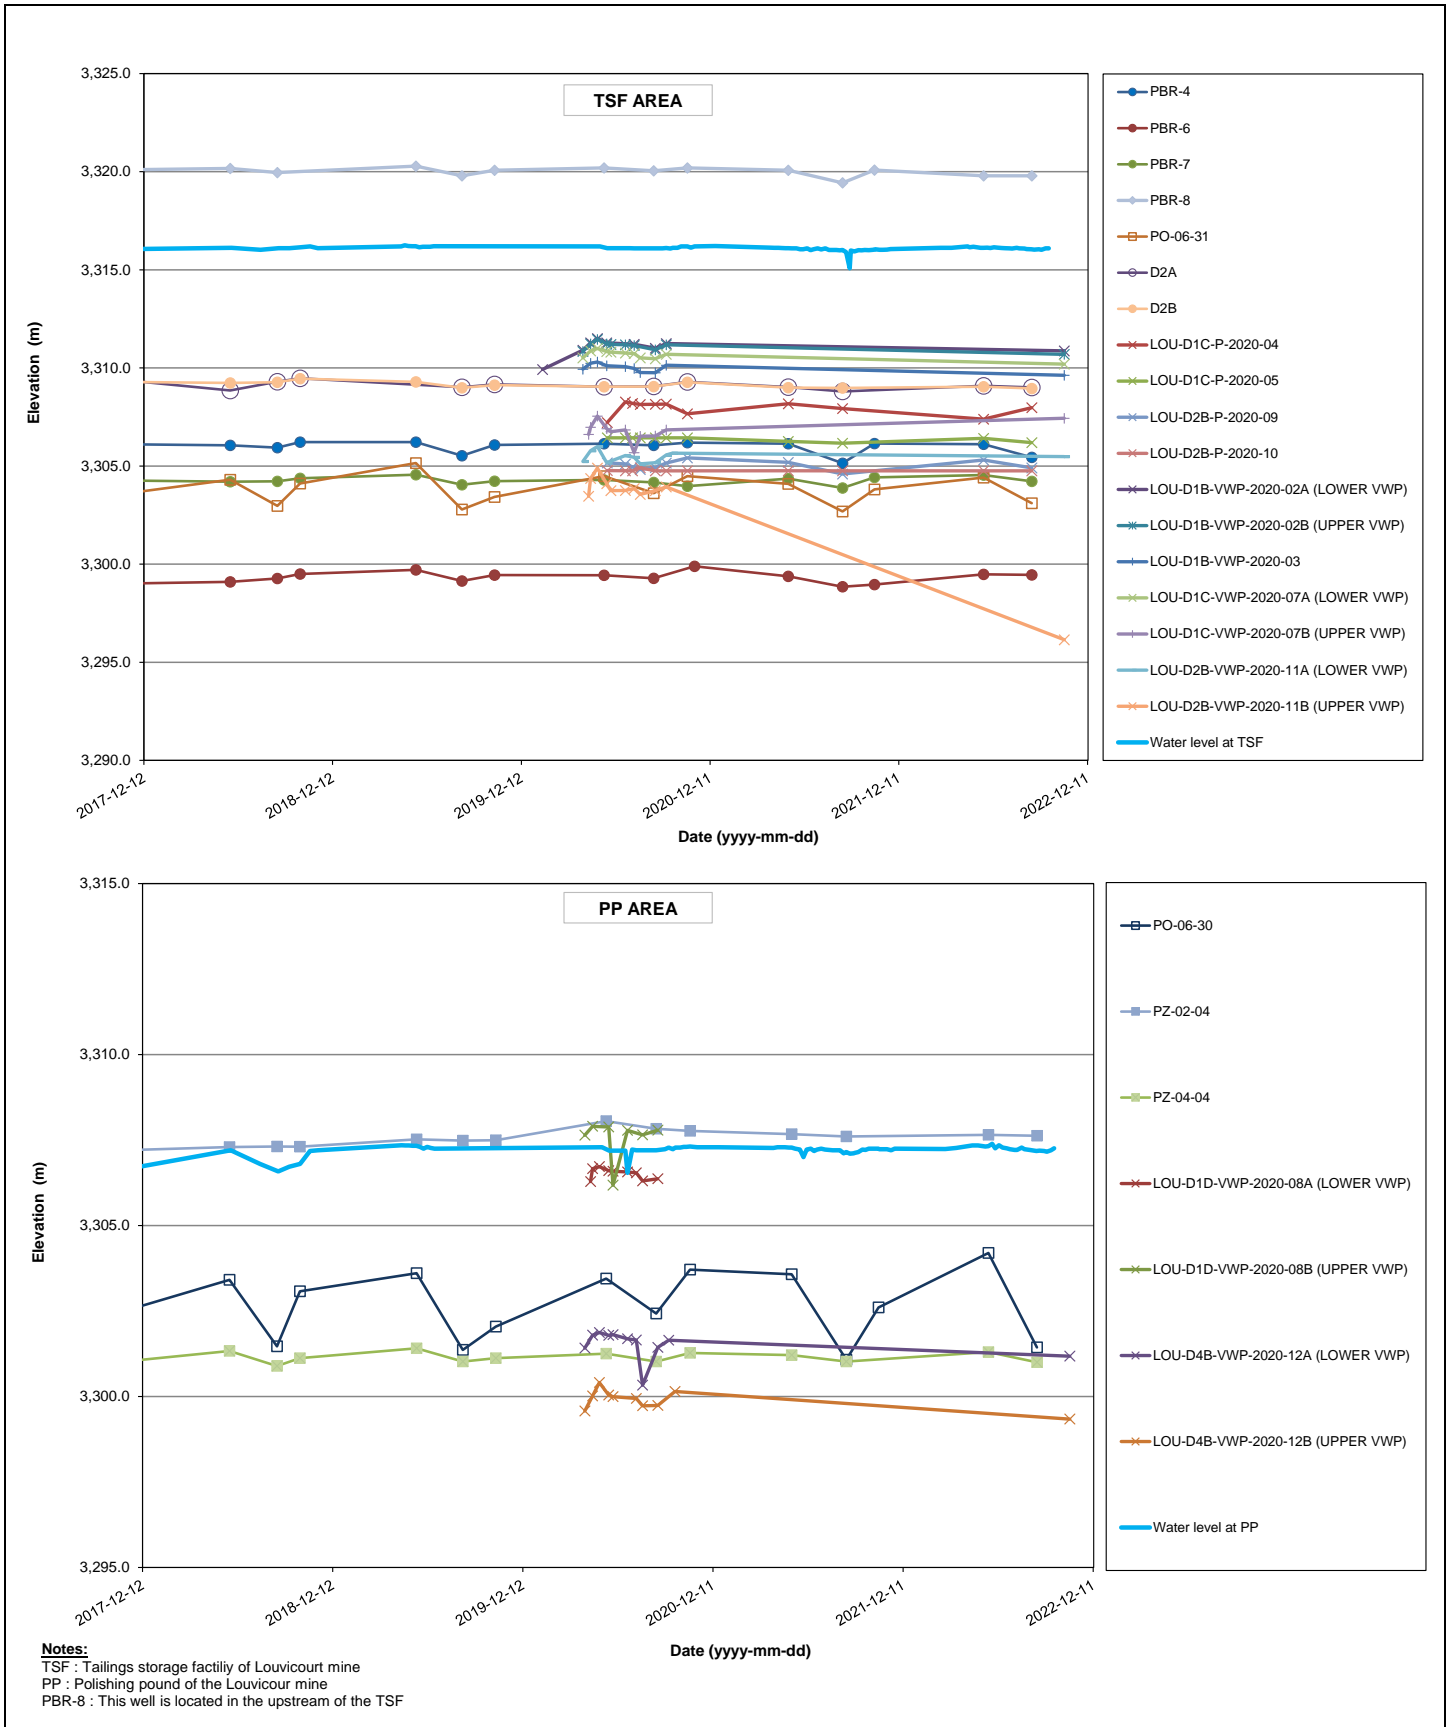
Louvicourt TSF Teck Resources Ltd	Tailings Storage Facility Annual Facility Performance Assessment - 2022		Water level measurements - piezometers (provided by Teck)	
		PROJECT NO.	22521237-2000	
		REV	0	
		FIGURE	4

Figure 4 presents groundwater levels for the polishing pond and tailings facility embankments for a total of eight standpipe piezometers and 11 vibrating wire piezometers installed on the berms of the three different embankments (1, 2 and 4).

Data for 2022 were provided by Teck (Figure 4). Recent values are quite stable for all standpipe piezometers and consistent with previous trends; historical trends for VWPs will be better defined in the coming years with more data collected.

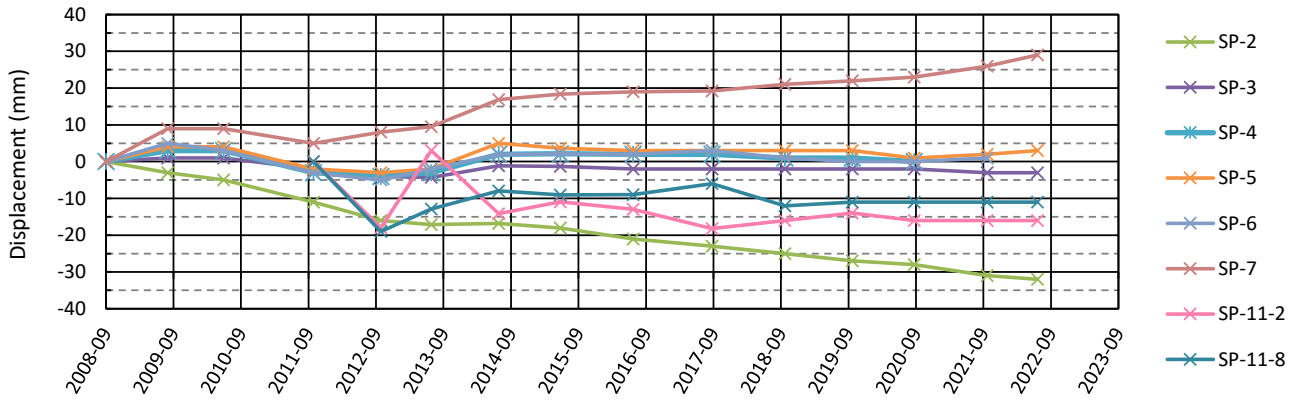
Figure 5 : Vertical Displacement of the Survey Monuments at Dam 1

Since the previous year, the vertical data shows that 13 monuments indicated minor vertical movements of +/- 1 mm or less, 4 monuments had vertical movements between plus or minus (+/-) 1 mm and +/- 3 mm (which is the stated survey accuracy) and 2 monuments had vertical movements between +/- 3 mm +/- 7 mm. All monuments show total settlement since installation of 31 mm or less, although, the survey data record suggests a pattern of continuing, minor settlement in some instruments. To better assess the settlement data, plots of historical settlement have been prepared as Figures 5 to 7.
