Klohn Crippen Berger

Teck Metals Ltd.

Pine Point Mine Tailings Impoundment Area

2022 Annual Facility Performance Review

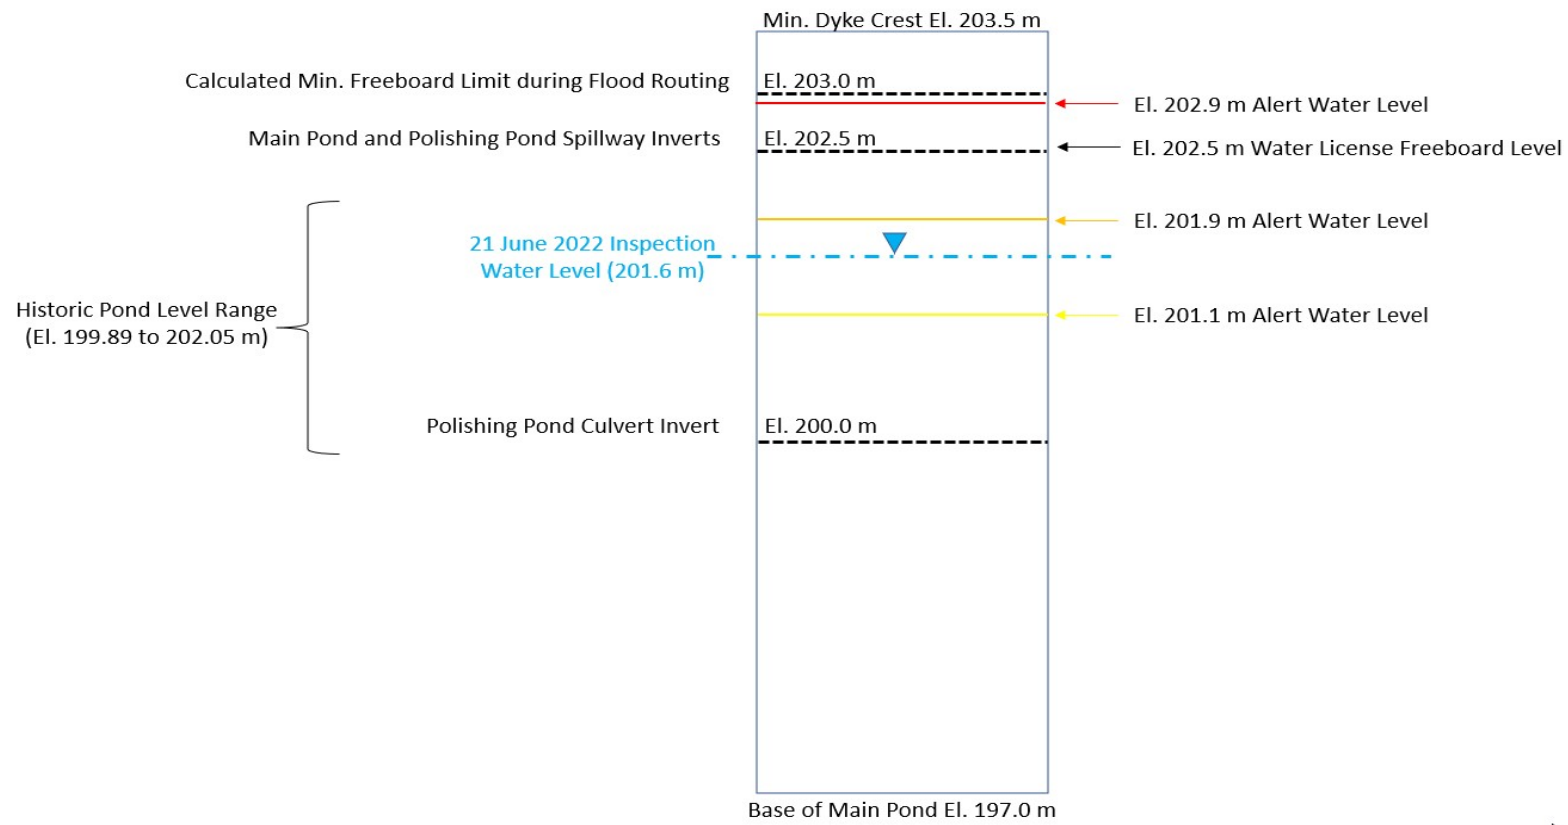
Teck updated the Trigger Action Response Plan (TARP) for pond management in April 2022. The updated version considers calculated flood routing water levels, historic water levels and dyke performance, annual water level forecasting based on manual snowpack measurements, active (daily) pond level monitoring, and daily precipitation forecasts. The alert water level limits defined in the TARP are shown in Figure 3.

Pond levels exceeded the TARP Level El. 201.1 m from May 3, 2022 to the end of the current reporting period (Figure 4). Teck followed the TARP (Figure 3), initiated daily monitoring, and started water treatment as soon as practicable. The rainfall forecast did not exceed 100 mm during this time and therefore the potential for overtopping was not considered.

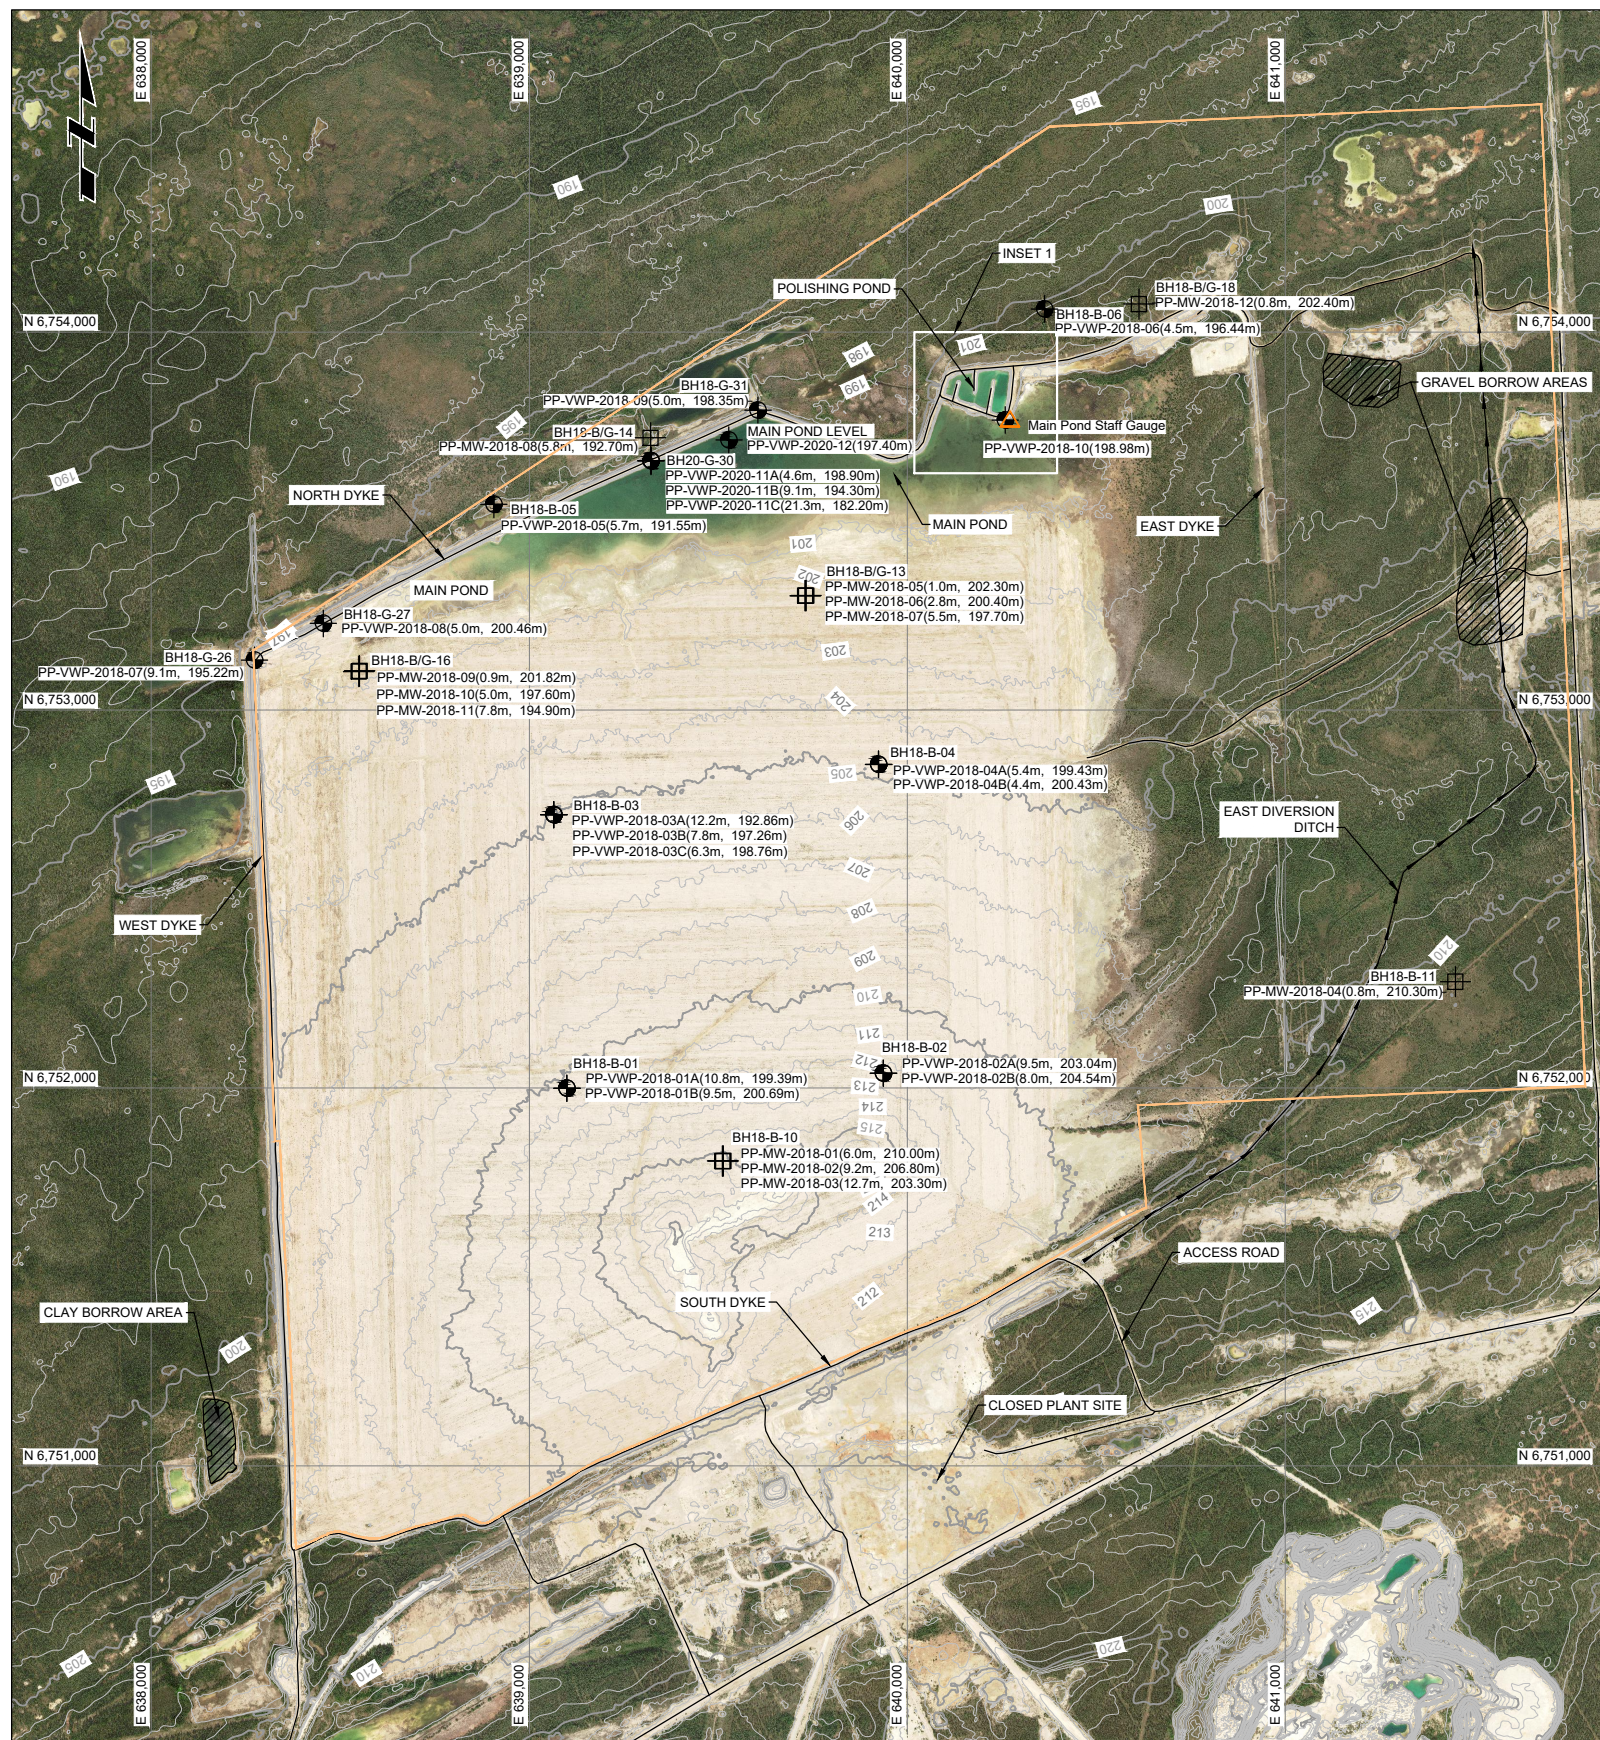
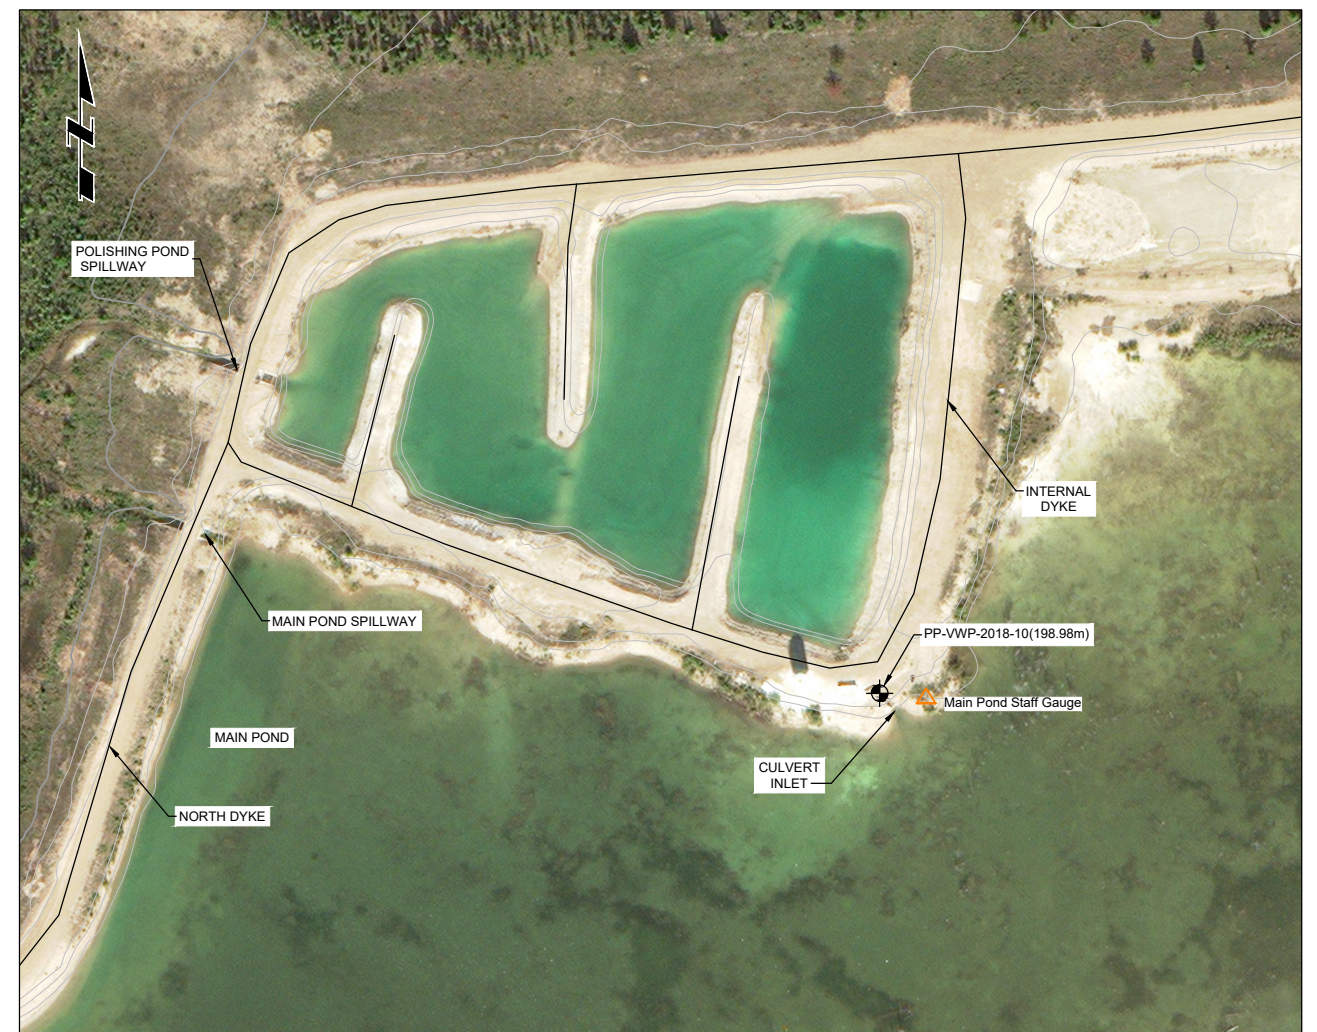
There are 20 VWPs installed at several locations around the TIA as shown in Figure 5 and listed in Table 4.1. The VWPs are installed in dyke fill, natural foundation material, and tailings. Two

-Instrument PP-VWP-2018-10: Tip elevation unconfirmed. Readings presented in this figure use a tip elevation of 199.6 m.

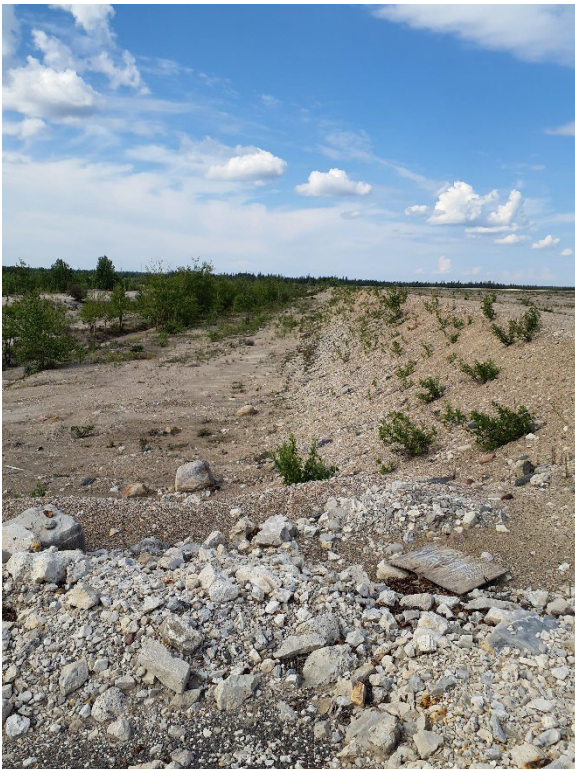
- The South Dyke crest and upstream and downstream slopes were in good condition (Photo II-1 to Photo II-6).
- There was ponded water near the downstream toe of the South Dyke in various locations. The Tailings Surveillance Officer indicated these are permanent pond features (Photo II-1 and Photo II-5).

Photo II-5 South Dyke – looking southeast, vegetation on downstream slope and permanent pond at toe

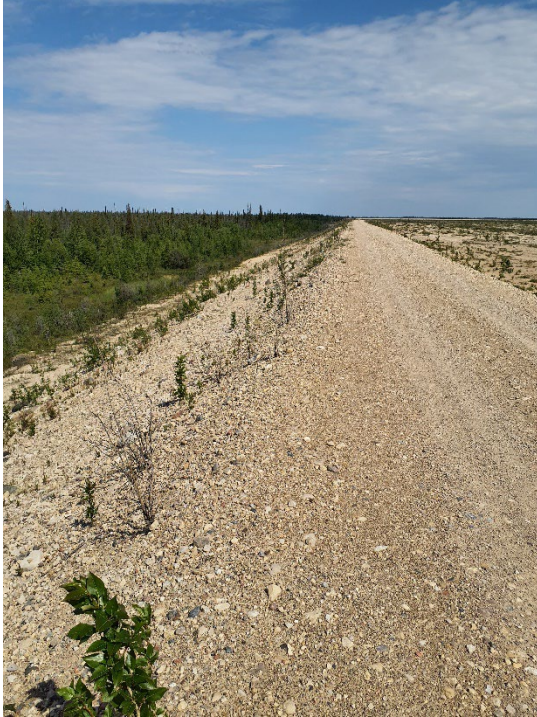
- The West Dyke crest and upstream and downstream slopes were in good condition (Photo II-7 to Photo II-12).
- Maintenance was completed at the two locations of “severe erosion” identified in the 2021 AFPR (Photo II-10 and Photo II-11). The maintenance consisted of regrading the dyke fill, and granular materials were not imported for use. There has been some washing of the fines from the repaired areas and there is minor rilling on the slope.
- Ponding was observed downstream of the toe in some areas, including two larger ponds at the north end. At the dyke toe minor seepage with red staining was observed flowing into these larger ponds (Photo II-10). The seepage water was clear.

Photo II-8 West Dyke – looking southwest at the downstream slope

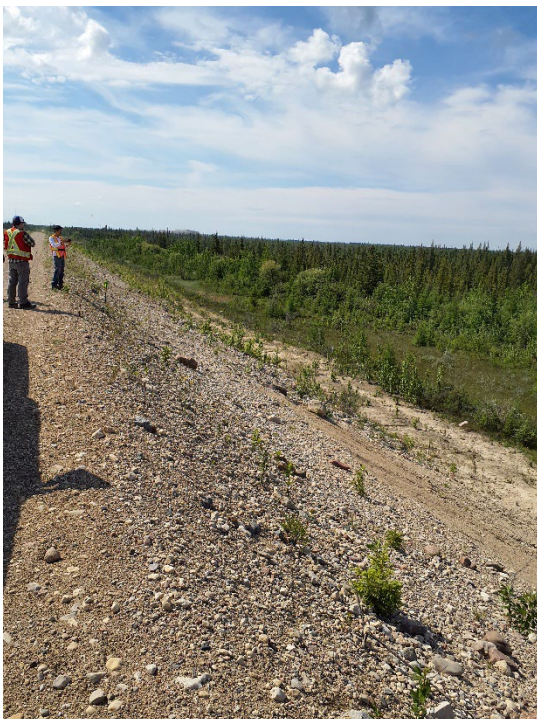
Photo II-9 West Dyke – looking south-southeast at the upstream crest and tailings surface

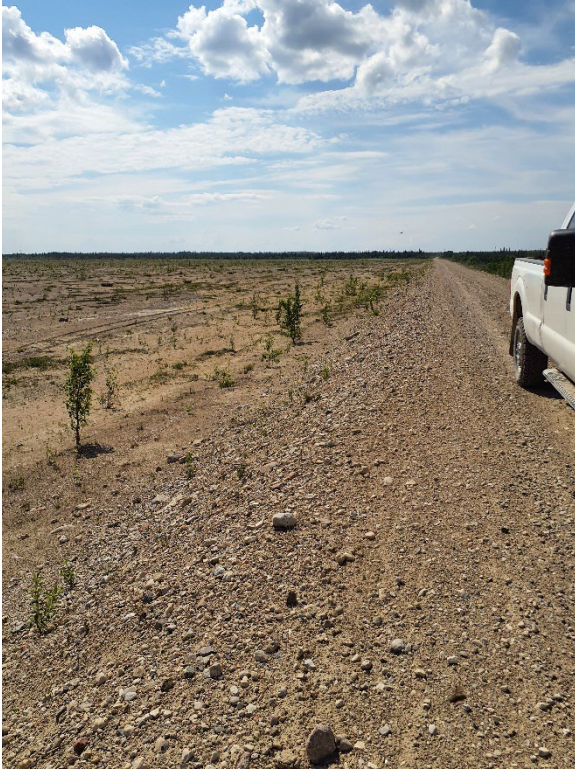
Photo II-10 West Dyke – looking west at the permanent pond downstream

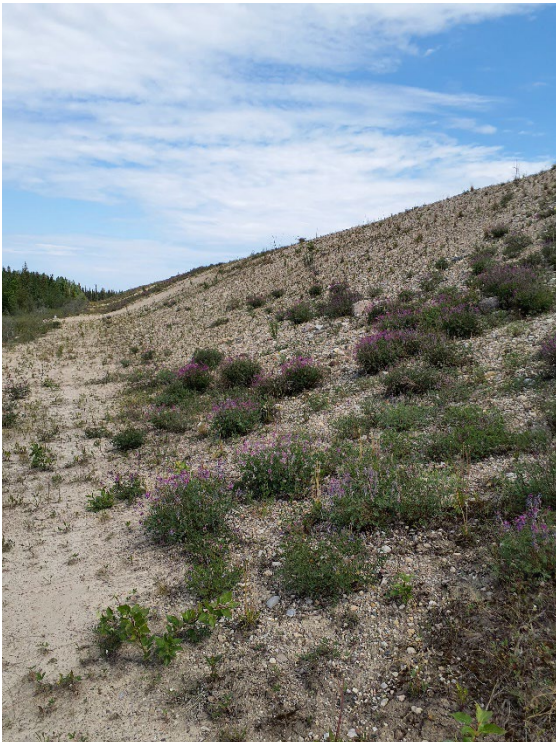
- The North Dyke crest and upstream and downstream slopes were in good condition (Photo II-13 to Photo II-21). Some minor rutting of the crest and rills on the slopes, but none requiring immediate repair.
- The Main Pond was in contact with the upstream slope of the North Dyke across most of its length, apart from a ~200 m zone near the northwest corner. The riprap placed in 2021 is in good condition (Photo II-18, Photo II-19, Photo II-20).
- Ponds were observed downstream of the toe in some areas (Photo II-14, Photo II-15, Photo II-17). No active seepage was observed at the downstream toe.
- Woody debris has been piled near the corner of the North and West Dykes (Photo II-40). This debris is within the Main Pond limits during the inflow design flood and could therefore be mobilized and block the spillway.

Photo II-13 North Dyke – looking east, some rutting on dyke crest

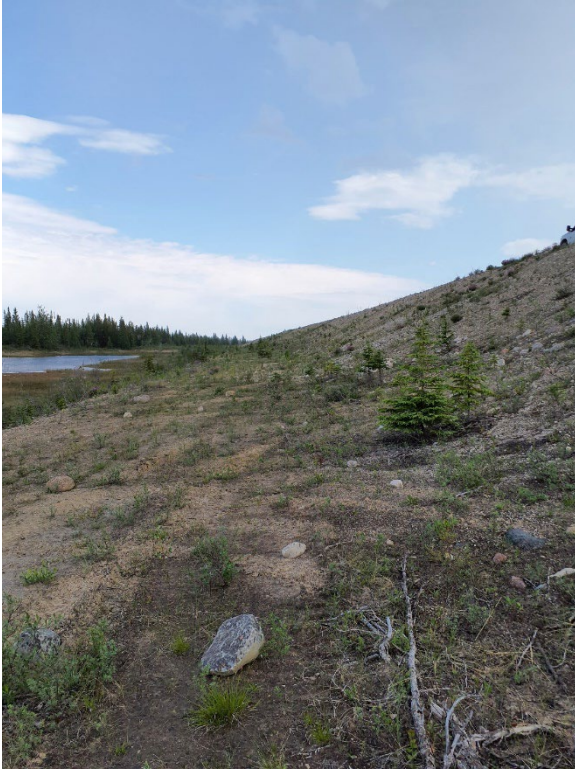
Photo II-16 North Dyke – looking east at the downstream slope

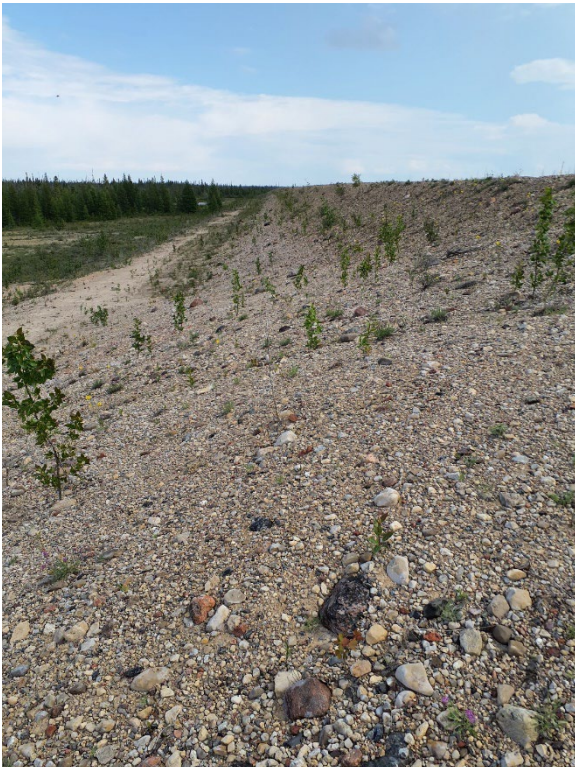
Photo II-17 North Dyke – looking west at the downstream slope and permanent pond

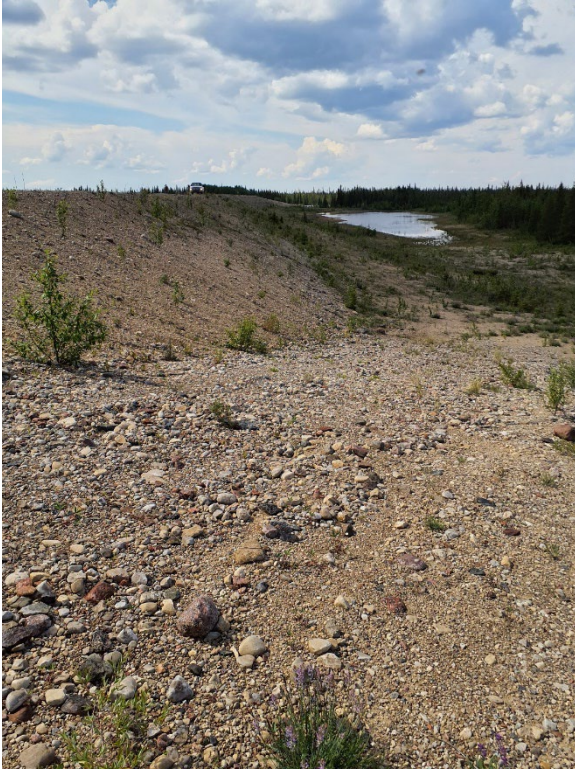
Photo II-18 North Dyke – looking west at the downstream slope where riprap was placed in 2021

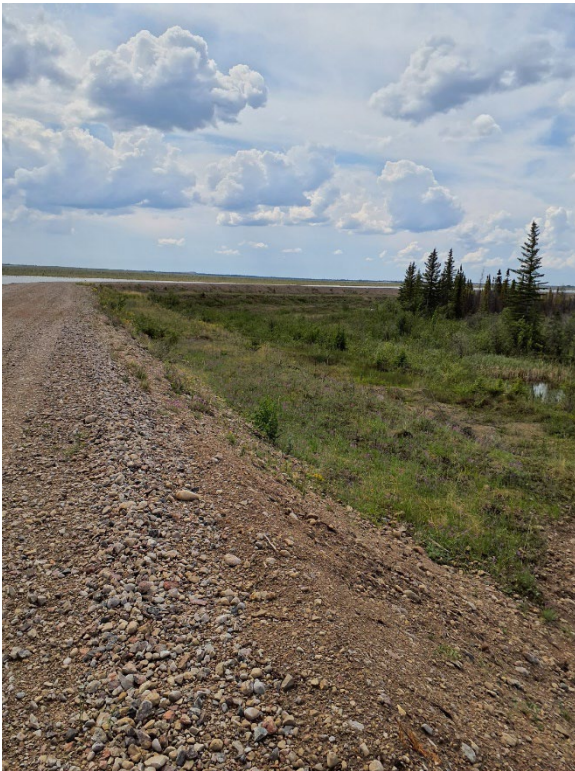
- The East Dyke crest and upstream and downstream slopes were in good condition (Photo II-22).
- There is a permanent pond near the southern end and a seasonal pond near the northern end (Photo II-22).

Photo II-22 East Dyke – looking north at the downstream slope and at the permanent pond located at the downstream toe

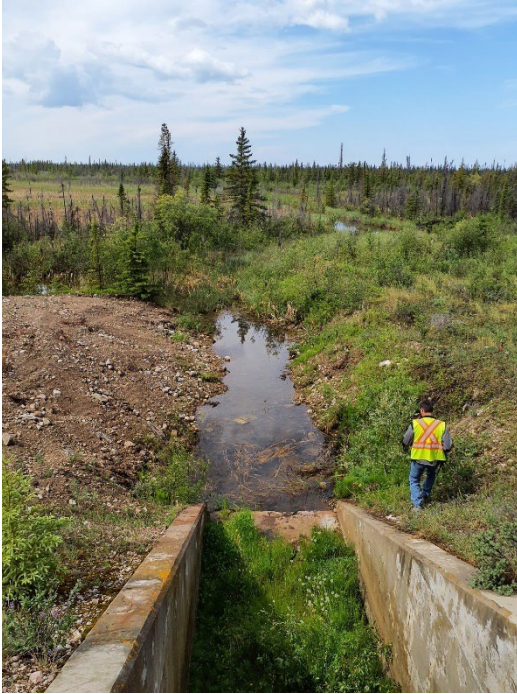
- The concrete Main Pond Spillway structure appeared to be in good condition (Photo II-23, Photo II-24, Photo II-25).
- There are dead trees in the Main Pond, and it is possible that debris mobilized during an extreme flood could reduce the flow capacity of one or both spillways.

Photo II-24 Main Pond Spillway – looking at the inlet to see the height of the clay plug upstream of the concrete wall

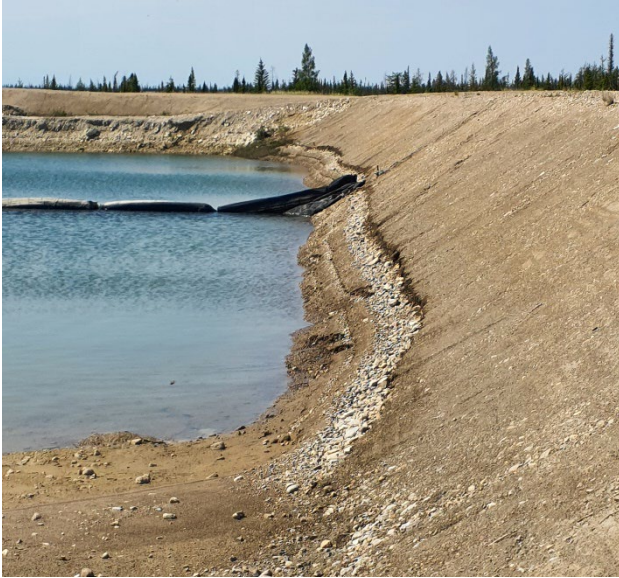
Photo II-30 Polishing Pond – looking north at the toe of the North Dyke; erosion at the winter water level. Note: photo taken June 22 and Polishing Pond water level was lowered by approx. 0.5 m as the water treatment started on June 21

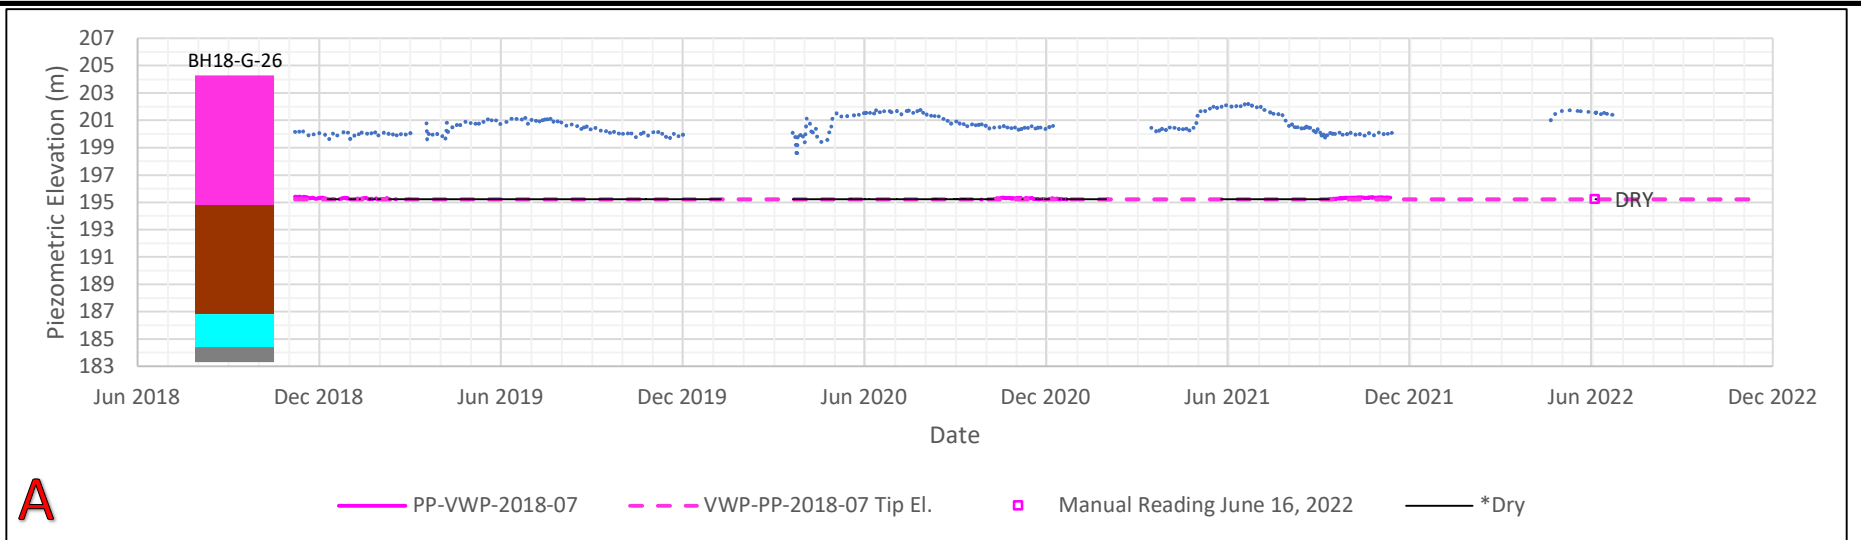
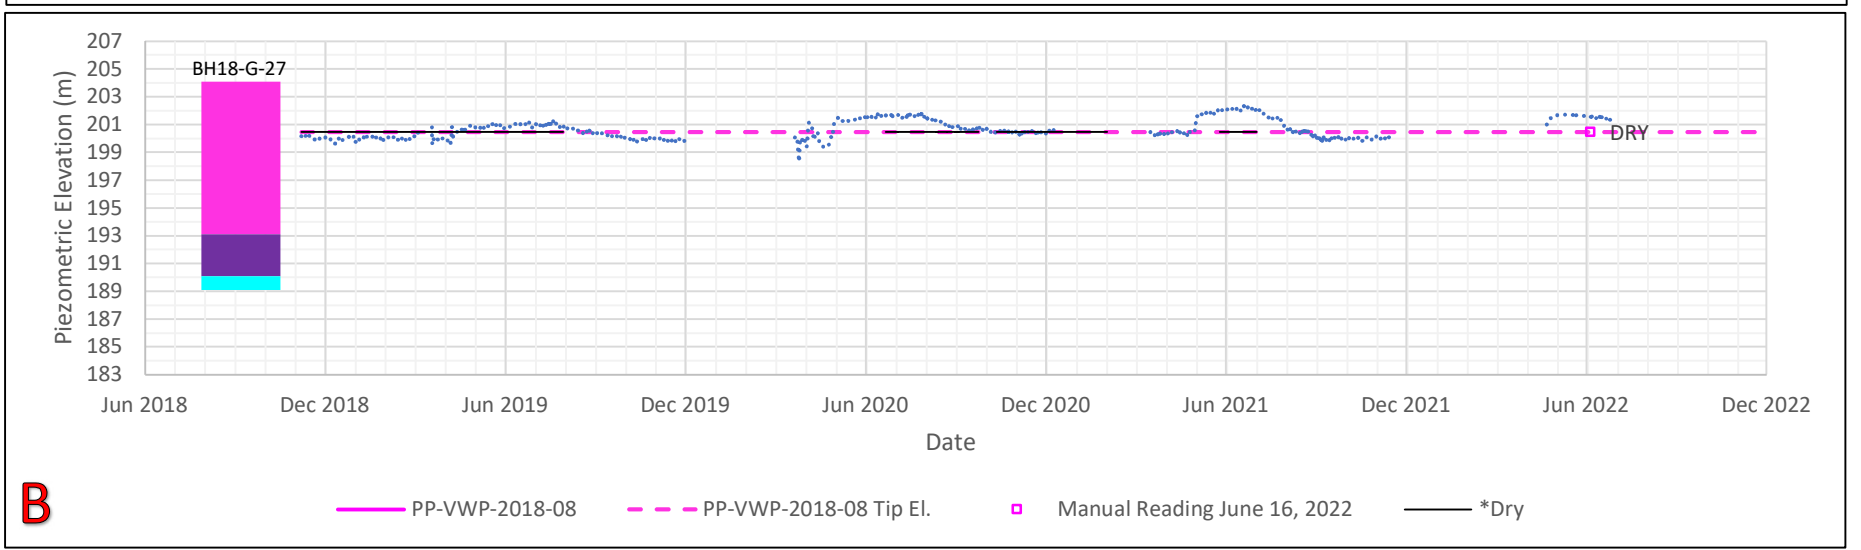
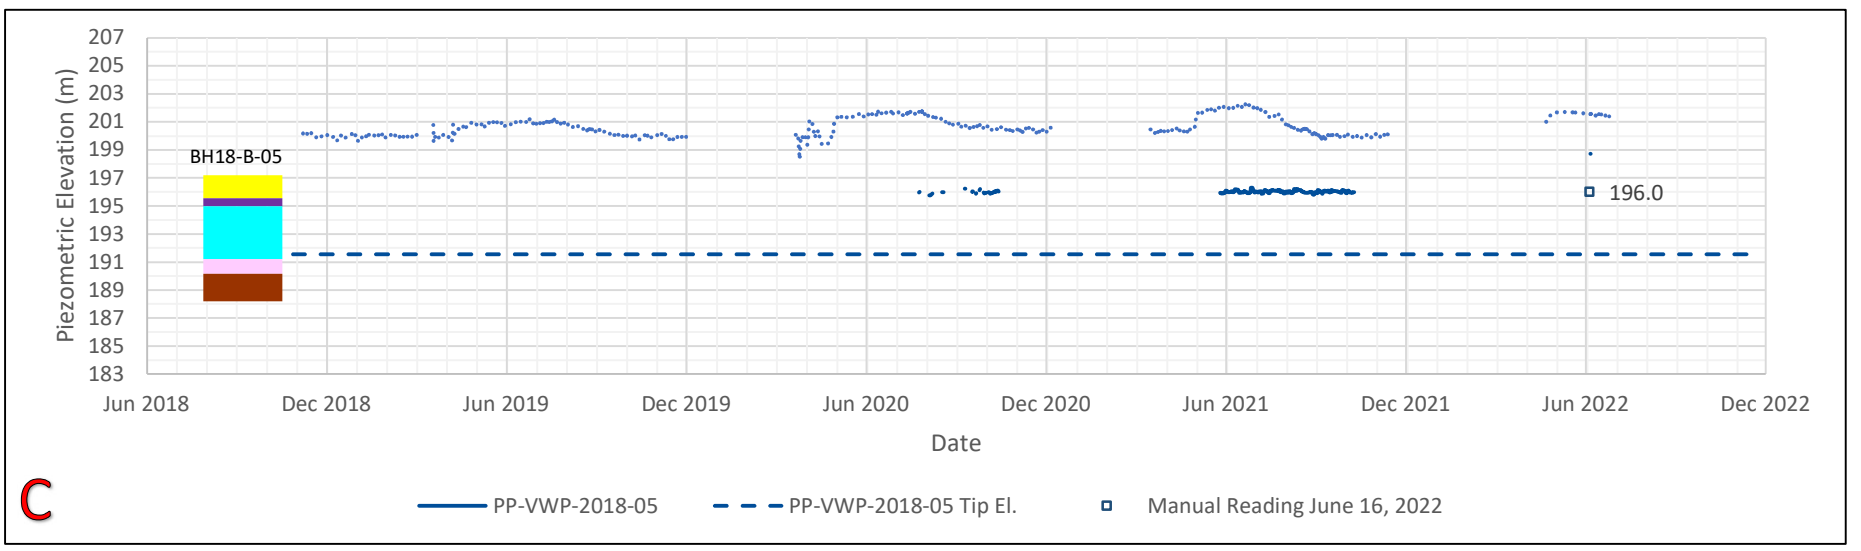
- A** -Instrument PP-VWP-2018-07: Pressure head readings fluctuate both positive and negative indicating the piezometric surface is near the tip elevation of the instrument.
- B** -Instrument PP-VWP-2018-08: Pressure head readings are consistently negative indicating the piezometric surface is below the tip elevation of the instrument.
- C** -Instrument PP-VWP-2018-05: No observations of note.

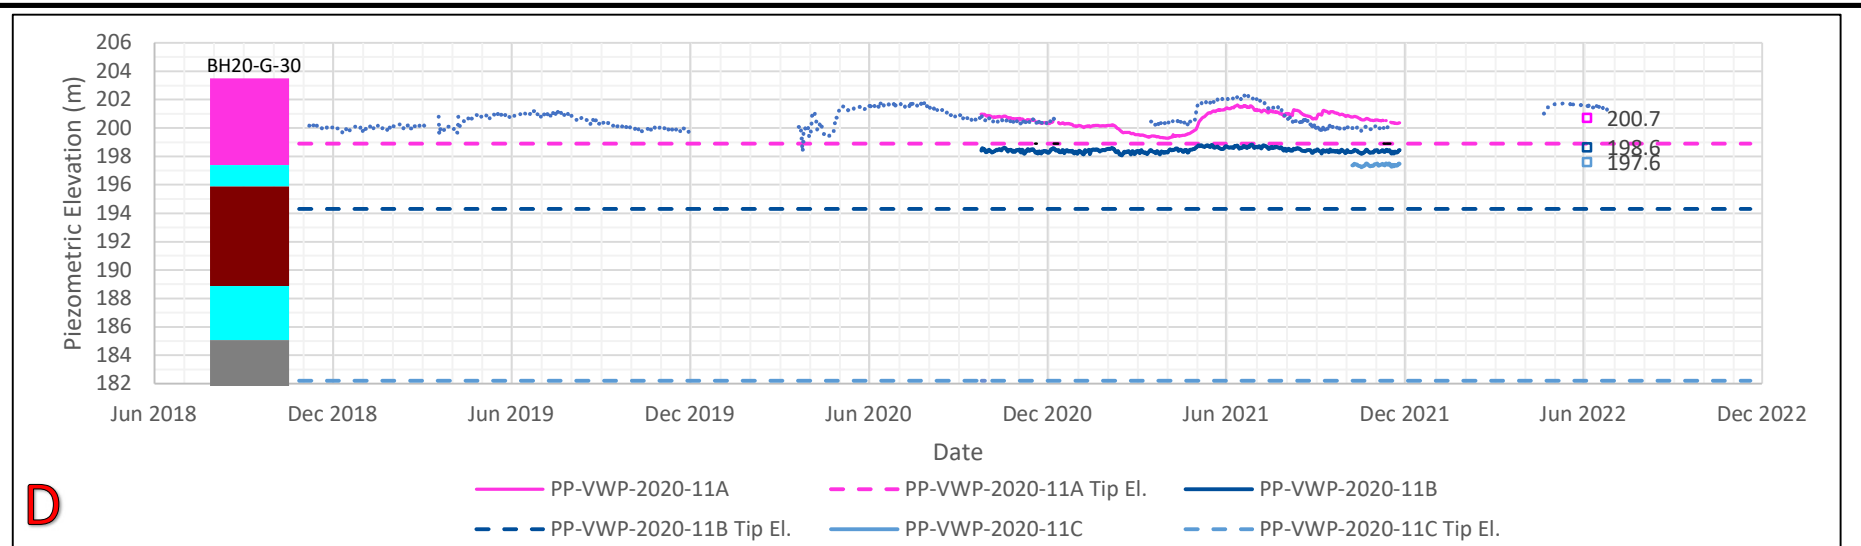
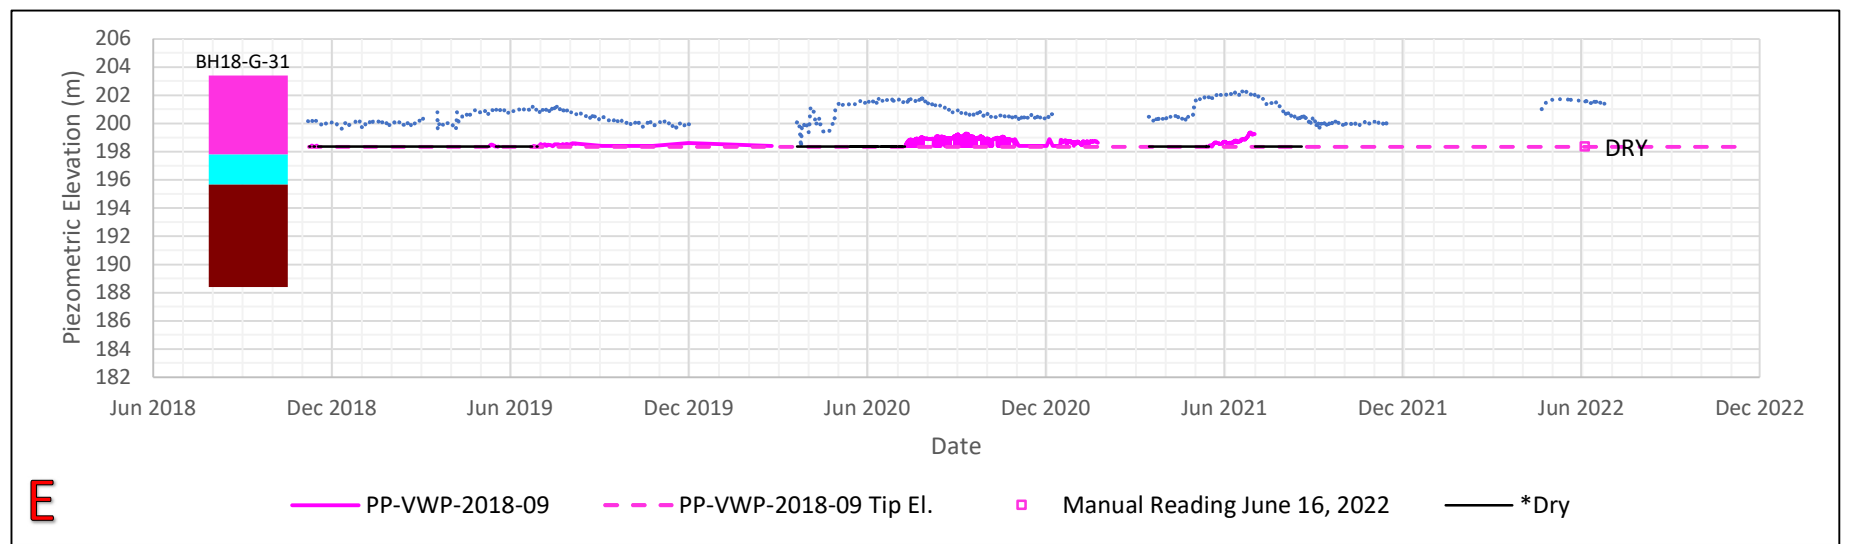
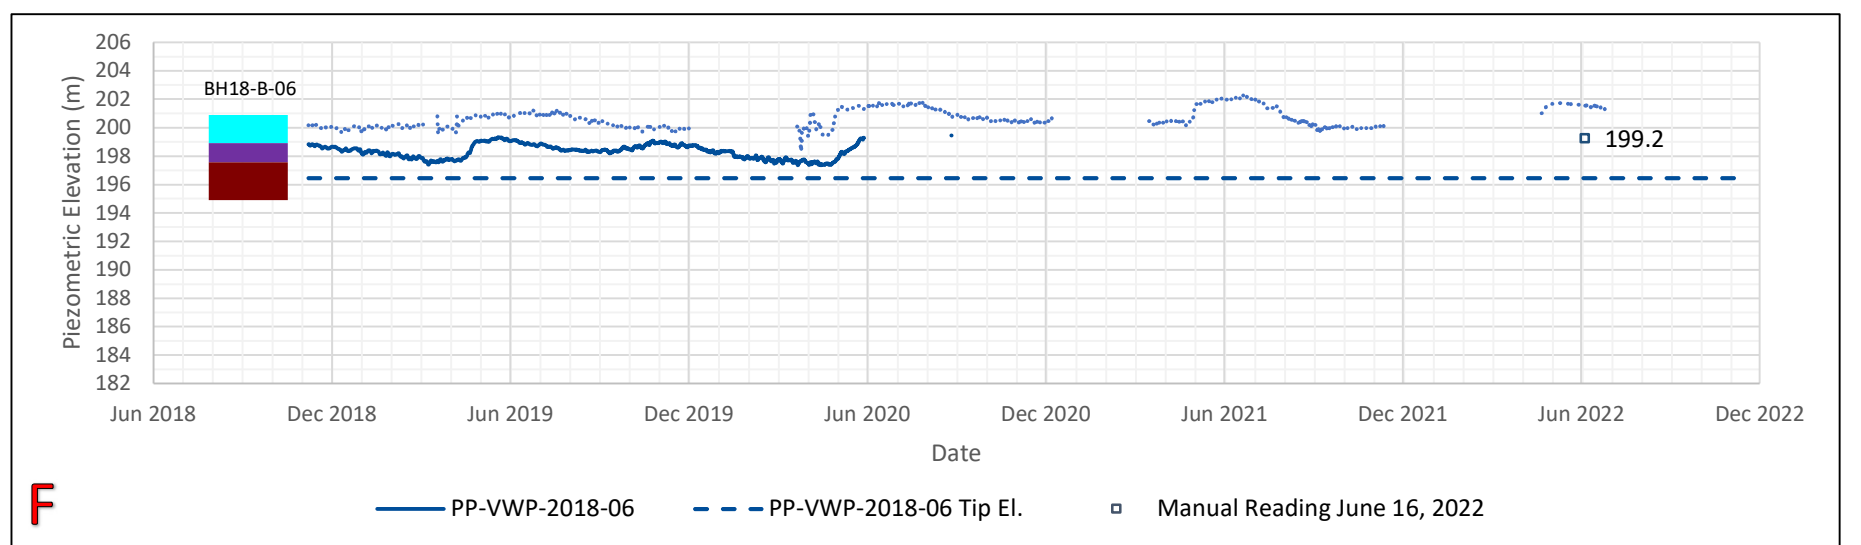
- D** -Instrument PP-VWP-2018-11A, -11B, -11C: No observations of note.
- E** -Instrument PP-VWP-2018-09: Pressure head readings are negative. Piezometric levels cannot be determined from negative pressure readings. The VWP datalogger appears to be malfunctioning as of July 10, 2021.
- F** -Instrument PP-VWP-2018-06: The VWP datalogger appears to be malfunctioning as of Sept 30, 2020.

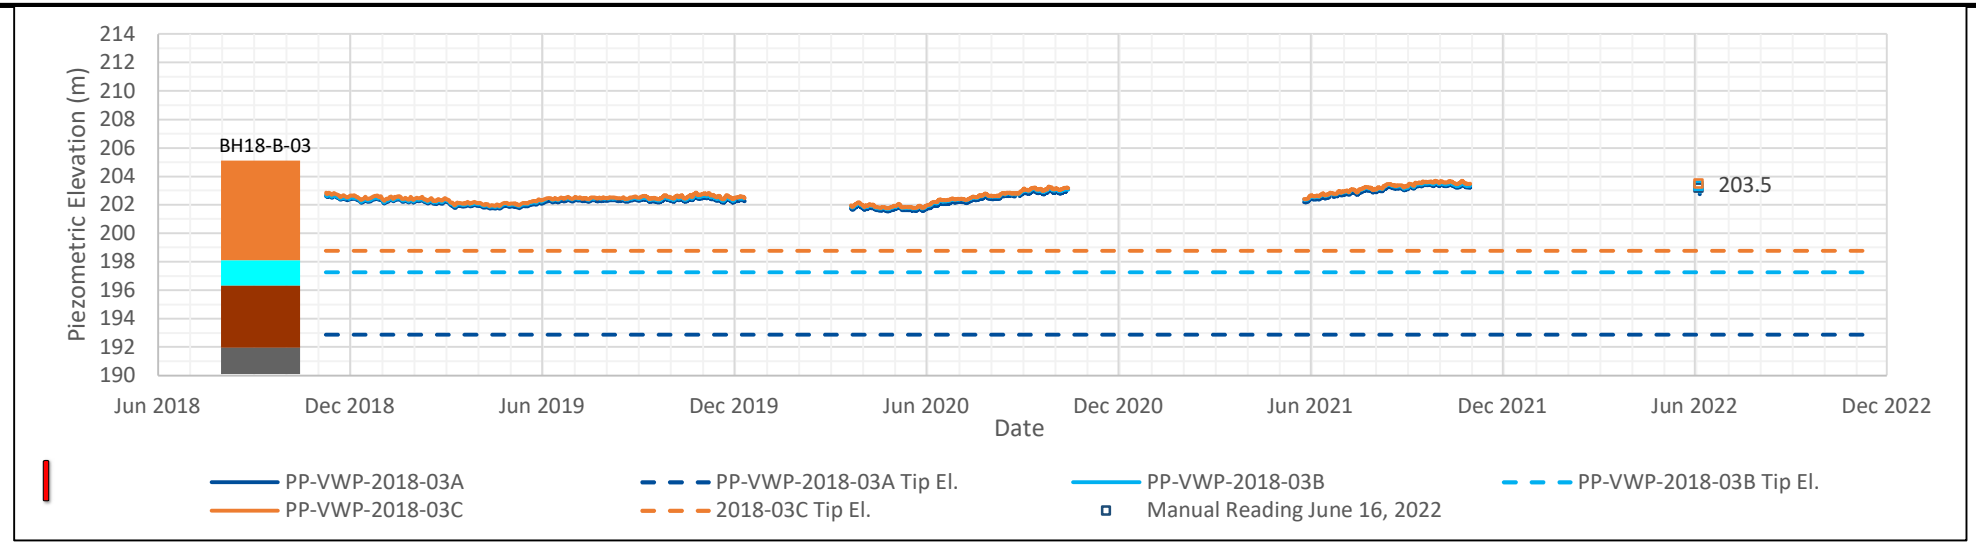
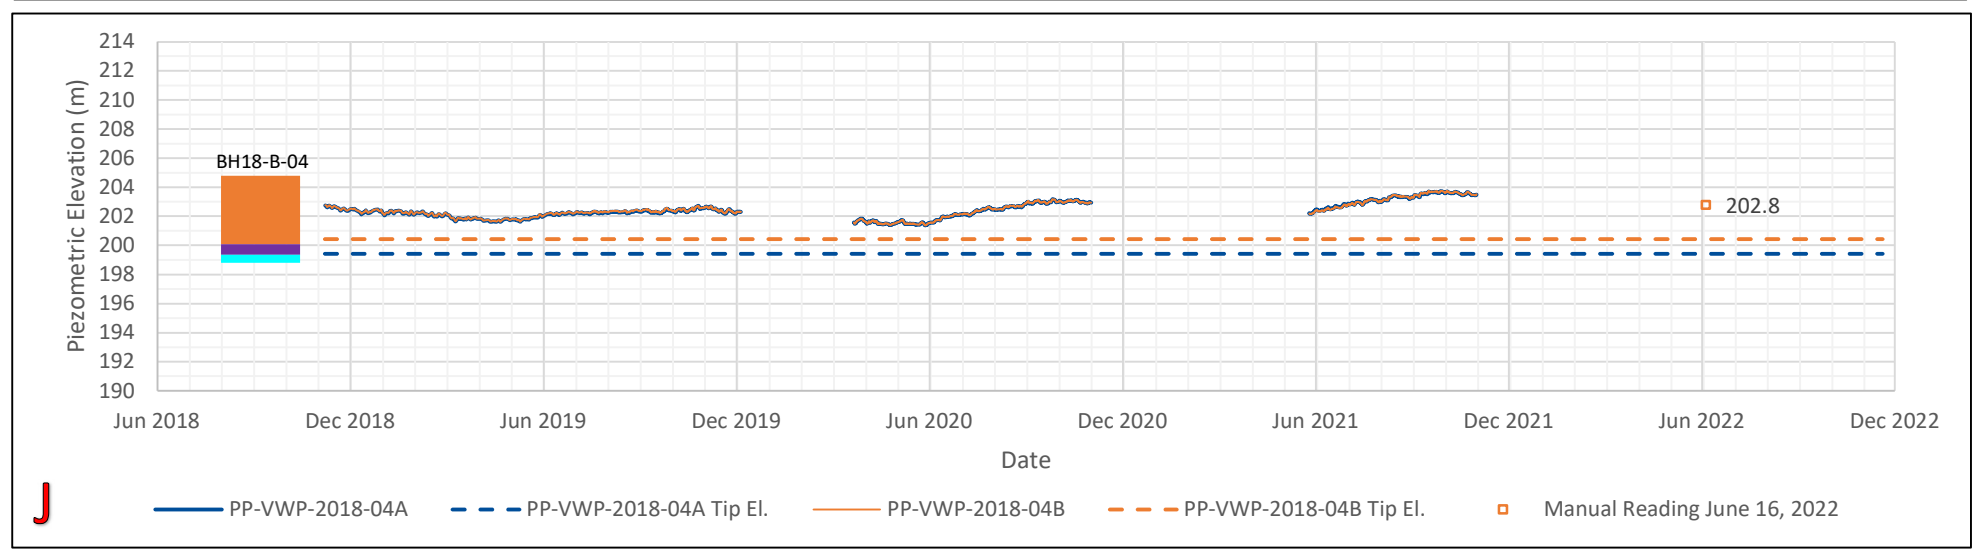
- I** -Instrument PP-VWP-2018-03A, -03B, -03C: No observations of note.
- J** -Instrument PP-VWP-2018-04A: No manual reading recorded on June 16, 2022.
- Instrument PP-VWP-2018-04B: No observations of note.
