2022 Annual Facility Performance Report

Red Dog Tailings Storage Facility

Red Dog Mine, Alaska

31404122.007-002-R-Rev0

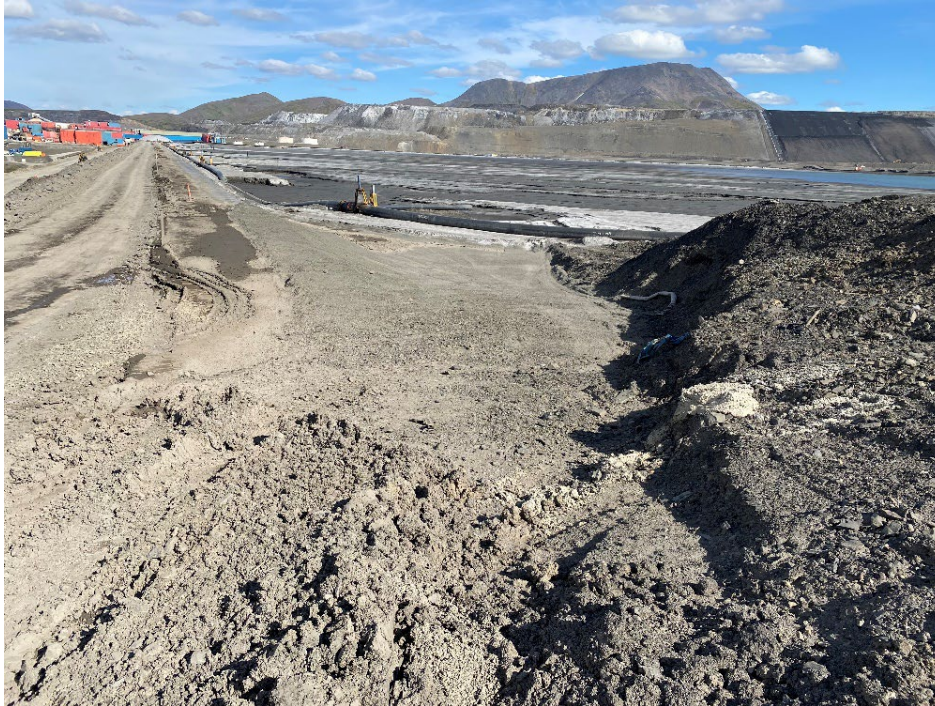
Photo 1: Upstream West Abutment of Embankment

West abutment of Embankment appeared to be in satisfactory physical condition with no indications of erosion, deterioration, horizontal displacement, or other instability (see Photos 1 and 6).

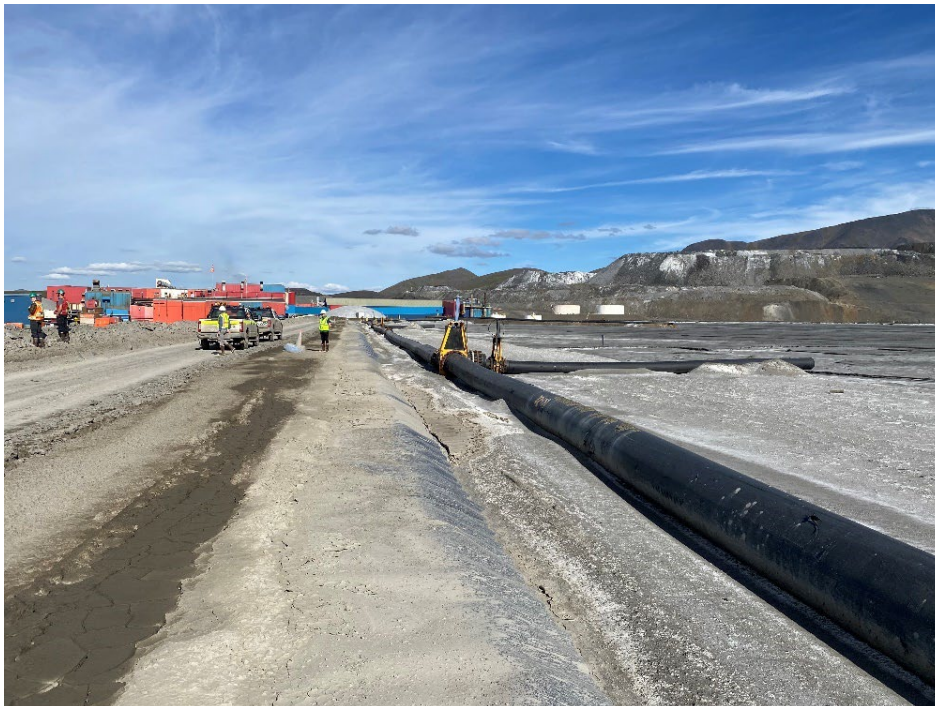
The dam crest appeared to be in satisfactory physical condition with no indications of settlement, cracking, or stability issues (see Photos 2, 3, 5, and 14 to 17). Tire tracks in soft soils were observed along crest of TMD Embankment (see Photo 2) that showed equipment had driven inside of the delimitation markers (either safety candles or reflectors) and came close to the exposed geomembrane liner near the anchor trench at several locations. Driving over the geomembrane liner without protective cover could damage the liner. We understand these occurred during the ongoing Stage XII raise construction and that the contractor had already been notified to stay outside of the delimitation markers. No apparent damage to the geomembrane liner was observed.

Upstream slope of Embankment and Wing Wall appeared to be in satisfactory physical condition with no indications of liner damage, displacement, or other signs of instability (see Photos 2, 3, and 15). A satisfactory subaerial tailings beach that appeared to meet the minimum target widths was observed at the Embankment and Wing Wall (see Photos 19 and 20). No piping or sinkholes were observed in the subaerial tailings beach.

Photo 2: Embankment Crest, Upstream Slope, and Tailings Pipe Bench

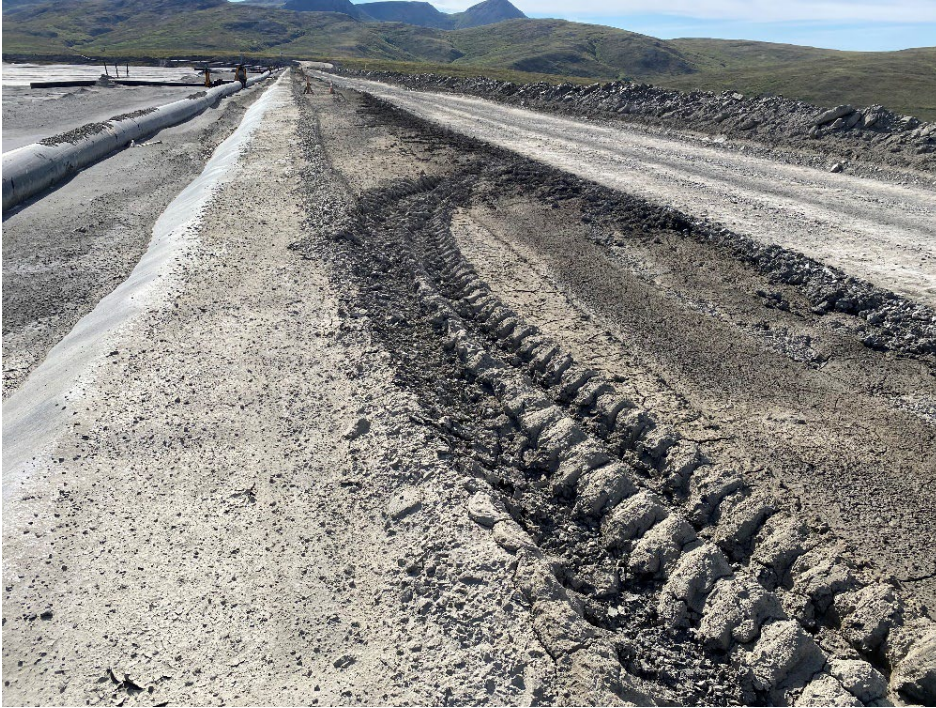
Downstream slope of Embankment and Wing Wall appeared to be in satisfactory physical condition with no vegetation or indications of instability (see Photos 3, 4, 11, and 12).

Photo 3: Equipment Tire Tracks near Geomembrane Liner at Embankment Crest

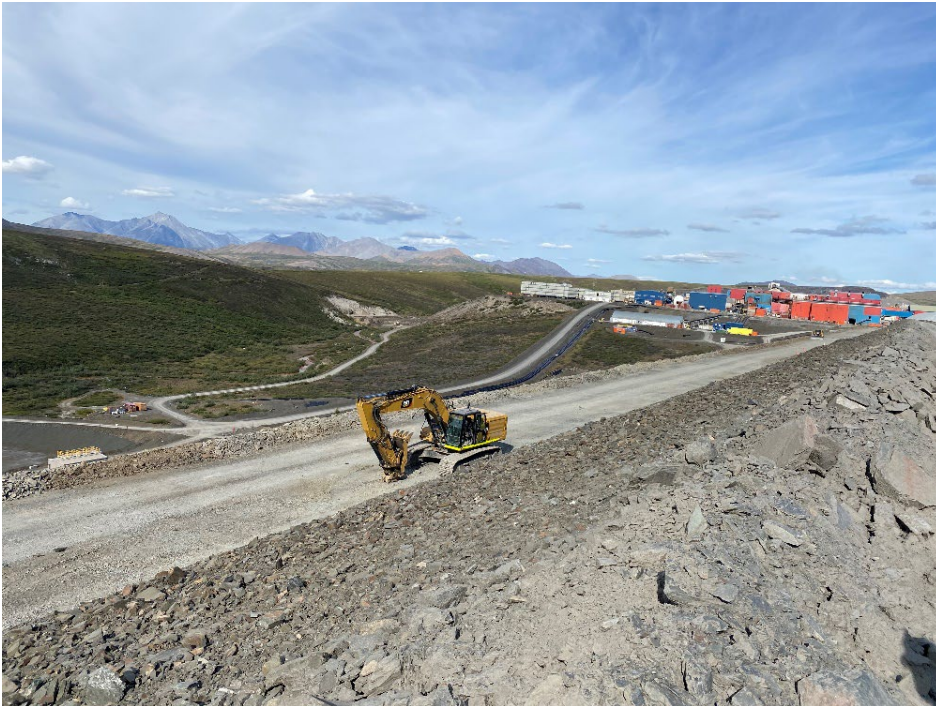
Stage XII widening construction was ongoing at the Embankment during the site inspection. This construction had reached a stage where the active construction bench was about 20 ft below the dam crest (see Photo 4). Therefore, the Embankment slope below the construction bench, including the lower buttress slope, was newly constructed in 2022.

Photo 4: Stage XII Construction Bench and Downstream Embankment Slope

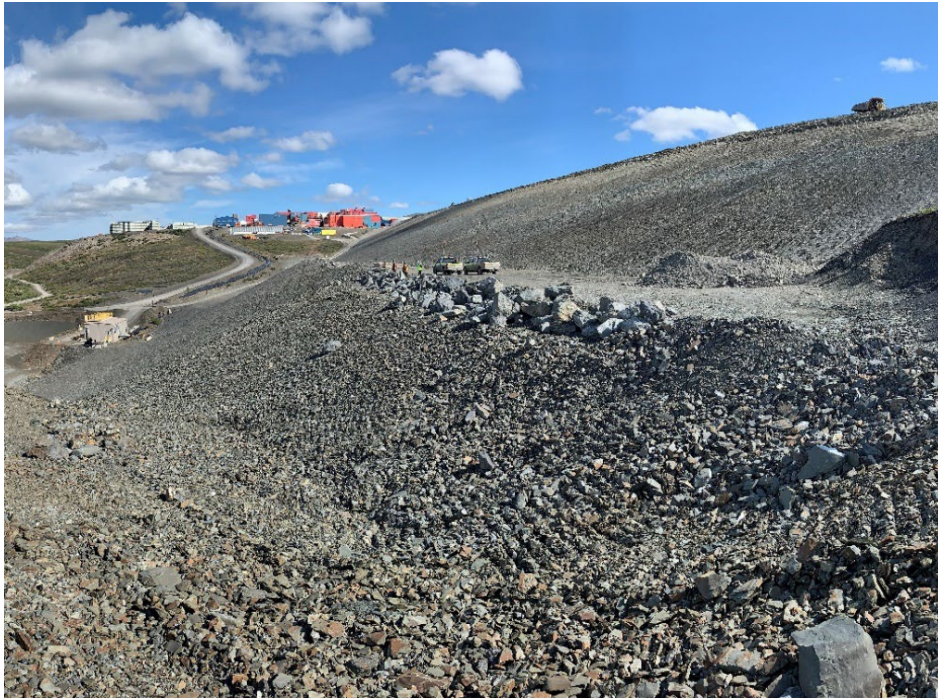
Photo 6: Downstream Slope and Buttress at West Abutment of Embankment

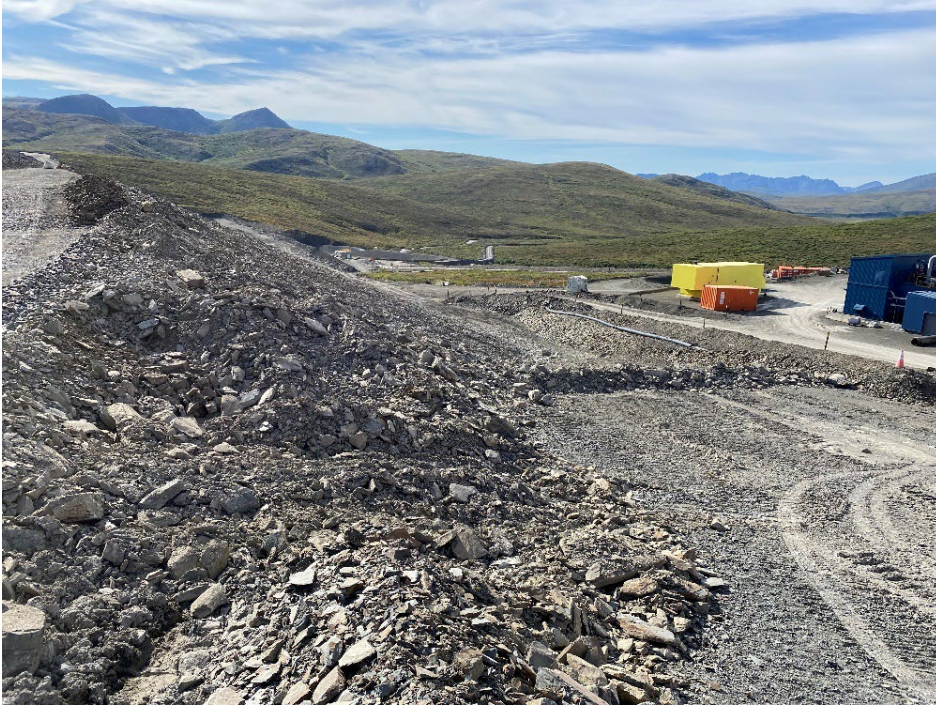
East abutment of Embankment appeared to be in satisfactory condition with no indications of erosion, deterioration, horizontal displacement, or other instability (see Photo 7).

Photo 7: Downstream Slope at East Abutment of Embankment

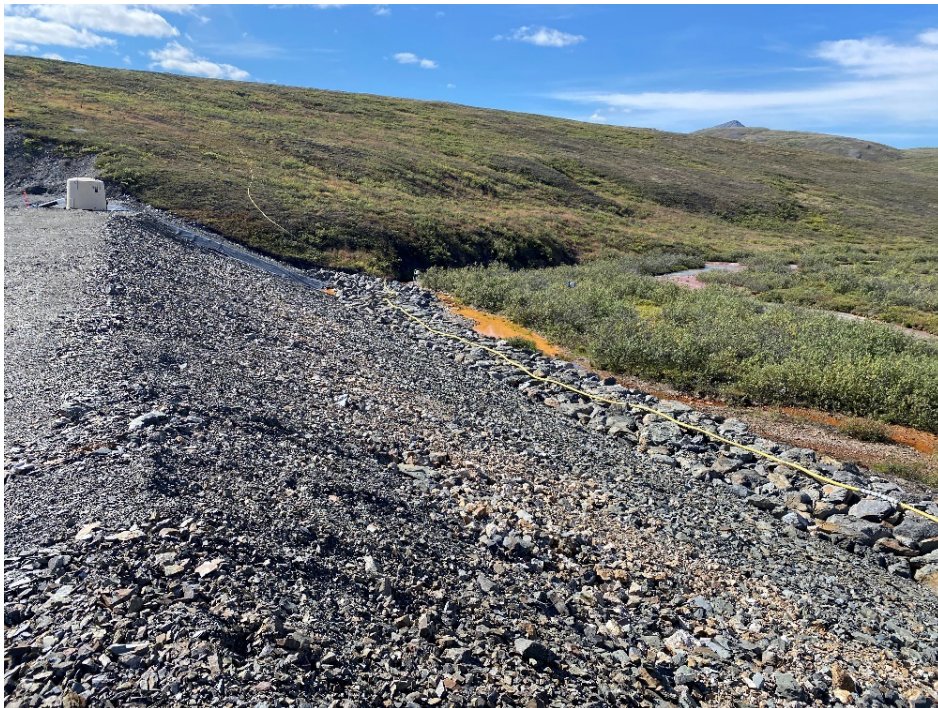
The Seepage Collection Pond and Dam crest, upstream and downstream slopes, and spillway appeared to be in satisfactory physical condition with no signs of damage, settlement, cracking, or instability (see Photos 8 to 11). The bottom of the Seepage Collection Pond had divots in the protective soils covering the geomembrane liner at the east side of the pond bottom (see Photo 9), which should be inspected to assess there is no damage to the liner and protective cover soil replaced. Ponding water was also observed at the base of the Embankment bench fill (see Photo 8), which may be an indicator that additional protective cover soil may be required in those areas.

Photo 10: Downstream Slope of Seepage Collection Dam

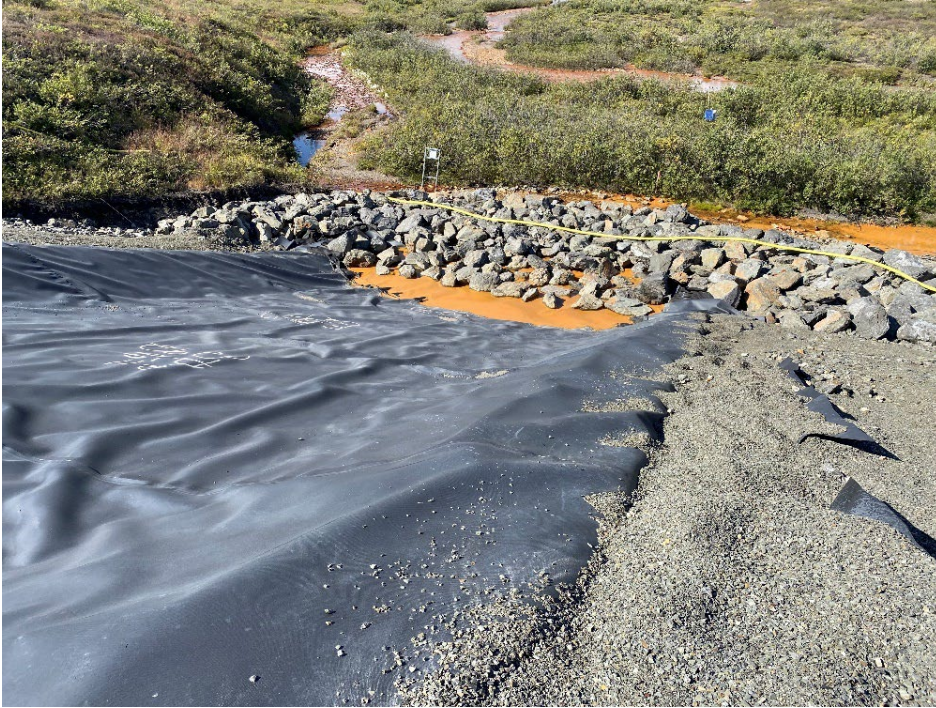
Photo 11: Seepage Collection Dam Spillway

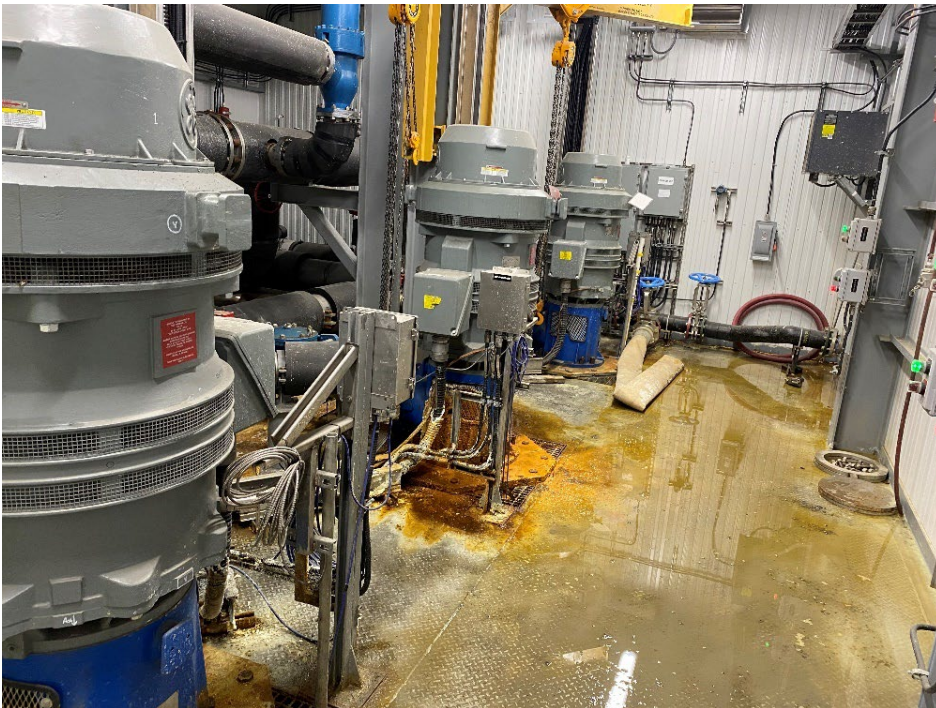
Photo 12: Turbine Pumps inside of Pumphouse

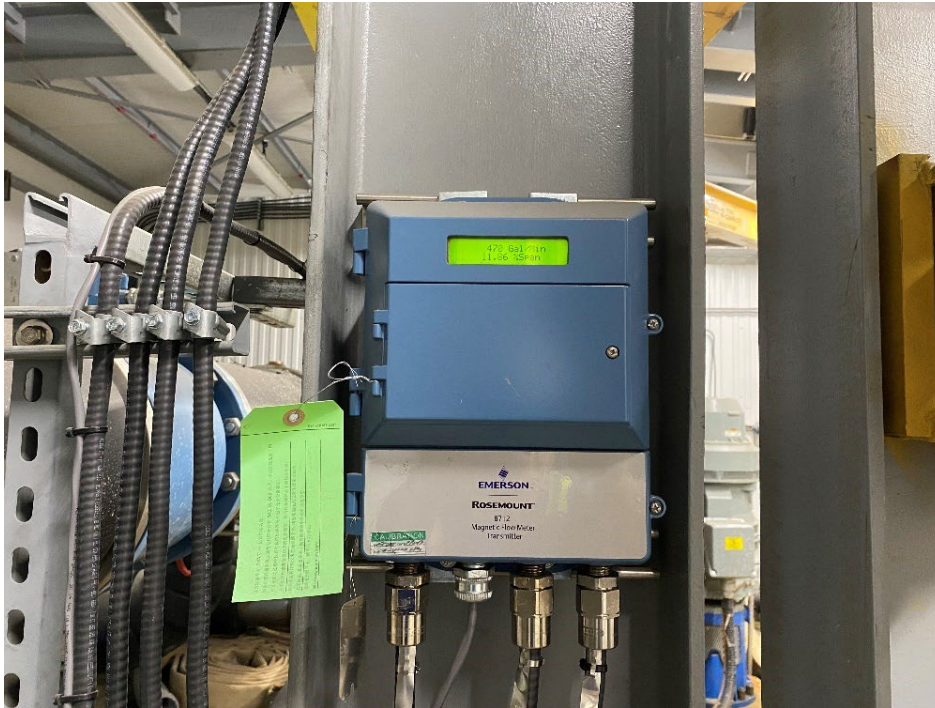
Photo 13: Flow Meter Inside of Pumphouse

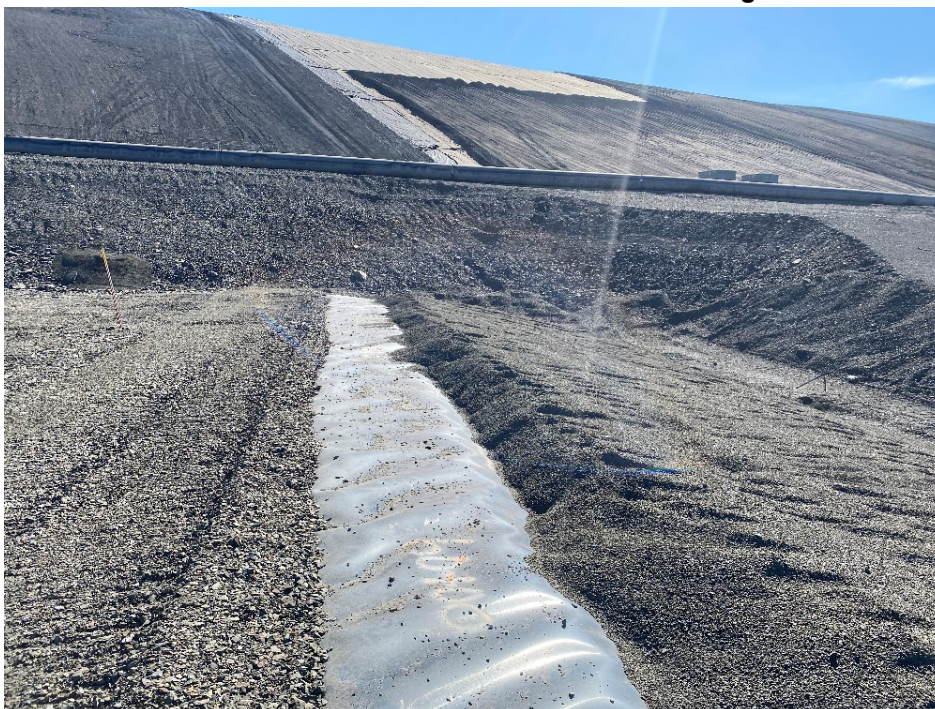
Photo 14: Insulation over Secant Wall at South End of Wing Wall

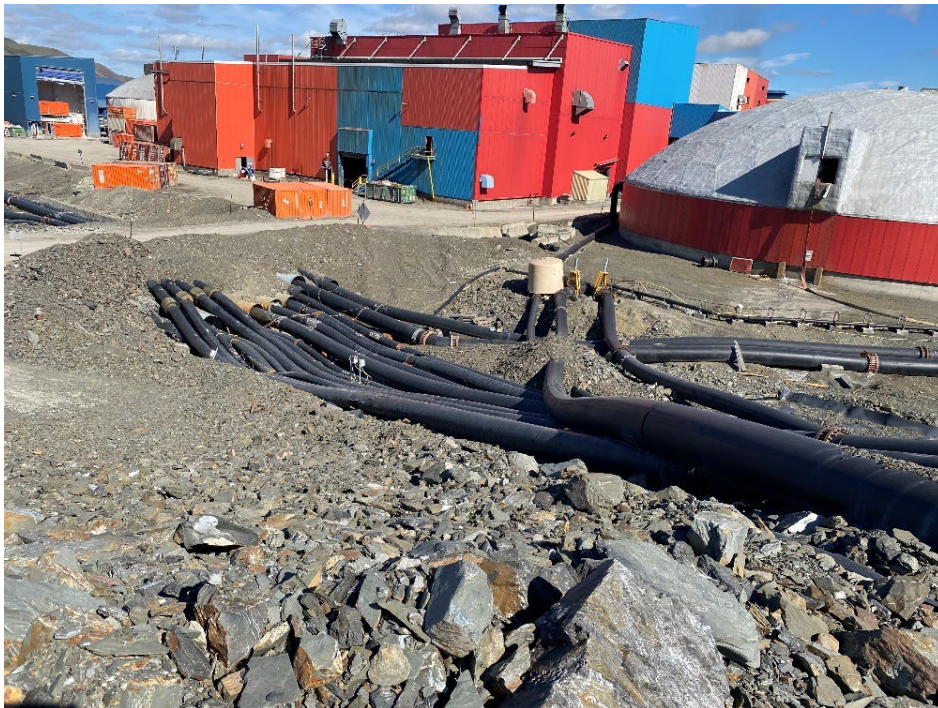
Photo 18: Downstream Slope at Pipeline Corridor

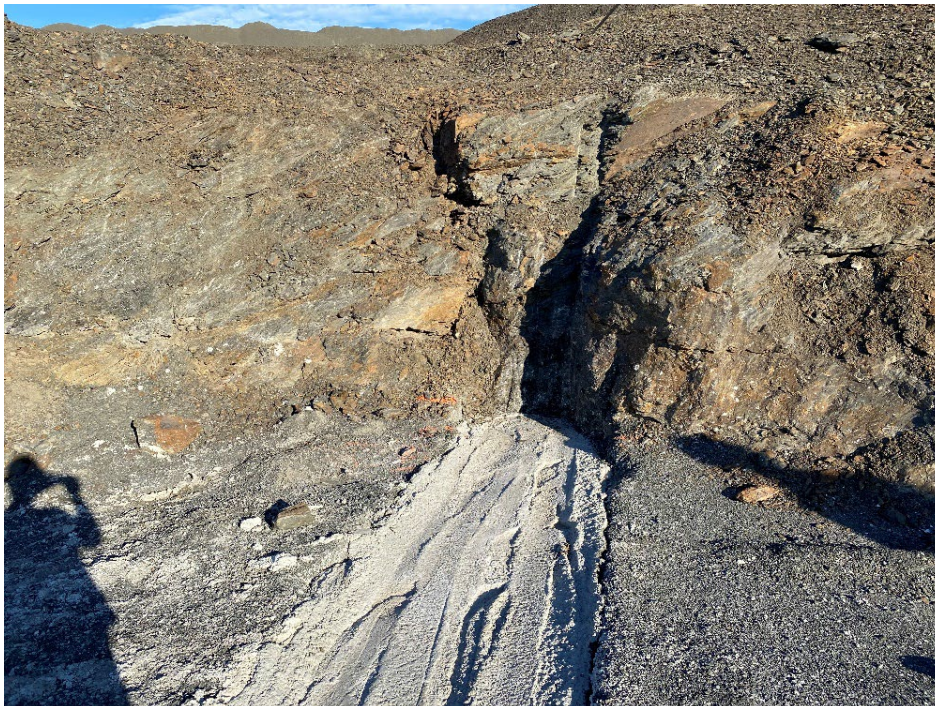
West abutment appears to be in satisfactory physical condition with no indications of displacement, settlement, erosion, or concerning issues (see Photos 1 and 2). Excavation to refusal into bedrock at cut-off wall tie in observed (see Photos 2).

Photo 2: Cut-off Wall Tie-In to Bedrock at West Abutment

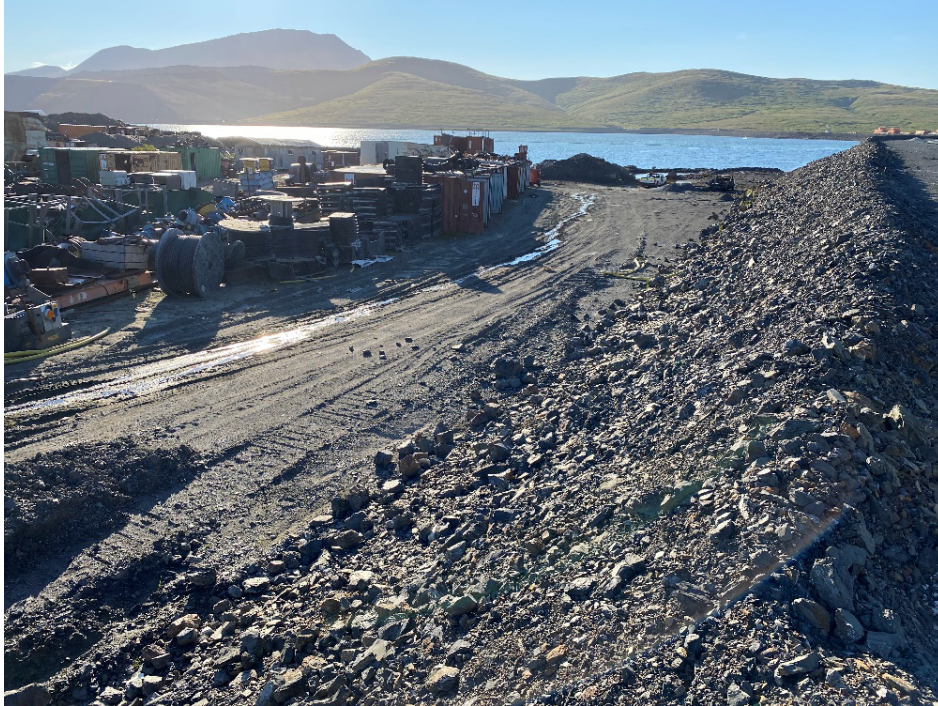
Upstream slope appears to be in satisfactory physical condition with no indications of erosion, displacement, or other signs instability (see Photos 3, 8, 9, 14, 17, and 19). Subaqueous tailings deposition ongoing (see Photo 9) but no tailings beach has been constructed yet.

Photo 3: Upstream Slope near West Abutment

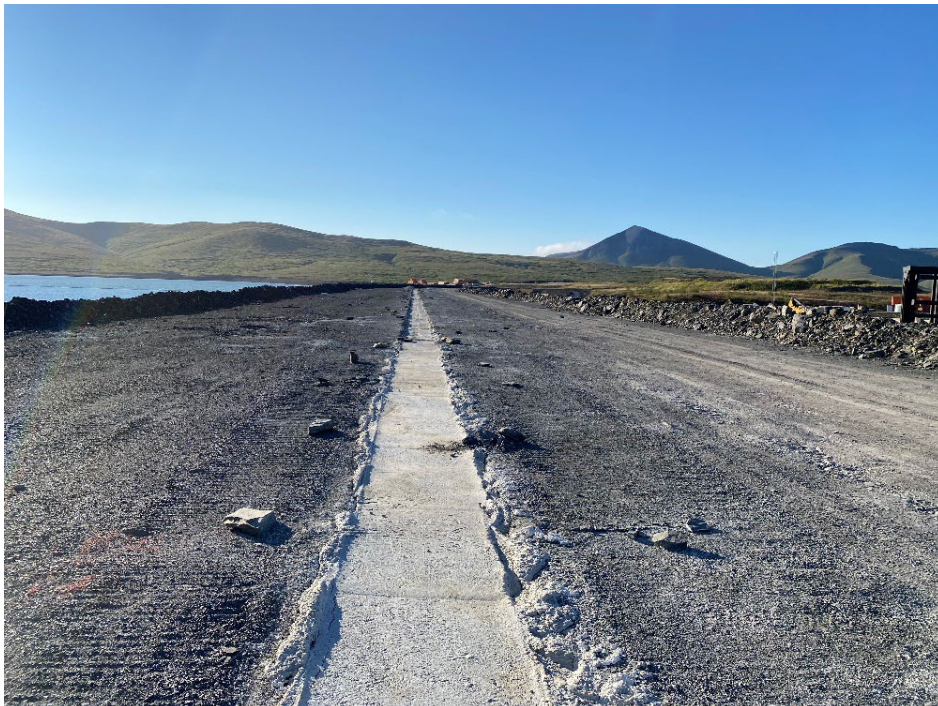
Photo 4: Dam Crest and Cut-off Wall near Station 2+00

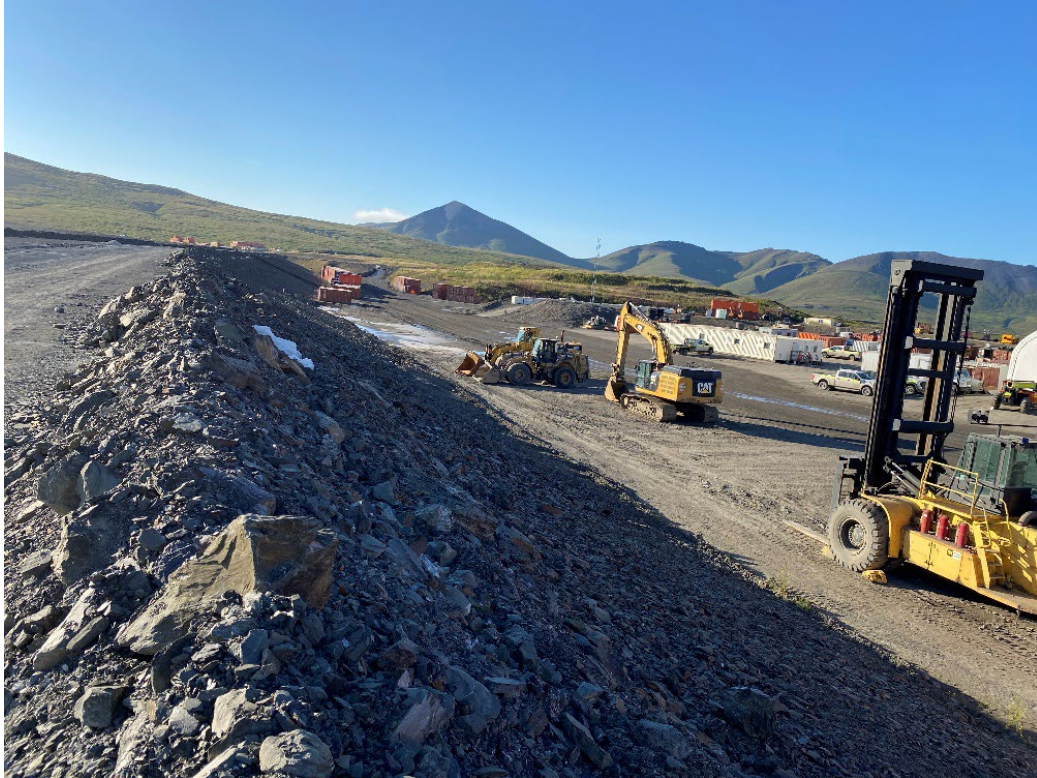
Downstream slope appears to be in satisfactory physical condition with no vegetation or indications of instability (see Photos 5, 7, 15, 18, and 21). Note that water shown in Photo 24 is from Upper Bons Creek and not seepage from the downstream dam embankment.

Photo 5: Downstream Slope near Station 2+50

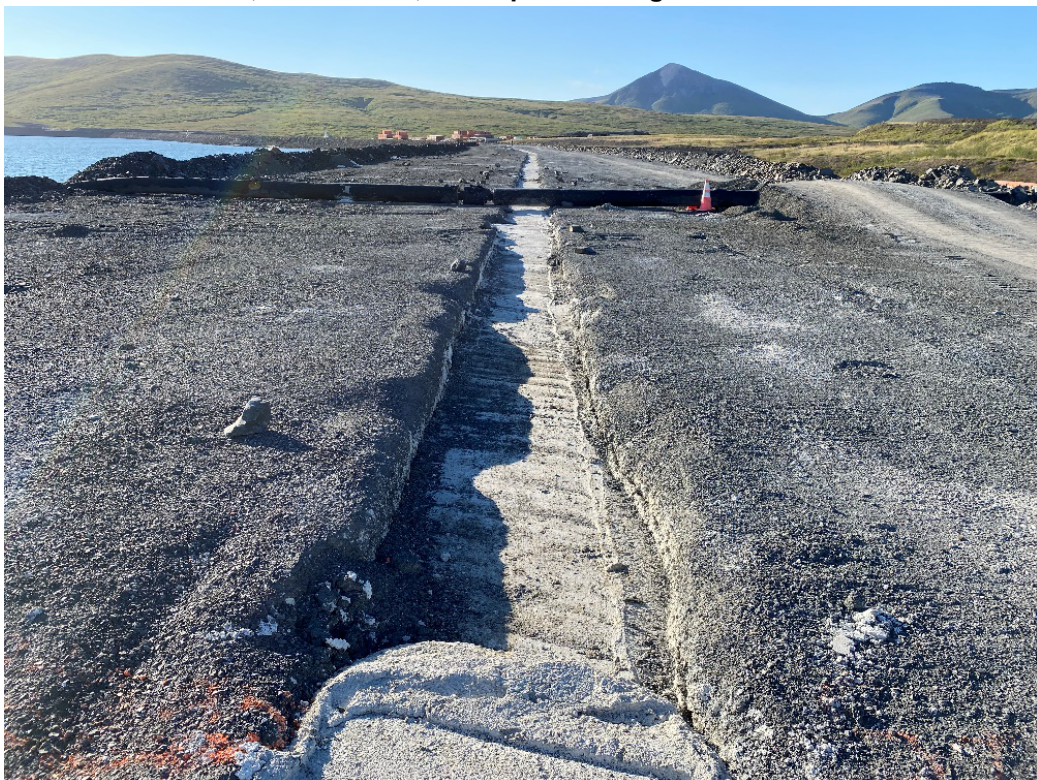
Photo 6: Dam Crest, Cut-off Wall, and Pipe Crossing near Station 10+00

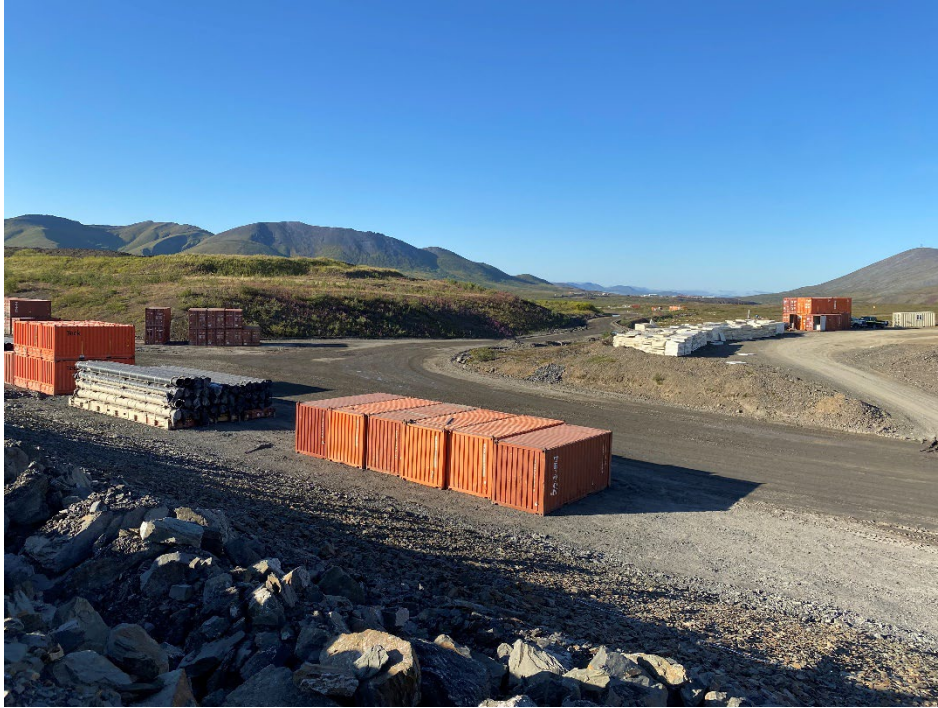
Photo 7: Downstream Slope and Kivalina Overburden Stockpile near Station 9+00

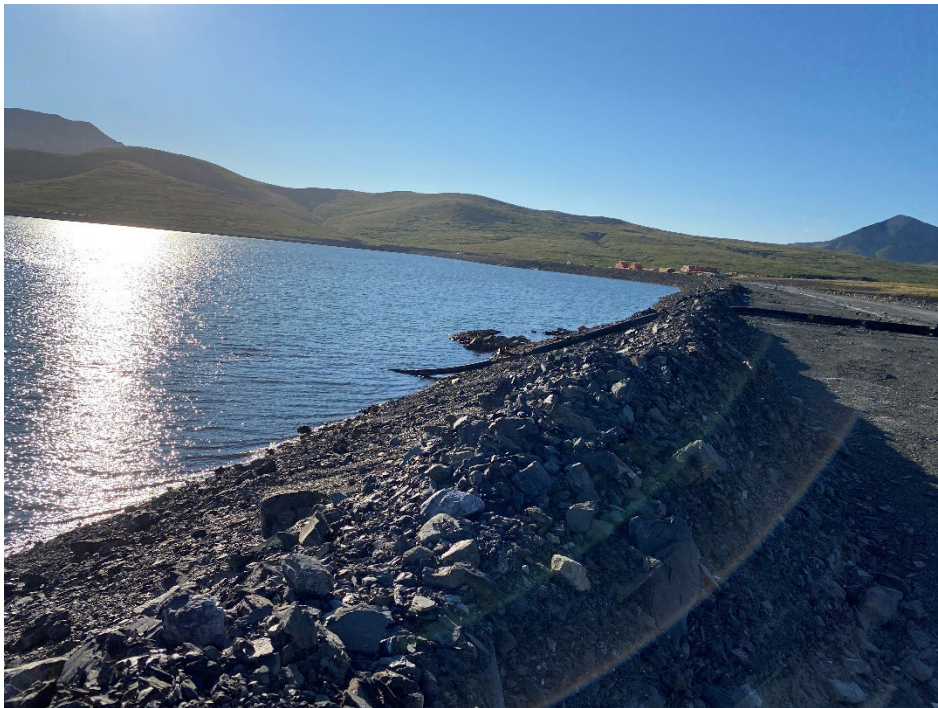
Photo 8: Upstream Slope near Station 9+00

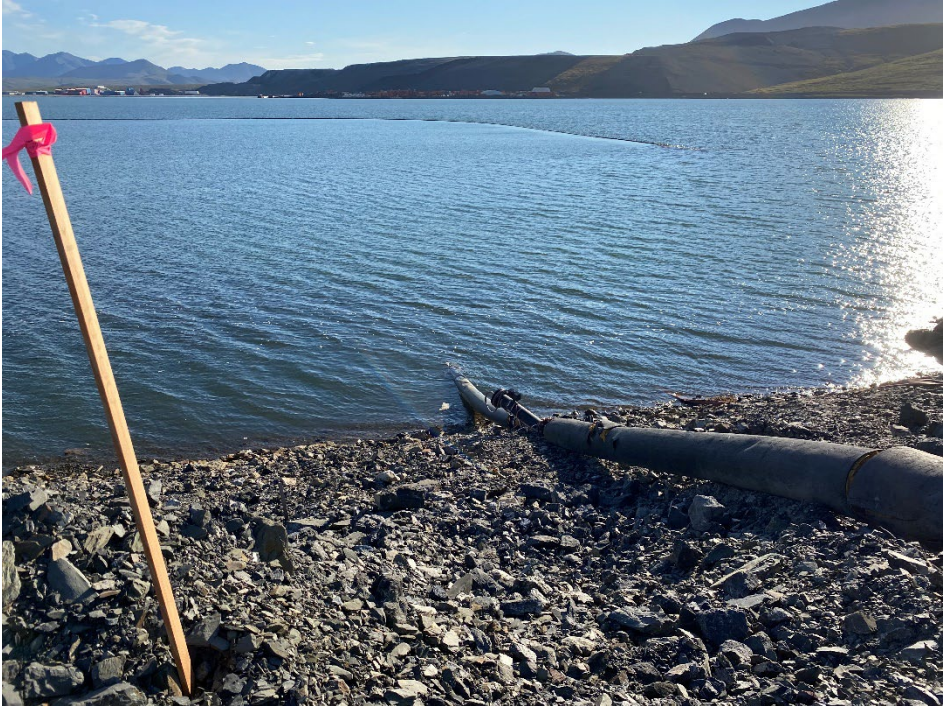
Photo 9: Upstream Slope near Station 10+00 and Subaqueous Tailings Discharge in Pond

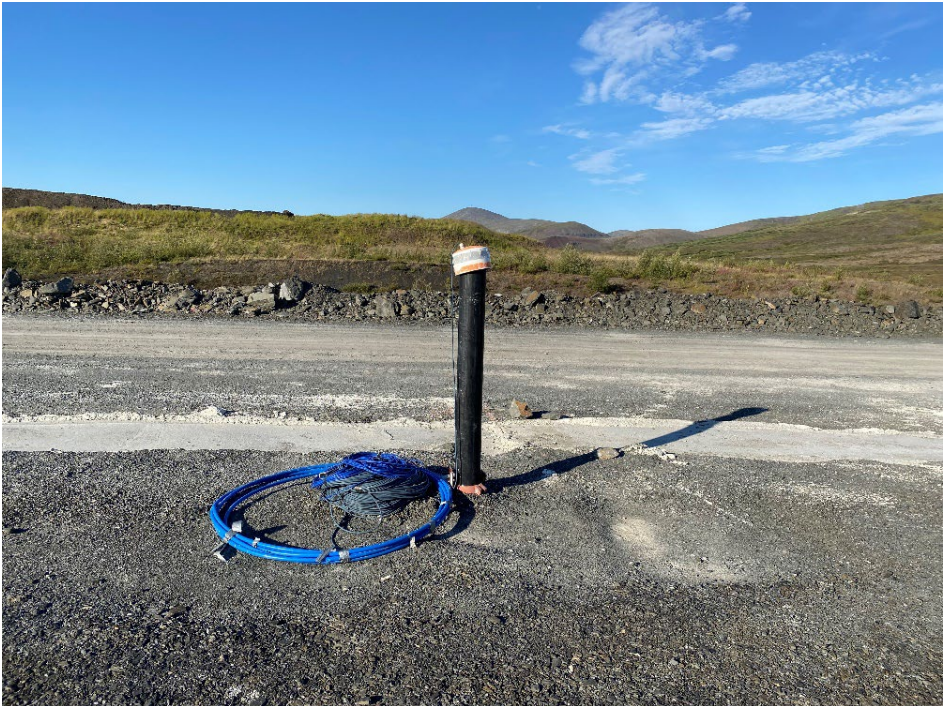
Photo 10: Dam Crest, Cut-off Wall, and SAA Inclinator near Station 14+00

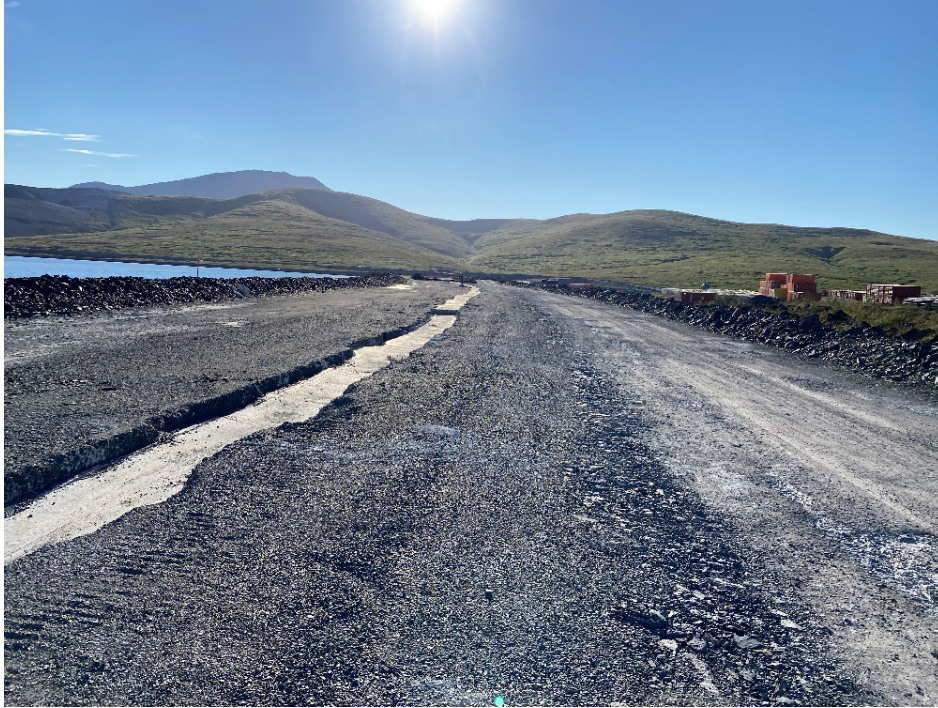
Photo 11: Dam Crest and Cut-off Wall near Station 21+50

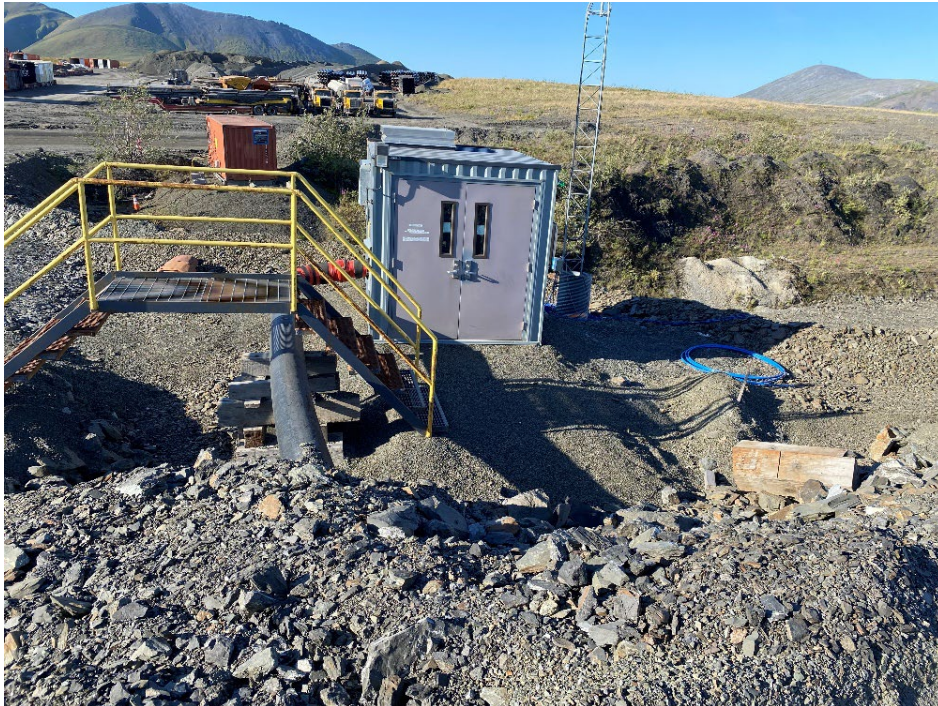
Photo 12: Sump Pumphouse and Discharge Pipe near Station 26+50

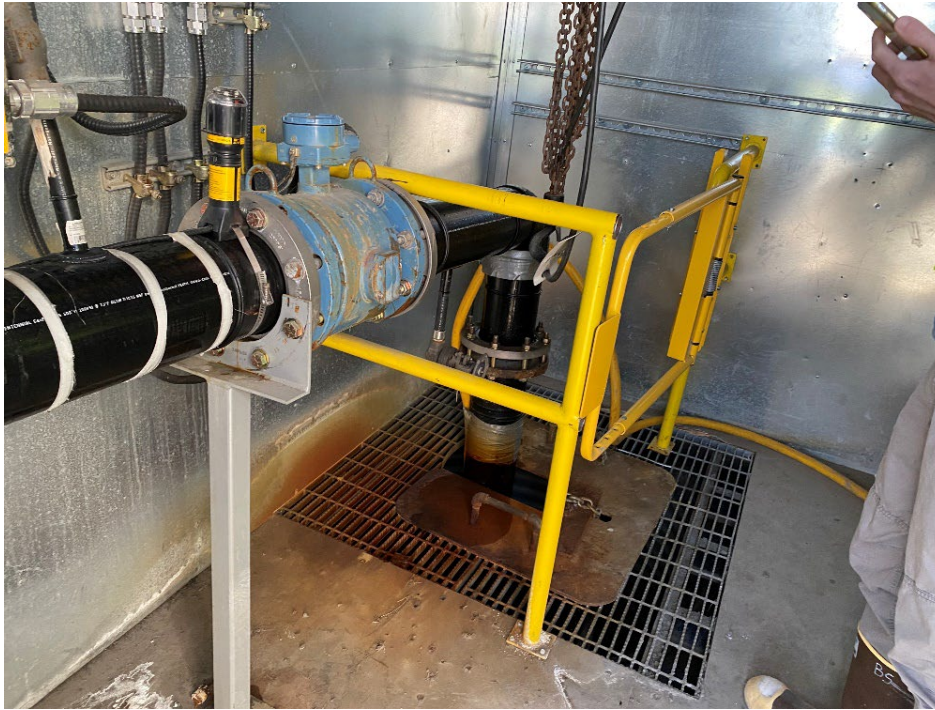
Photo 13: Sump Pump Pipe and Flow Meter Inside Pumphouse

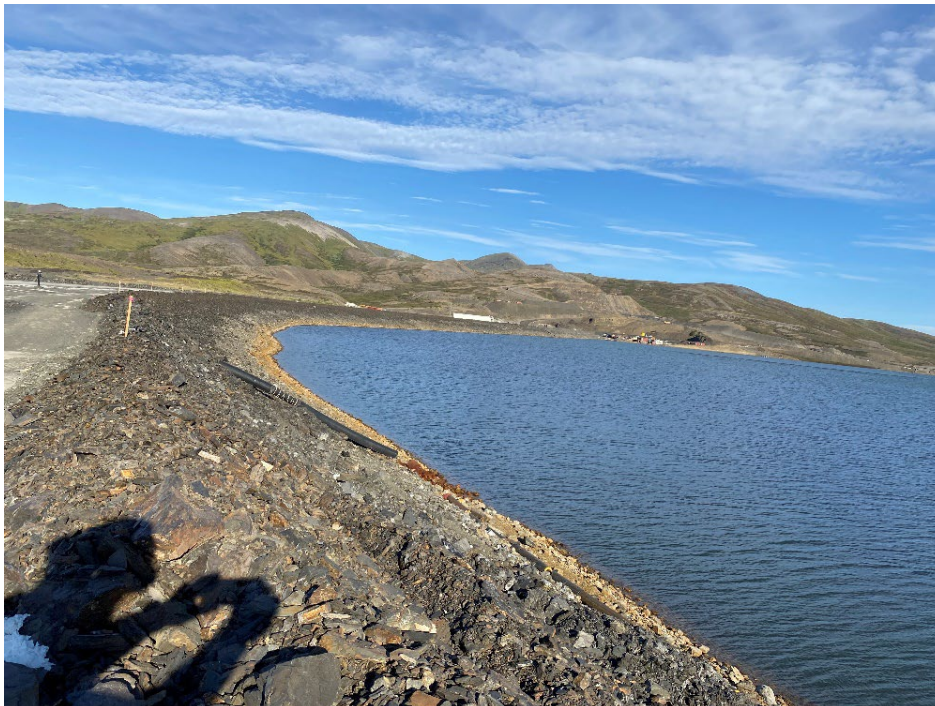
Photo 14: Sump Pump Discharge Pipe and Upstream Slope near Station 27+00

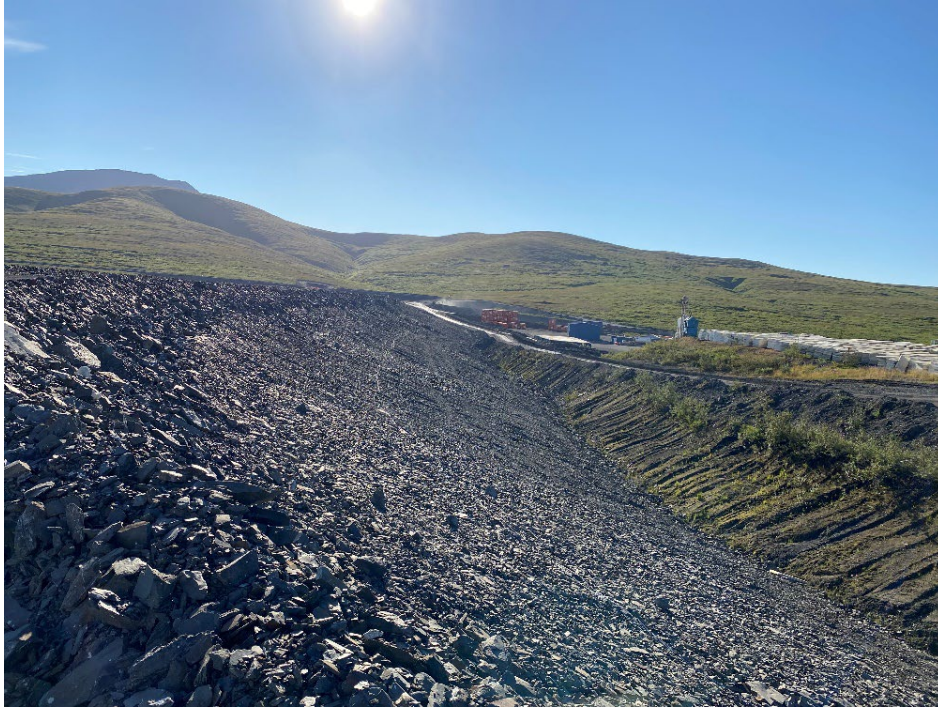
Photo 15: Downstream Slope near Station 27+00

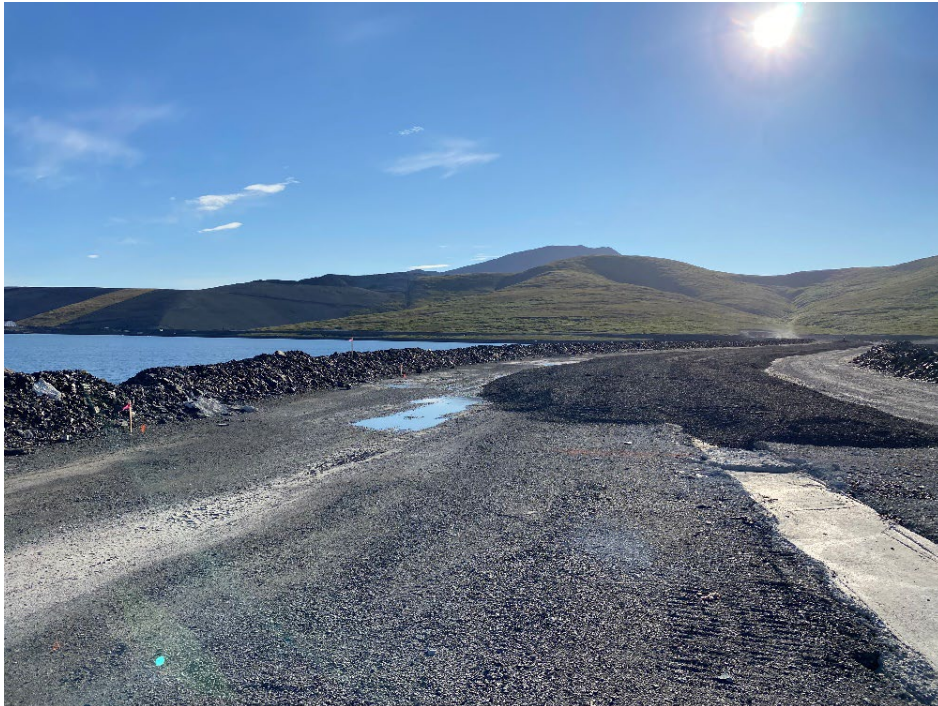
Photo 16: Dam Crest, Cut-off Wall, and Initial Lift of Insulation Layer Fill near Station 28+00

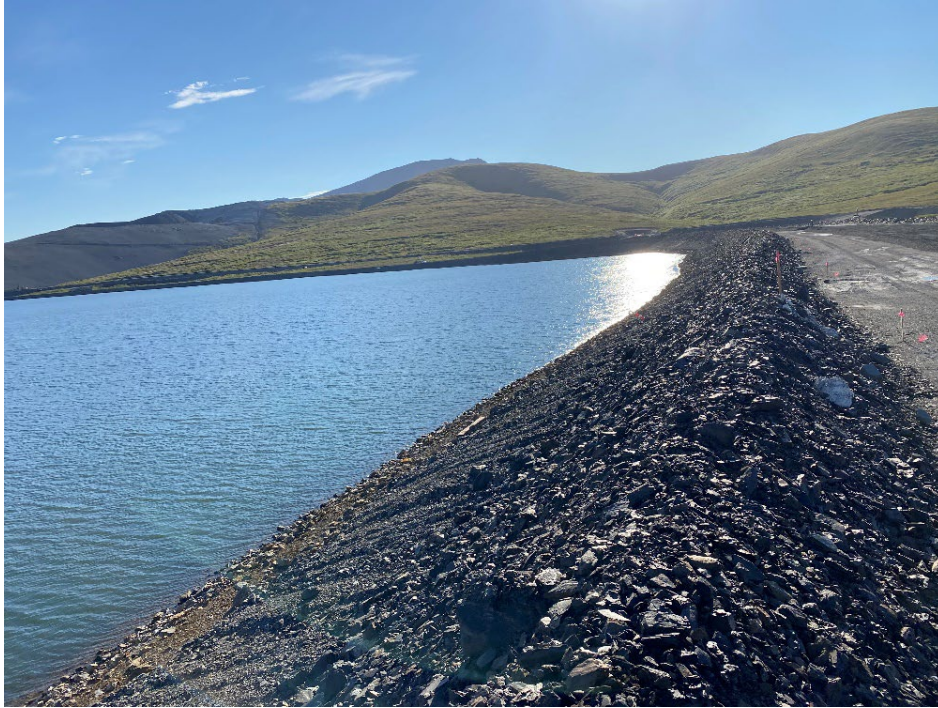
Photo 17: Upstream Slope near Station 30+50

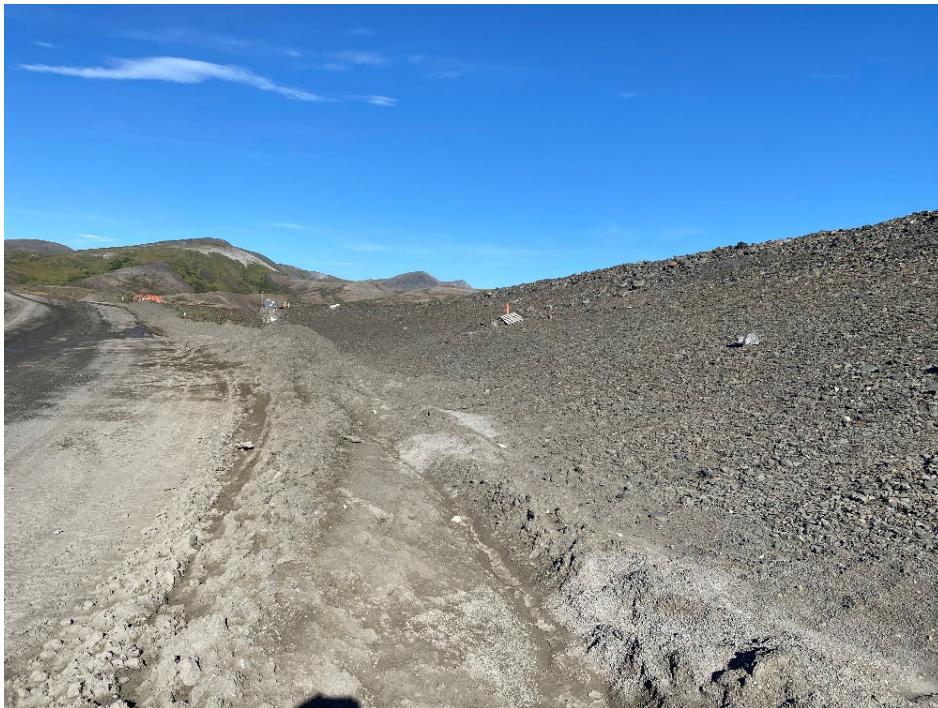
Photo 18: Downstream Slope and Piezometer near Station 39+00

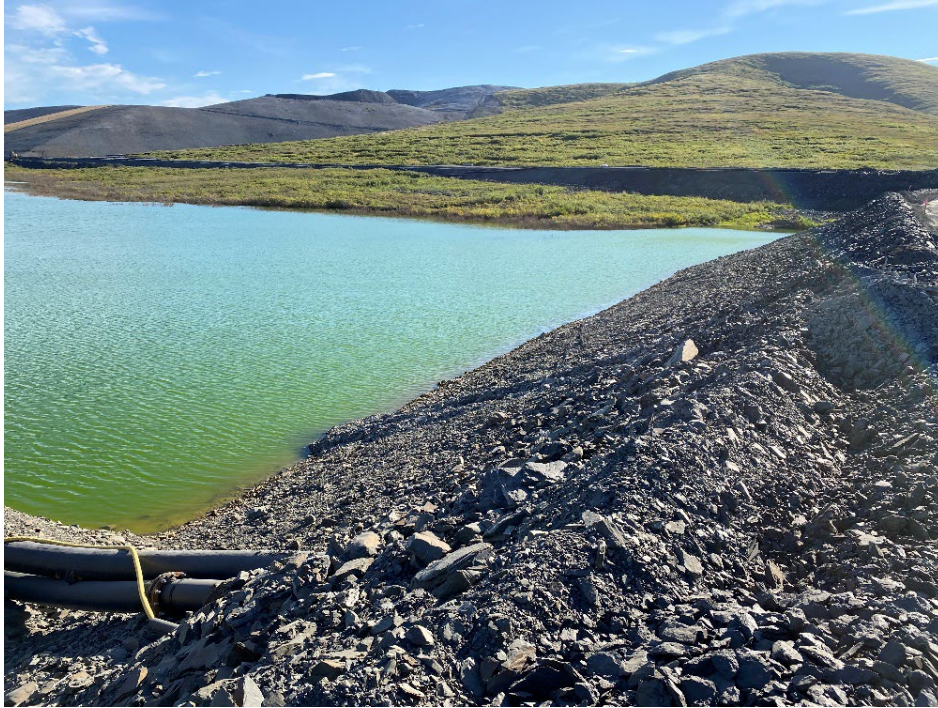
Photo 19: Upstream Slope near Station 43+00

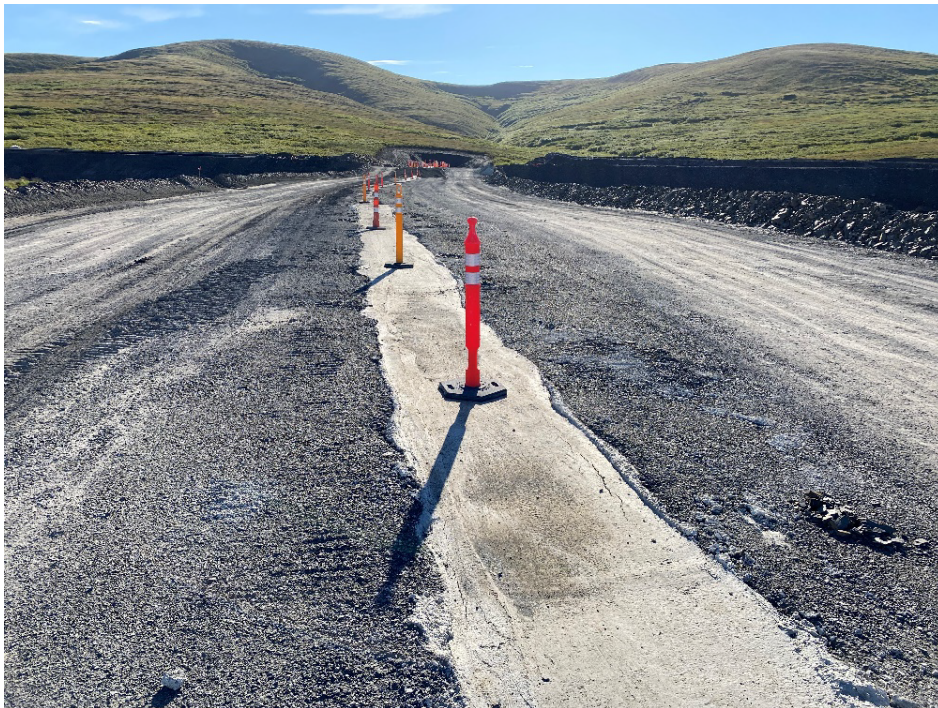
Photo 20: Dam Crest and Cut-off Wall near Station 44+00

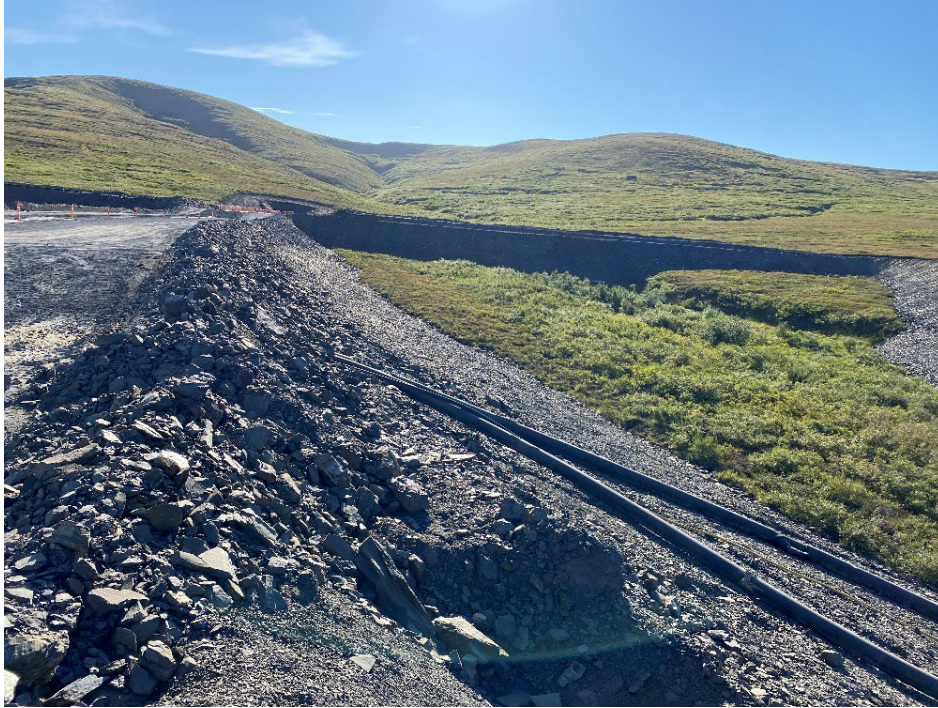
Photo 21: Downstream Slope and Transportation Corridor near Station 43+00
