2022 Annual Facility Performance Report

Red Dog Tailings Storage Facility

Red Dog Mine, Alaska

31404122.007-002-R-Rev0

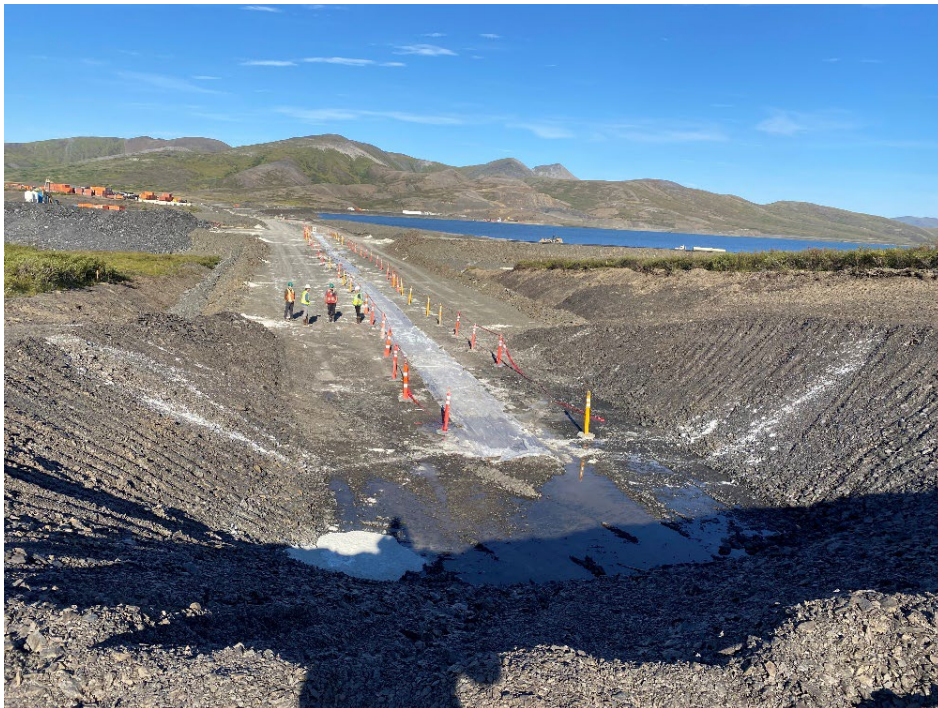
East abutment appears to be in satisfactory physical condition with no indications of displacement, settlement, erosion, or stability issues. Excavation to bedrock and cut-off wall constructed to Stage V-B elevation observed. Standing water from seeps observed at base of Stage V-B cut slope (see Photo 22). If water is not allowed to drain away it could saturate plastic concrete immediately below insulation layer and lead to potential freeze-thaw degradation of plastic concrete with time. This potential can be mitigated during ongoing or future construction scheduled to be completed in 2024.

Photo 22: East Abutment and Standing Water from Seep

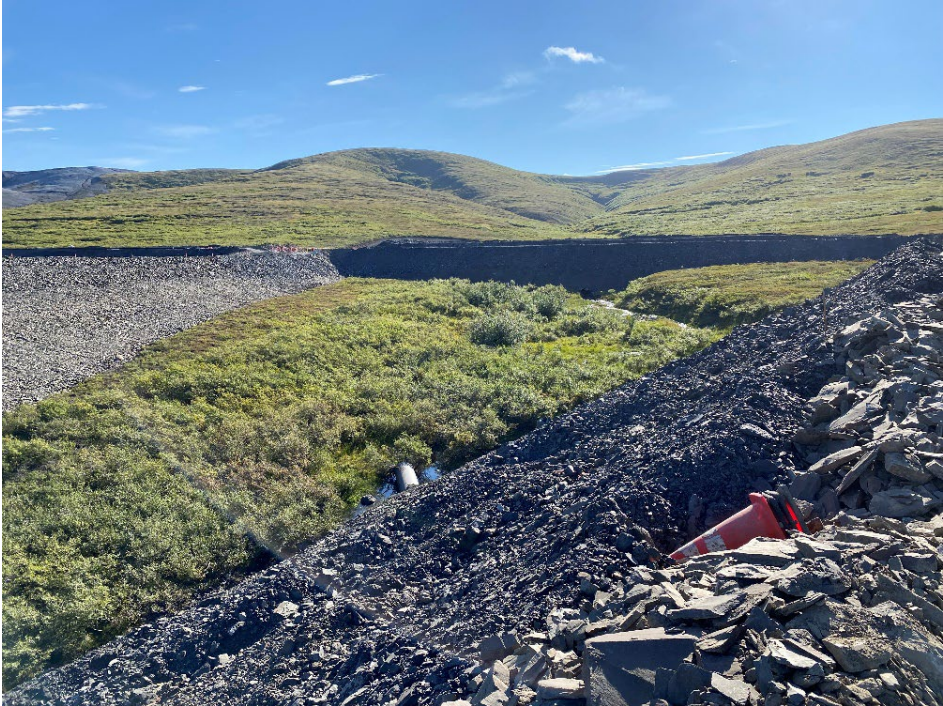
Photo 23: New Transportation Corridor and Upper Bons Creek Culverts Downstream of Back Dam

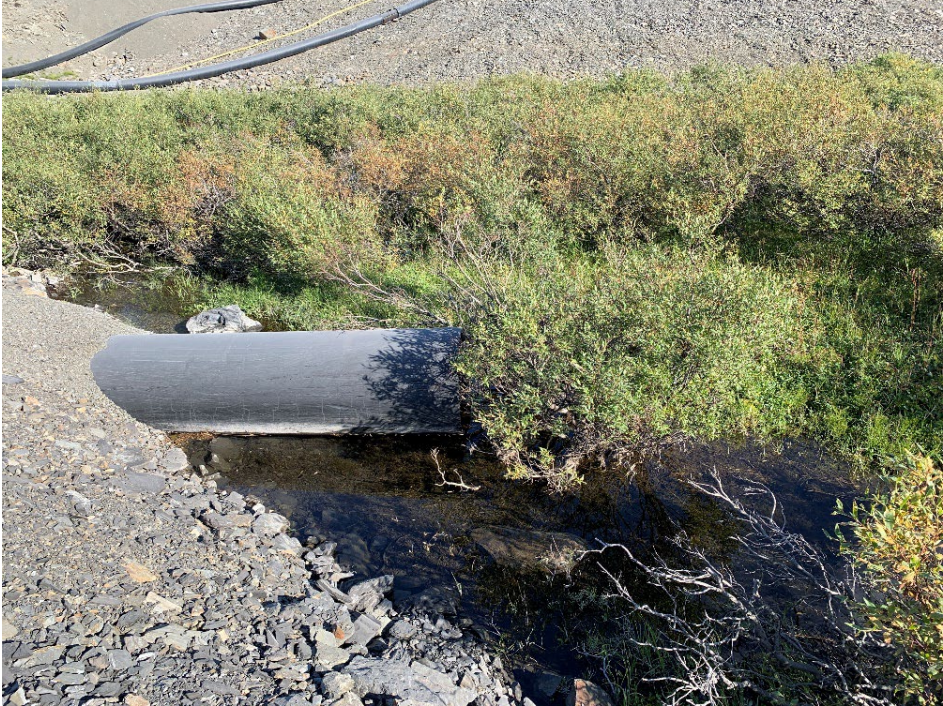
Downstream slope appears to be in satisfactory physical condition with no vegetation or indications of instability (see Photos 5, 7, 15, 18, and 21). Note that water shown in Photo 24 is from Upper Bons Creek and not seepage from the downstream dam embankment.

Photo 24: Close Up of Upper Bons Creek Culvert Inlet Downstream of Back Dam
