Bullmoose Mine

2017 Dam Safety Inspection

Bullmoose Tailings Dam

Bullmoose Mine
Bullmoose Tailings Dam
2017 Dam Safety Inspection – Rev. 1

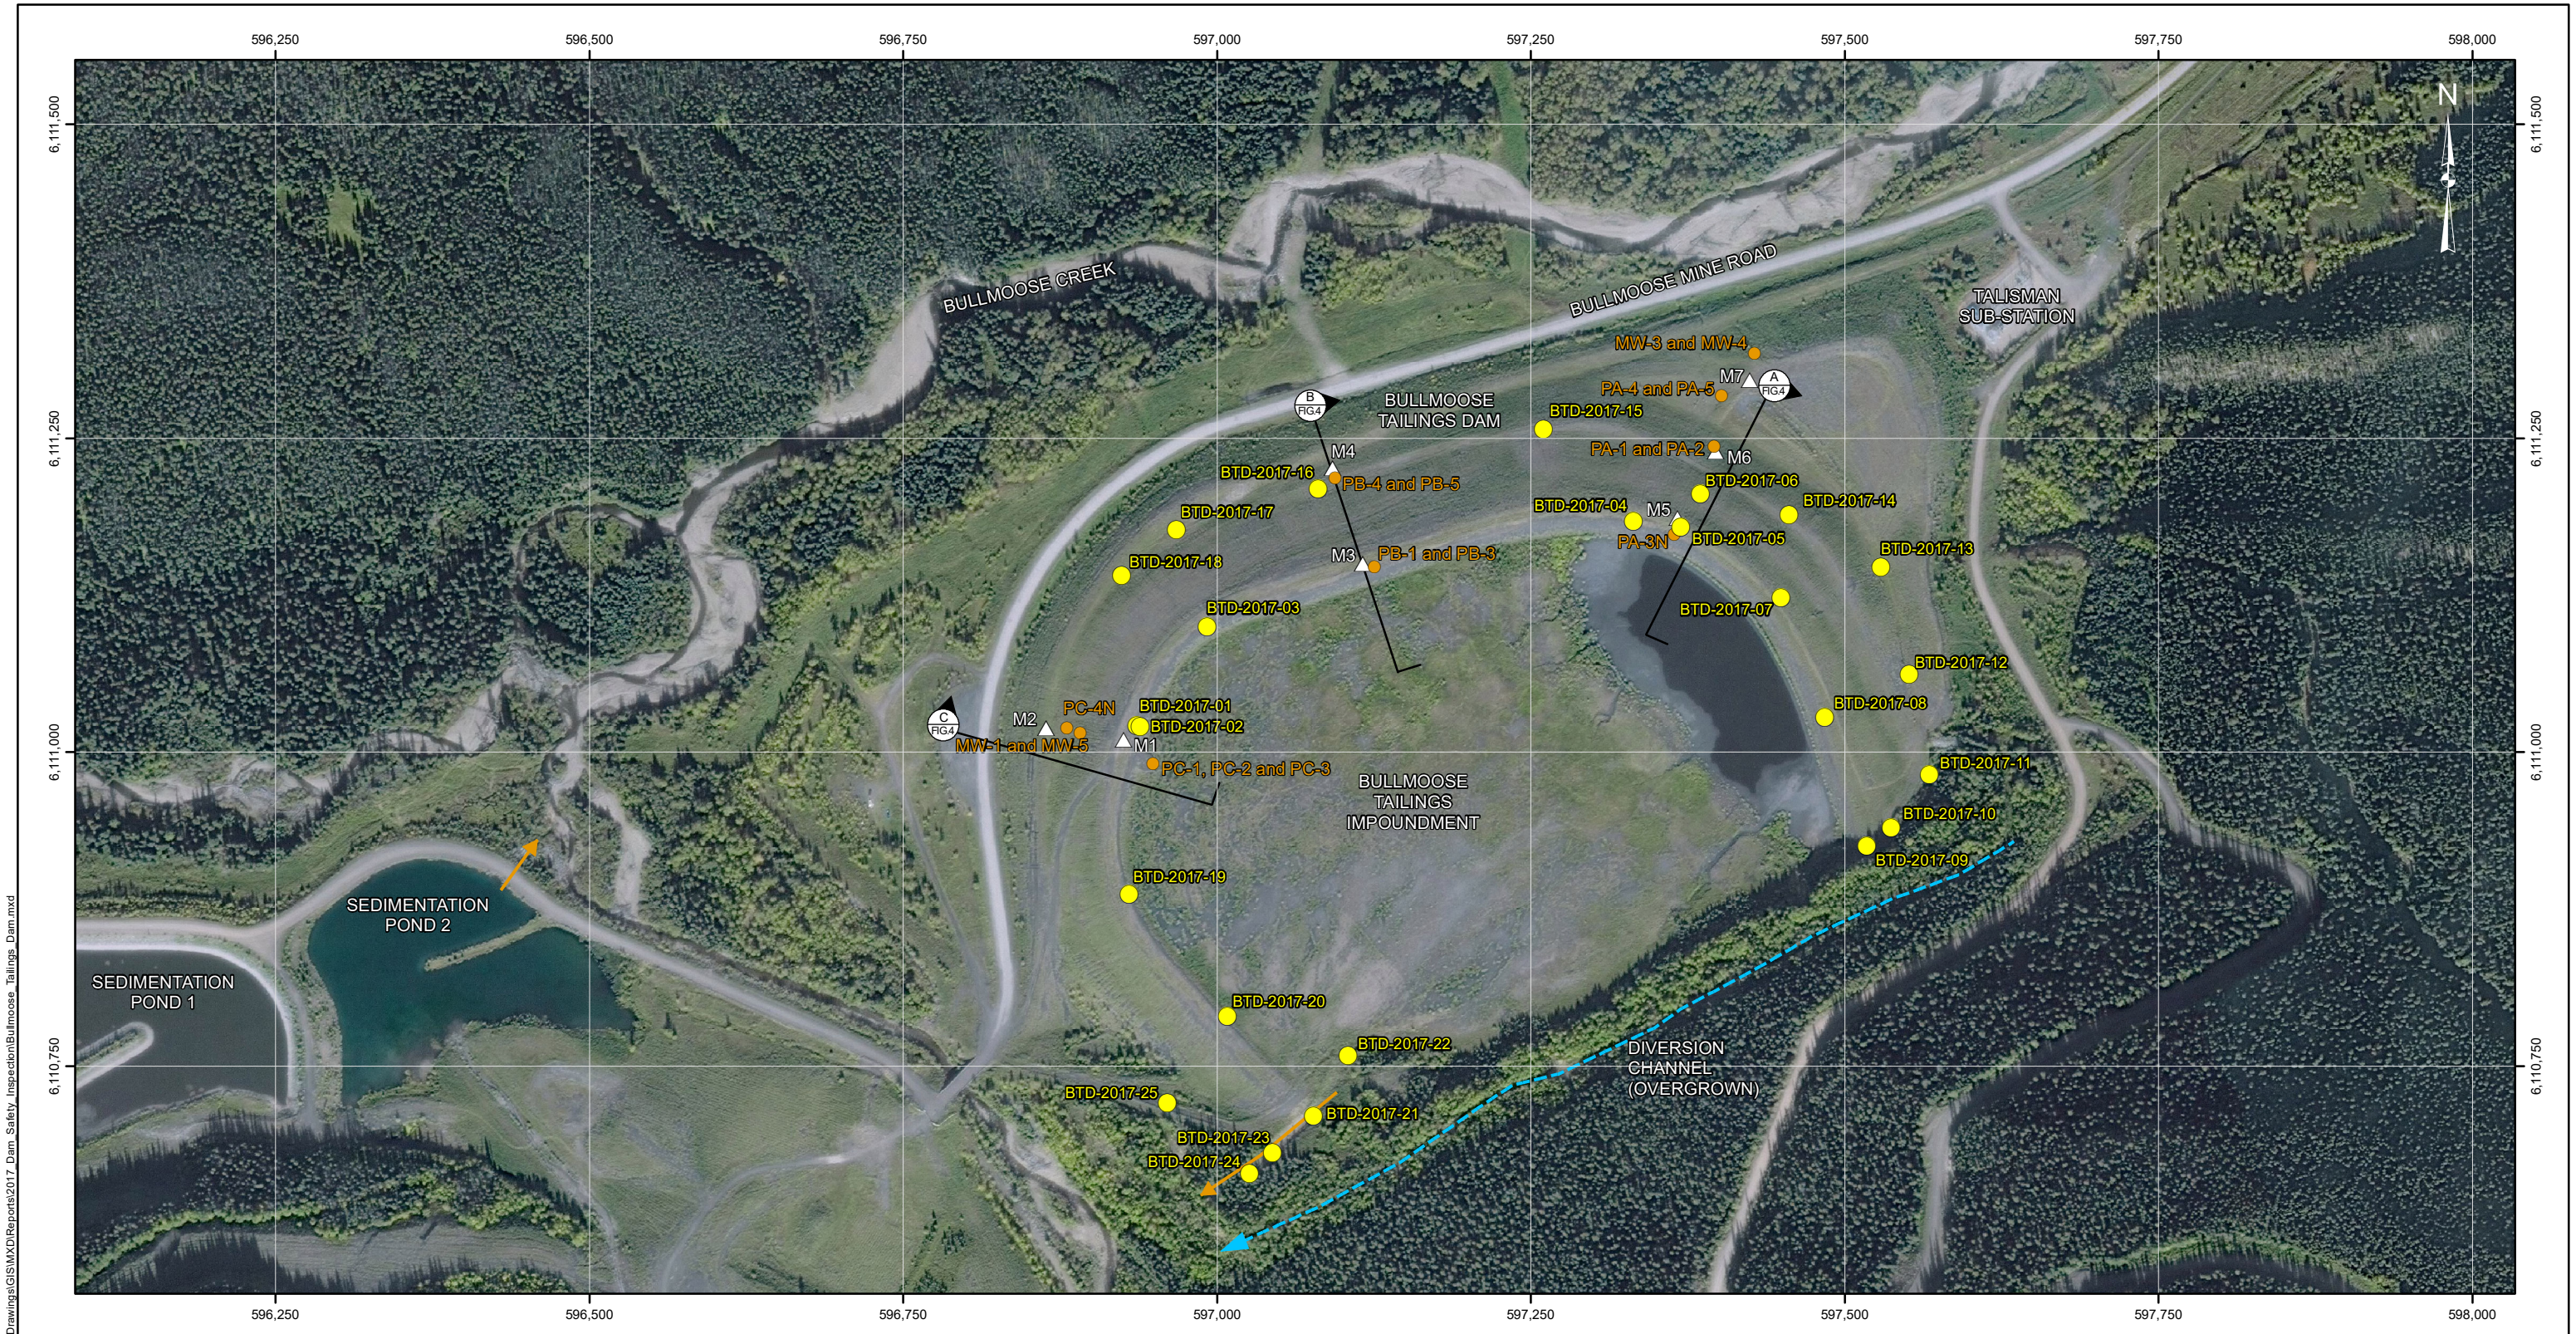
11 standpipes and 2 pneumatic piezometers were measured during the 2017 DSI site visit (see Figure 2). Four monitoring wells were also monitored; however, because no proper labels were provided to these wells, water levels obtained from these wells are not relied upon. These monitoring wells are not critical for on-going monitoring of the BTM.

- 6 piezometers (PB-1, PB-3, PB-5, PC-2, PC-3 and MW-1/5) were “dry” (no water table measured within piezometer casing). Piezometers PB-4 located adjacent to PB-5 indicates water level slightly below PB-5 tip elevation (Figure 4).

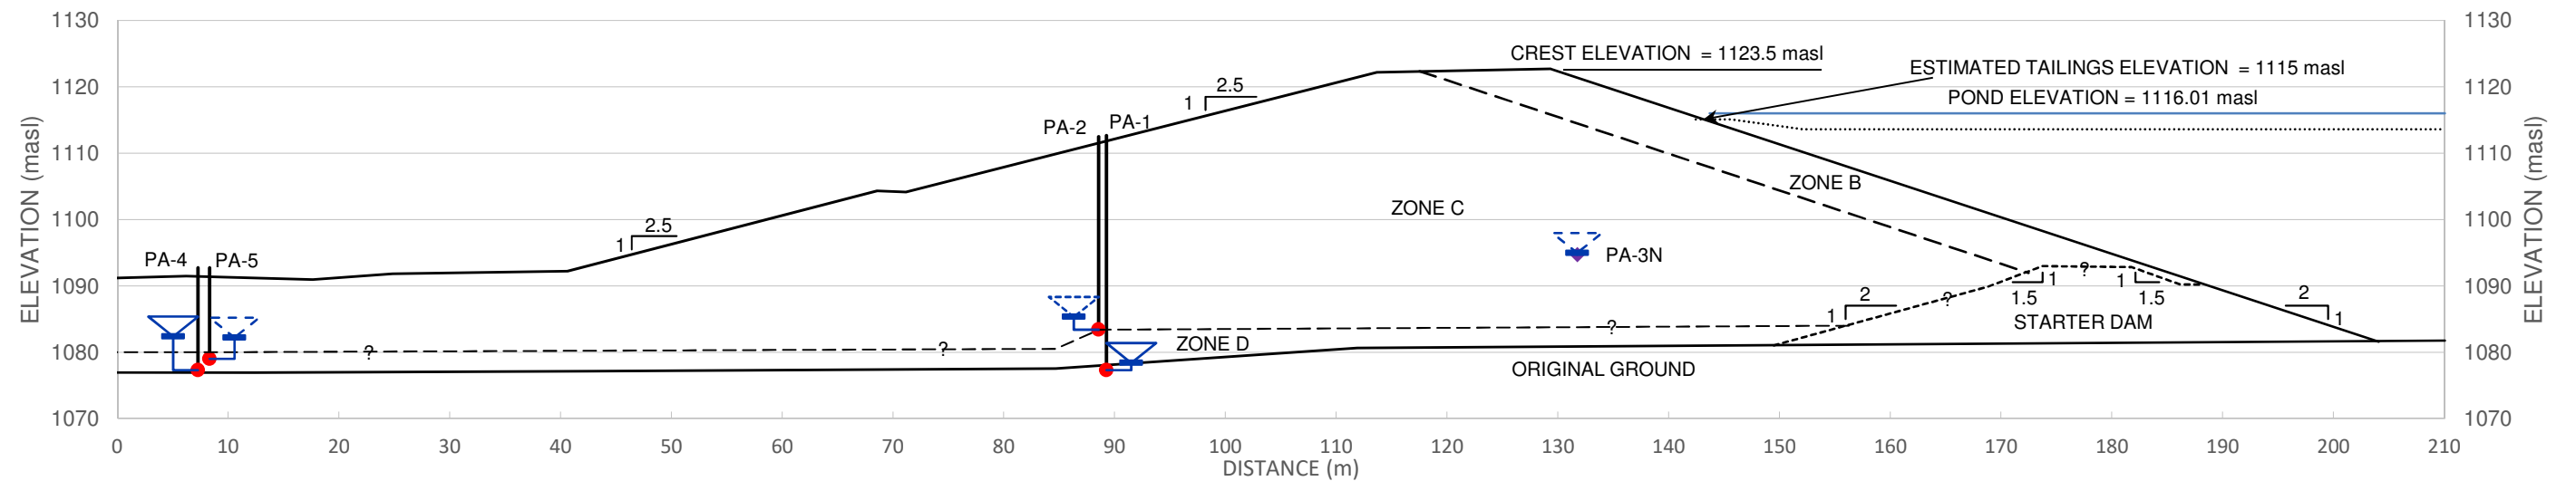
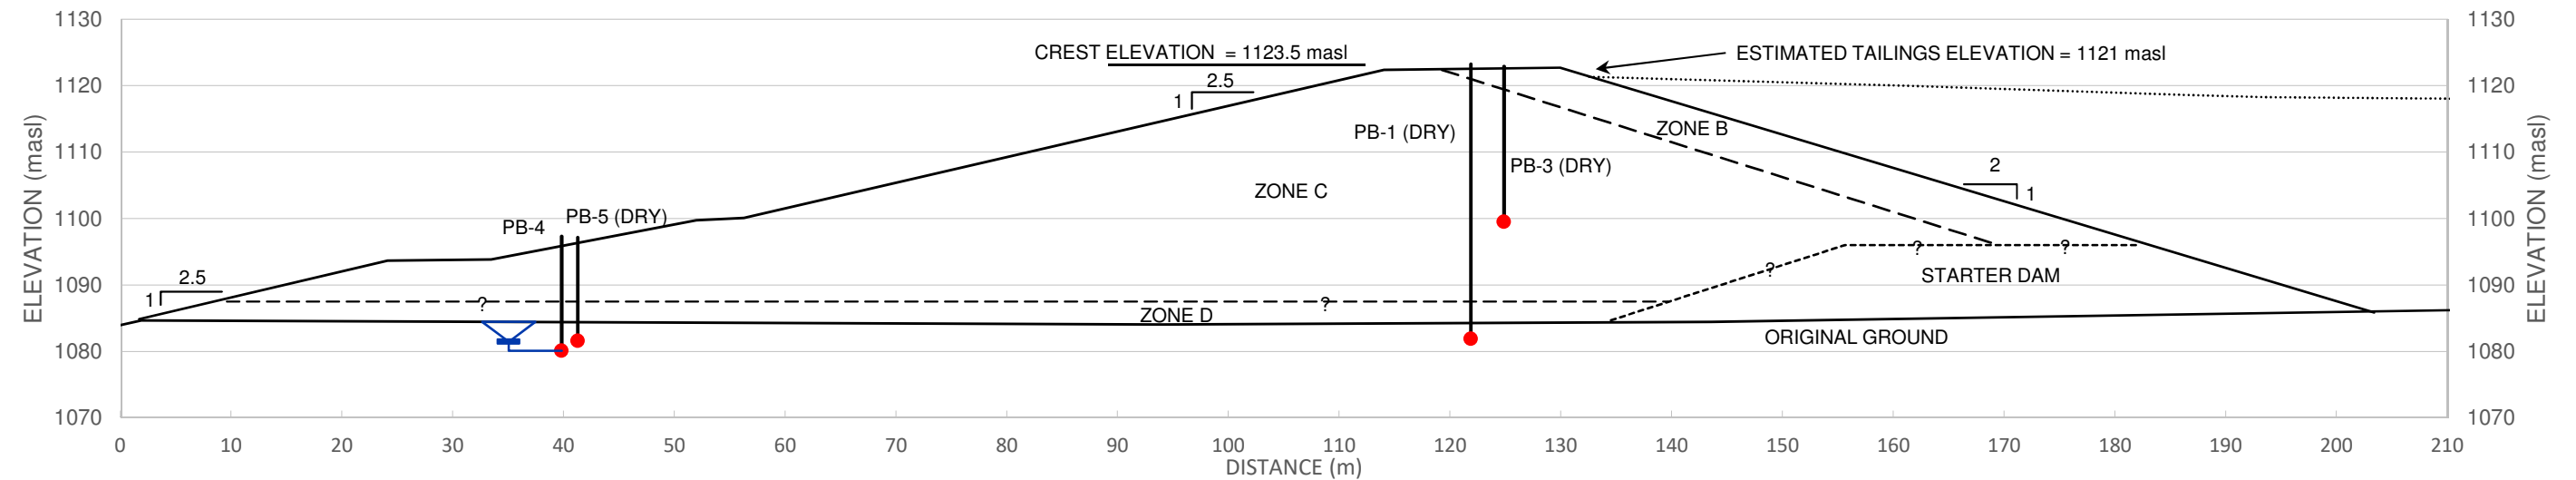
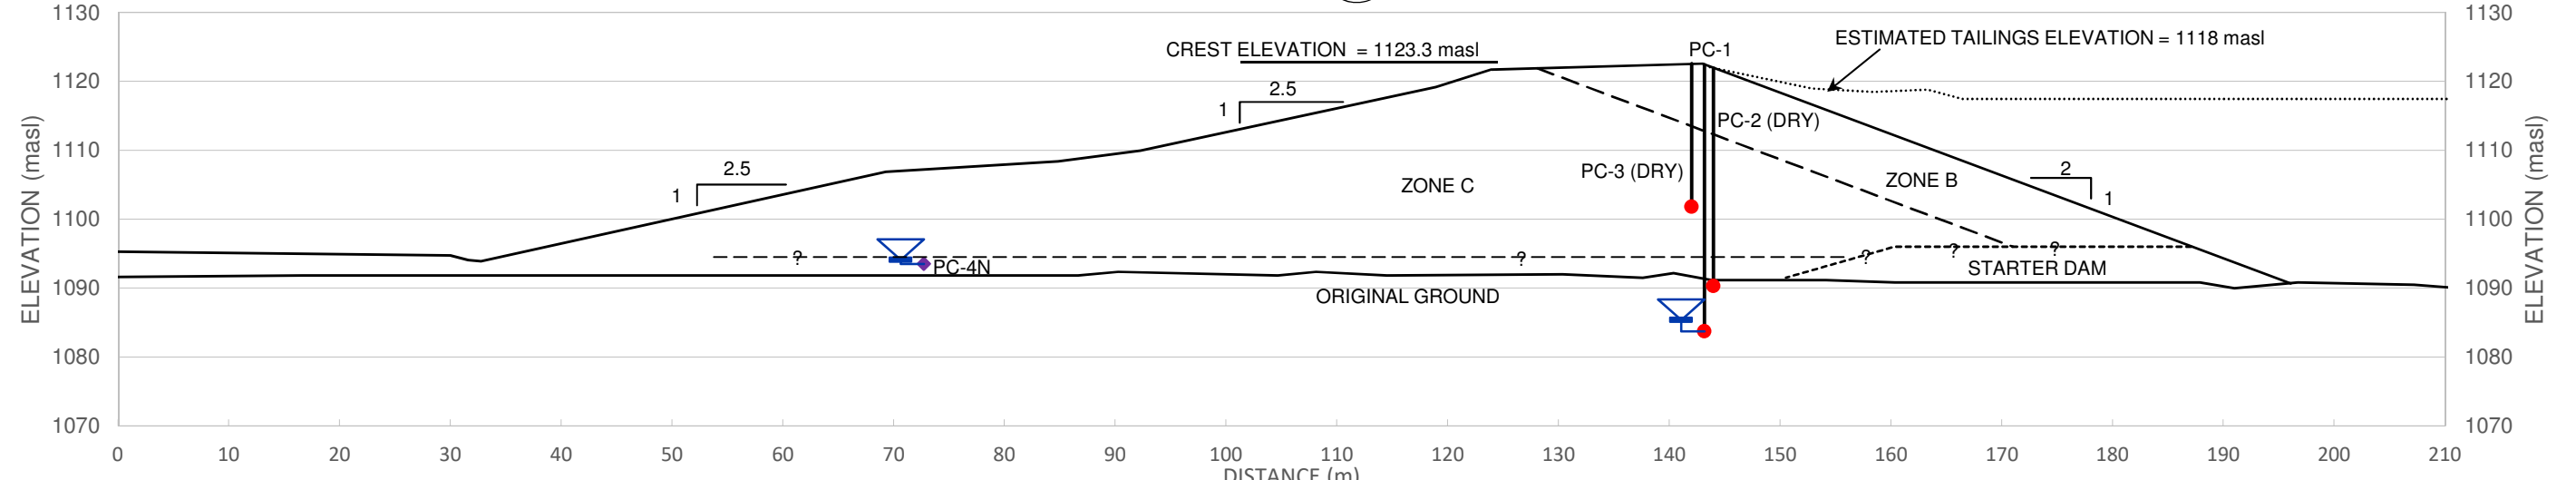
PROJECT	BULLMOOSE MINE 2017 DAM SAFETY INSPECTION	
TITLE	BULLMOOSE TAILINGS DAM INSTRUMENTATION SCHEMATIC SECTIONS A, B AND C	
PROJECT No.	M09893A07	FIG. No. 4

Low pore pressures in the downstream shell of the dam indicate that dam drainage and foundation seepage capacity exceeds flow requirements (see Figure 4). Pore pressures have been stable and the dam shell is drained with low gradient of approximately 0.04 to 0.05 (KCB 2018b). Operation and construction induced pore pressure responses are no longer observed. Therefore, piezometers monitoring frequency of once per year is sufficient for ongoing monitoring of the structure under “Closure-Passive Care” conditions.

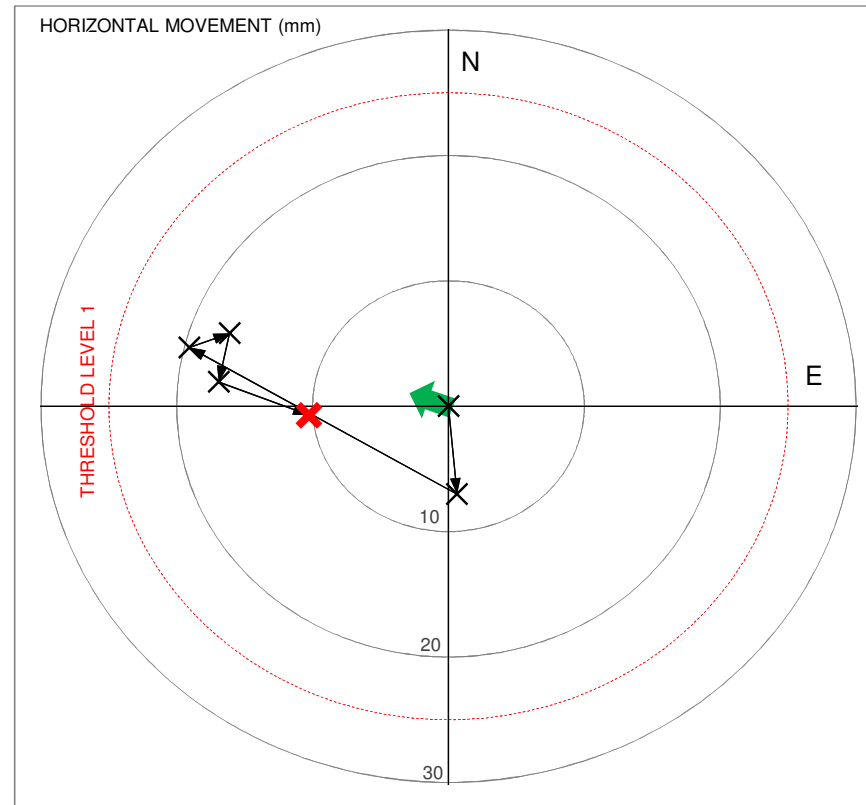
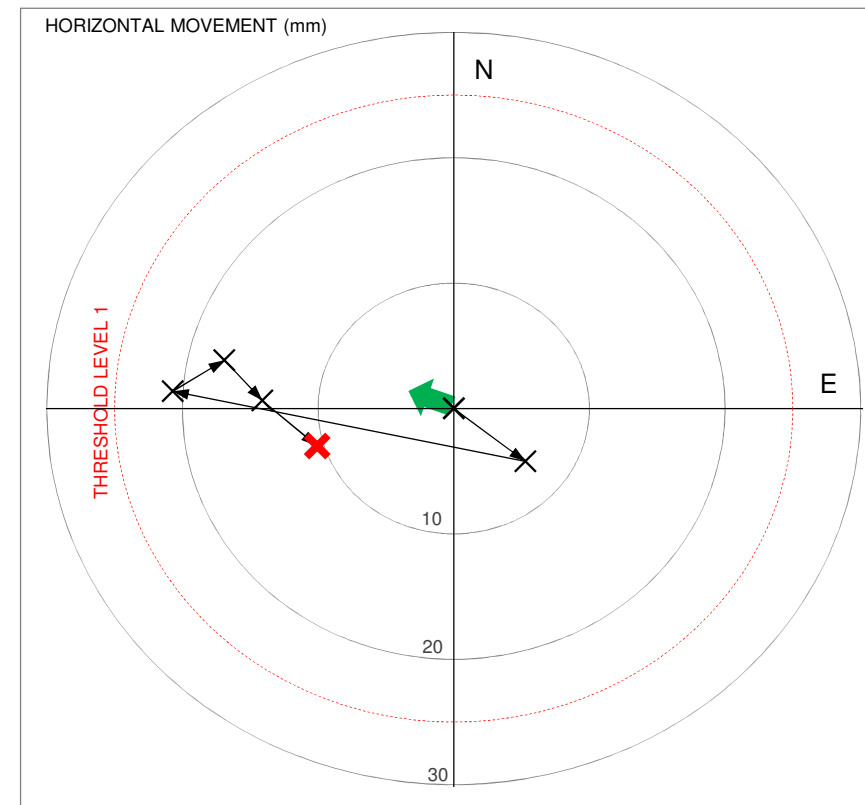
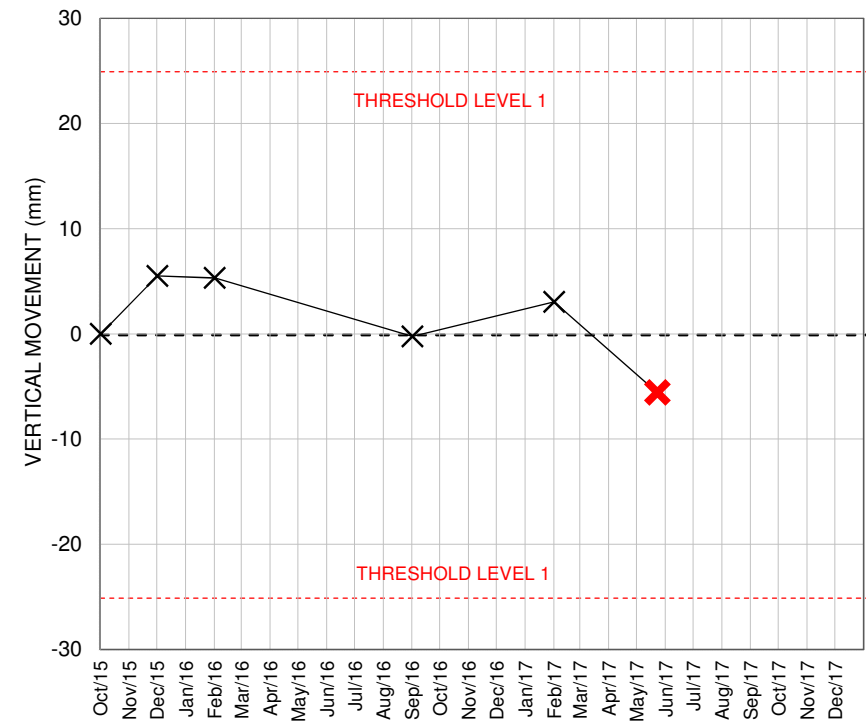
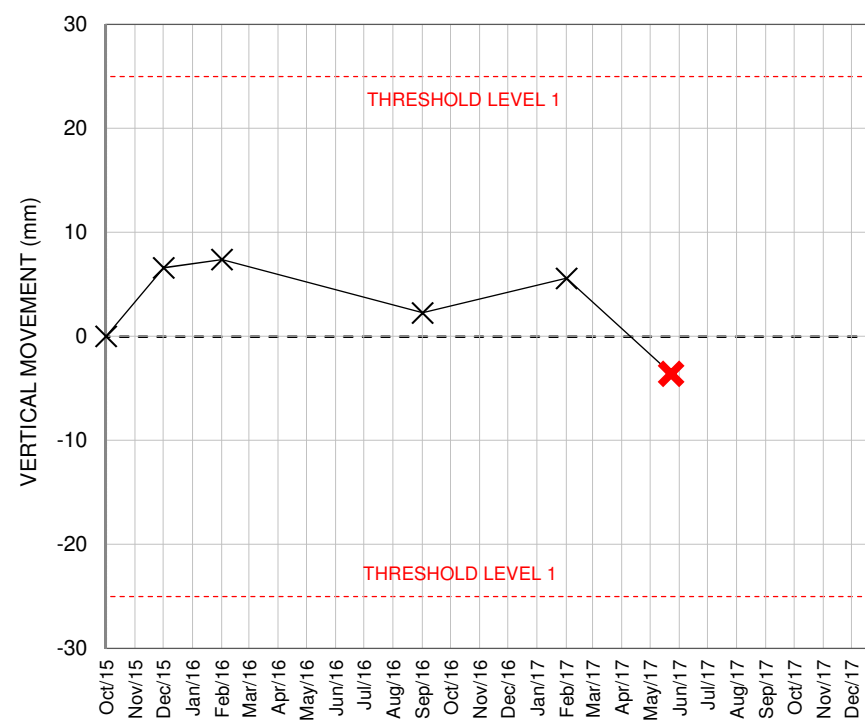
PROJECT	BULLMOOSE MINE 2017 DAM SAFETY INSPECTION
TITLE	BULLMOOSE TAILINGS DAM SURVEY MONUMENTS (M1 AND M2) AND THRESHOLD LEVELS
PROJECT No.	M09893A07
FIG. No.	6

7 survey monuments were installed on the BTD in July 2015. Teck has completed 6 survey readings (2 readings per year) which are summarized in Figure 5. Survey measurements are also shown in Figures 6 through 8. After the completion of May 2017 reading, QPOs for the survey monuments and their reading frequency have been established and were recommended in a separate letter (KCB 2017b). QPOs summary and recommendations are as follow:

Threshold Level 1 values are illustrated in Figures 6 to 8.

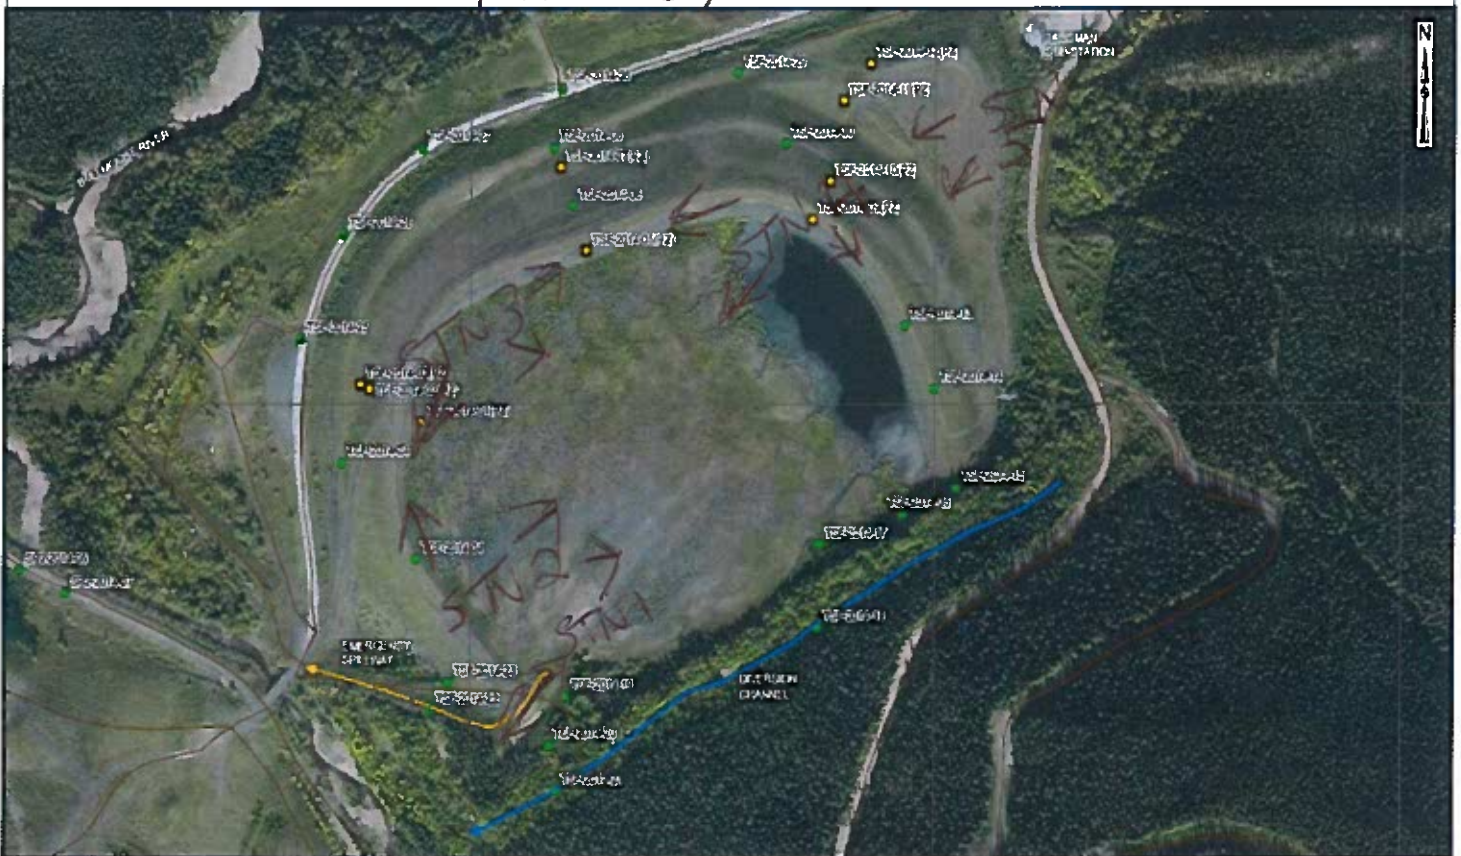
Pictures

INDICATOR	YES/NO	COMMENTS
Piping	<input type="checkbox"/> Yes <input checked="" type="checkbox"/> No	
Sinkholes	<input type="checkbox"/> Yes <input checked="" type="checkbox"/> No	
Seepage Turbidity/Clear	<input type="checkbox"/> Yes <input checked="" type="checkbox"/> No	
External Erosion	<input type="checkbox"/> Yes <input checked="" type="checkbox"/> No	
Cracks	<input type="checkbox"/> Yes <input checked="" type="checkbox"/> No	
Settlement	<input type="checkbox"/> Yes <input checked="" type="checkbox"/> No	
Slope Slough/Failure	<input type="checkbox"/> Yes <input checked="" type="checkbox"/> No	
Animal Borrow/Digging	<input type="checkbox"/> Yes <input checked="" type="checkbox"/> No	
Unusual Ponded Area	<input type="checkbox"/> Yes <input checked="" type="checkbox"/> No	
SP2 - Plugged Culverts	<input checked="" type="checkbox"/> Yes <input type="checkbox"/> No	partial - see pictures
Others:

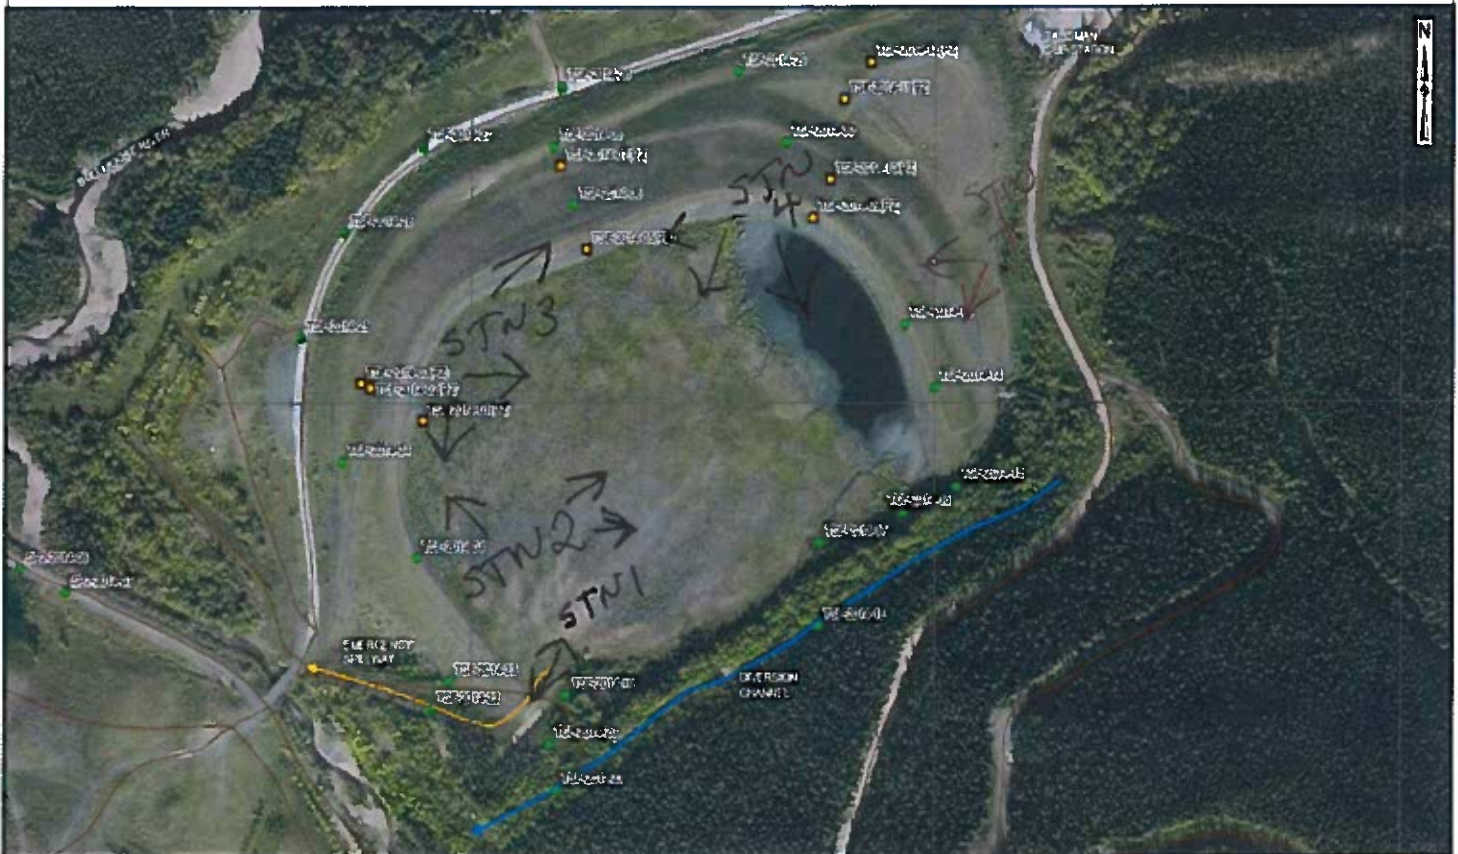
Site Plan:

S no w covered
