March 2018

TECK RESOURCES LTD.

Louvicourt Mine Tailings and Polishing Ponds 2017 Dam Safety Inspection

Report Number: 001-1775965-Rev0

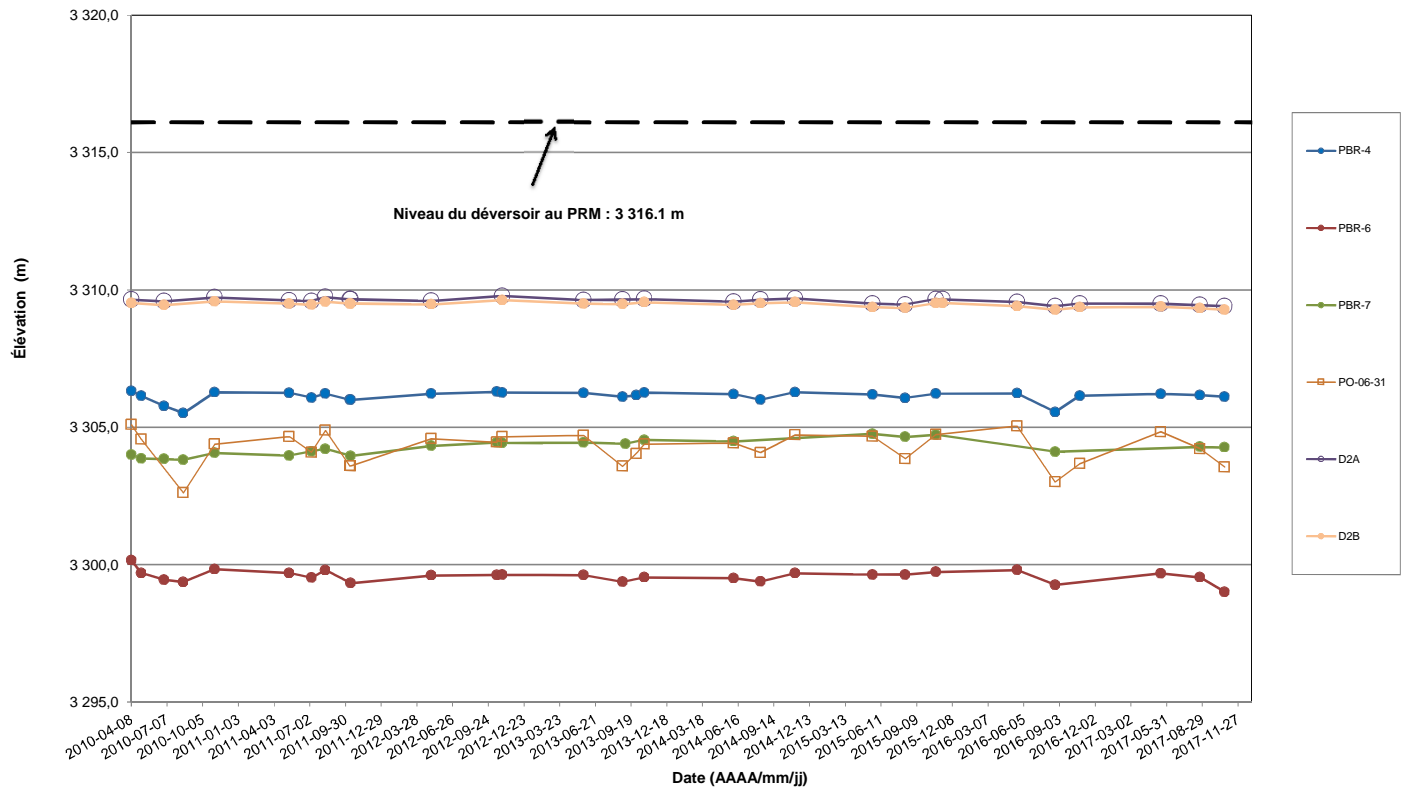
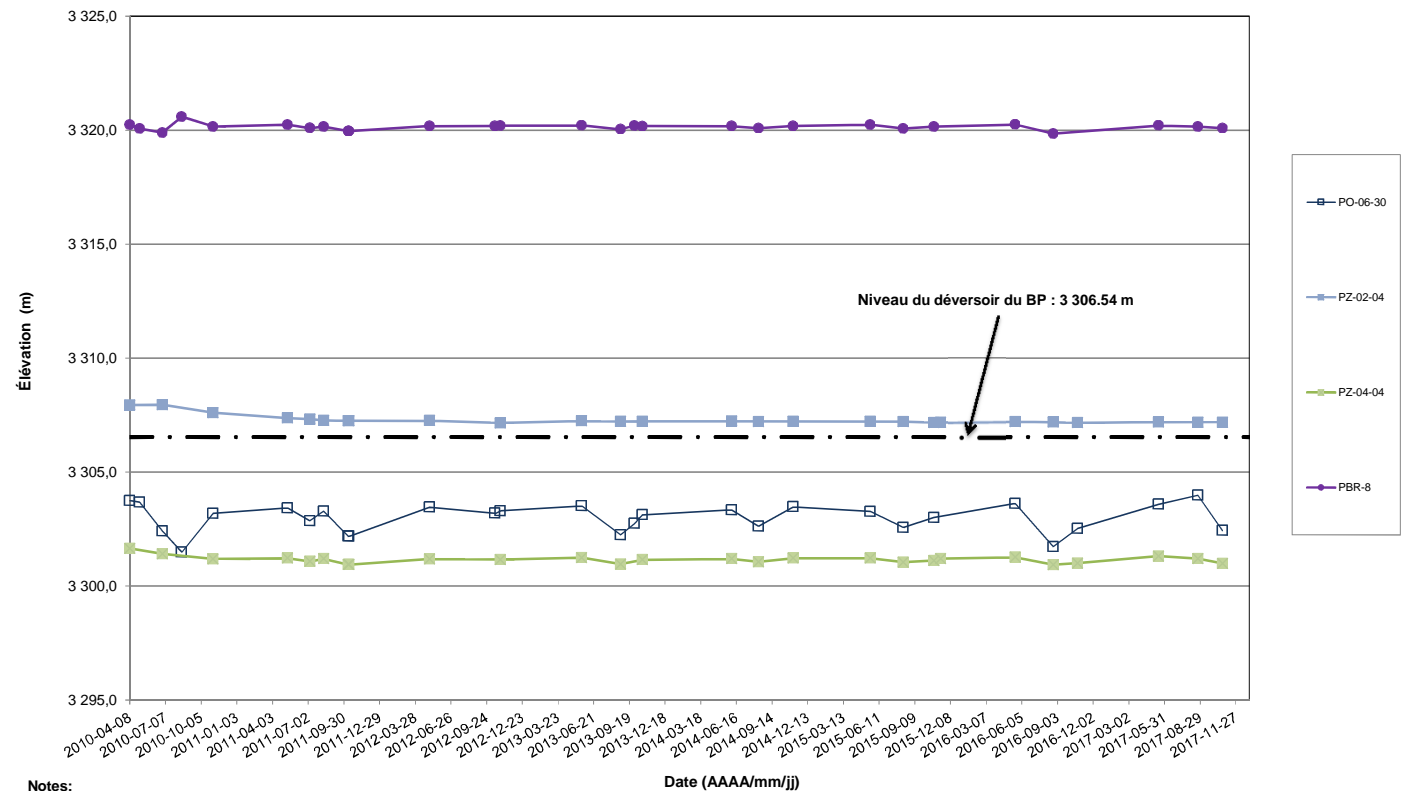
Teck	DSI 2017	Water level measurements - piezometers (provided by Teck)					
	Louvicourt TSF	CONFIDENTIEL					
	Teck Resources Ltd.	DESIGNED BY:	BZ	DATE	14/11/2017	GOLDER PROJECT NO	1775965
		VERIFIED BY:	EG	DATE	14/11/2017		
		REVISED PAR:		DATE		FIGURE:	Figure 3

Figure 3 presents available groundwater levels for the dams. A total of four piezometers (PZ-02-04, PZ-04-04, D2A, D2B) are installed on the berms of three different dams. Six other observation wells (PBR 4, PBR 6, PBR 7, PRB 8, P06-30, P06-31) are located on natural ground, some distance away from the toe of the dams. The position of these wells is shown in Figure 1. Data for 2017 was compiled by Teck. It can be seen that recent values are quite stable for all wells and consistent with previous trends.
