Teck Metals Ltd.

Pinchi Lake Mine Tailings Storage Facility

2017 Dam Safety Inspection

March 2018

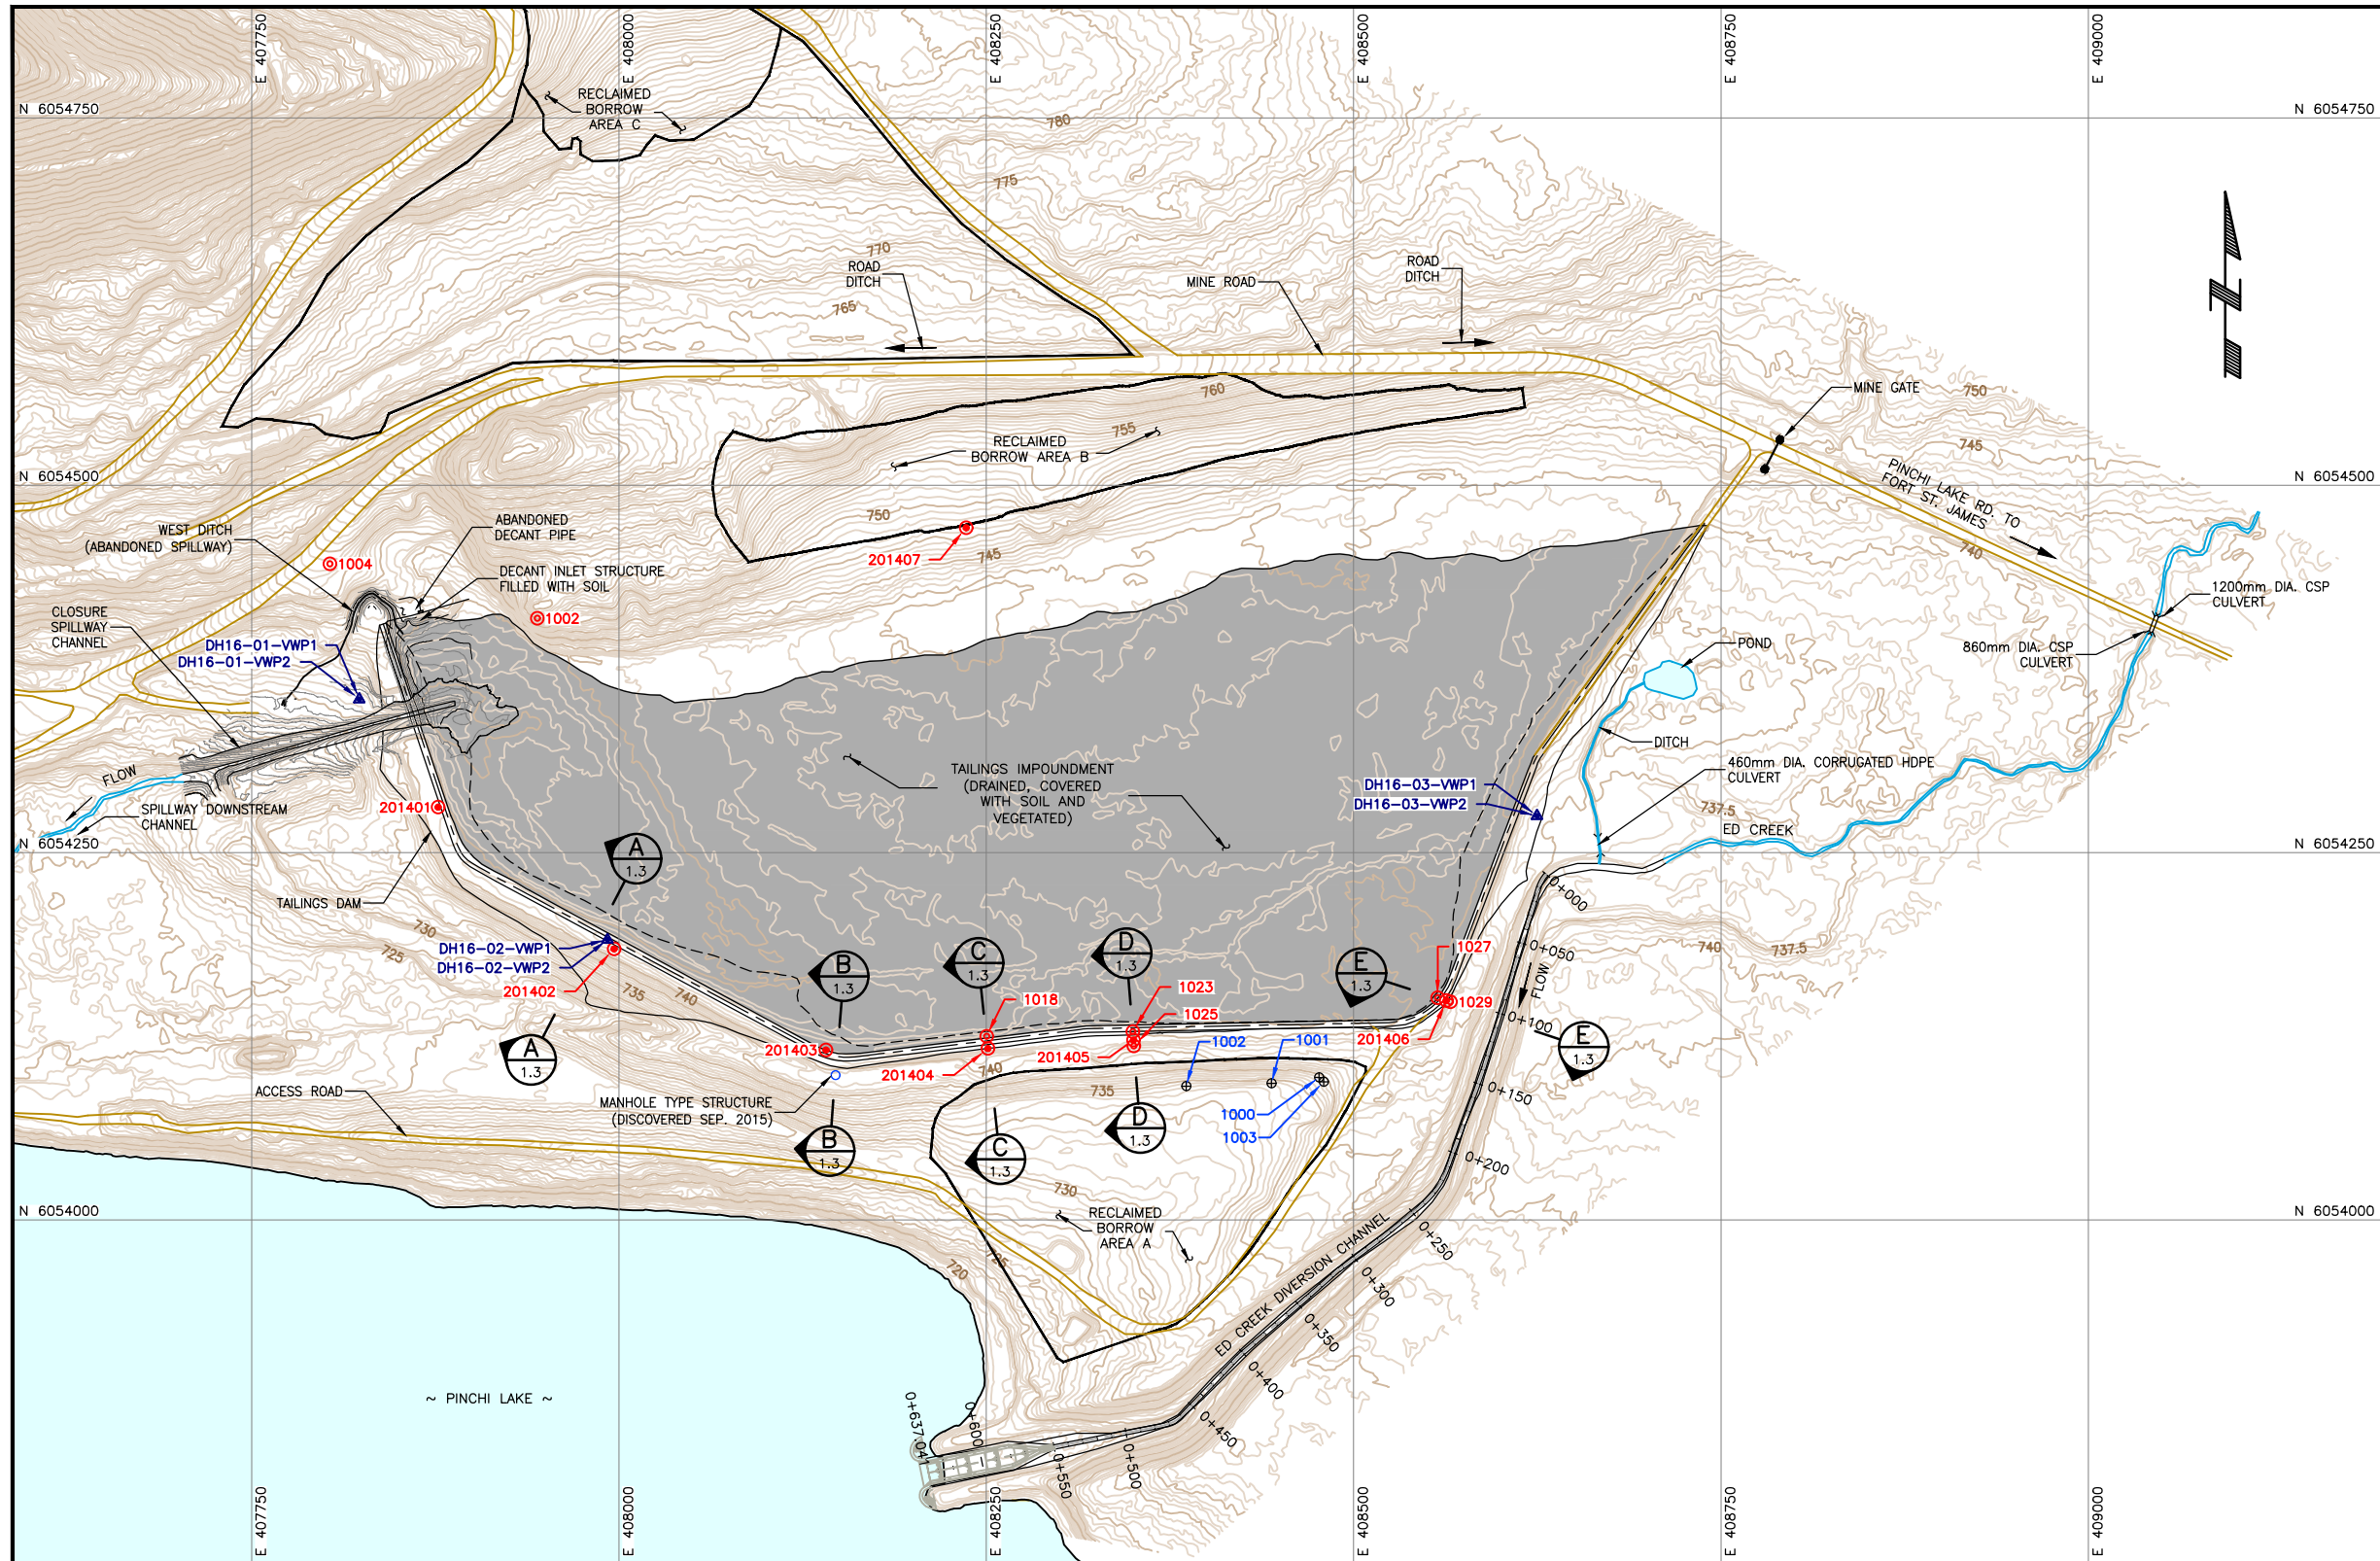
PROJECT PINCHI LAKE MINE TSF 2017 DAM SAFETY INSPECTION	
TITLE TAILINGS STORAGE FACILITY PLAN	
PROJECT No. M0728 A32	FIG. No. 1.2

- Four small seepage areas were identified in July 2011 on the slope of Borrow Area A (Location 7 in Figure 4.1). The surveyed locations of these seeps are shown in Figure 1.2, and in the figures presented in Appendix V. Ed Creek originally flowed through the Tailings Impoundment area north of the four seeps, and it is suspected that Ed Creek is the source of the seepage water. During the August 2017 inspection, the ground in the toe area was barely damp, except in the northeast corner of the borrow area where the ground was wet but no seepage was observed (Photo II-33).

There are six vibrating wire piezometers at three locations around the dam (four piezometers at the toe, two at the crest) as shown in Figure 1.2, and these are read twice per year. These are currently the only functional instruments in the dam. Quantifiable performance objectives (QPOs) for the piezometers are defined as threshold piezometric elevations, and these are given in Appendix VII.

Survey monitoring stations were installed on the Tailings Dam crest in 1998; however, some stations were destroyed over the years. New survey monitoring stations were installed in June 2014. The locations of the 2014 monuments and the surviving 1998 monuments are shown in Figure 1.2. QPOs for the survey monuments are provided in Appendix VII.

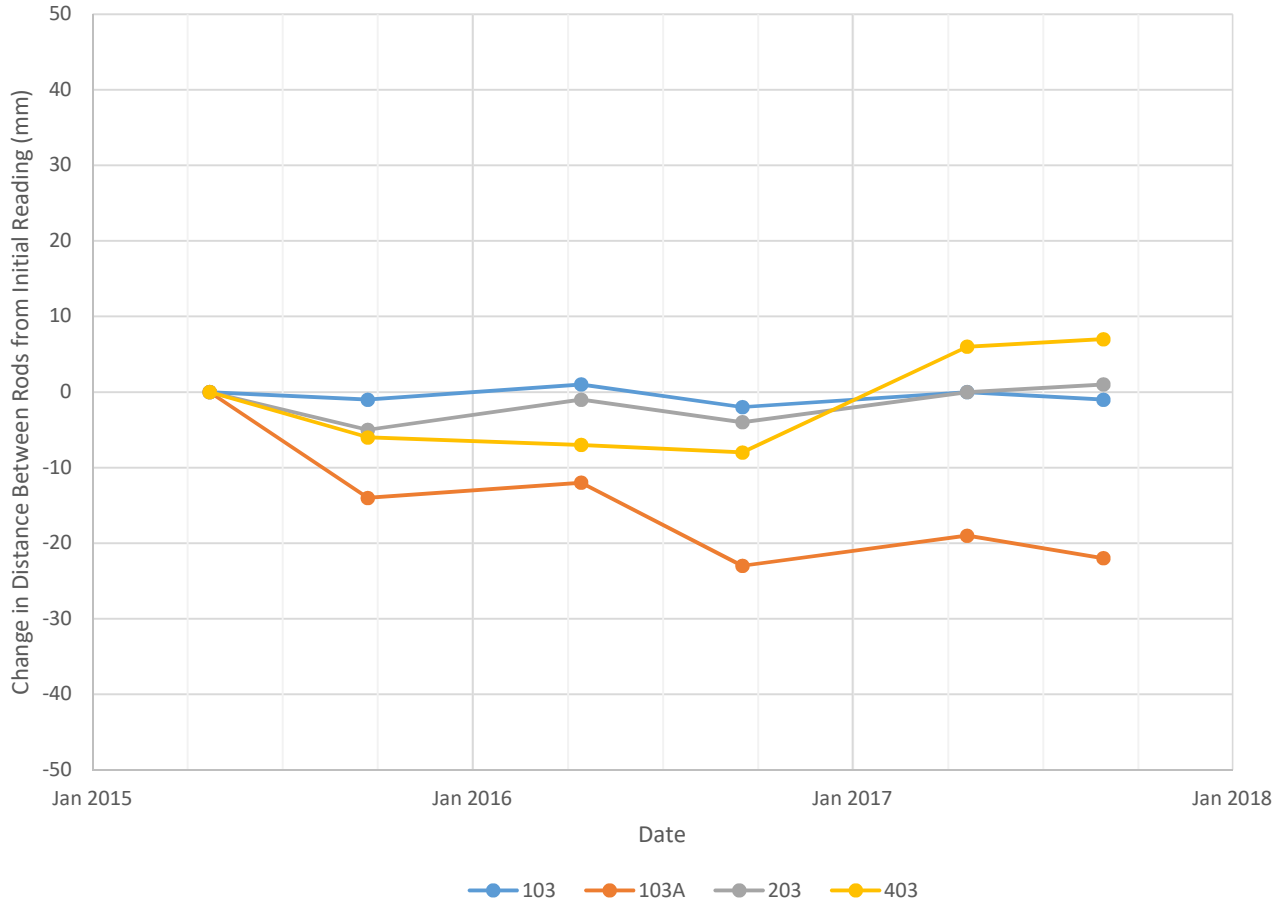
The rod measurements are given in Table 4.2, and changes in the measurements relative to the initial reading are plotted in Figure 4.3.

NOTE:
 1. Negative values indicate the rods have moved closer together.

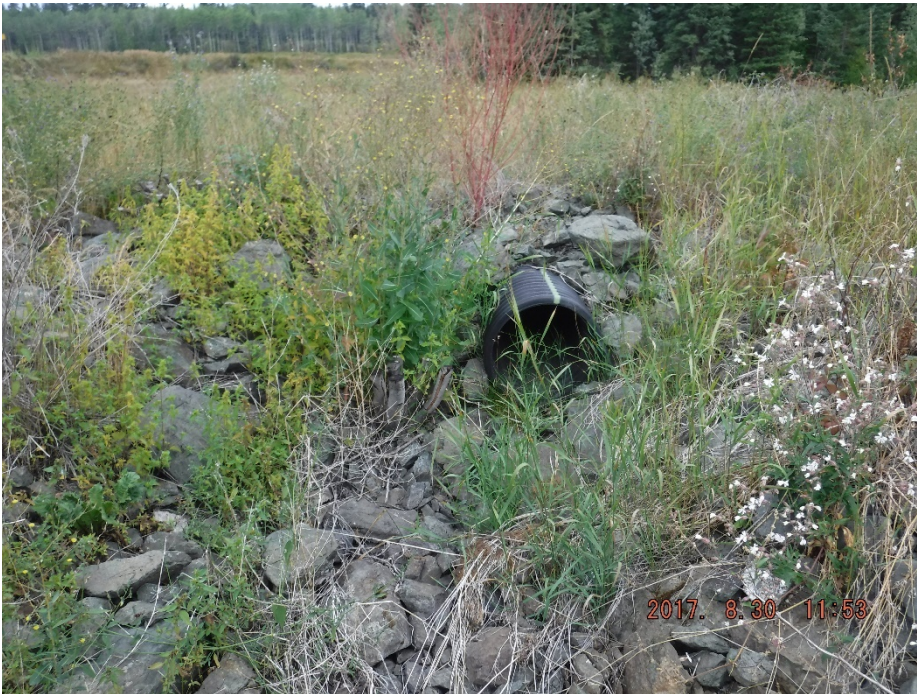
Photo II-46 Inlet of 460 mm culvert on north bank of Ed Creek Diversion Channel. There is vegetation upstream of the inlet that could block the channel during flood conditions.

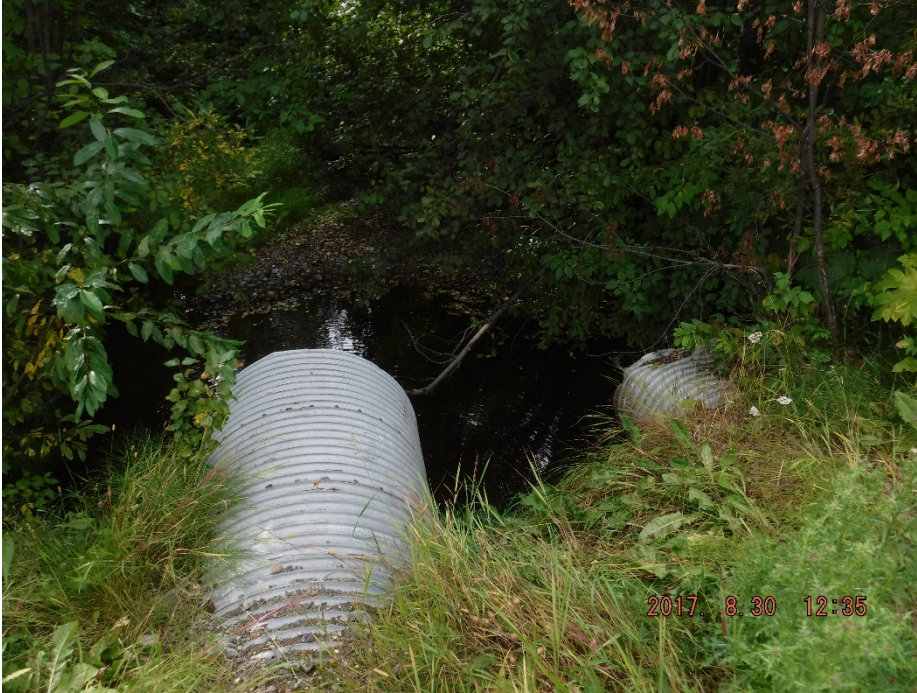
Photo II-49 Outlets of Ed Creek culverts under Pinchi lake Road.
