Teck Coal Limited – Elkview Operations

**Tailings Storage Facilities
West Fork Tailings Facility
and Lagoons A, B, C and D**

2017 Dam Safety Inspection

Final Report

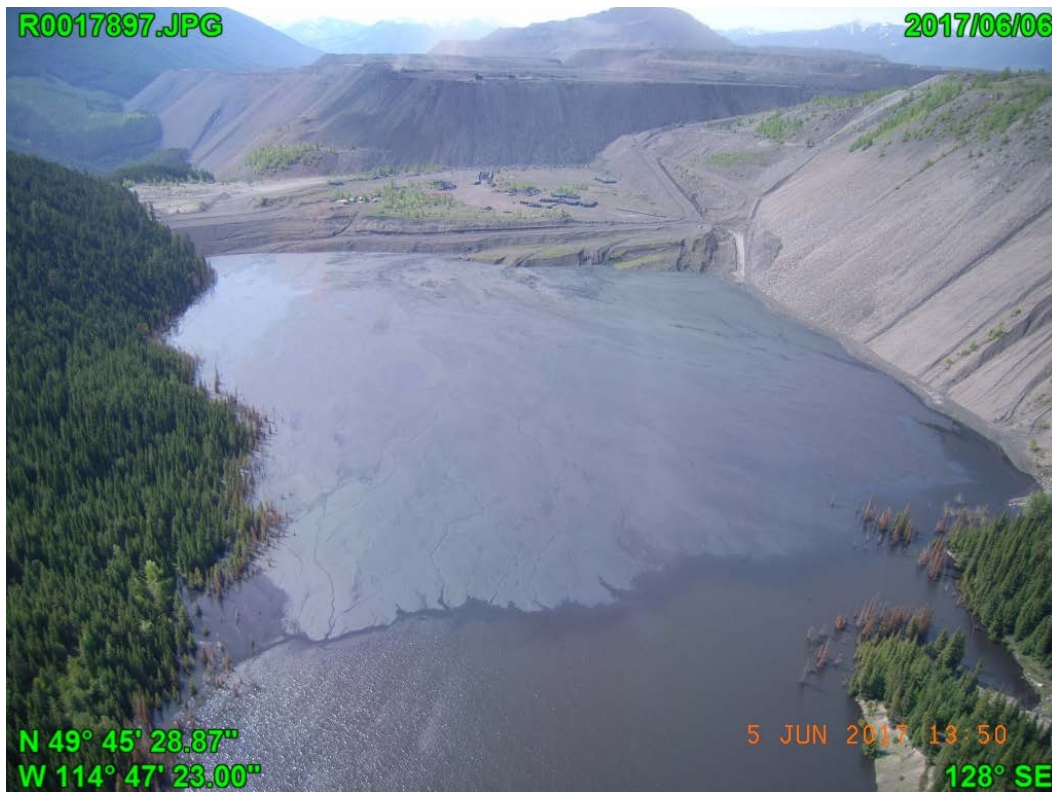
Photograph F - 2: Showing aerial overview of upstream of WFTF, looking south.

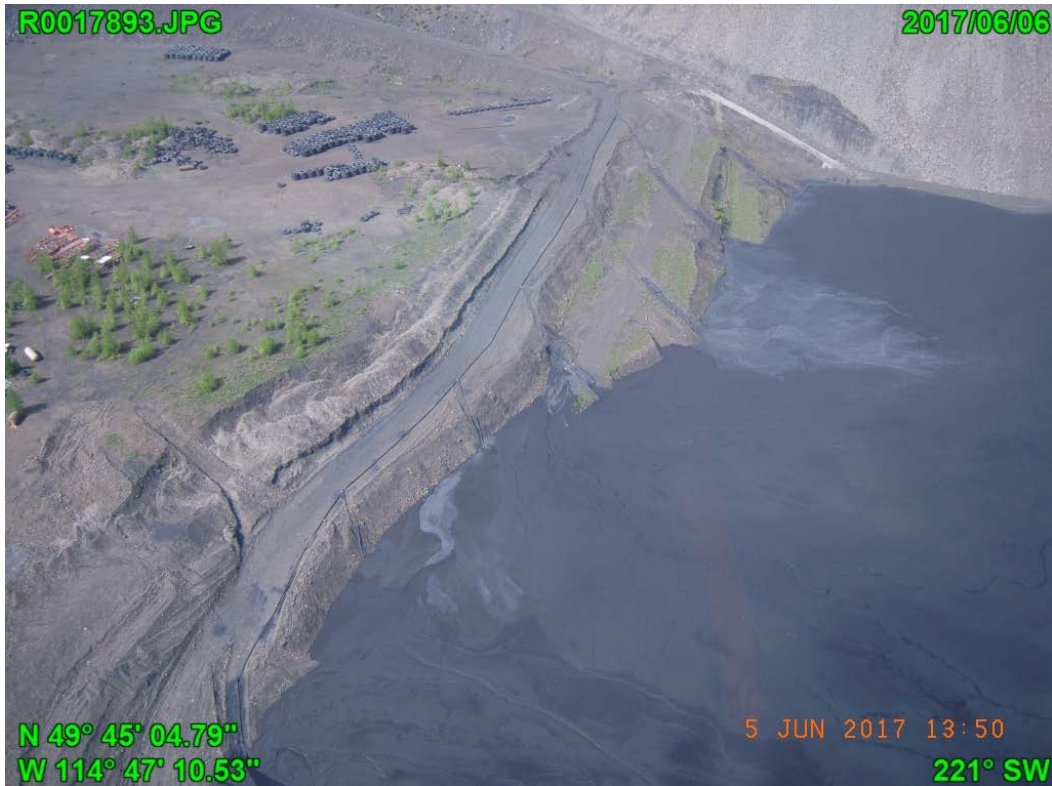
Photograph F - 3: Showing an aerial view of tailings pipelines and tailings beaching at the WTF, looking west.

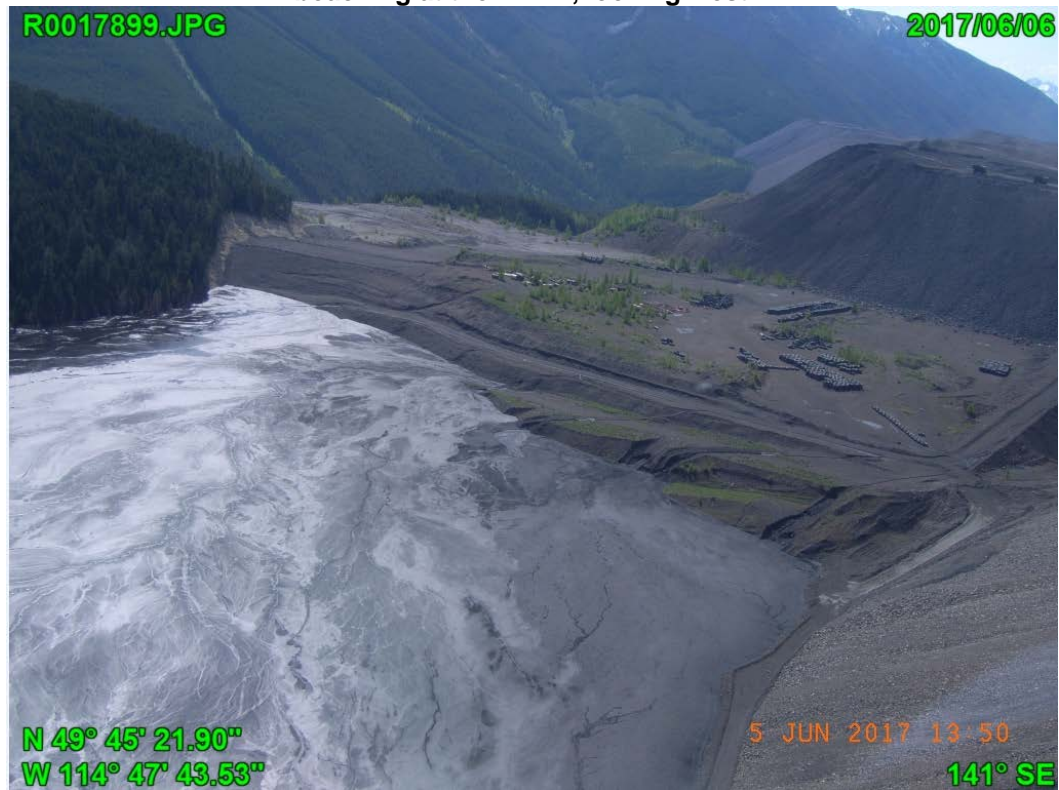
Photograph F - 4: Showing an aerial view of upstream of the WTF, looking southeast.

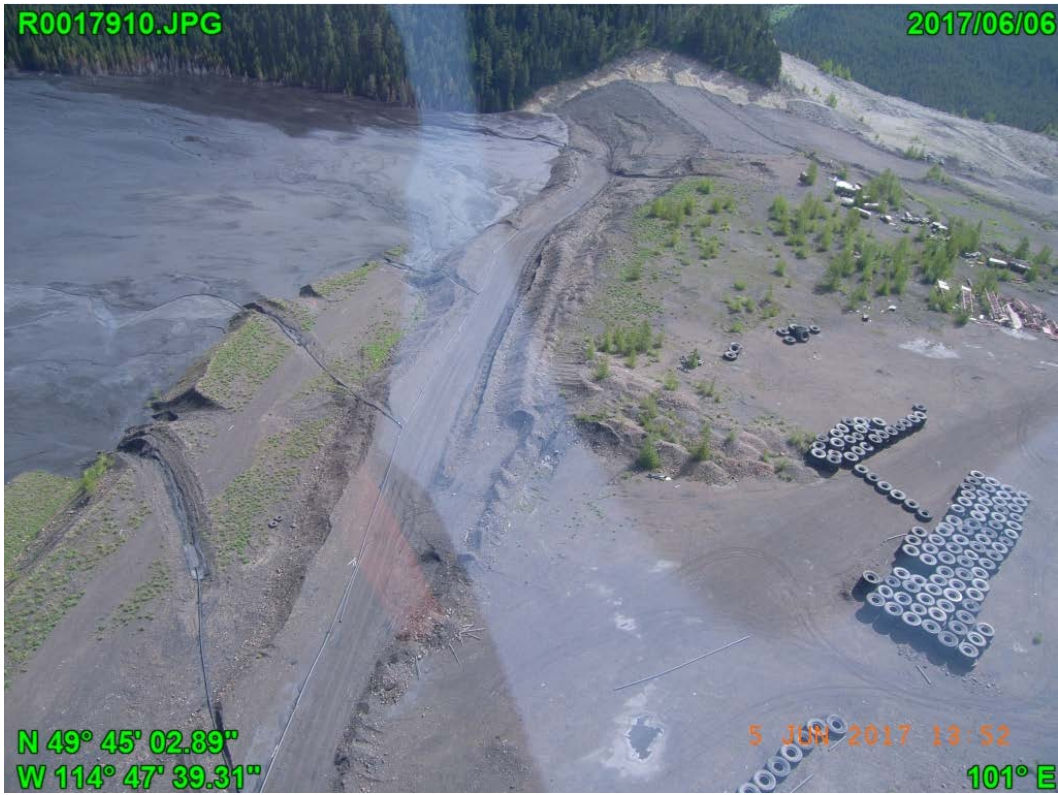
Photograph F - 5: Showing an aerial view of upstream of the WTF, looking east.

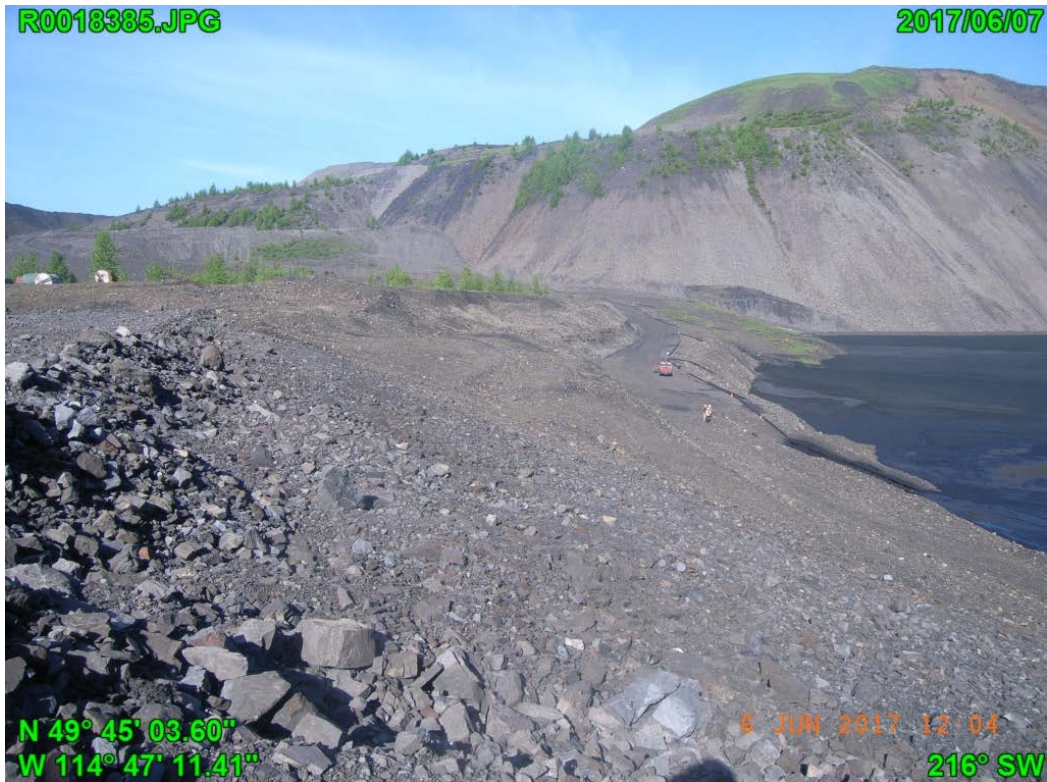
Photograph F - 6: Showing the south abutment, looking southwest from east abutment.

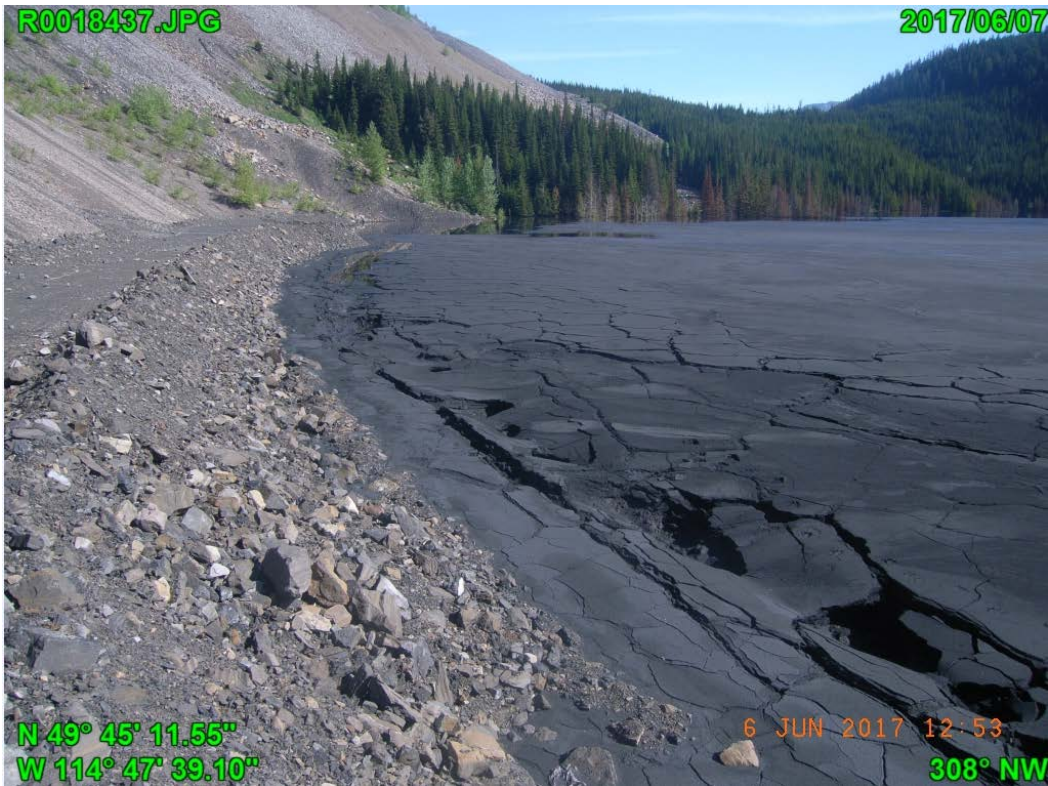
Photograph F - 7: Showing road constructed along toe of Adit dump looking northwest.

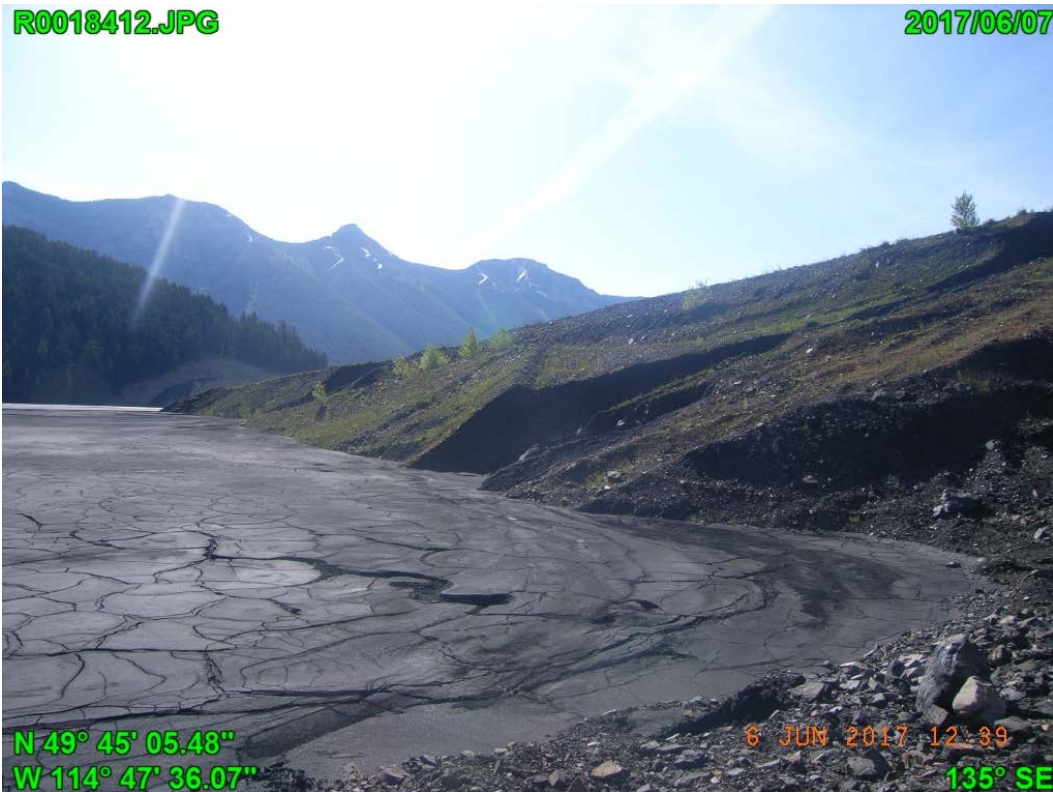
Photograph F - 8: Showing beach tailings on upstream, looking southeast from west abutment.

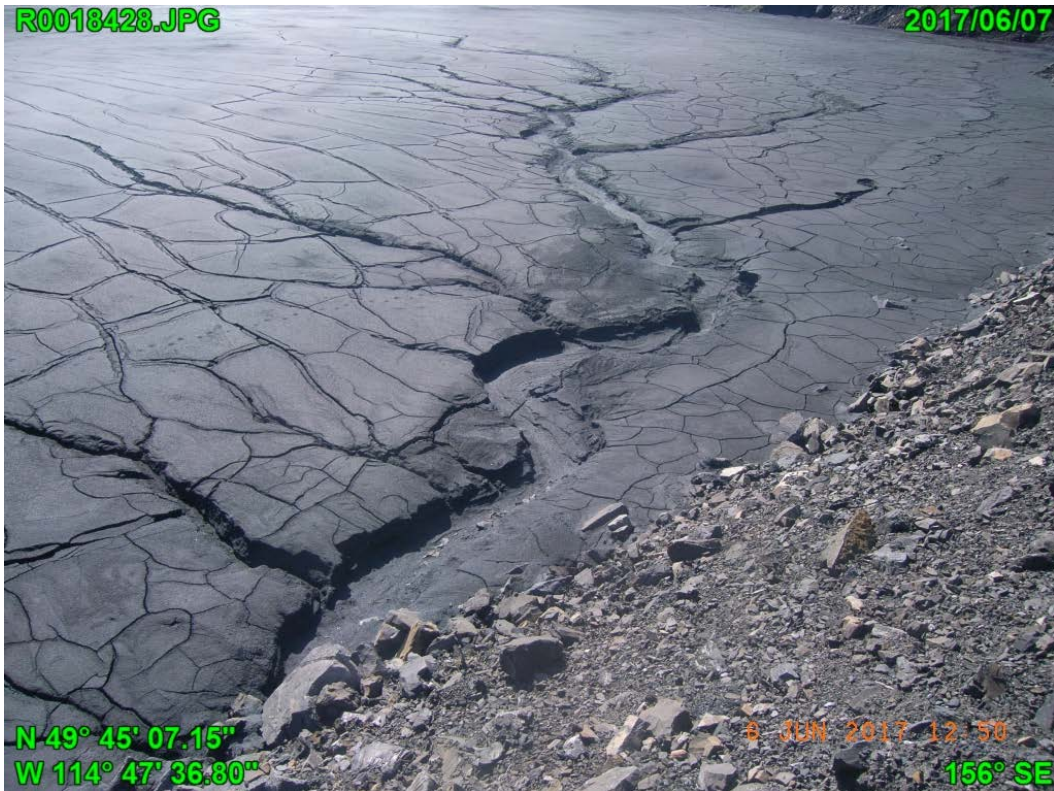
Photograph F - 9: Showing evidence of infiltration on the west side of the WTFF near the Adit dump, looking south.

2.0 Dam Crest and Above Water Beach (if applicable)					
2.1	Evidence of Shoulder Erosion		X		
2.2	Evidence of Cracking		X		
2.3	Other Deformation/Settlement/Sinkholes	X			Sinkholes at left abutment and along adit dump toe road up to 0.6 m dia.

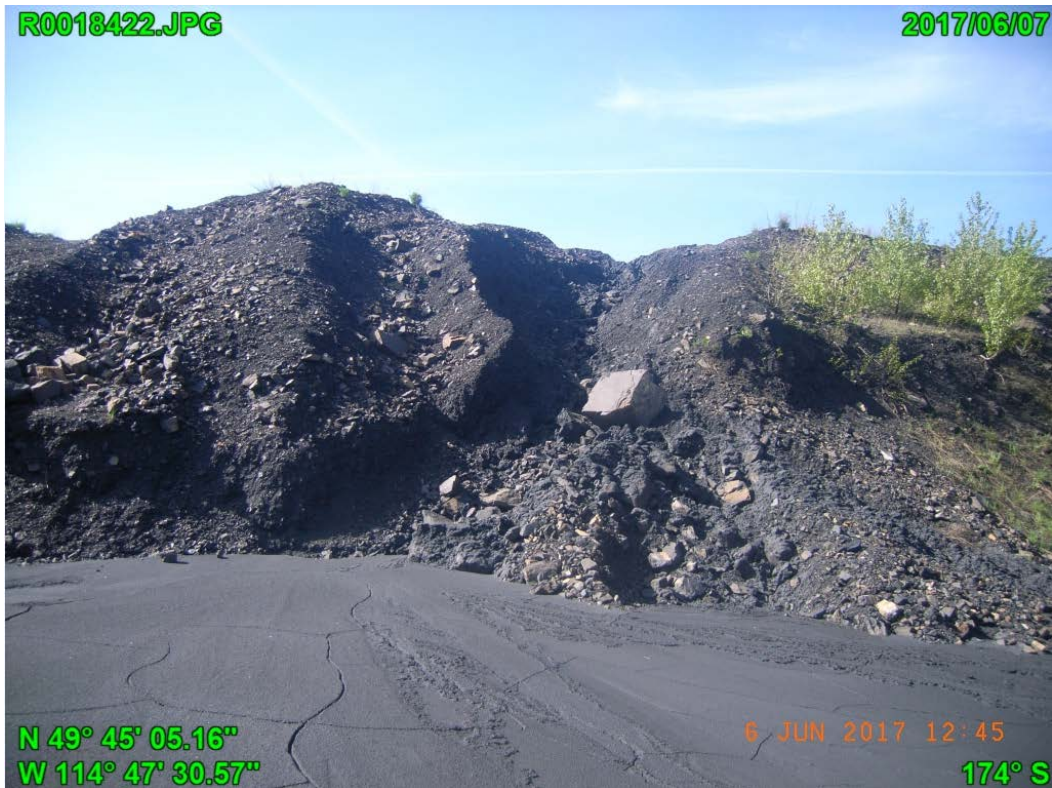
Photograph F - 11: Showing an erosion gully on upstream slope due to tailings discharged from spigot 1 pipe located close to the Adit dump, looking south.

ID	Observed Features	Yes	No	N/A	Comments
1.0 Upstream Dam Slope					
1.1	Concern with Current or Previous Water Level		X		
1.2	Evidence of Wave or Other Erosion	X			Significant erosion around spigots 1-3 from tailings

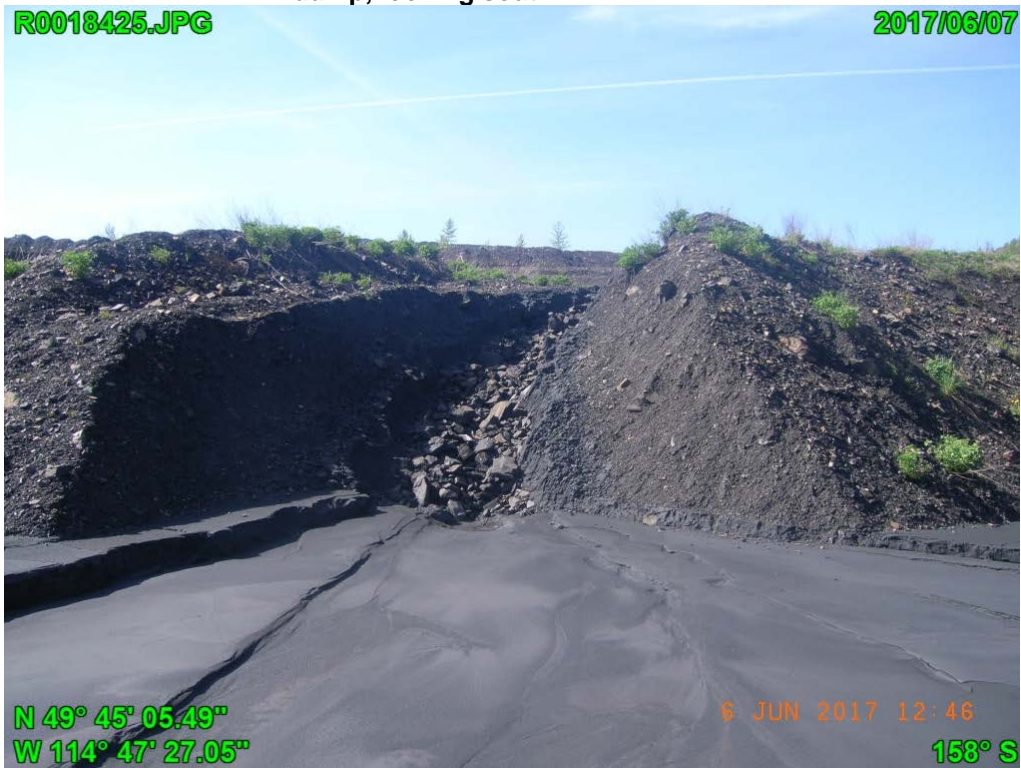
Photograph F - 12: Showing an erosion gully on upstream slope due to tailings discharged from spigot 2 pipe, looking south.

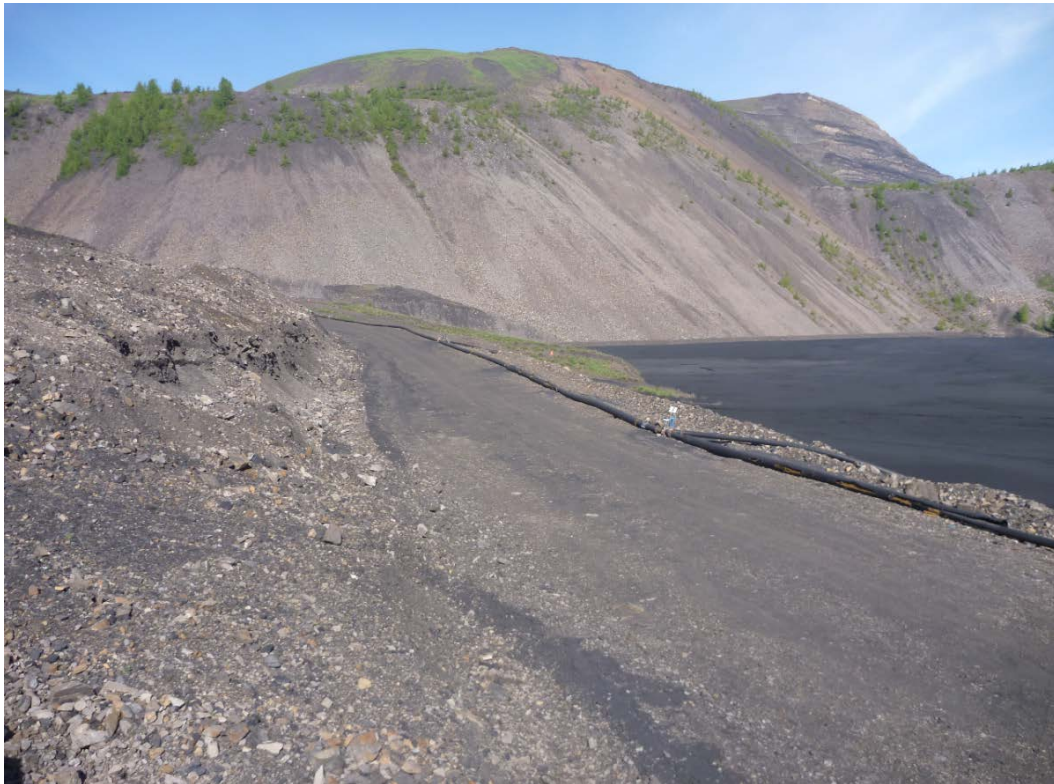
Photograph F - 13: Showing Geho Road, looking west. (Photo P1100592, 07/06/2017).

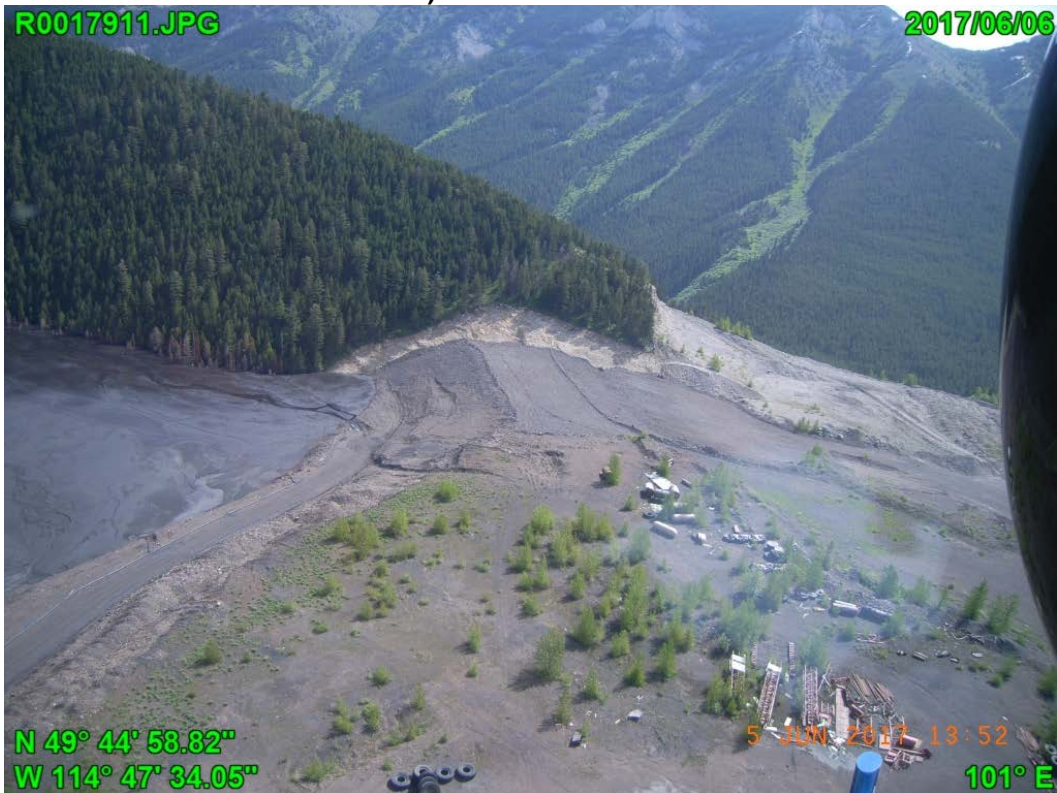
Photograph F - 14: Showing the 2013 raised area at the east abutment, looking east.

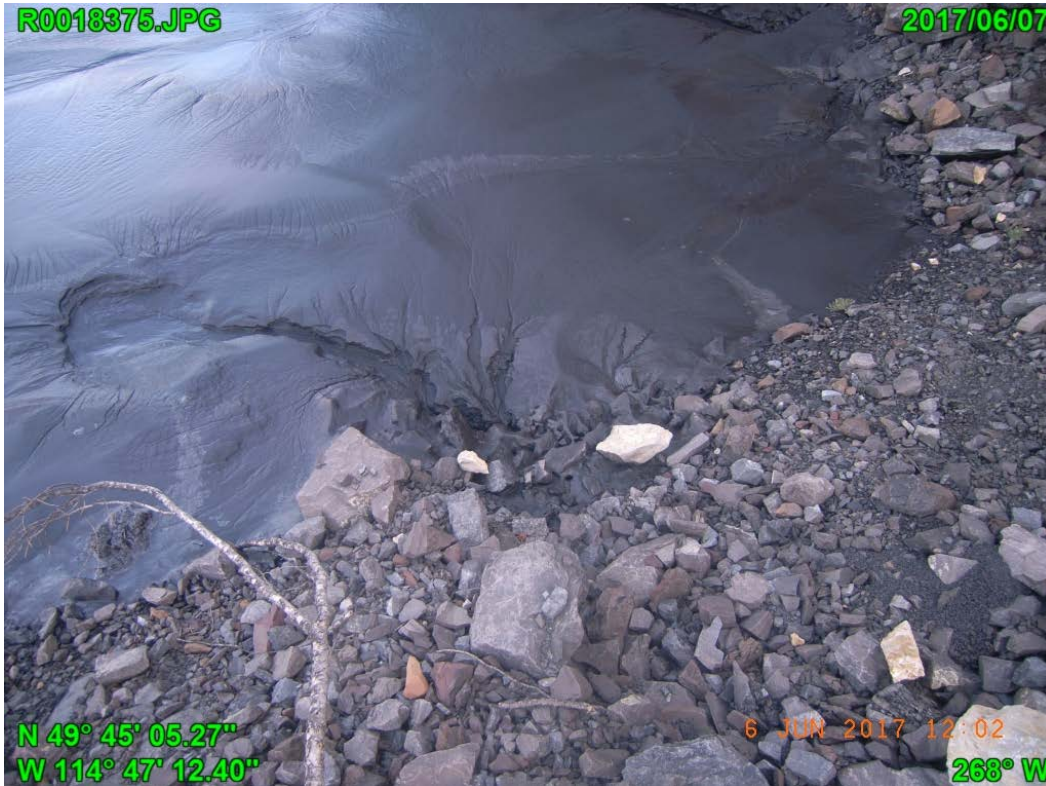
Photograph F - 15: Showing seepage at the east abutment against the 2013 raised, looking north.

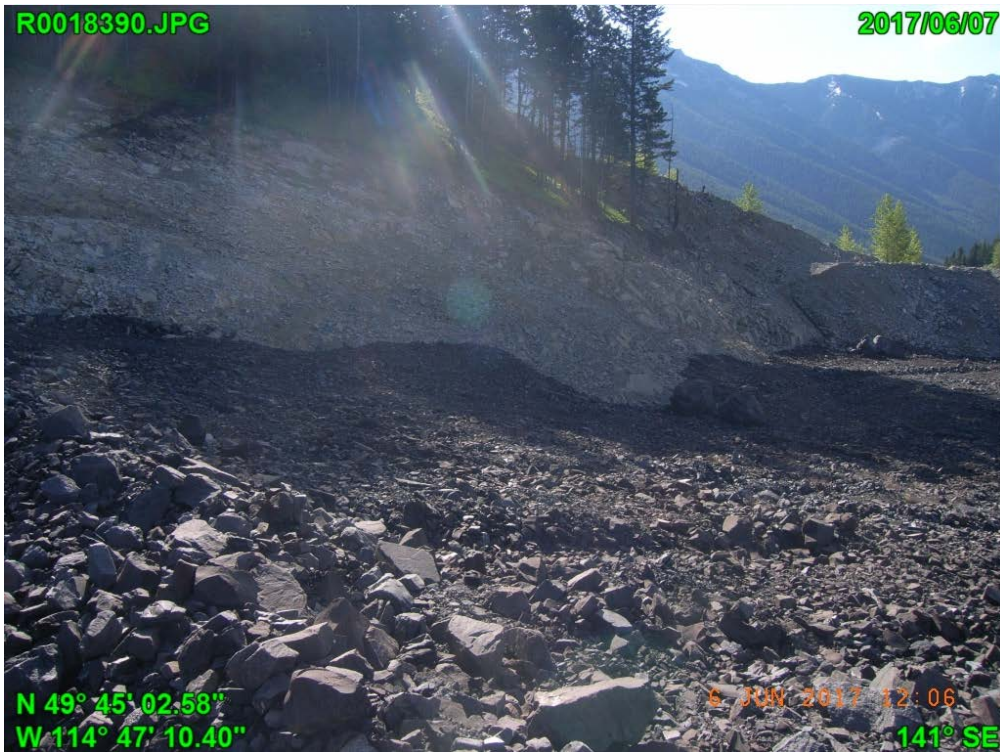
Photograph F - 17: Showing east abutment at WTFF downstream slope, looking southeast.

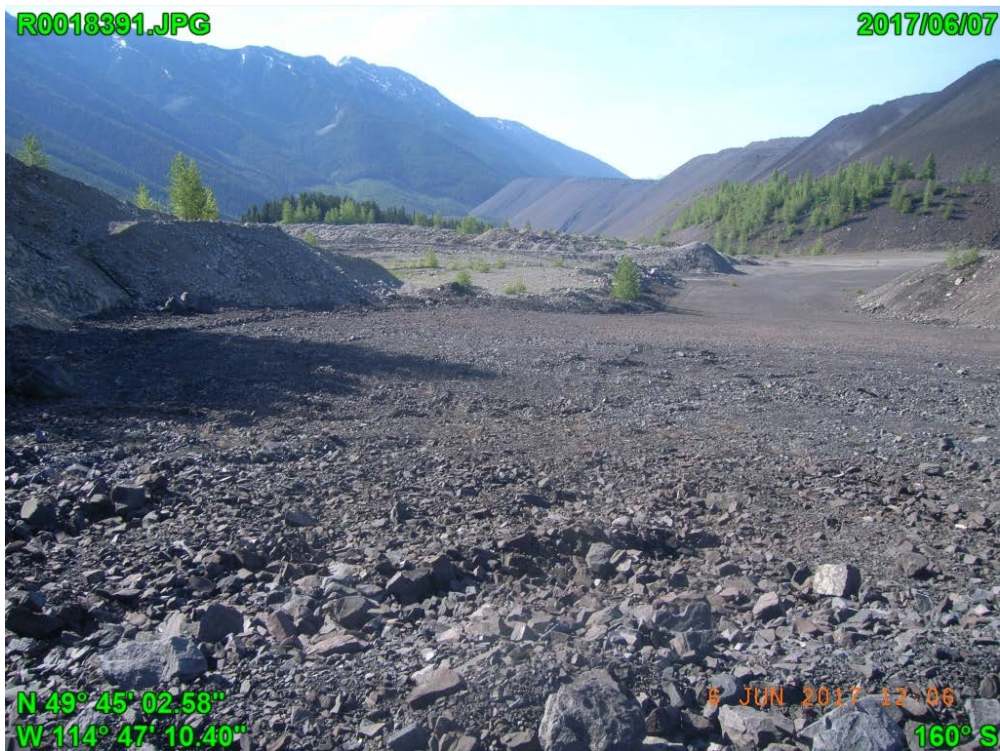
Photograph F - 18: Showing downstream slope, east abutment and toe looking south.

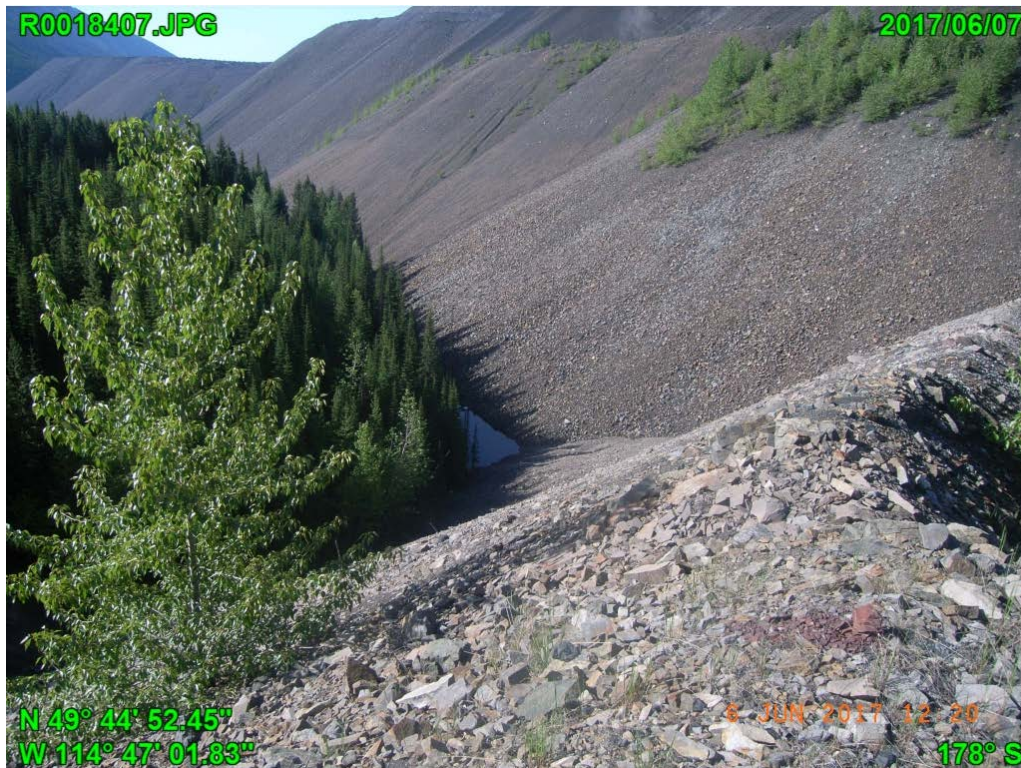
Photograph F - 20: Showing toe of Cowboy dump looking south. Note toe is located approximately 450 m downstream of crest centerline.

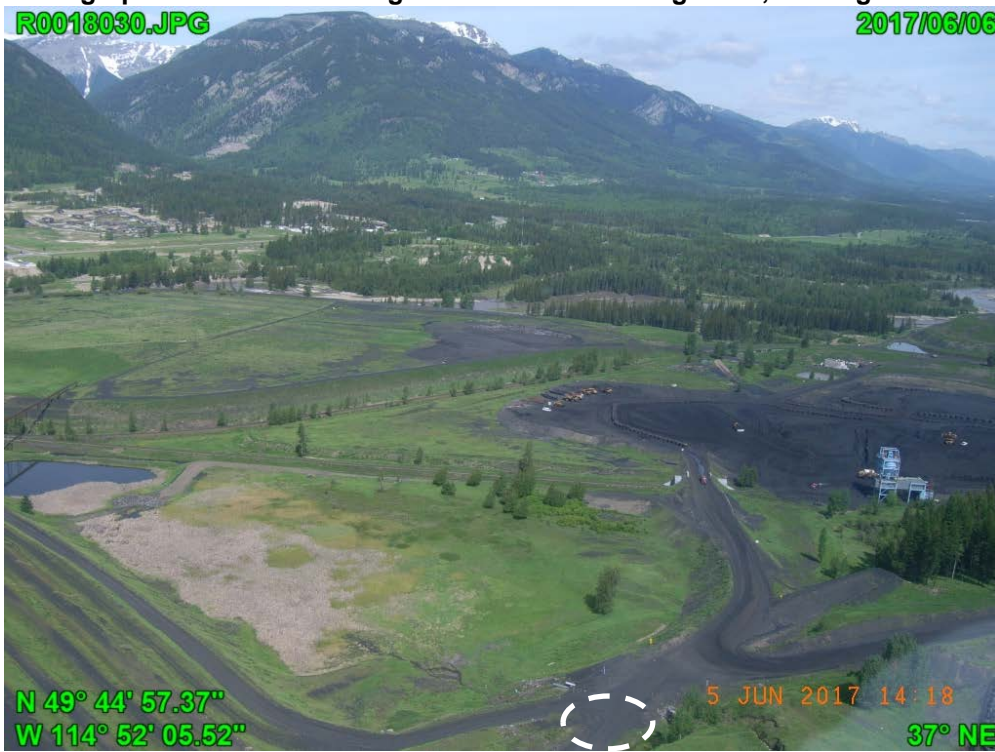
Photograph G - 2: Showing an overview of the Lagoon A. Noted the Cossarini Creek inflow to east side of Lagoon A through 2 culverts, looking northwest.

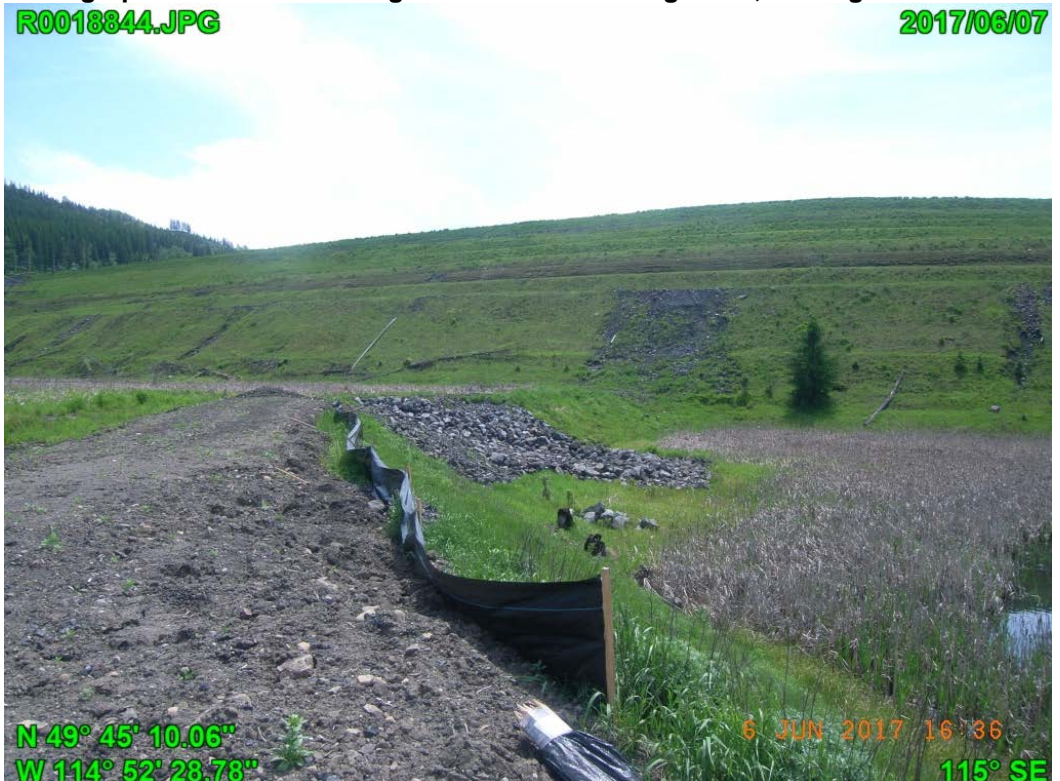
Photograph G - 4: Showing west berm and the spillway, looking southeast.

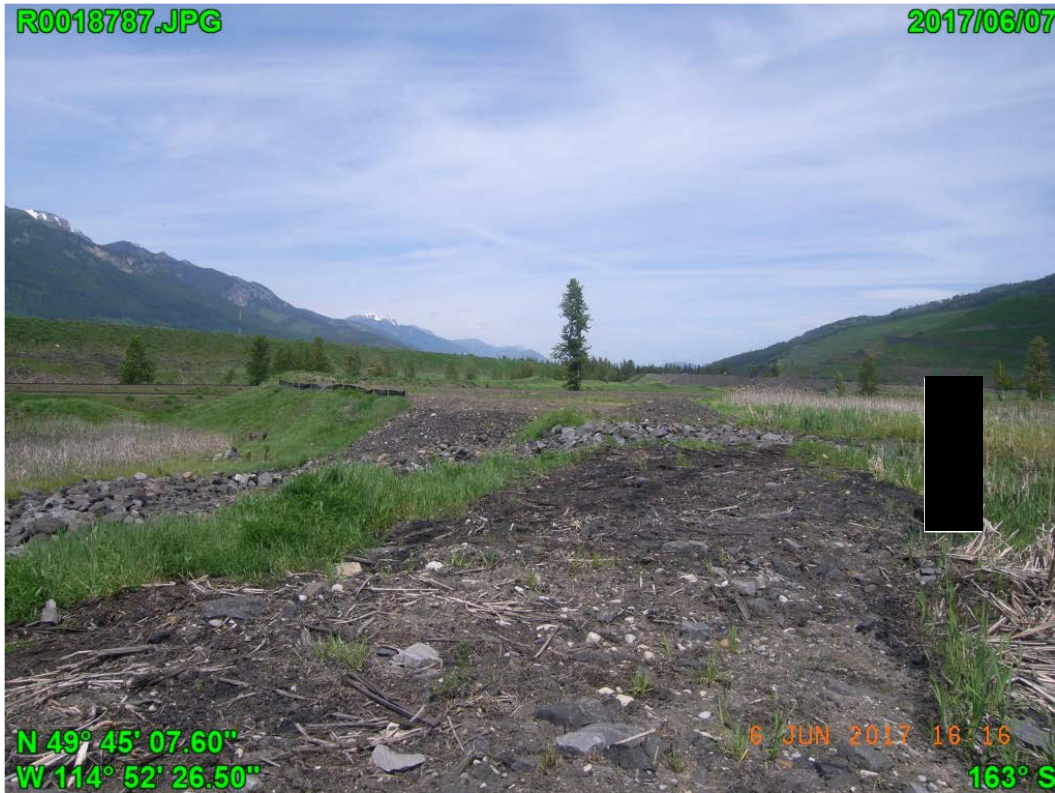
Photograph G - 5: Showing downstream of the west berm and the spillway, looking north.

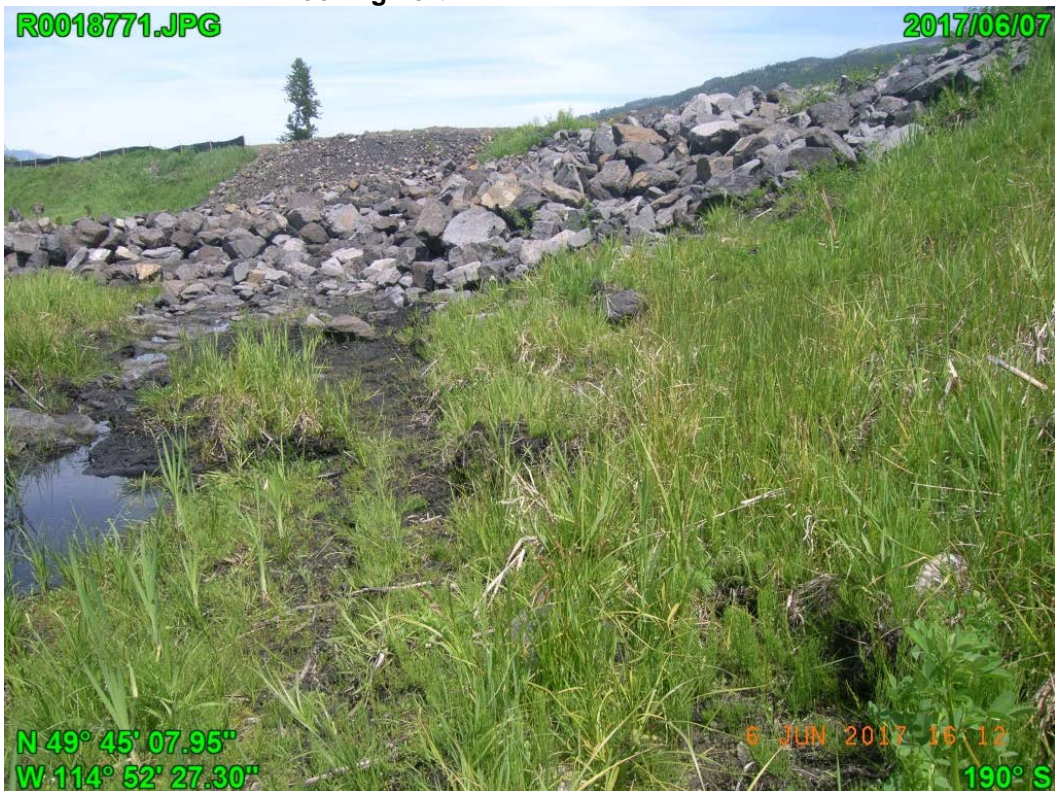
Photograph G - 6: Showing downstream of the spillway of the west face of Lagoon A, looking north.

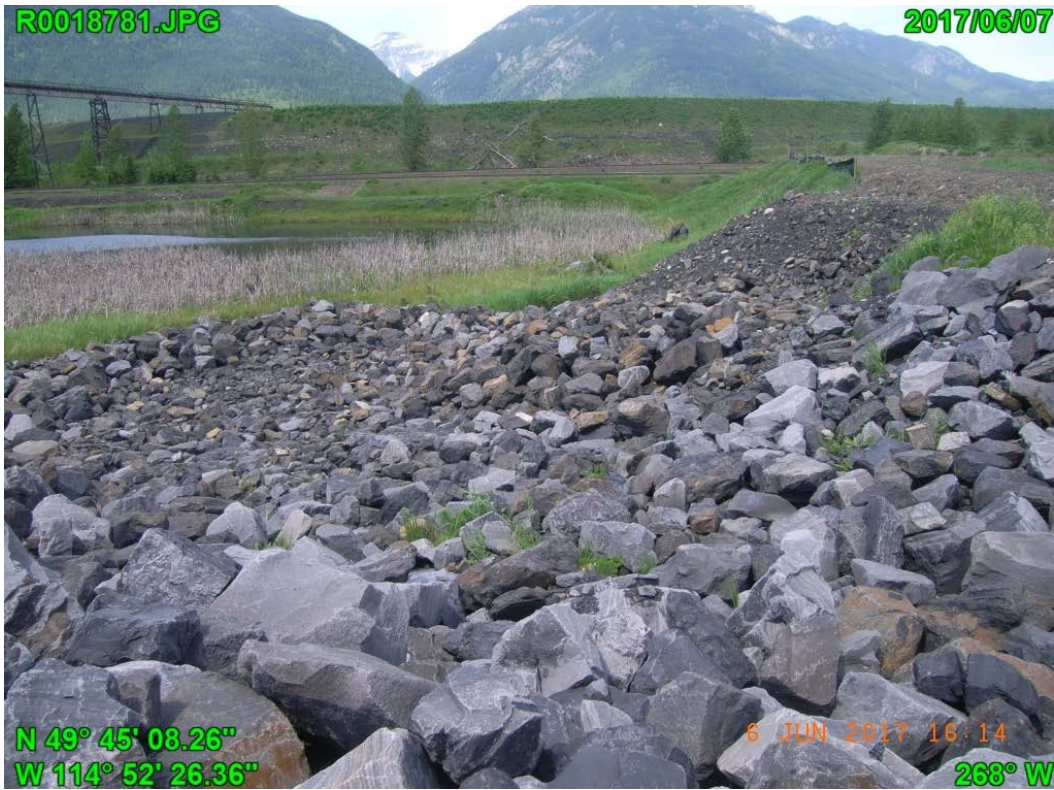
Photograph G - 7: Showing the spillway and riprap placement at downstream west slope, looking northwest.

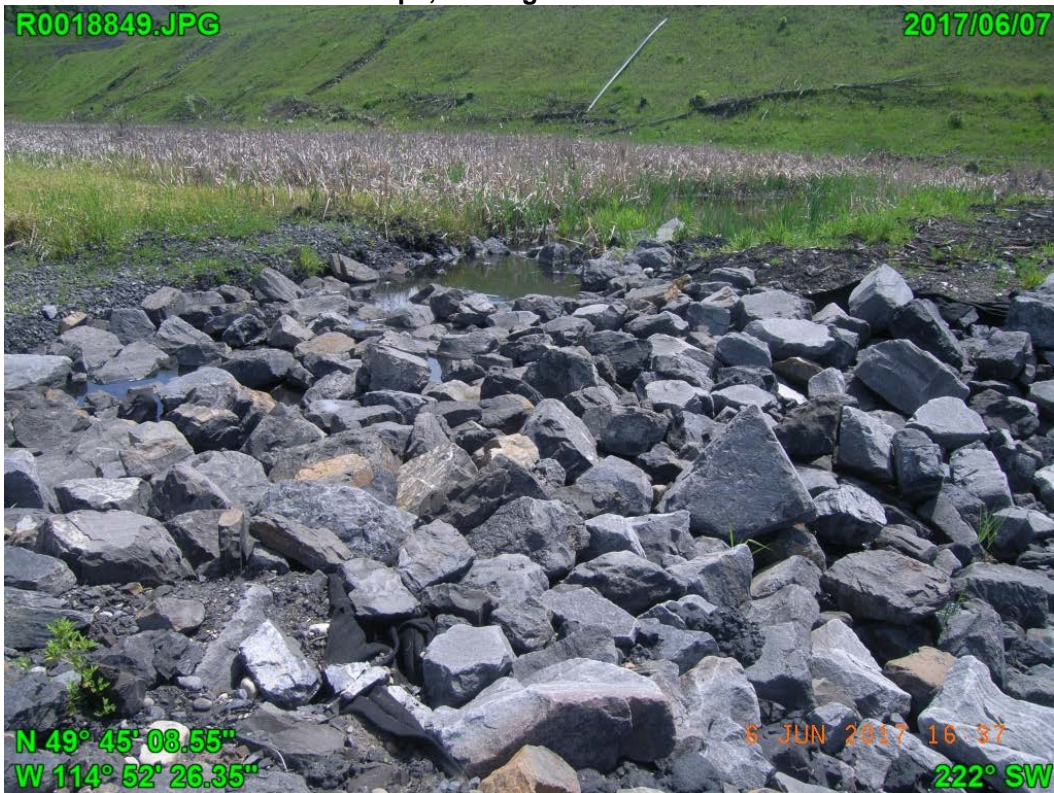
Photograph G - 8: Showing upstream of the upgraded spillway, looking southeast.

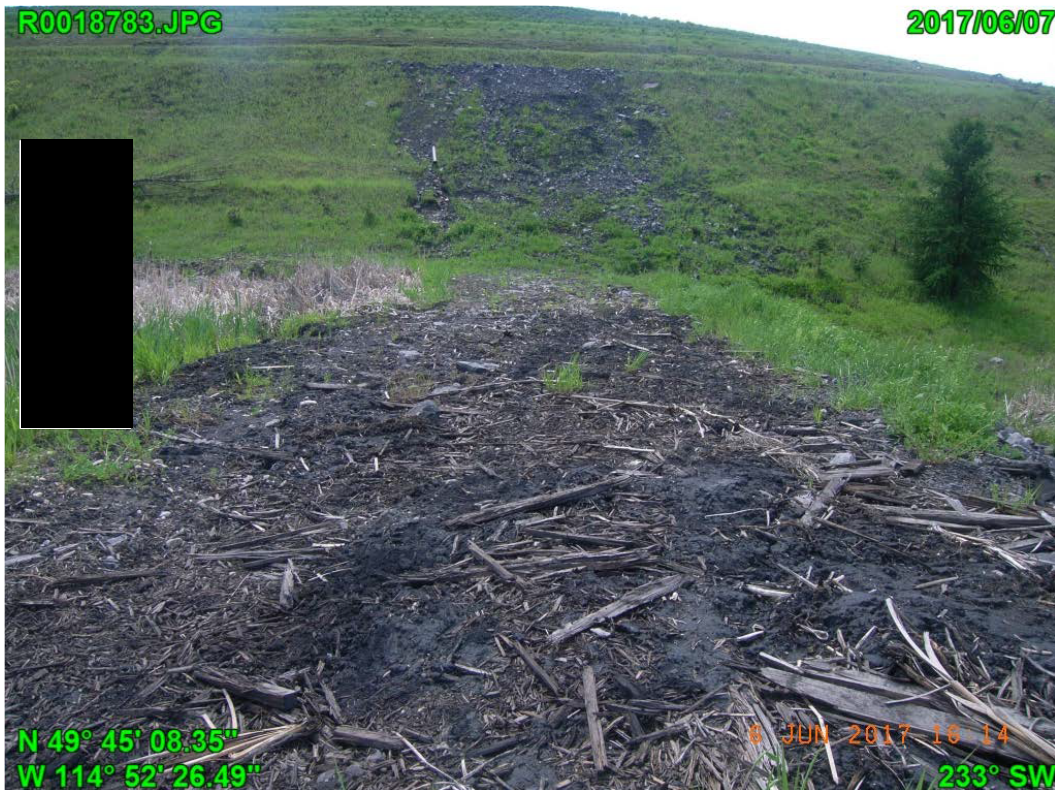
Photograph G - 9: Showing the crest of at the west face, looking south.

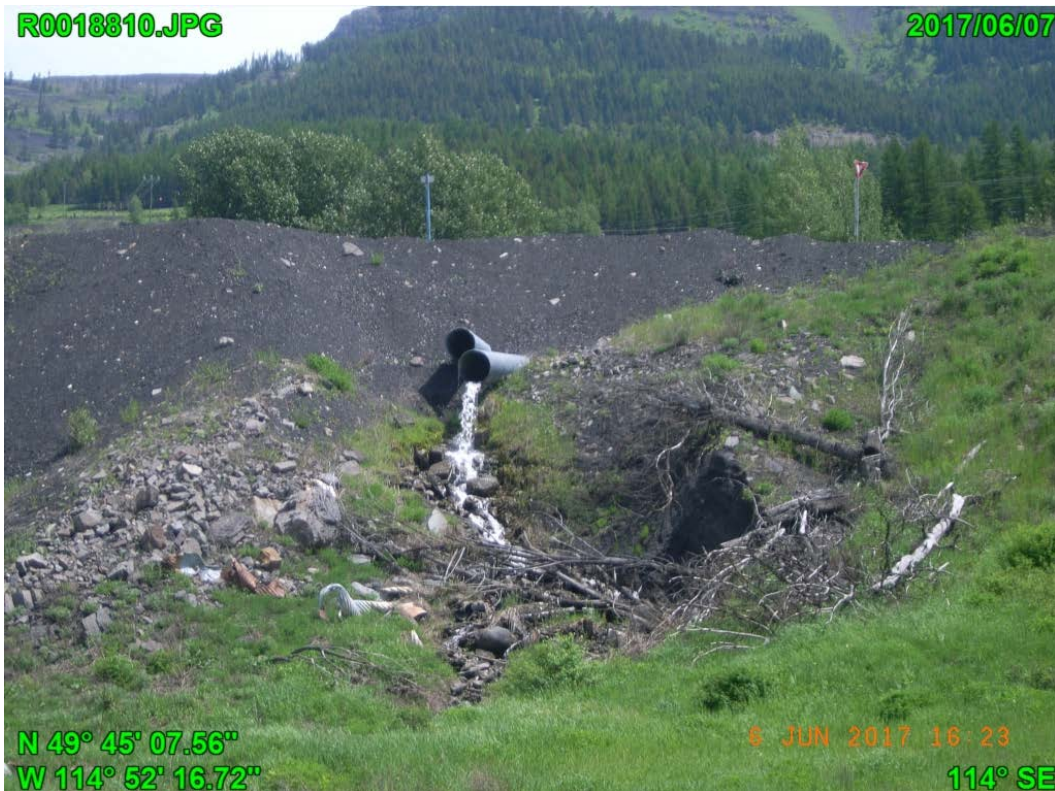
Photograph G - 10: Showing water discharge from Cossarini Creek onto east side of Lagoon A, looking east.

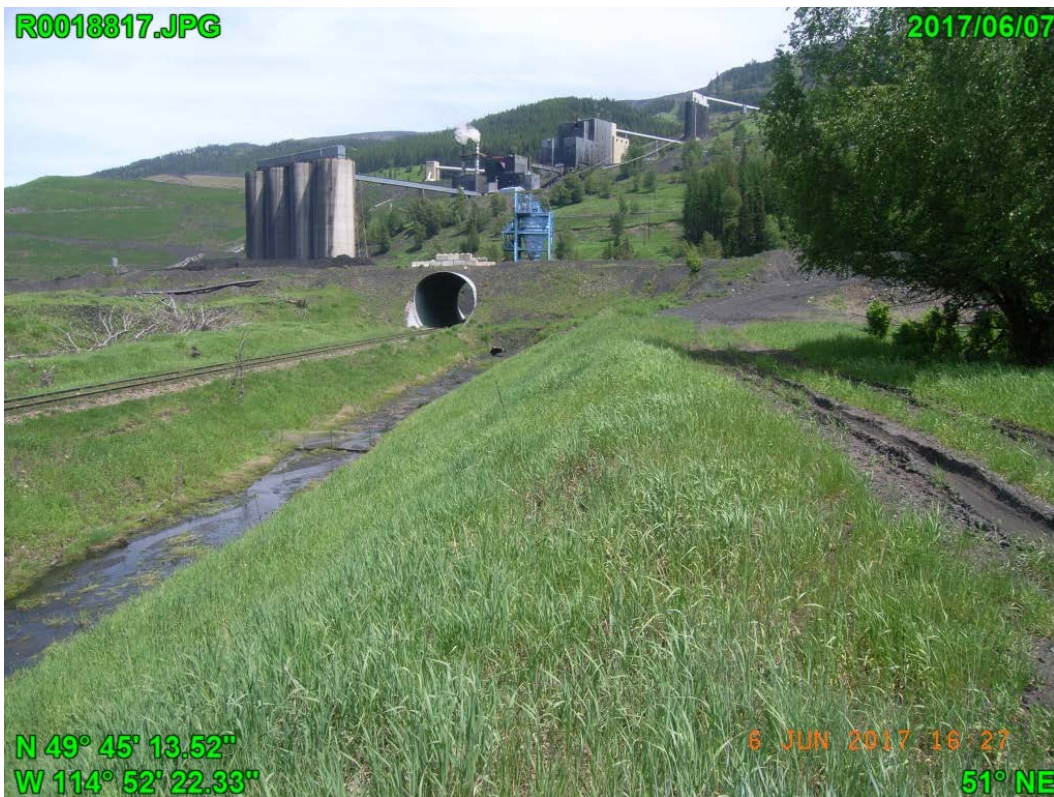
Photograph G - 12: Showing downstream slope of Lagoon A on north embankment at northeast corner, looking northeast.

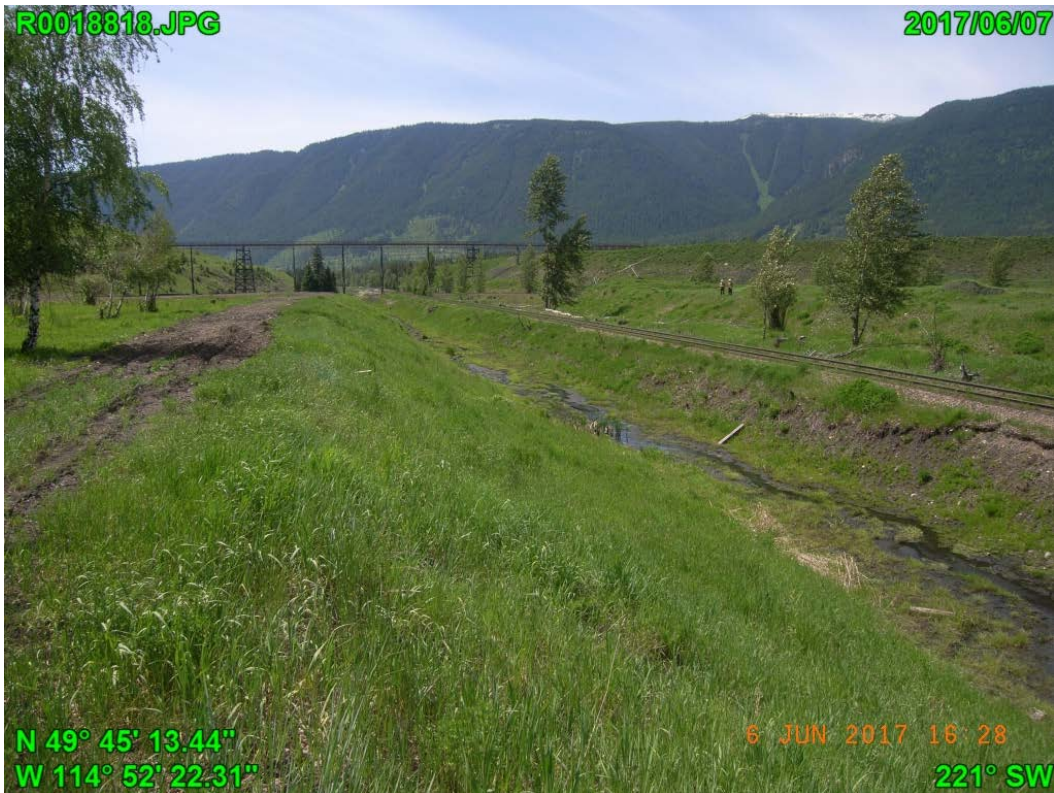
Photograph G - 13: Showing downstream slope of Lagoon A north embankment, looking southwest.

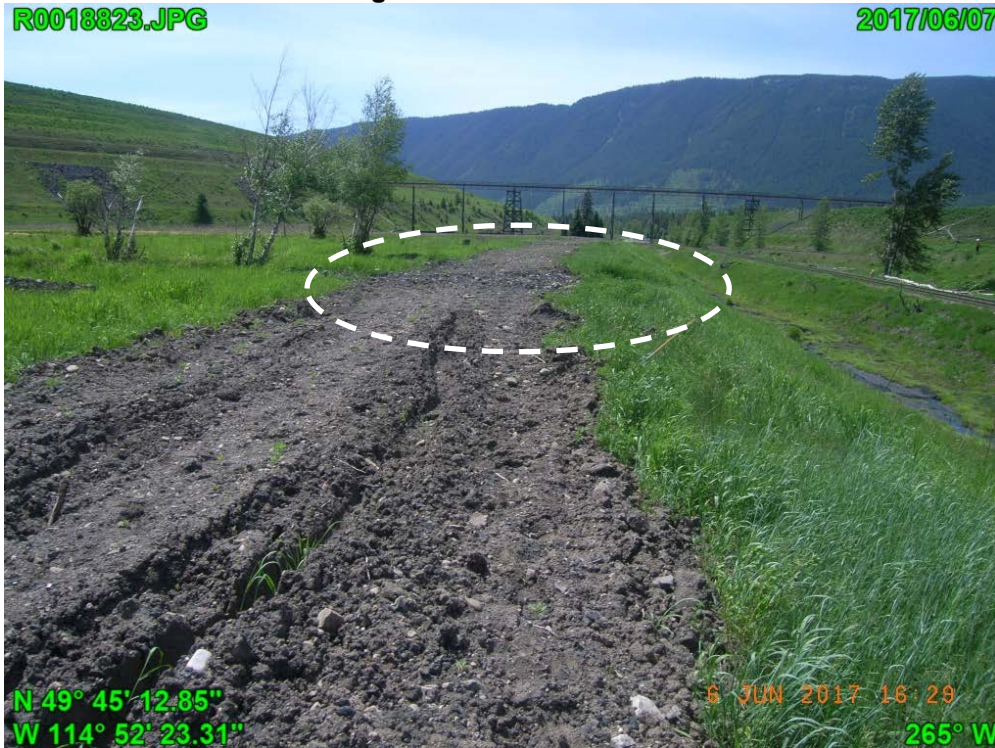
Photograph G - 14: Showing the road along the north side of Lagoon A, looking southwest. Noted an amoured outlet in the mid length of the north berm.
