Teck Coal Limited – Elkview Operations

**Tailings Storage Facilities
West Fork Tailings Facility
and Lagoons A, B, C and D**

2017 Dam Safety Inspection

Final Report

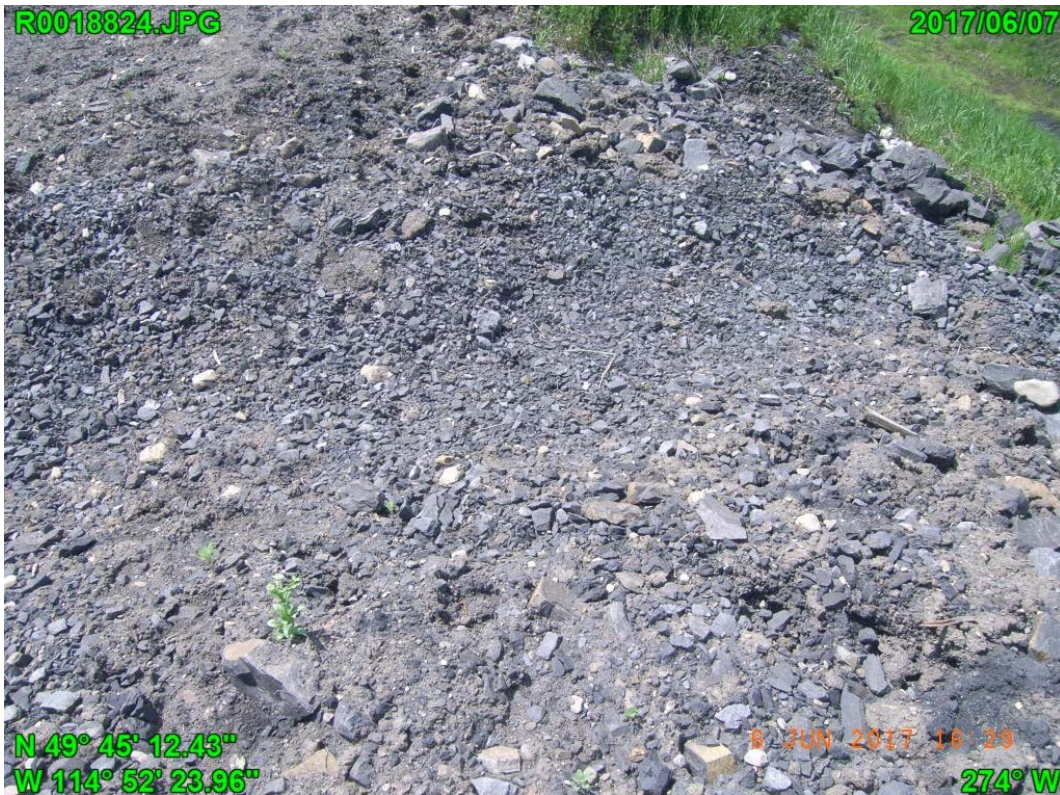
Photograph G - 15: Showing the closer view of the armored outlet on the north slope, looking west.

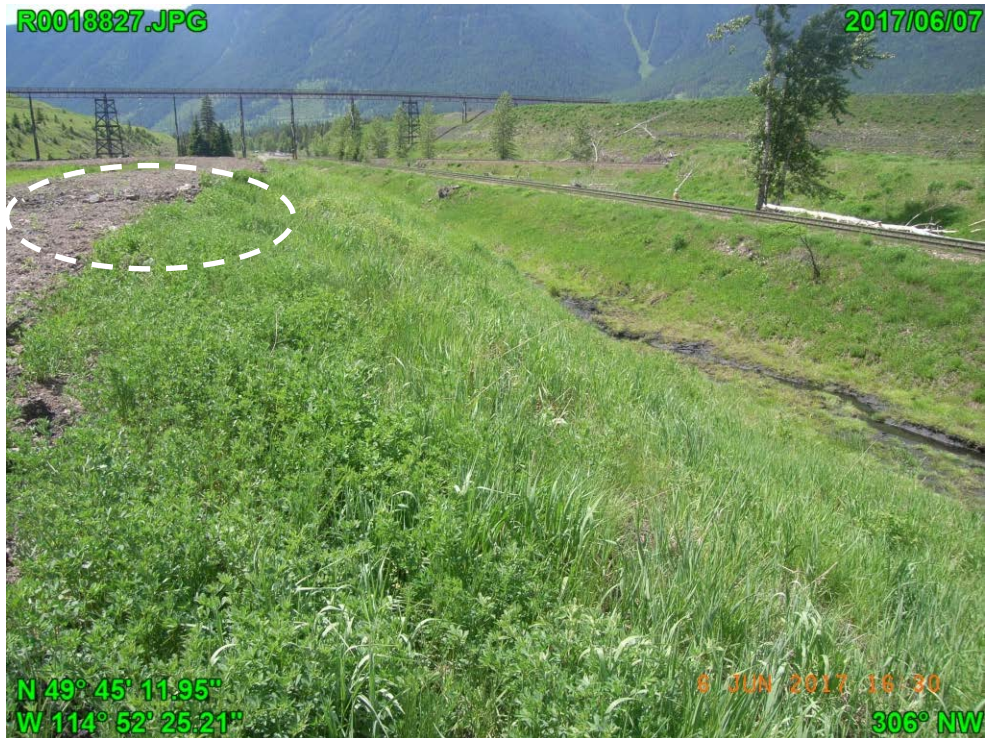
Photograph G - 16: Showing the downstream of north slope and another armored outlet further west, looking west.

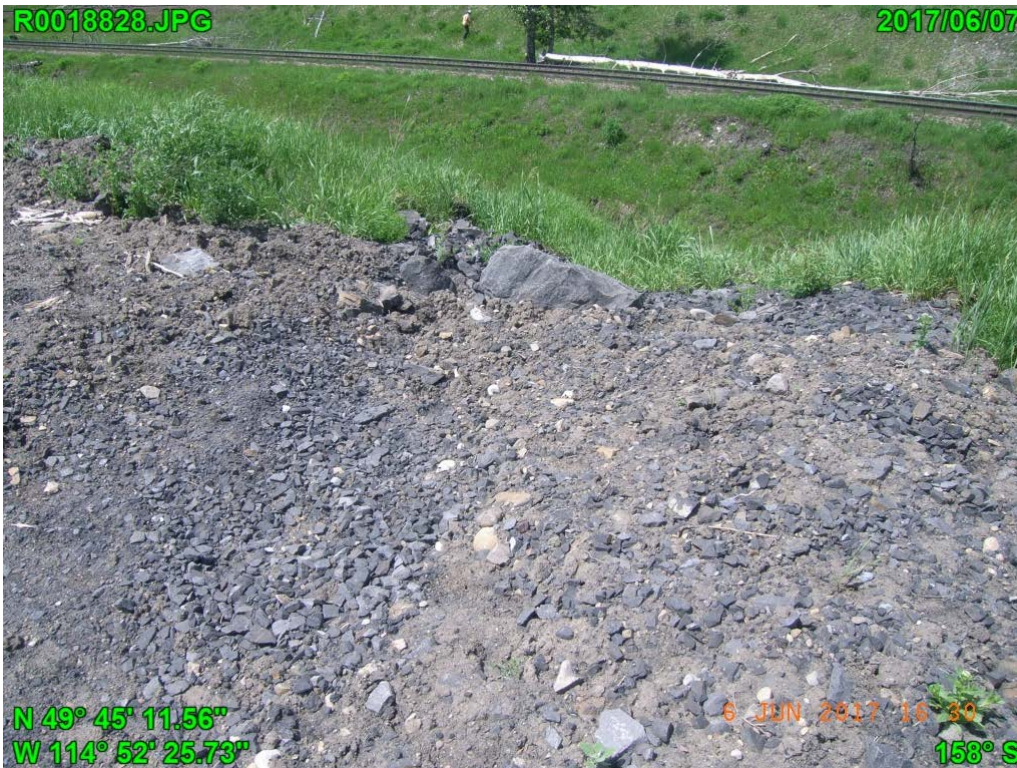
Photograph G - 17: Showing a closer view of the amoured outlet at the west end of the north slope, looking northeast.

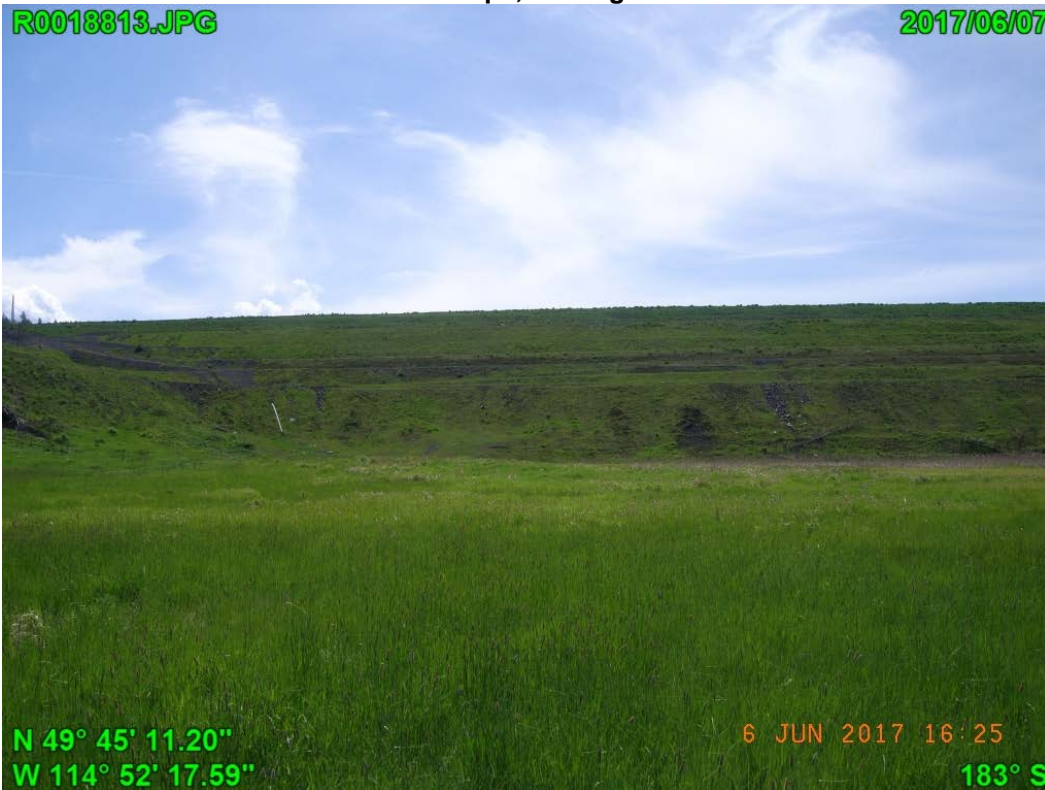
Photograph G - 18: Showing the surface of Lagoon A at southeast corner, looking southeast.

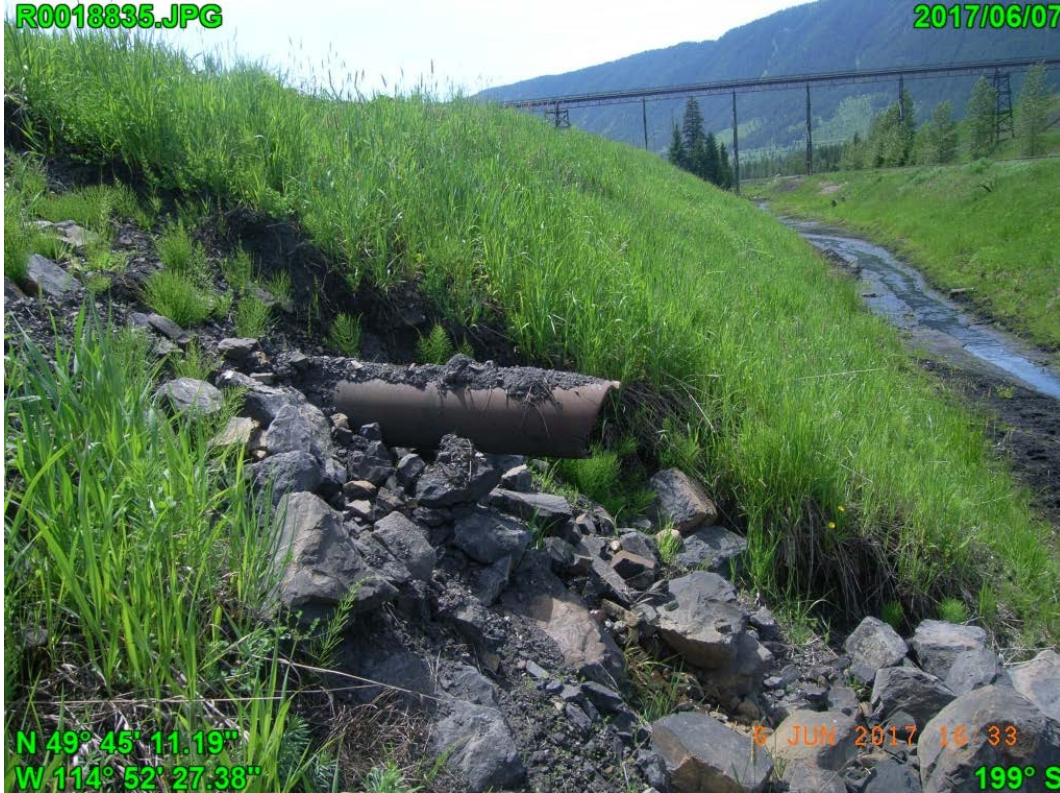
Photograph G - 19: Showing pipe flow on northwest end of Lagoon A, looking southwest.

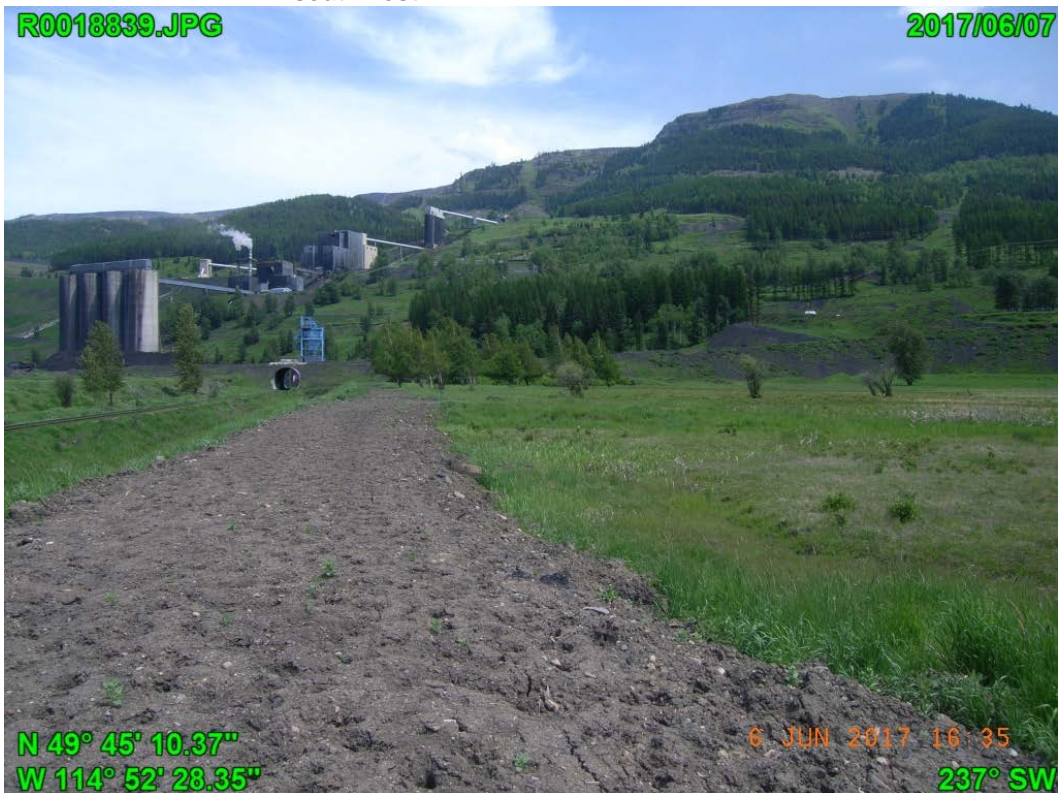
Photograph G - 20: Showing the north side of Lagoon A, looking northeast.

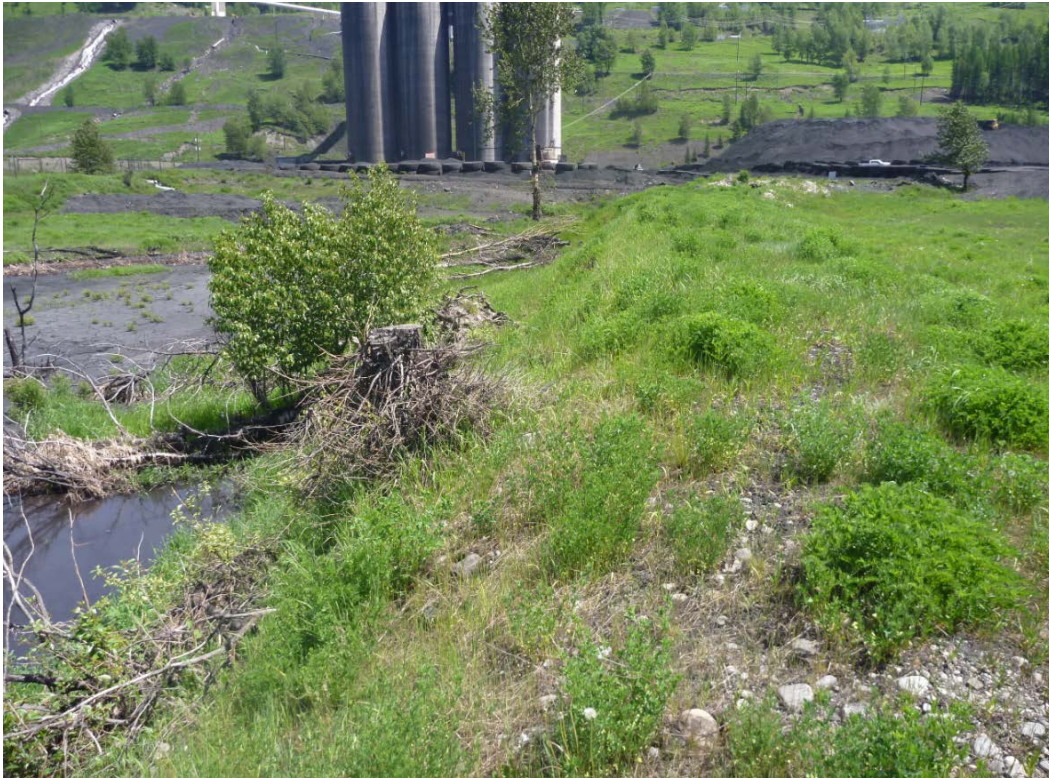
Photograph H - 3: Showing east end of the north embankment of Lagoon B, looking east. (Photo No. P1100789, 2017/06/07).

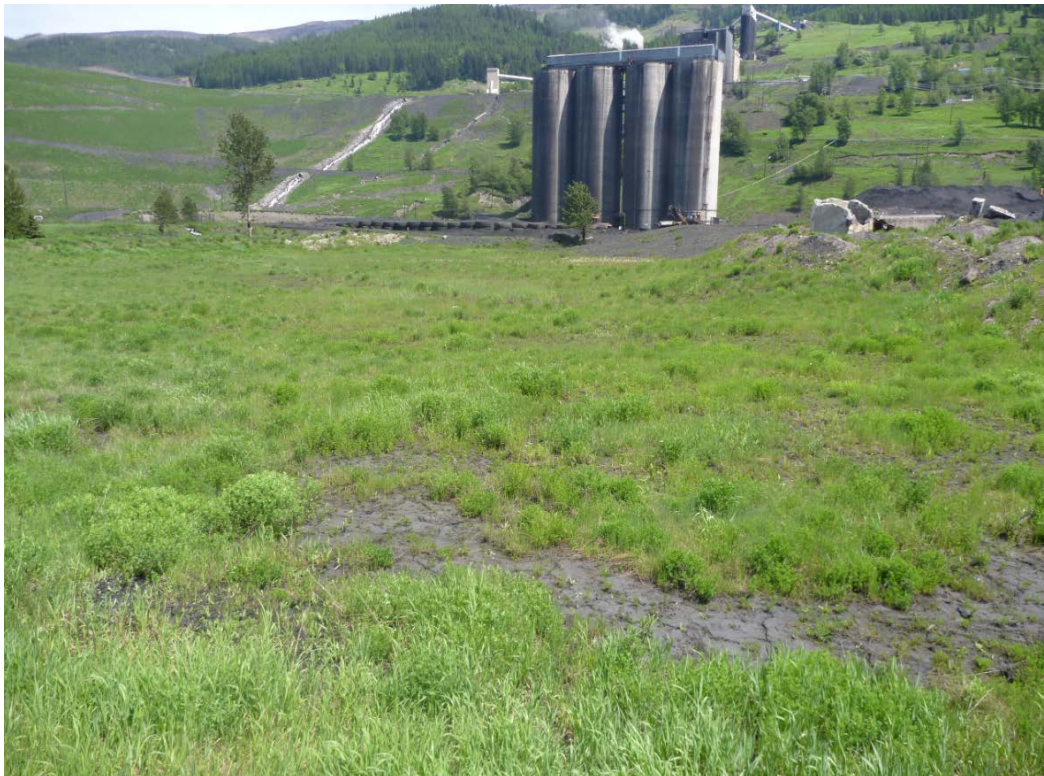
Photograph H - 4: Showing northeast area of Lagoon B, looking northeast. (Photo No. P1100788, 2017/06/07).

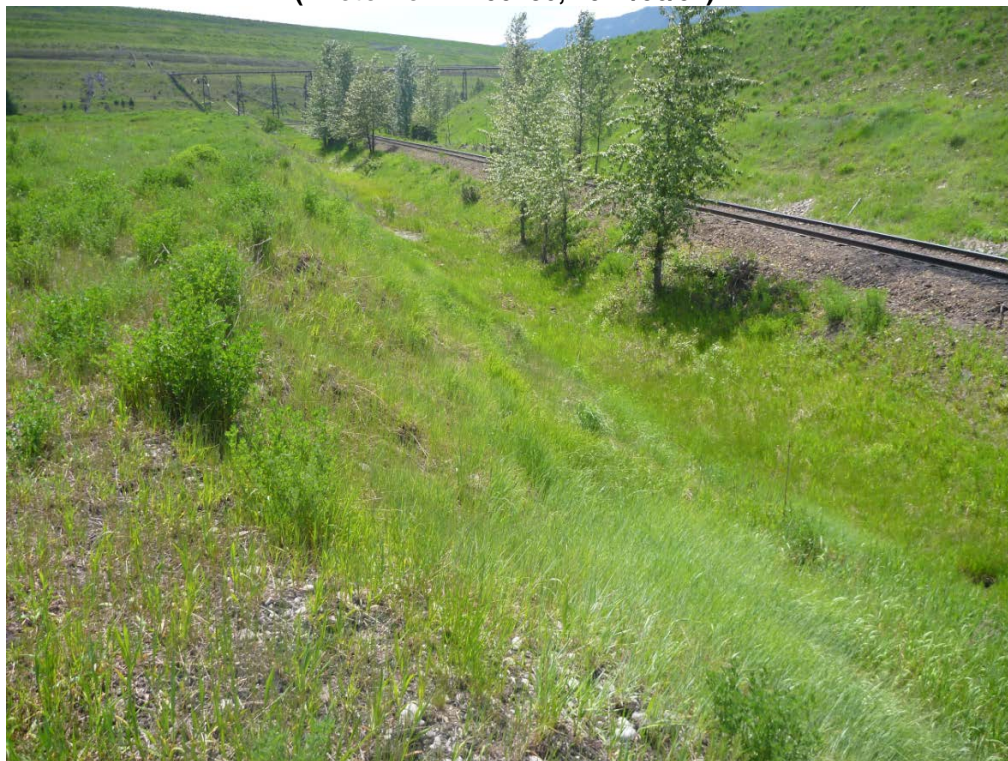
Photograph H - 6: Showing west embankment of Lagoon B, looking southwest. (Photo No. P1100784, 2017/06/07)

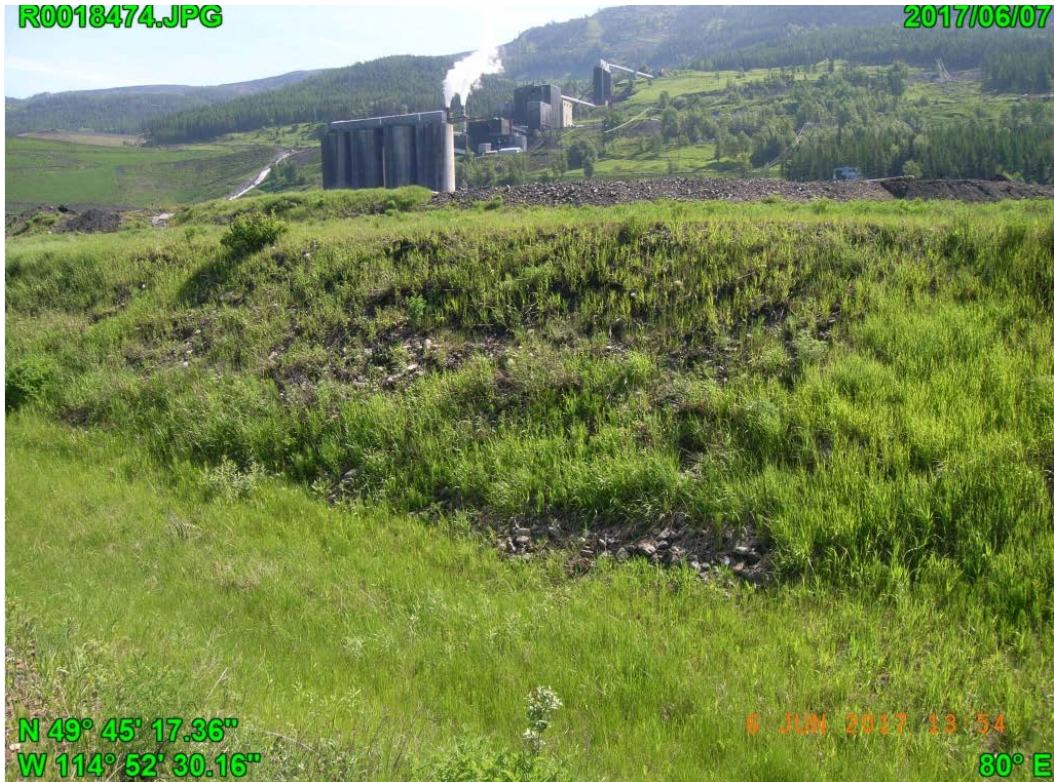
Photograph H - 7: Showing erosion on the slope of west embankment of Lagoon B, looking northeast.

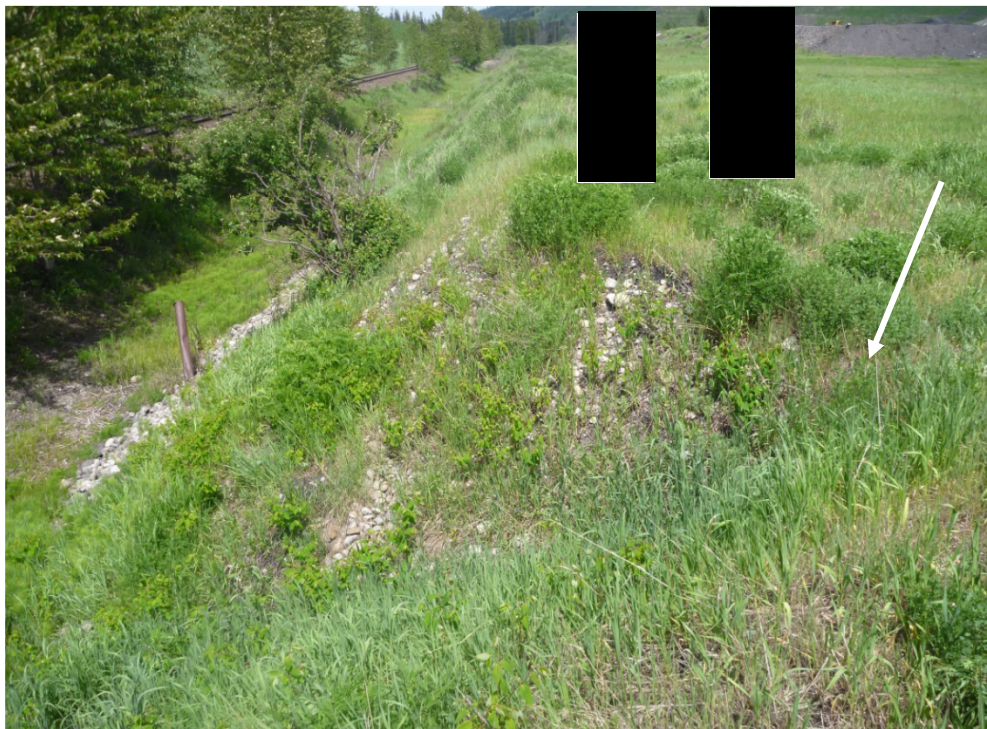
Photograph H - 8: Showing a pipeline at the toe at south end of the west embankment and an erosion gully, looking north. (Photo No. P1100775, 2017/06/07)

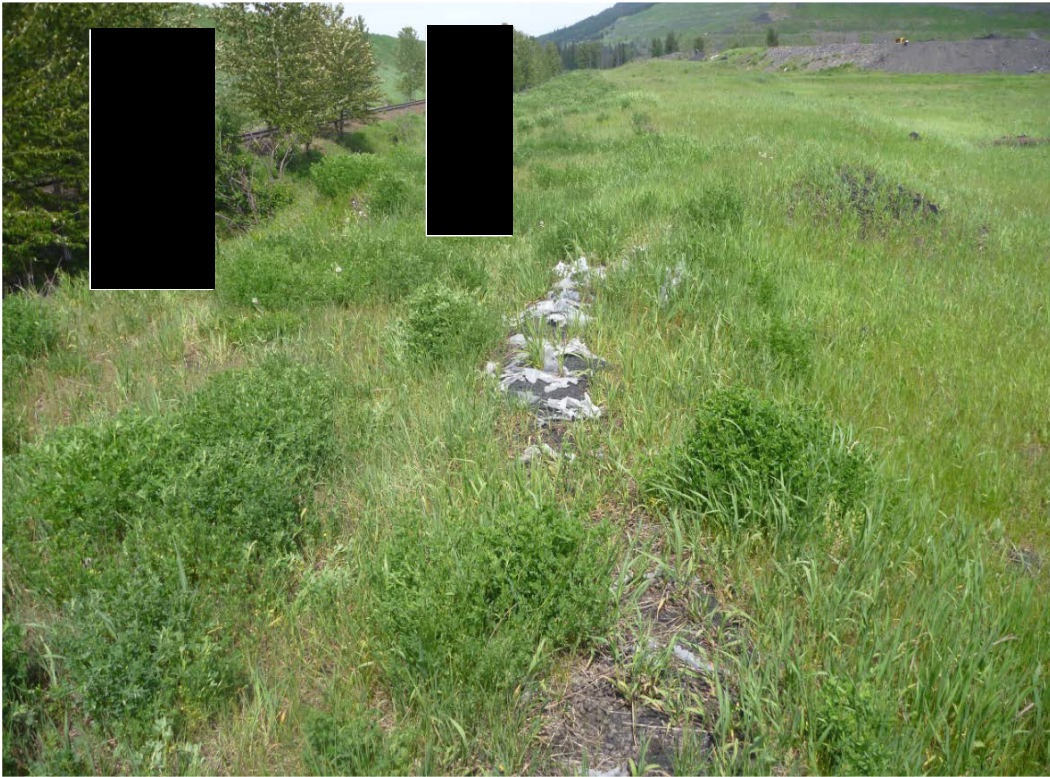
Photograph H - 9: Showing plastic sand bag left at the southwest corner, looking north. (Photo No. P1100770, 2017/06/07)

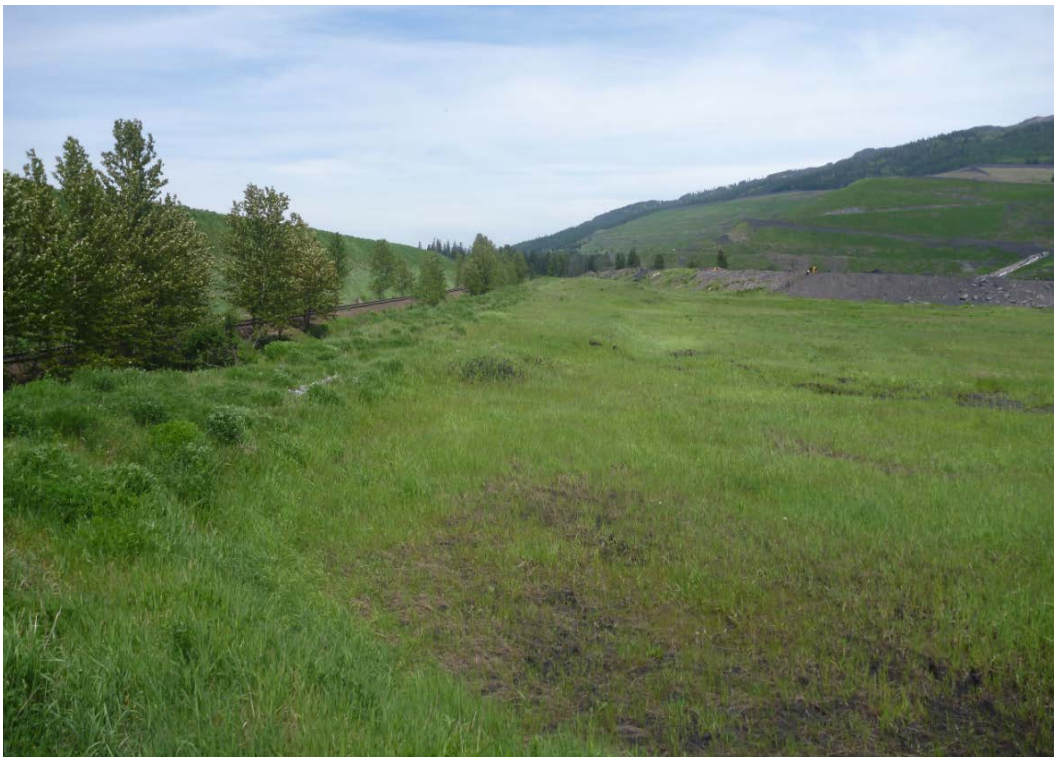
Photograph H - 10: Showing west surface of Lagoon B, view from southwest corner, looking north. (Photo No. P1100769, 2017/06/07)

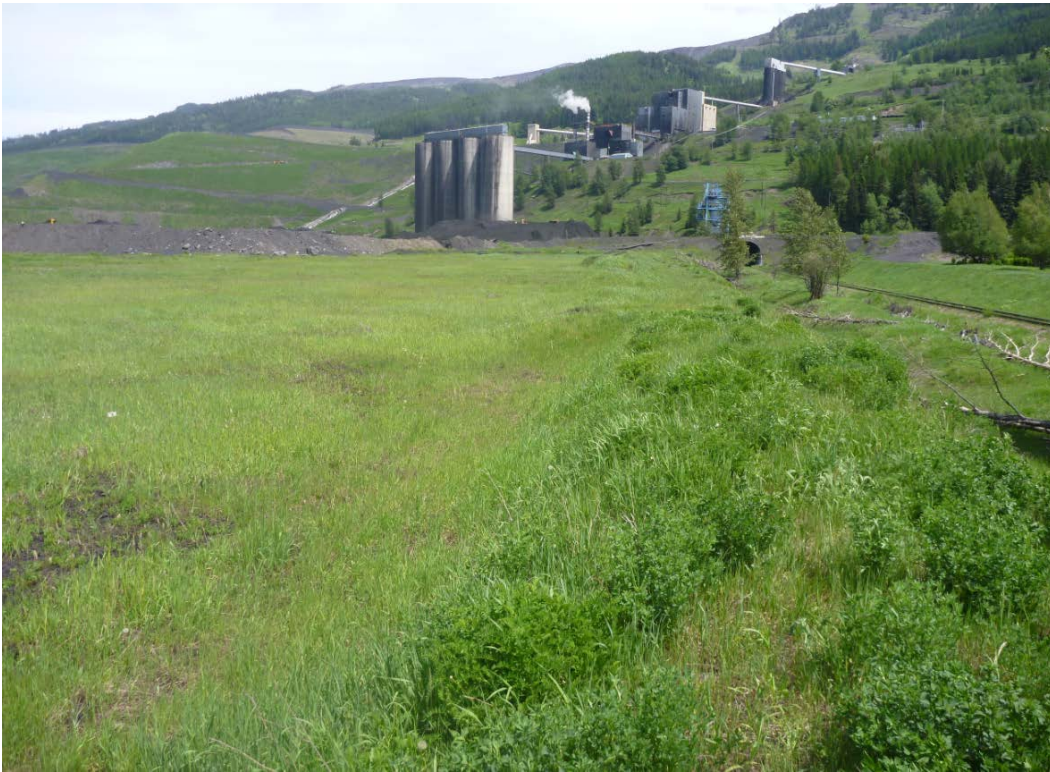
Photograph H - 11: Showing south surface of Lagoon B, view from southwest corner, looking northeast. (Photo No. P1100767, 2017/06/07)

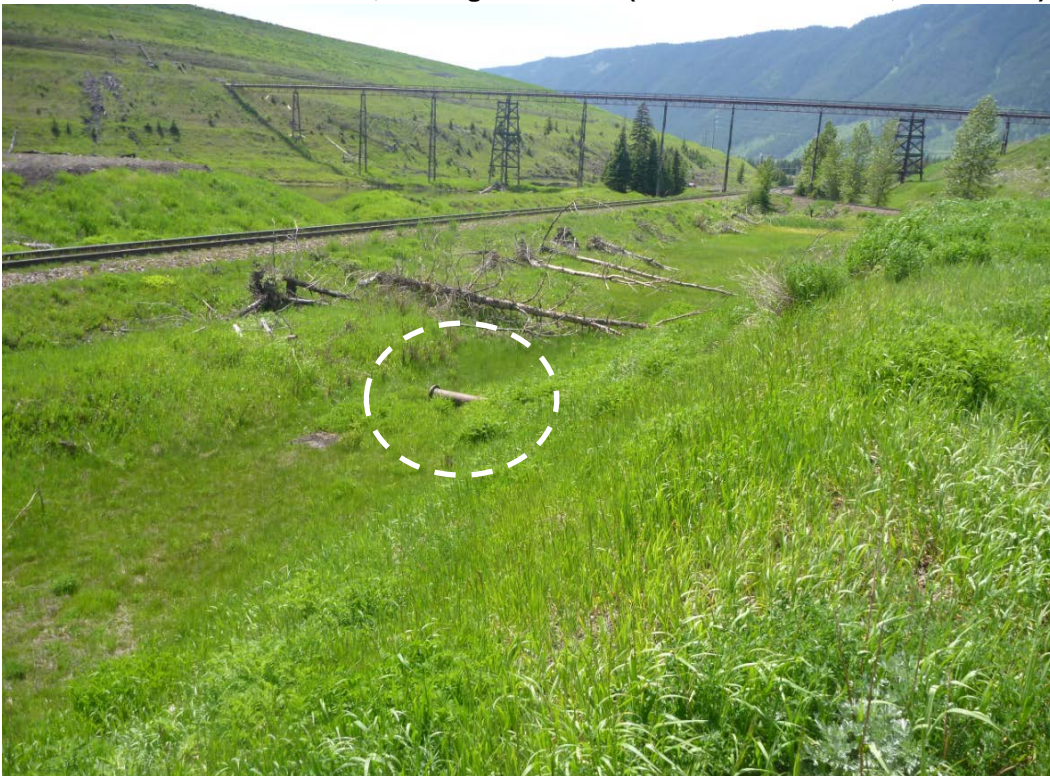
Photograph H - 12: Showing south end of Lagoon B, looking southwest. Noted the outlet steel pipe on the south slope. (Photo No. P1100764, 2017/06/07)

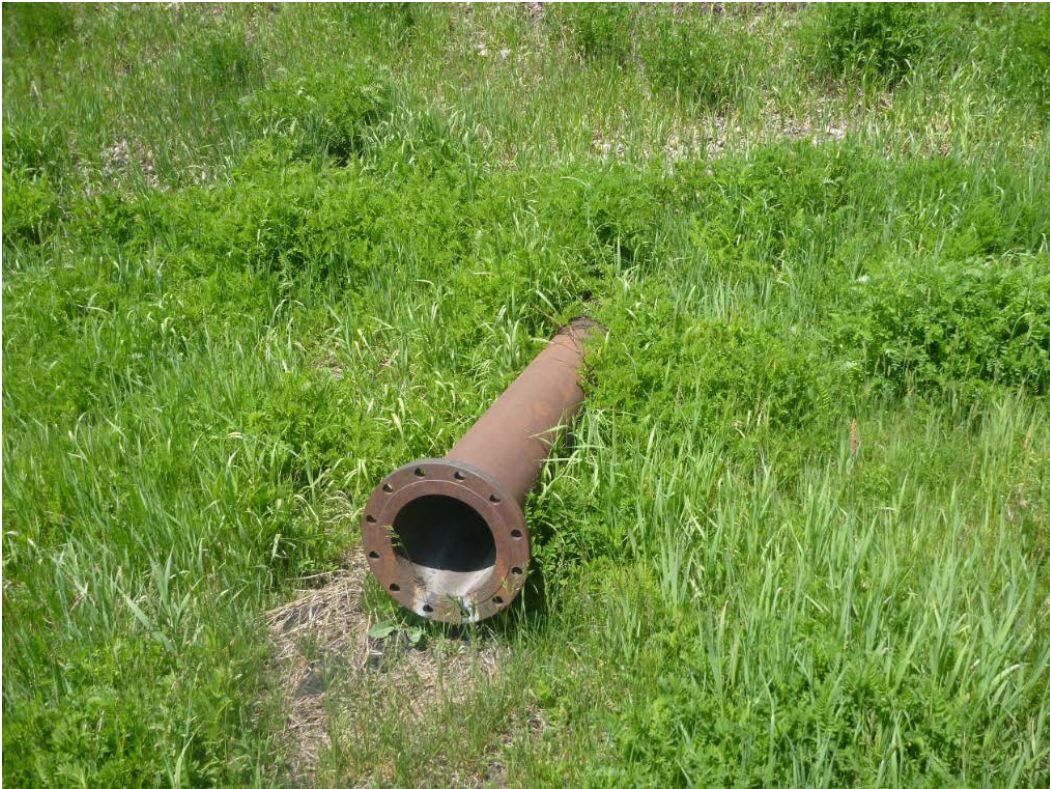
Photograph H - 13: Showing dry outlet at southwest corner of Lagoon B, looking north. (Photo No. P1100766, 2017/06/07)

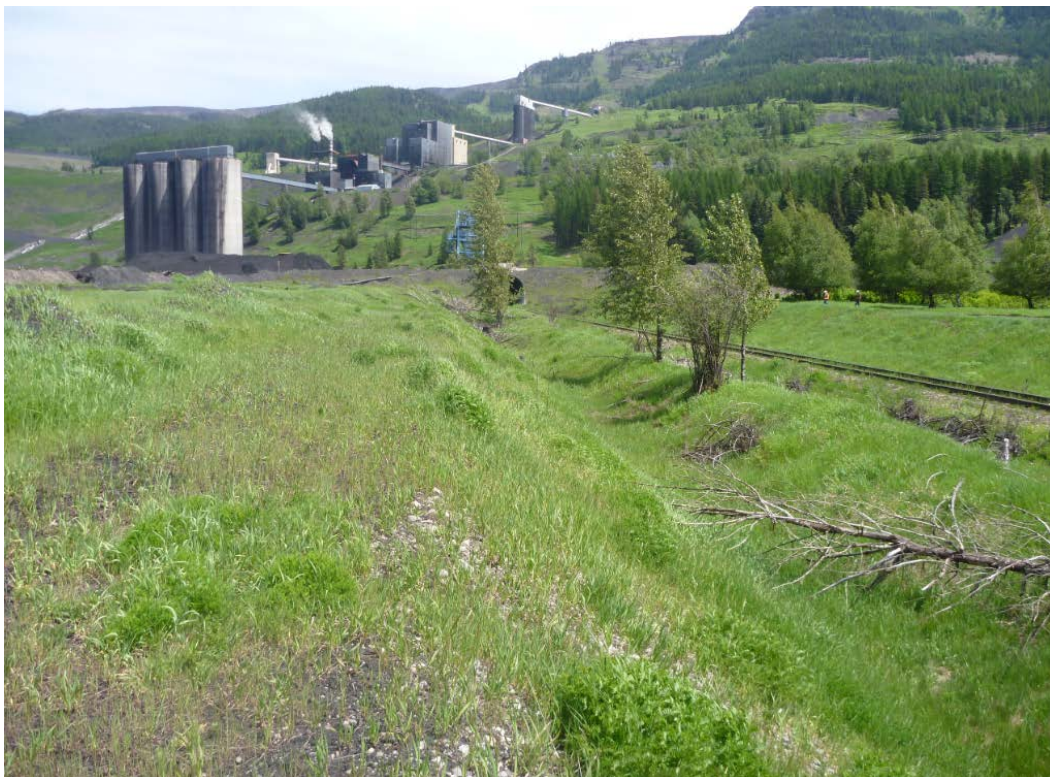
Photograph H - 14: Showing northwest area of Lagoon B, looking northeast. (Photo No. P1100762, 2017/06/07)

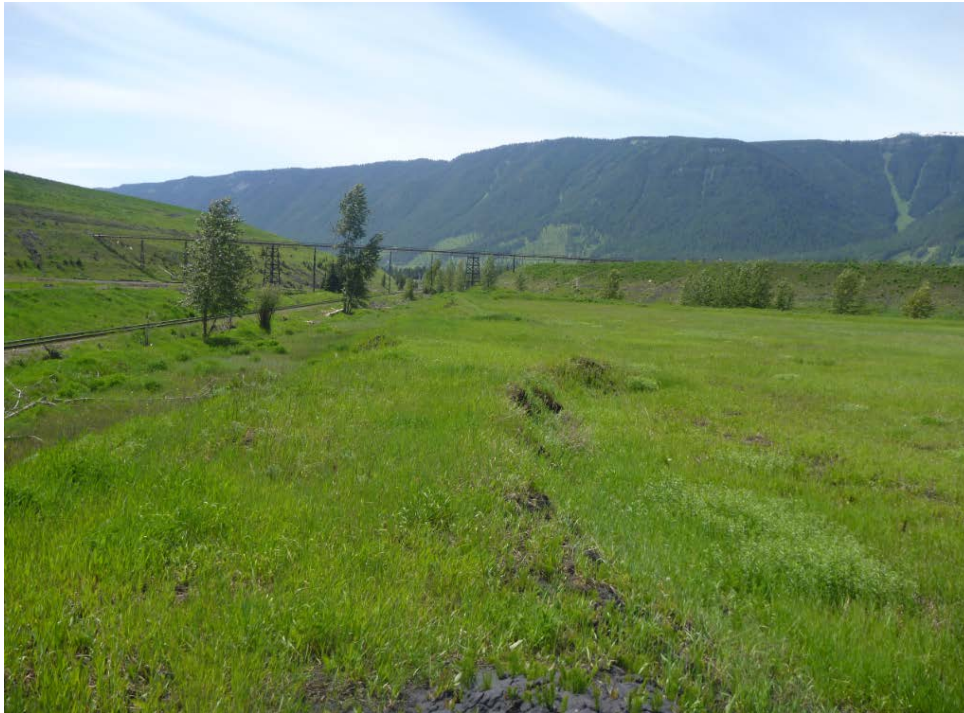
Photograph H - 15: Showing crest and slope on south side of Lagoon B, Looking southwest (Photo No. P1100758, 2017/06/07).

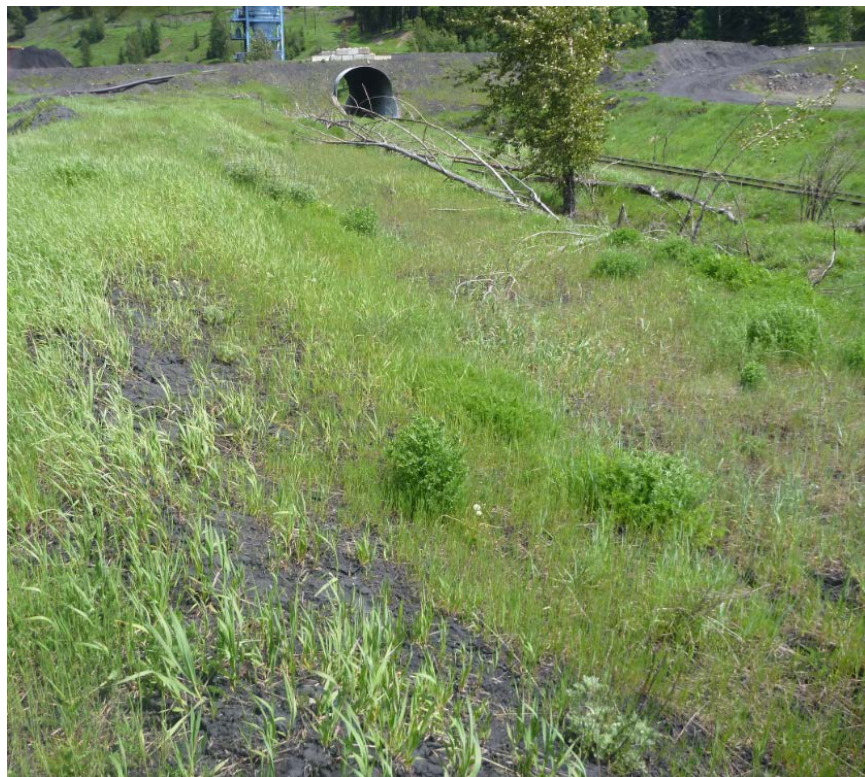
Photograph H - 16: Showing north end of the south side of Lagoon B, looking northeast. (Photo No. P1100759, 2017/06/07).

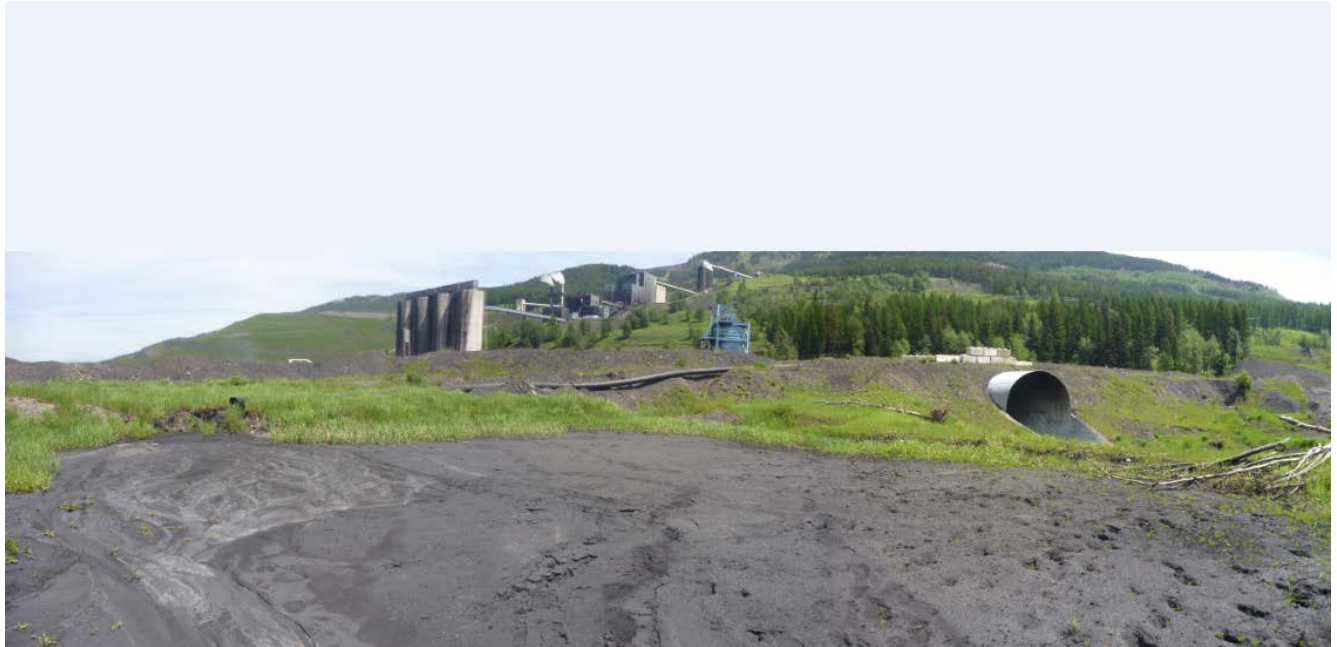
Photograph H - 17: Showing tailings discharge pipe and discharge area located at the southeast corner of Lagoon B, looking northeast. (Panorama Photo, 2017/06/07)

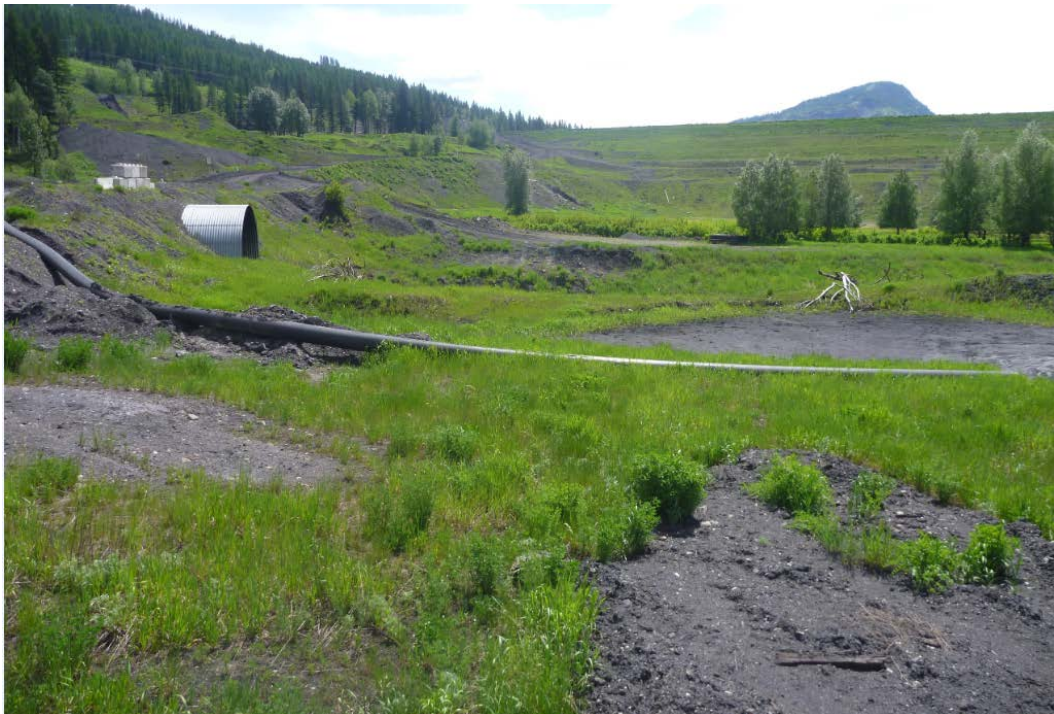
Photograph H - 18: Showing tailings discharge area located at the southeast corner of Lagoon B, looking southeast (Photo No. P1100748, 2017/06/07).

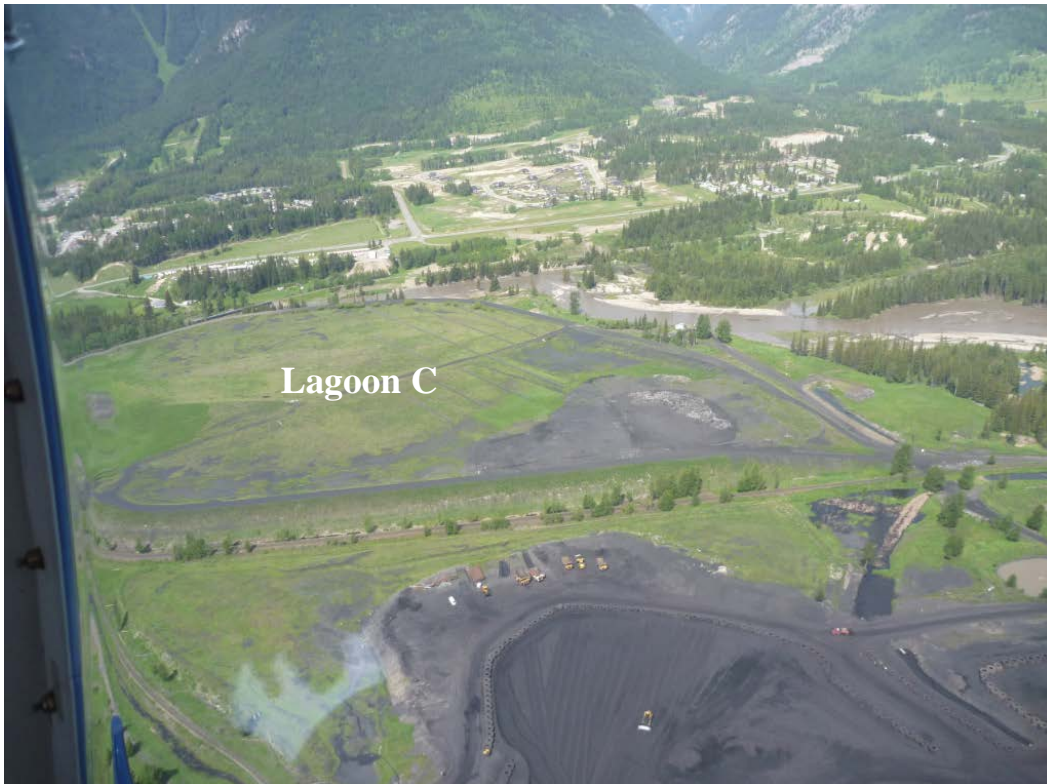
Photograph I - 4: Showing aerial overview of Lagoon C, looking west.
(Photo No. P1100452, 2017/06/06)

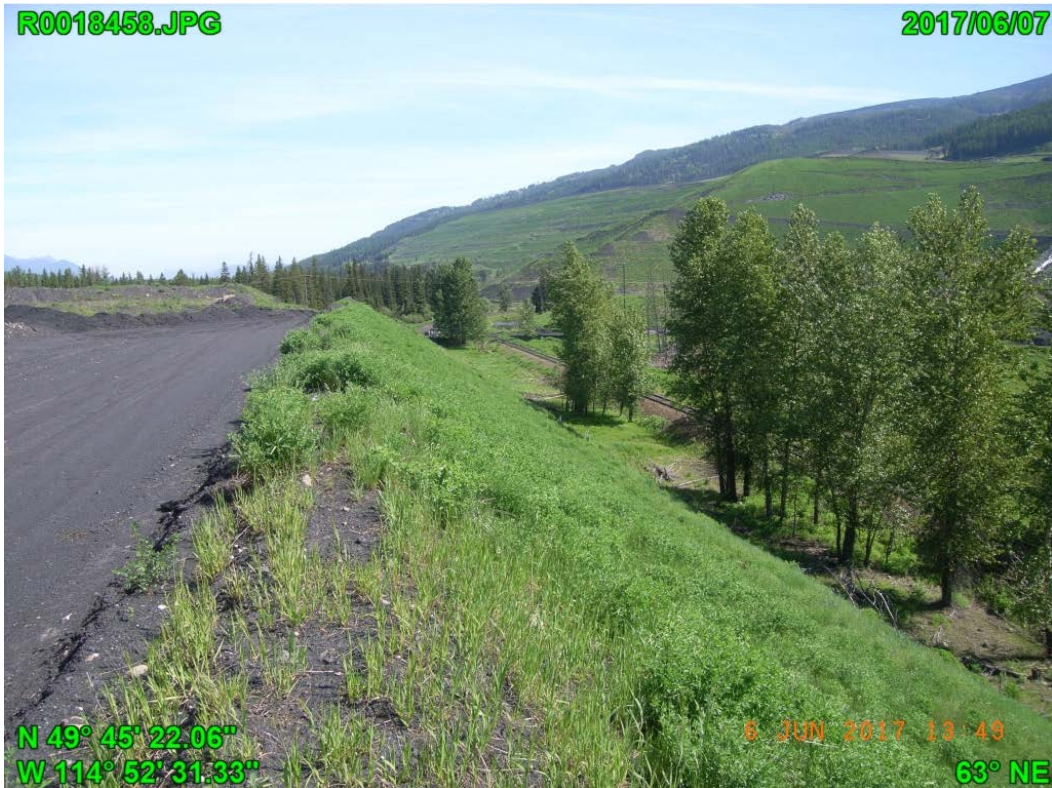
Photograph I - 5: Showing the crest and shoulder of the north end of east slope of Lagoon C, looking north.

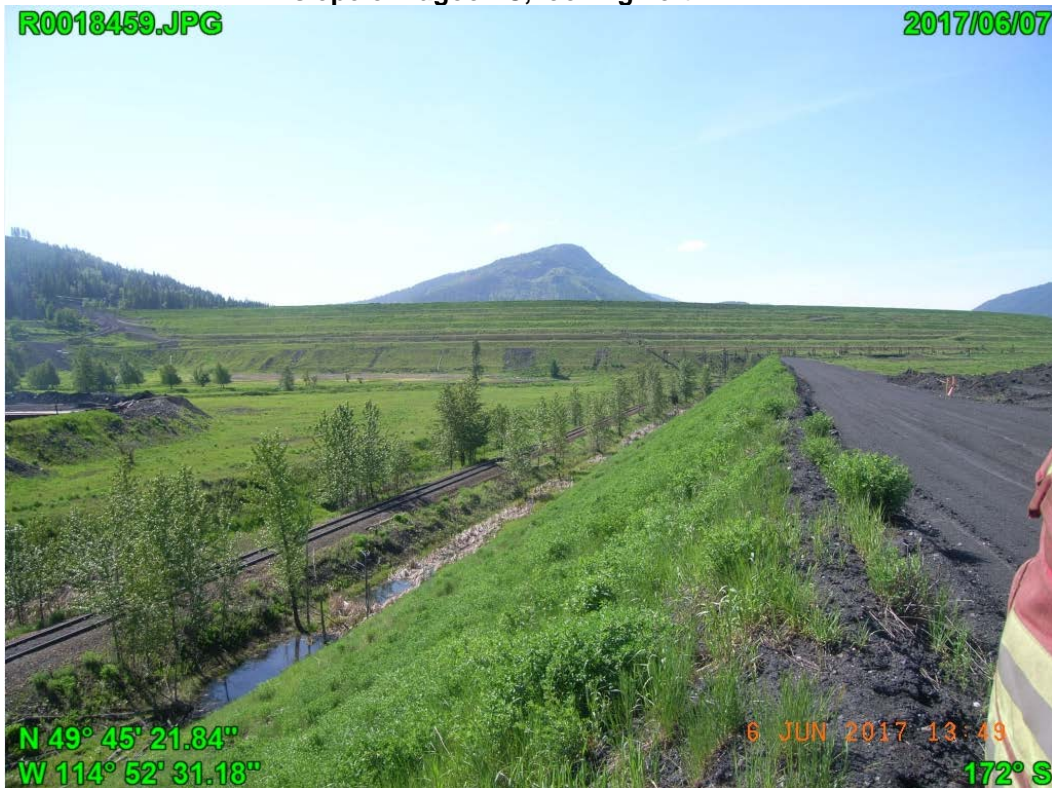
Photograph I - 6: Showing the crest and shoulder of the north end of east slope of Lagoon C, looking south.

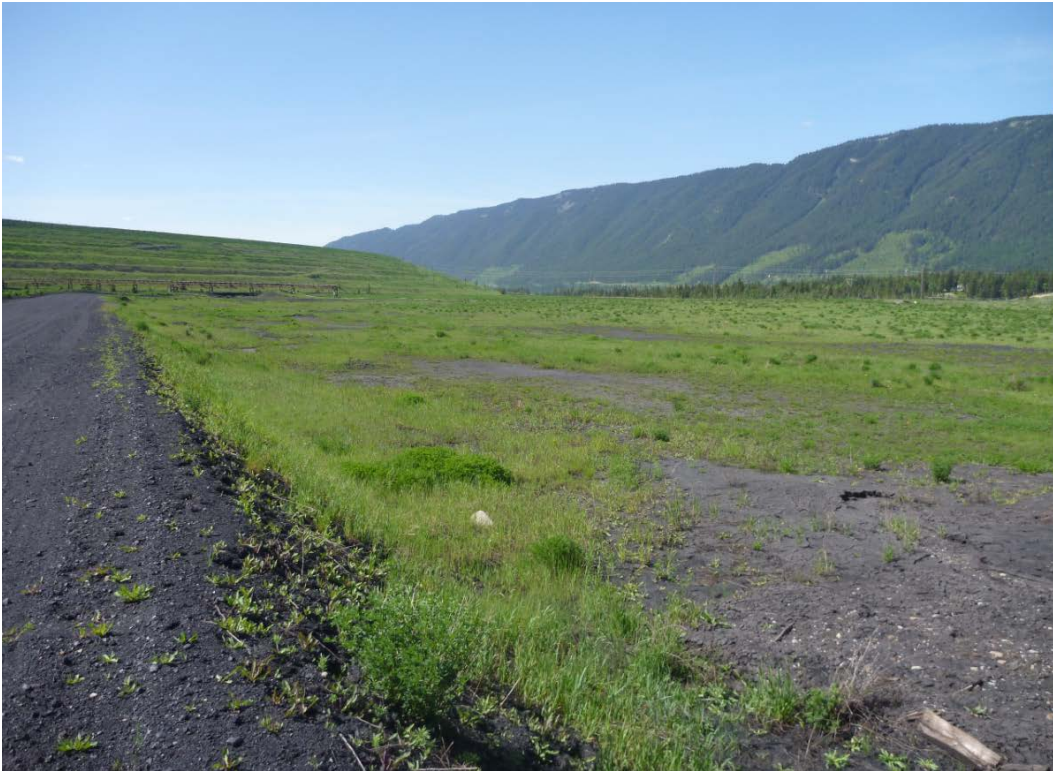
Photograph I - 7: Showing the crest and upstream from the north end of Lagoon C, looking south. (Photo No. P1100611, 2017/06/07)

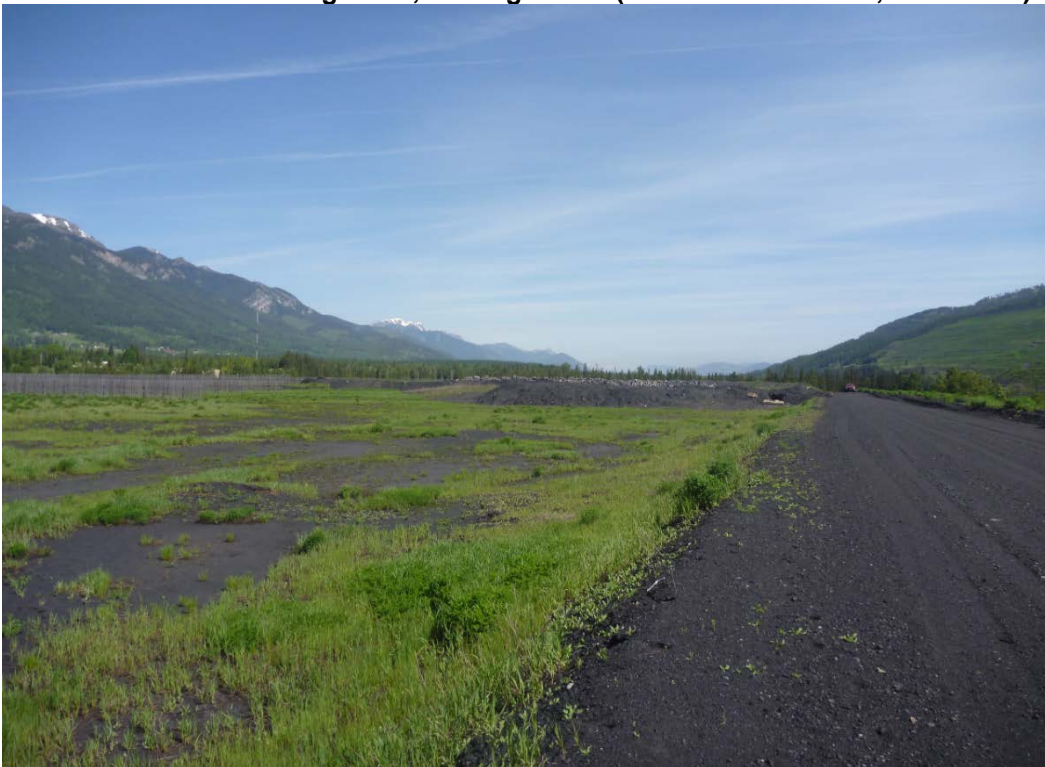
Photograph I - 8: Showing the crest and upstream at the north end of Lagoon C, looking north. (Photo No. P1100615, 2017/06/07)

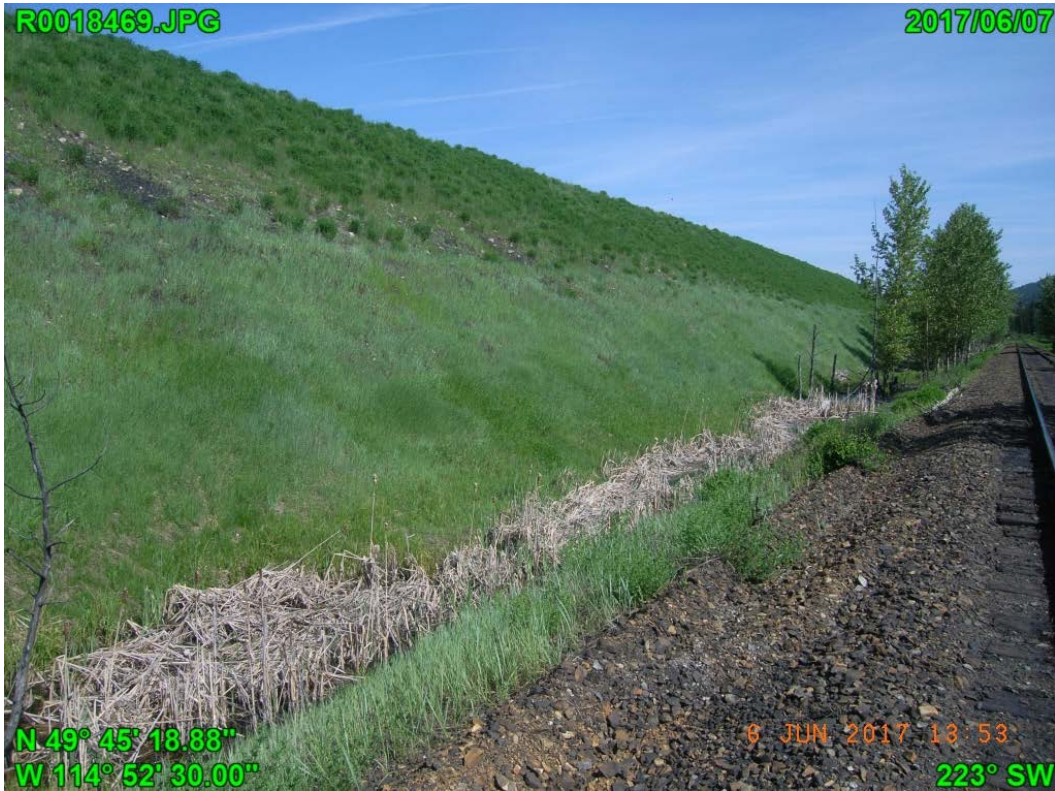
Photograph I - 9: Showing erosion at east slope toe of Lagoon C, looking north.

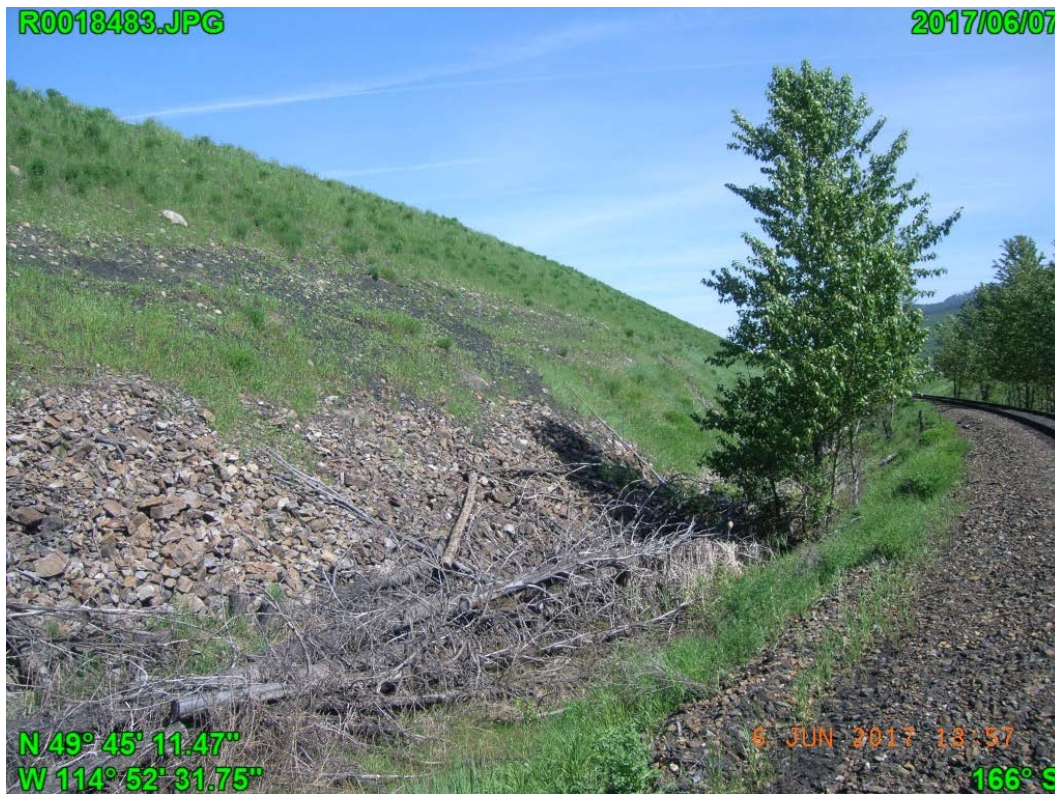
Photograph I - 10: Showing erosion at the south end of the east slope toe of Lagoon C, looking north.
