Teck Coal Limited – Elkview Operations

**Tailings Storage Facilities
West Fork Tailings Facility
and Lagoons A, B, C and D**

2017 Dam Safety Inspection

Final Report

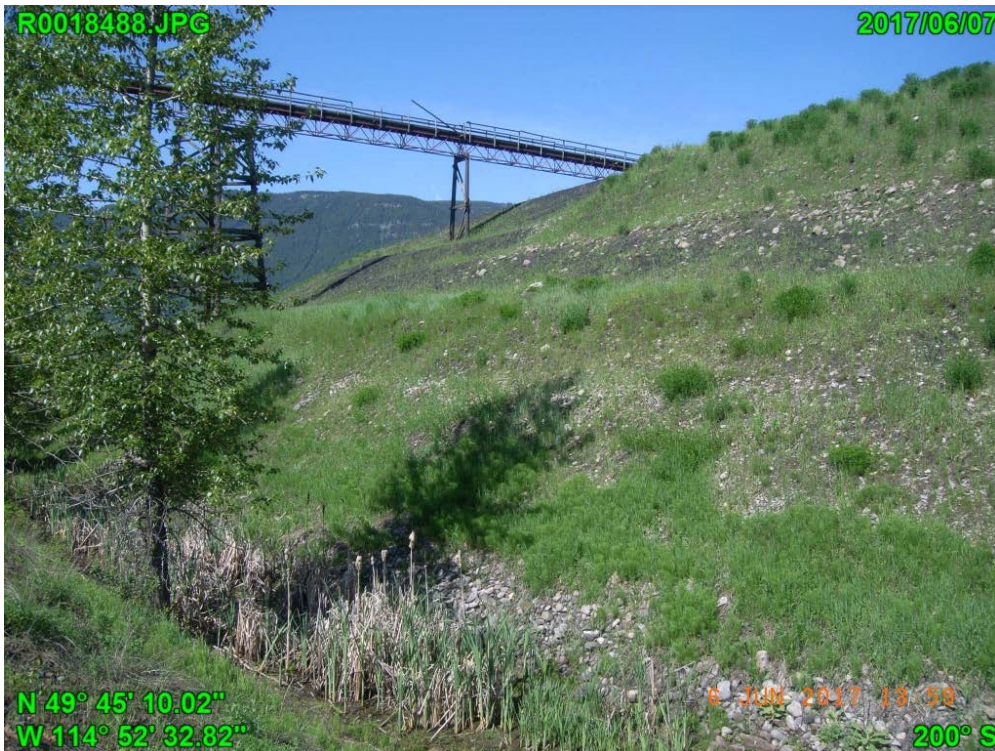
Photograph I - 11: Showing toe and downstream slope at the southeast corner of Lagoon C, looking southwest.

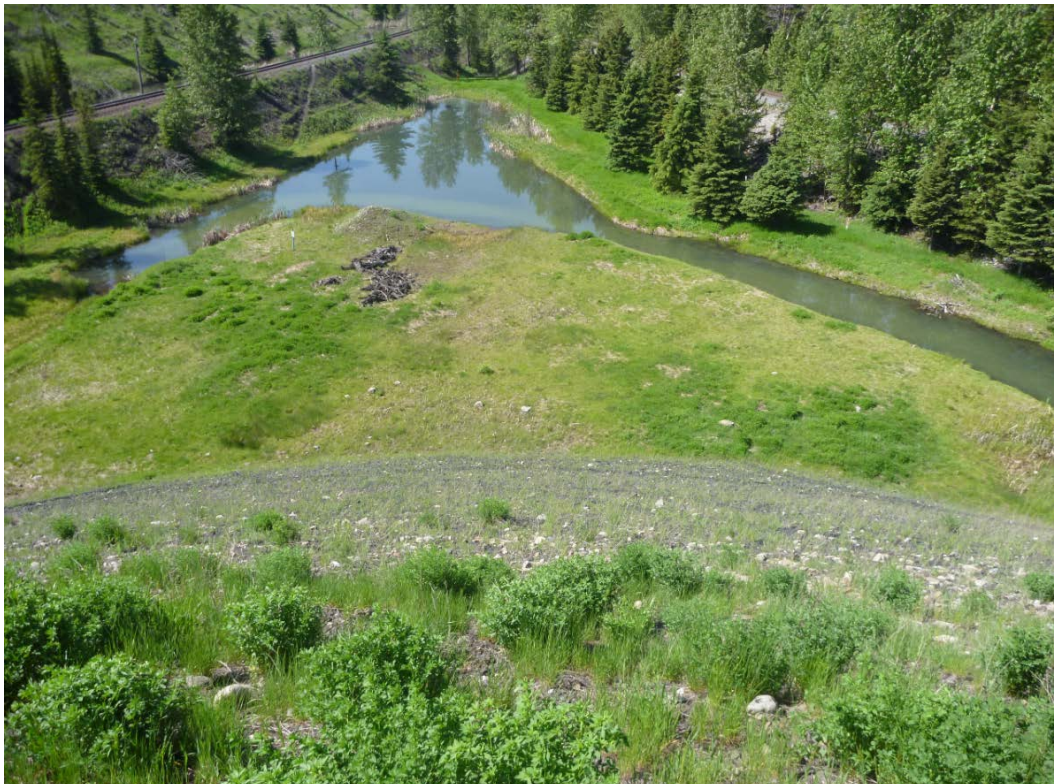
Photograph I - 14: Showing downstream toe at southwest corner of Lagoon C, looking southwest. (Photo No.P1100641, 2017/06/07)

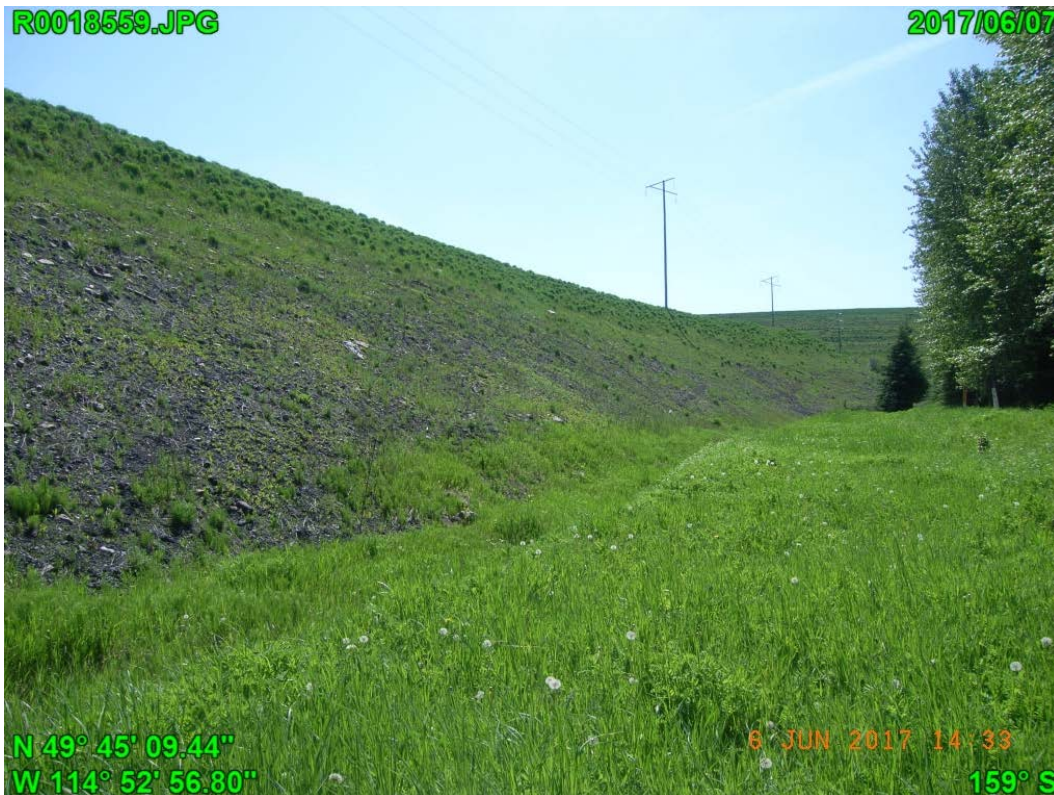
Photograph I - 16: Showing west slope and toe of Lagoon C, looking southeast.

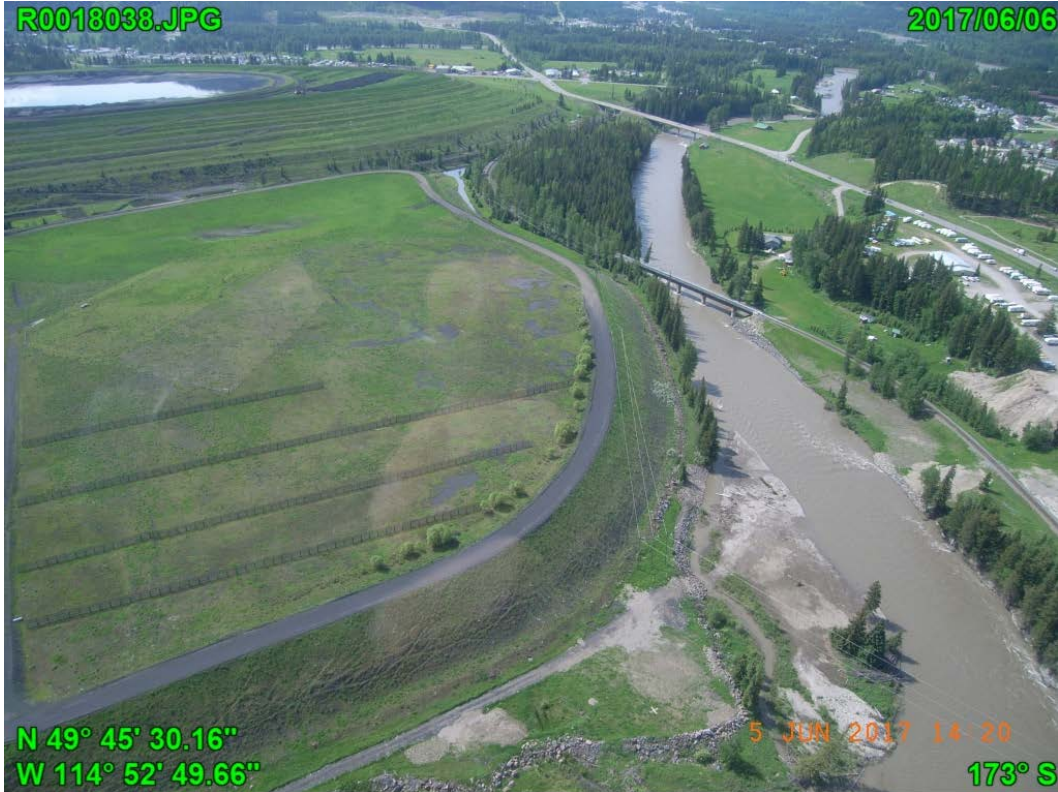
Photograph I - 17: Showing an aerial view of the west slope and toe of Lagoon C, looking south.

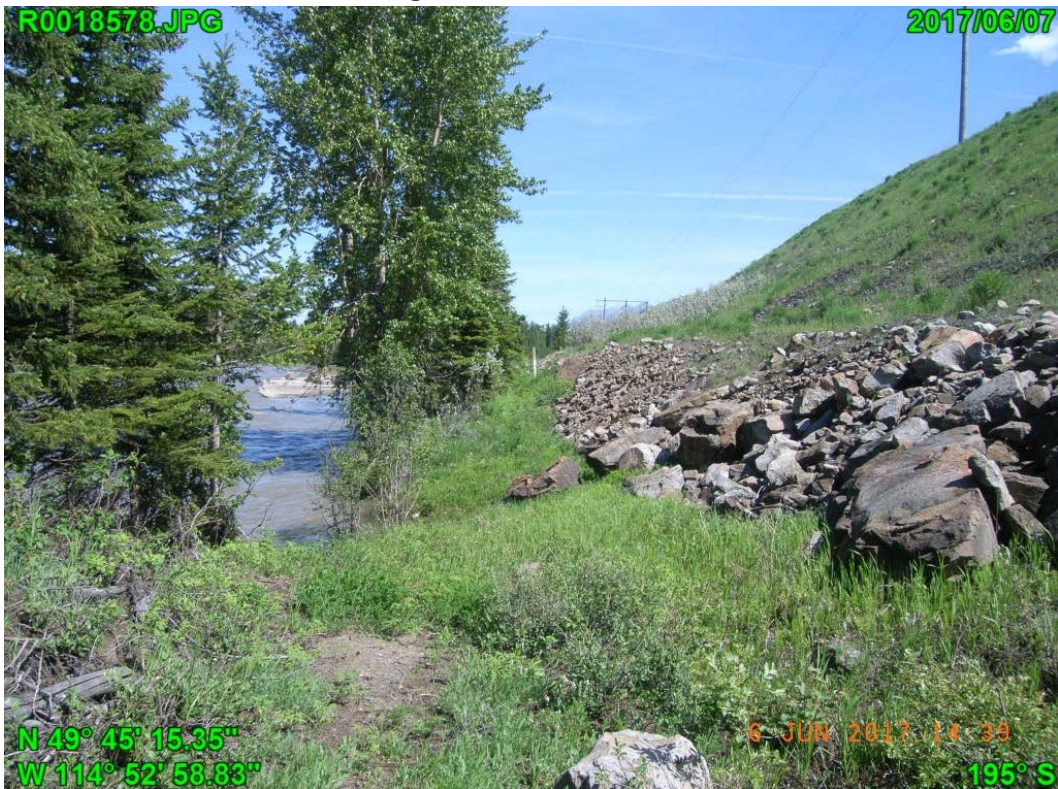
Photograph I - 18: Showing west slope and toe of Lagoon C, showing erosion protection, looking north.

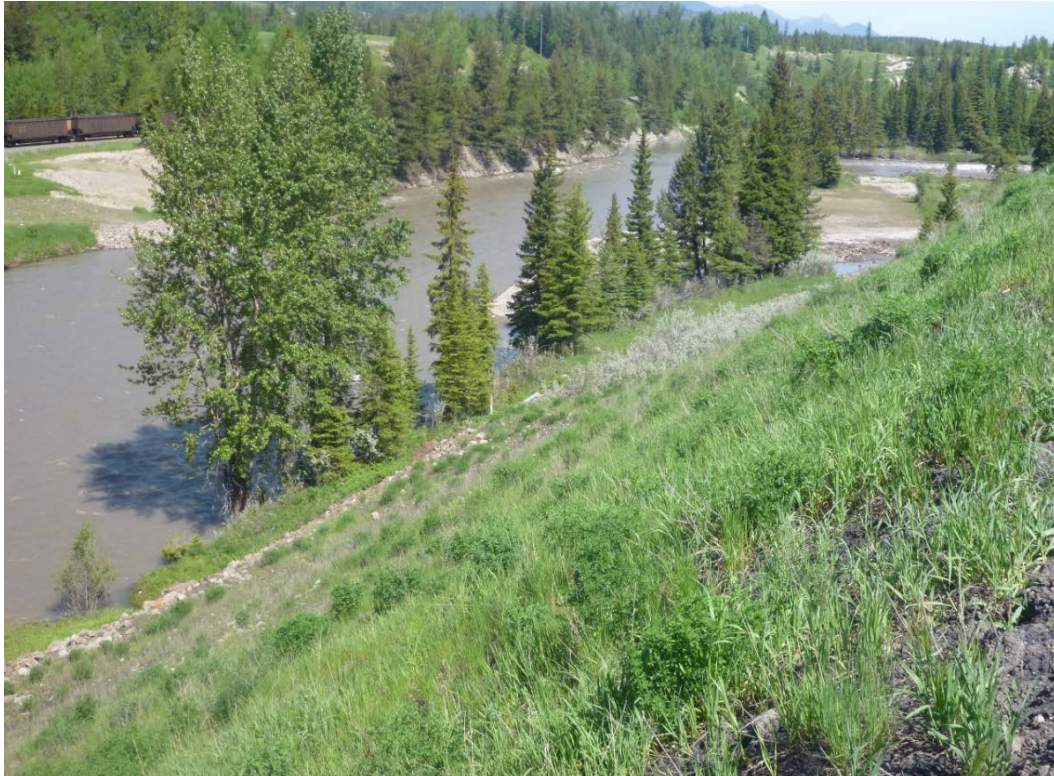
Photograph I - 19: Showing west slope and toe of Lagoon C, looking northwest.
(Photo No. P1100657, 2017/06/07)

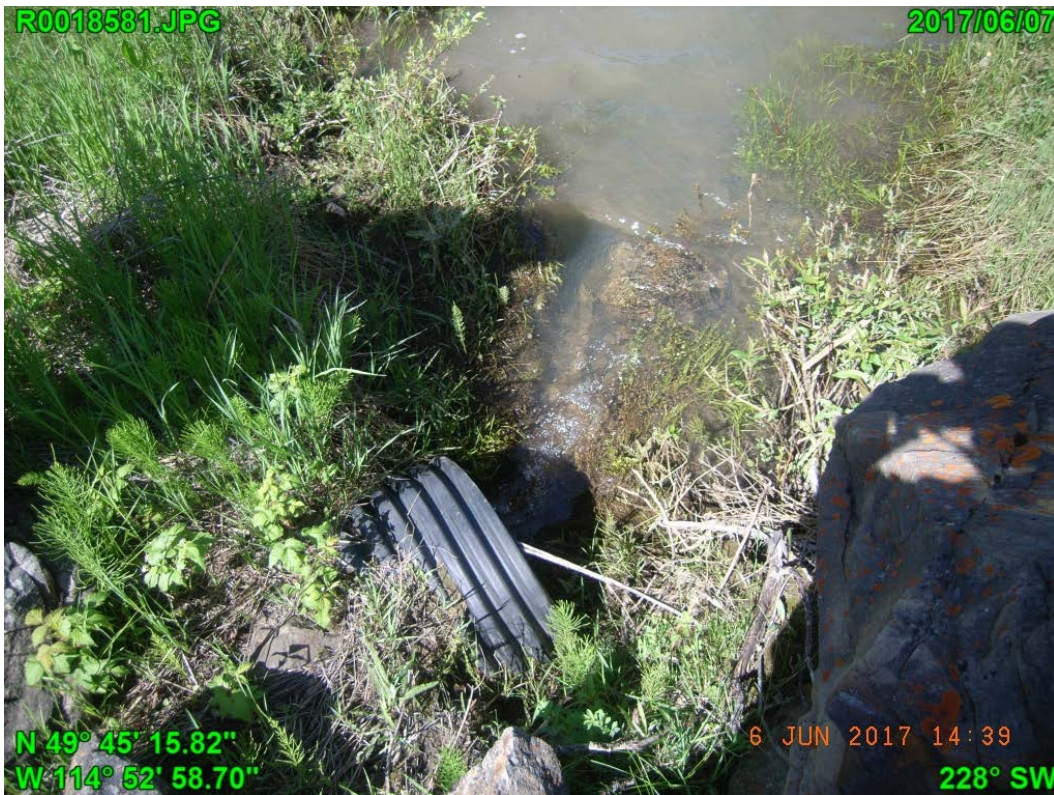
Photograph I - 20: Showing discharge outlet at the west slope toe of Lagoon C.

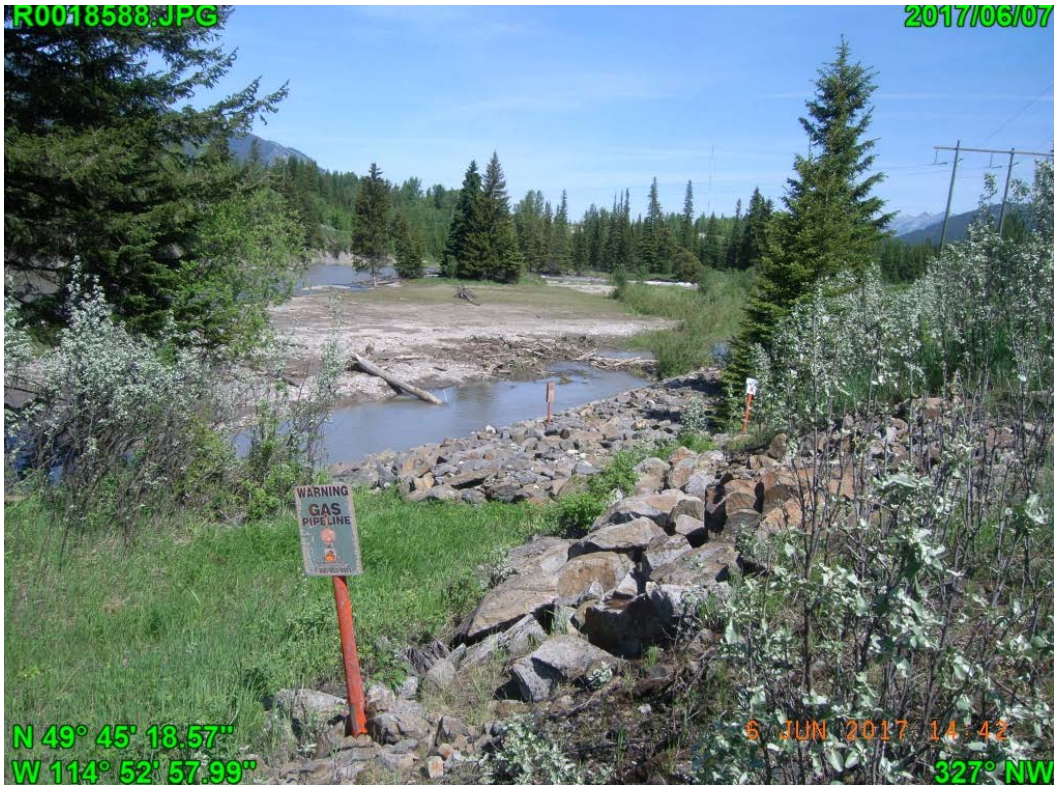
Photograph I - 21: Showing the sign of natural gas line at west slope toe of Lagoon C, looking north.

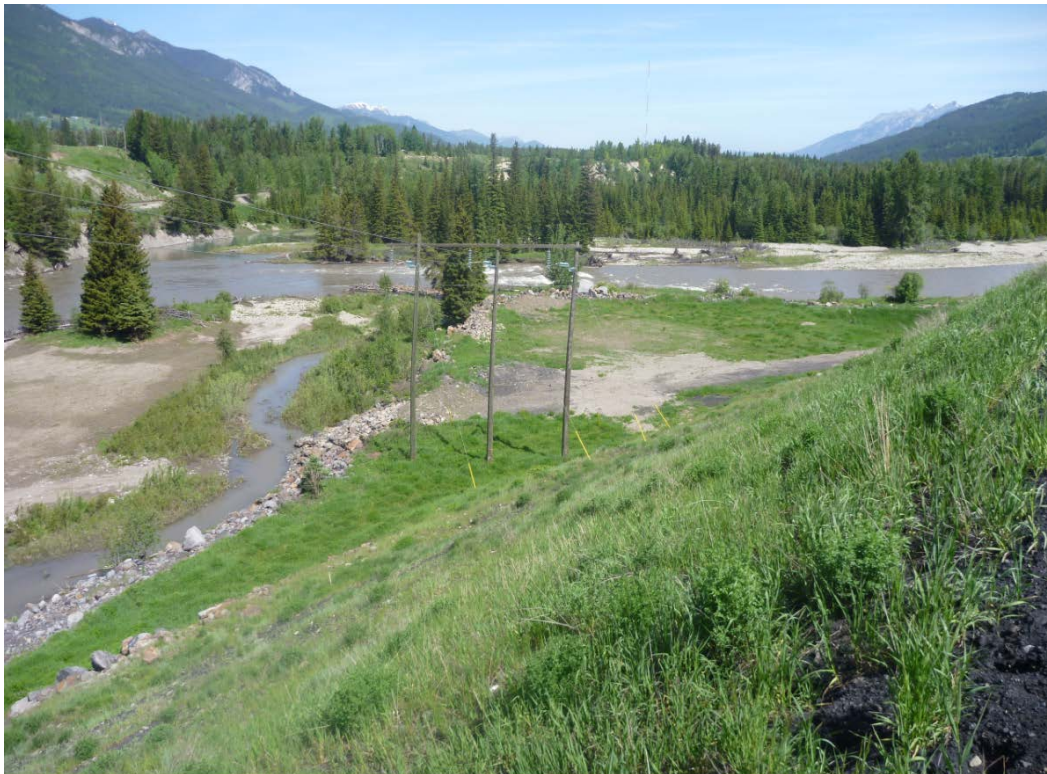
Photograph I - 22: Showing west slope and toe of Lagoon C at northwest corner, looking north. (Photo No.P1100665, 2017/06/07)

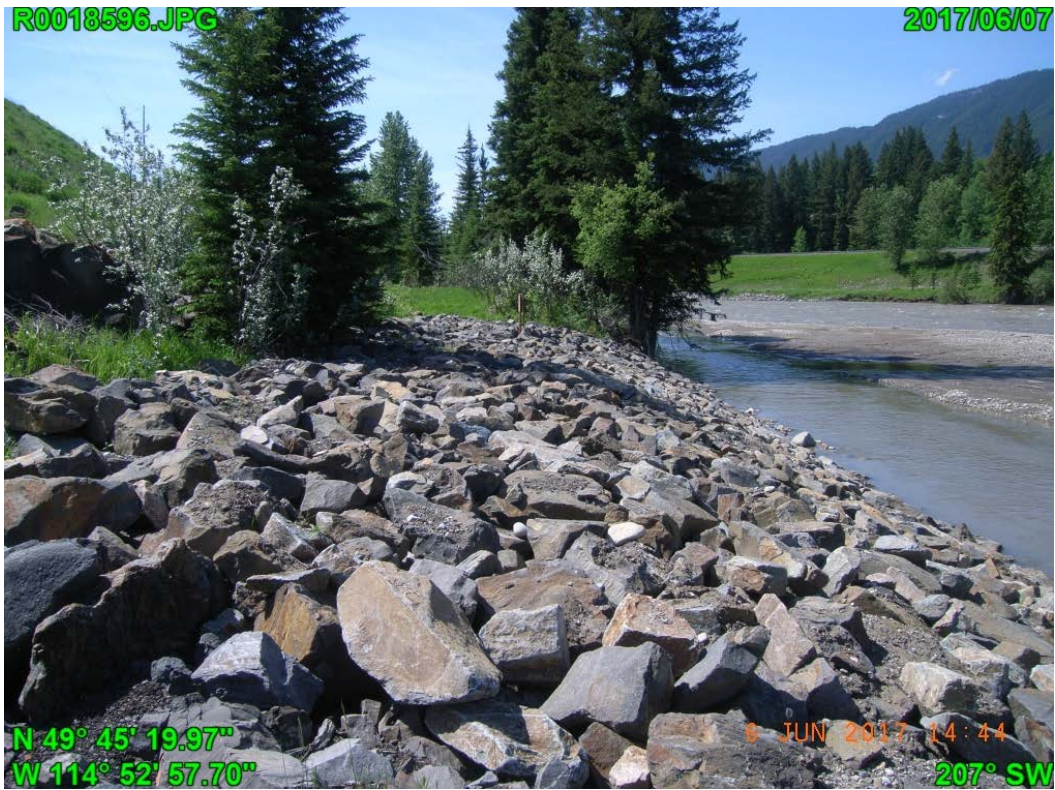
Photograph I - 23: Showing erosion riprap along the shoreline of the Elk River, at the west toe of Lagoon C, looking southwest.

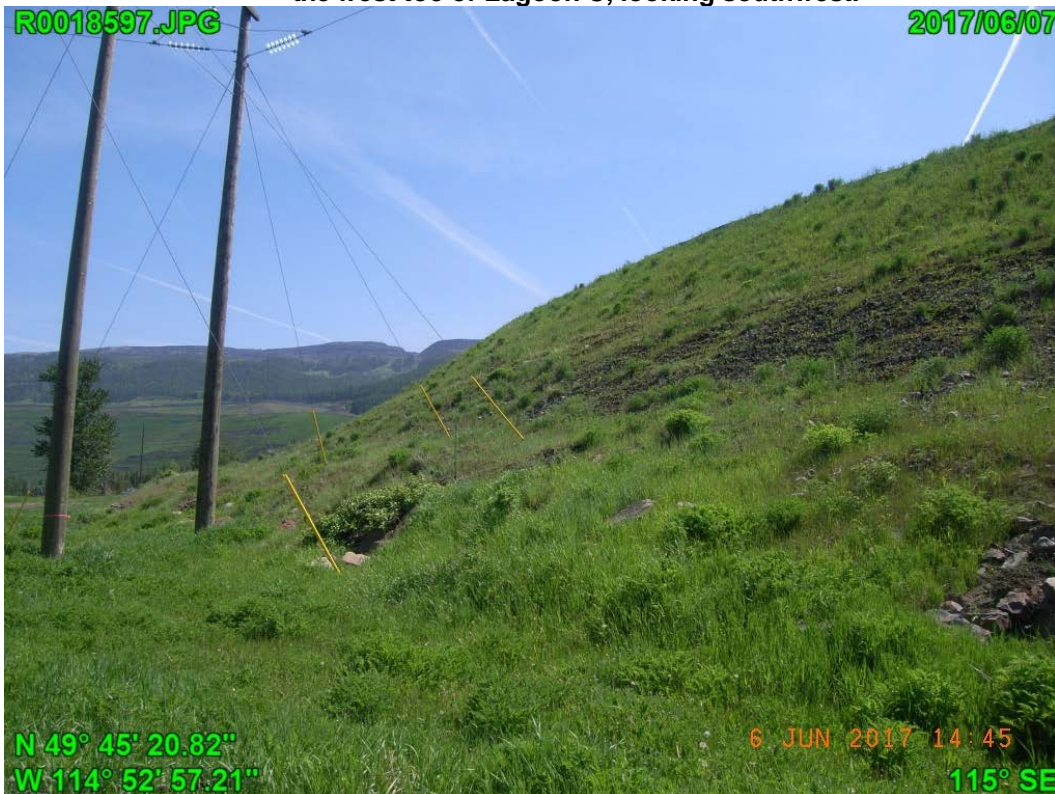
Photograph I - 24: Showing erosion on slope at northwest corner of Lagoon C, looking northeast.

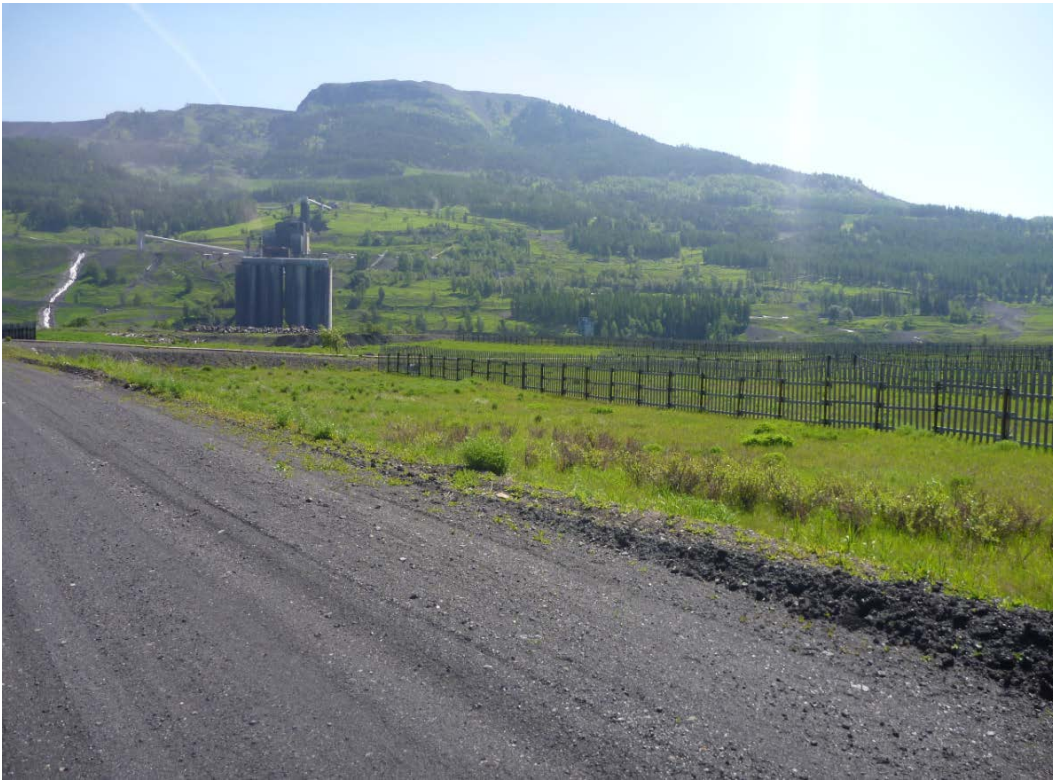
Photograph I - 25: Showing crest and upstream at the northwest corner of Lagoon C, looking northeast. (Photo No. P1100670, 2017/06/07)

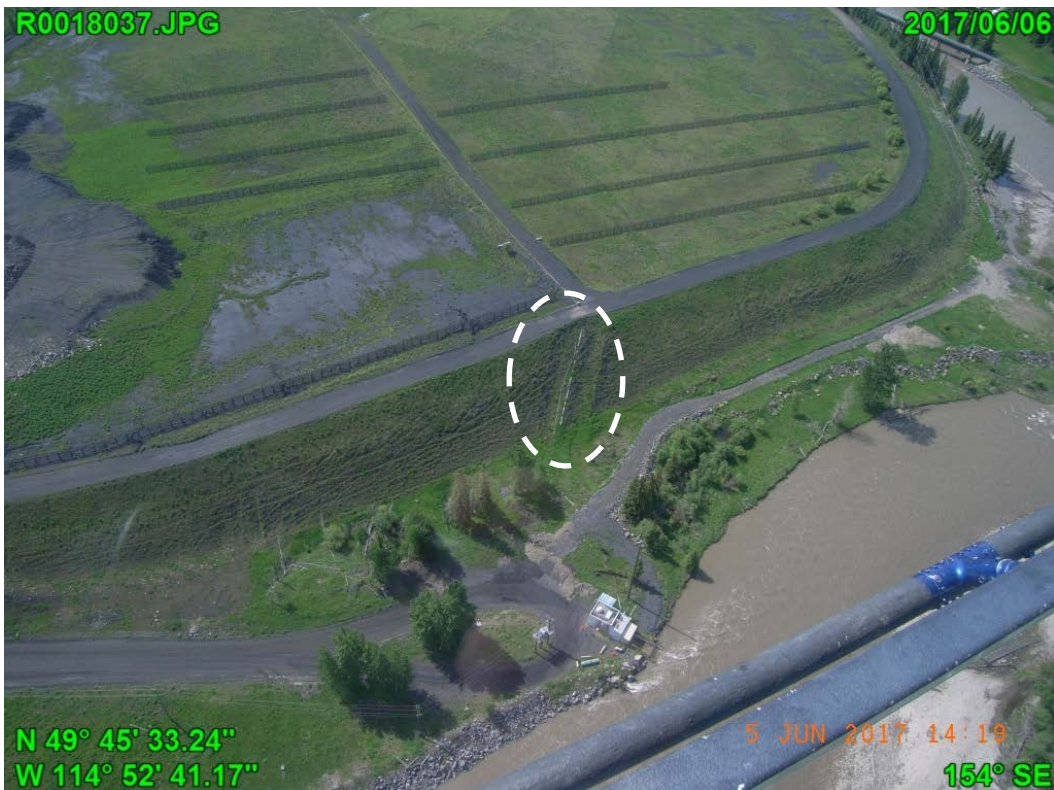
Photograph I - 26: Showing pipeline routed on north slope of Lagoon C, looking Southwest.

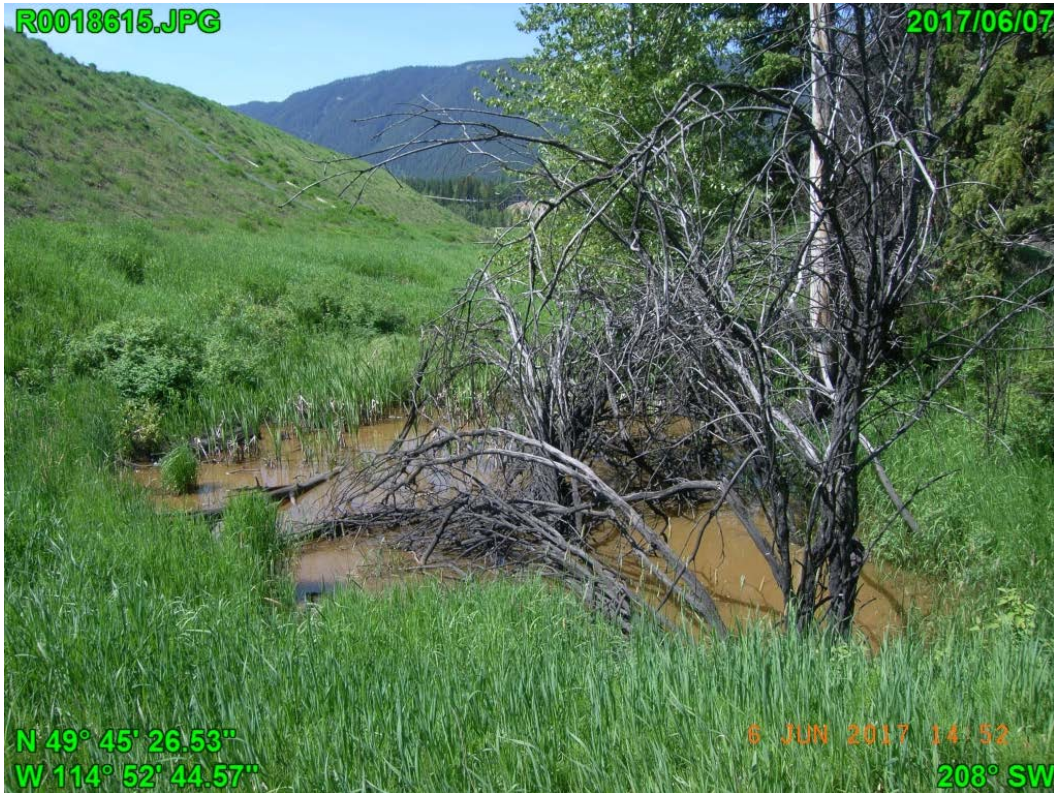
Photograph I - 27: Showing ponded water at toe of north slope of Lagoon C, looking west.

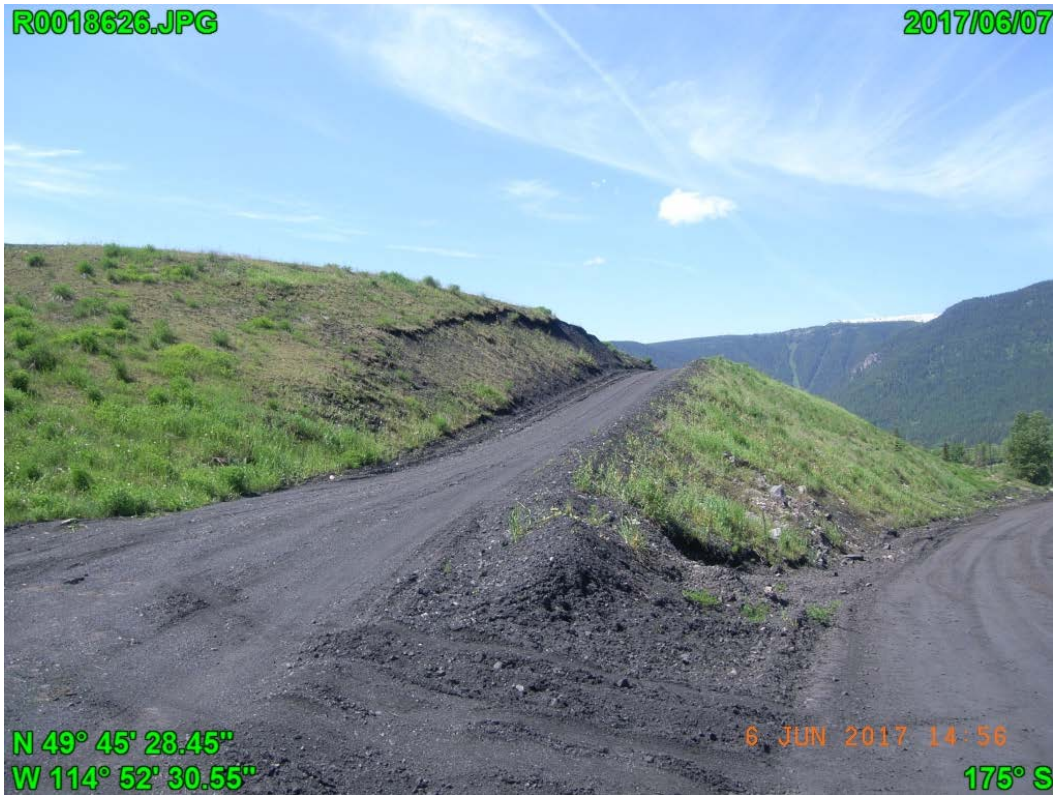
Photograph I - 29: Showing the toe of northeast corner of Lagoon C, looking west.

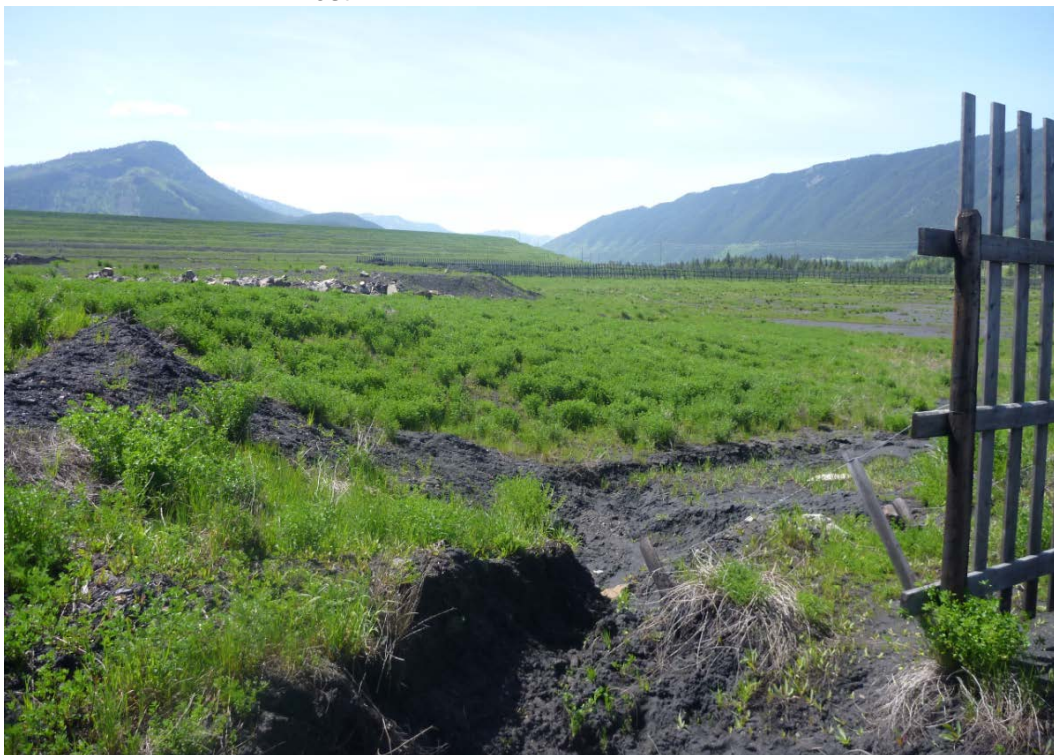
Photograph I - 30: Showing the surface of northwest area of Lagoon C, looking southwest. (Photo No.P1100678, 2017/06/07)

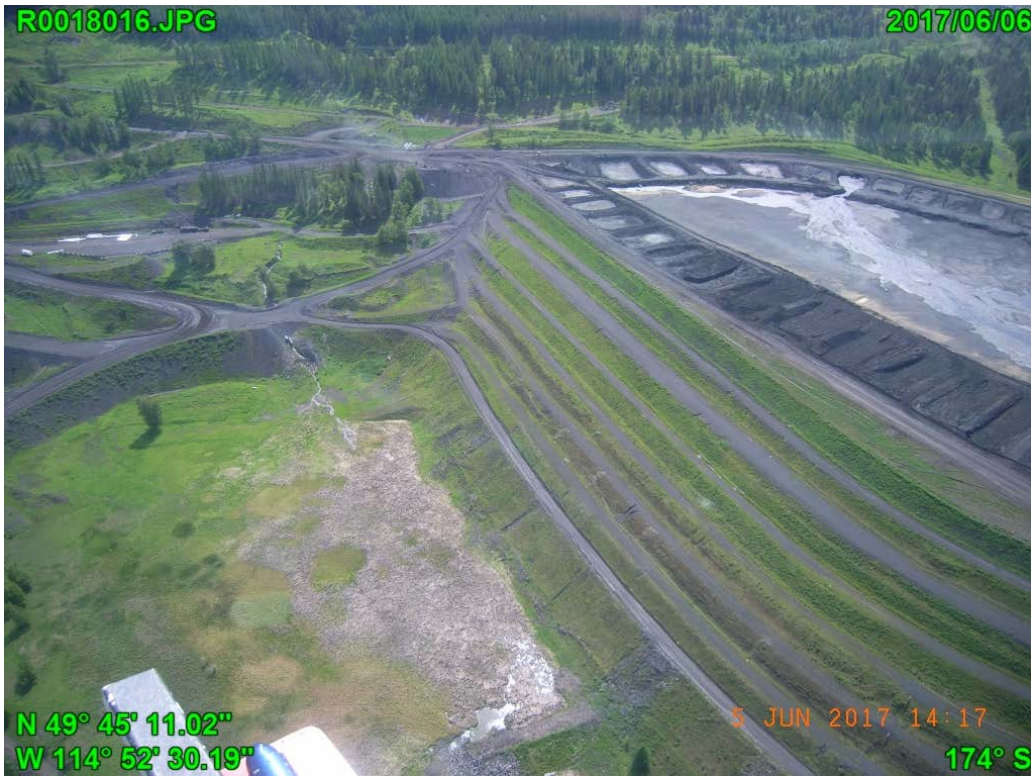
Photograph J - 3: Showing surface of the west corner and east end of the north slope of Lagoon D, looking east.

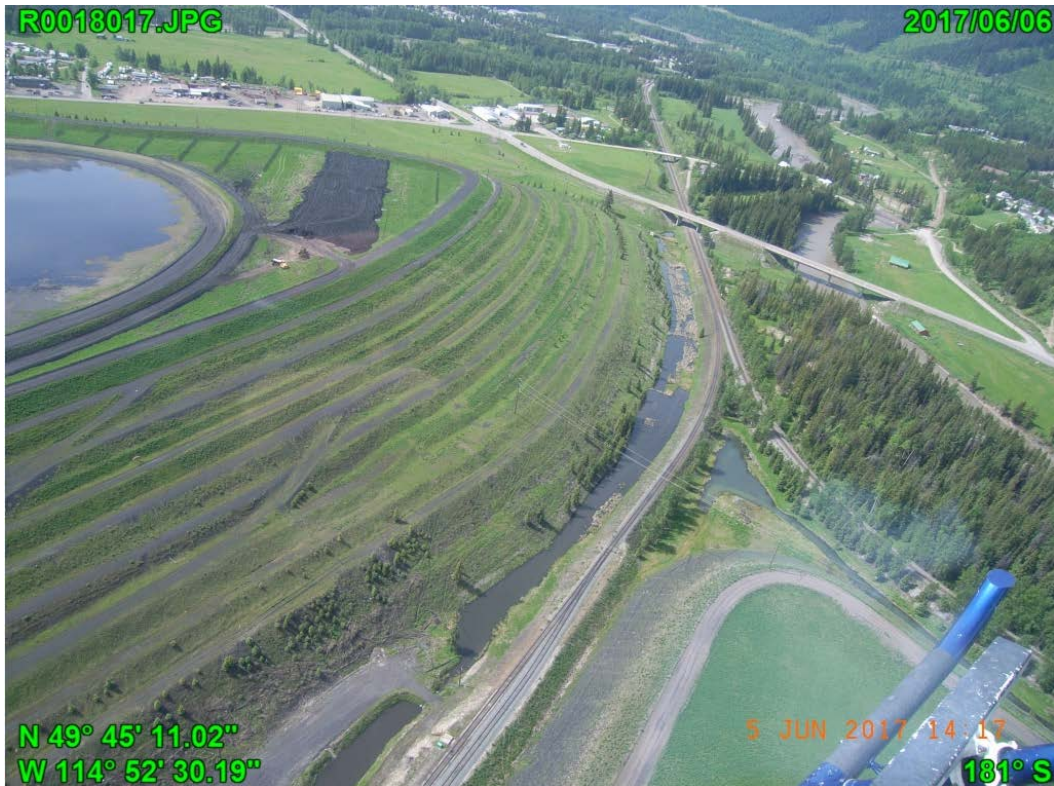
Photograph J - 4: Showing surface of the east corner and west end of the north slope of Lagoon D, looking southwest.

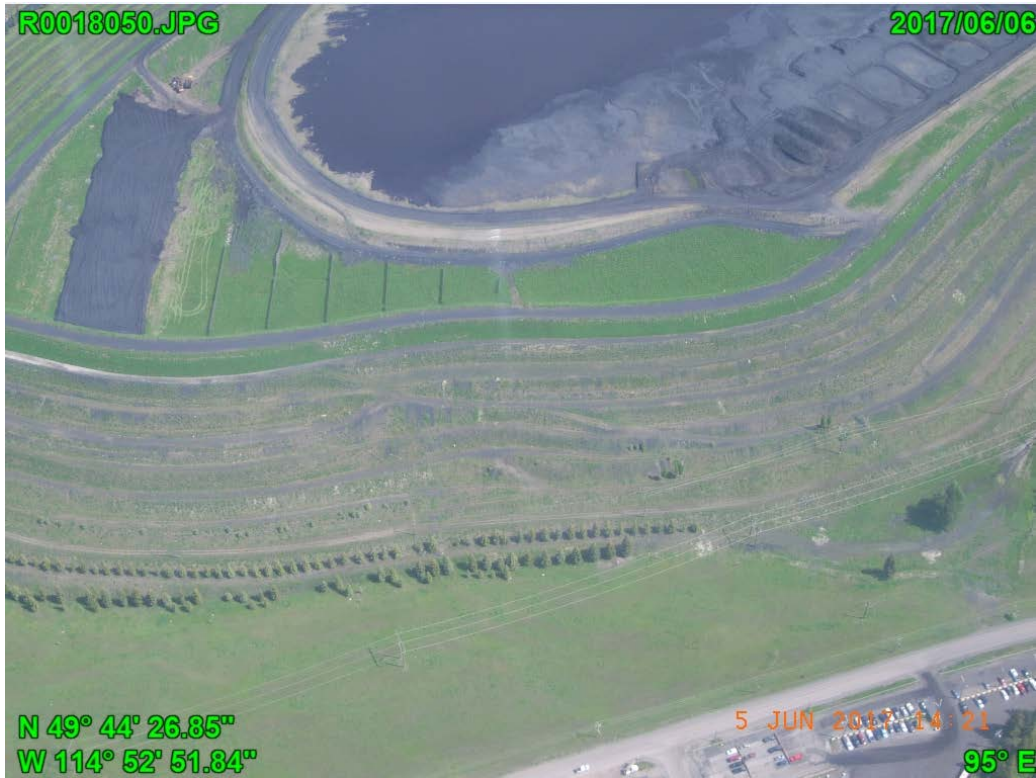
Photograph J - 5: Showing surface of the west corner and west end of the south slope of Lagoon D, looking north.

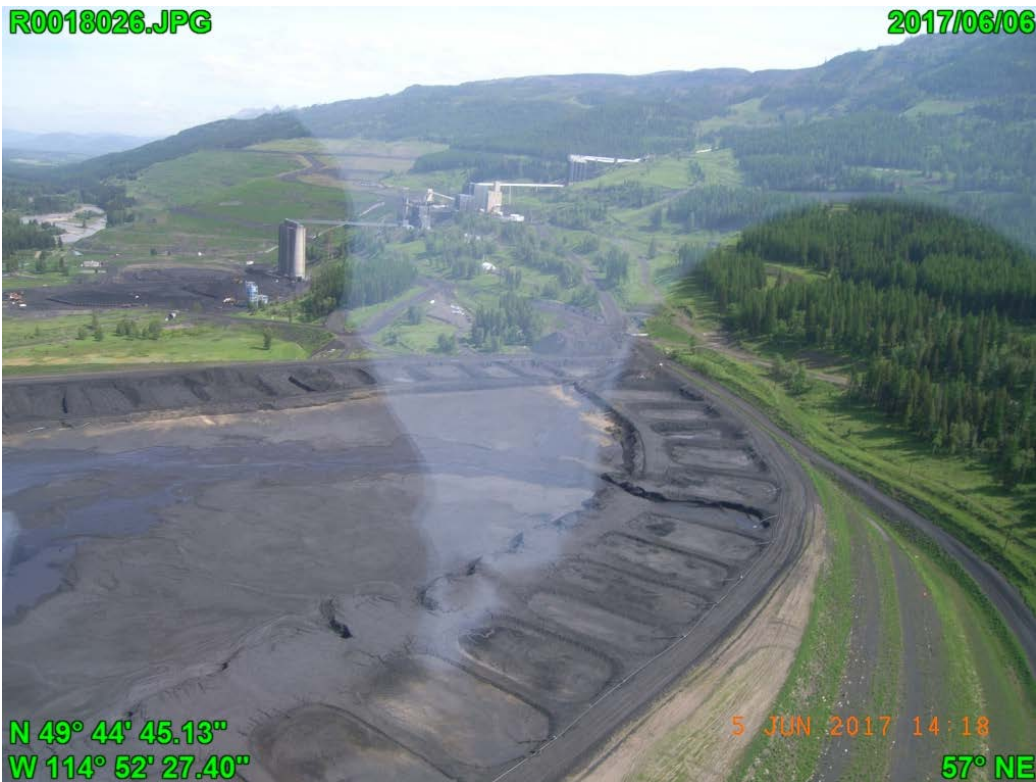
Photograph J - 6: Showing surface of the east corner and east end of the south slope of Lagoon D, looking northeast.

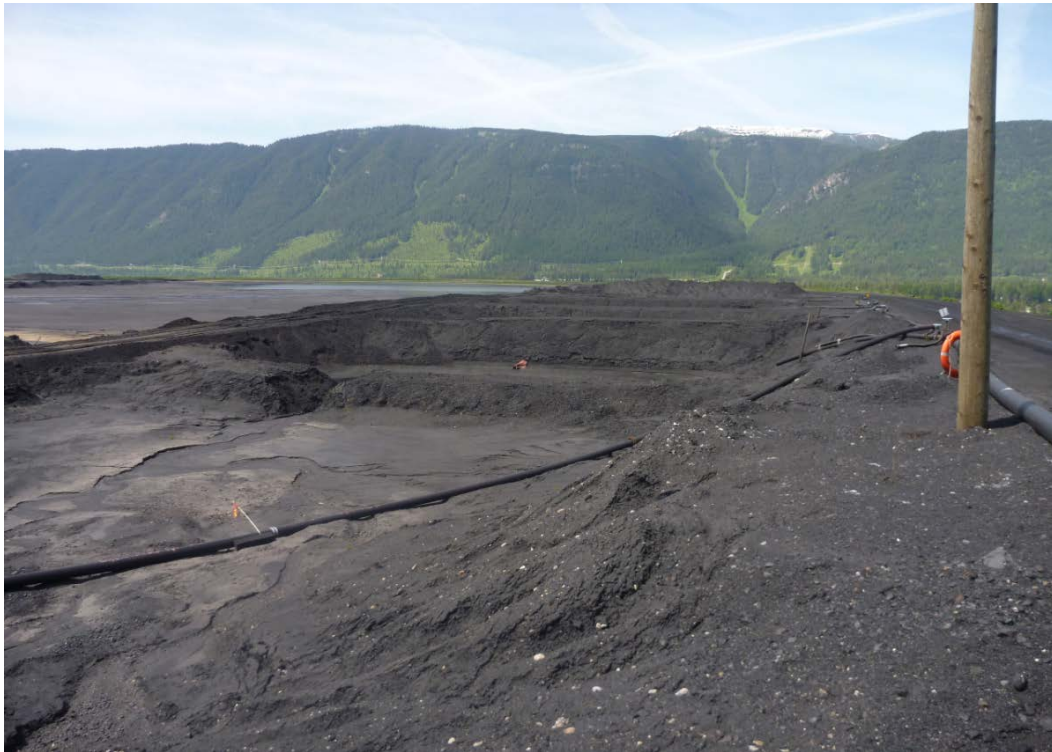
Photograph J - 7: Showing an upstream tailings cells at the northeast corner of Lagoon D, looking west. (Photo P1100684, 2017/06/06)

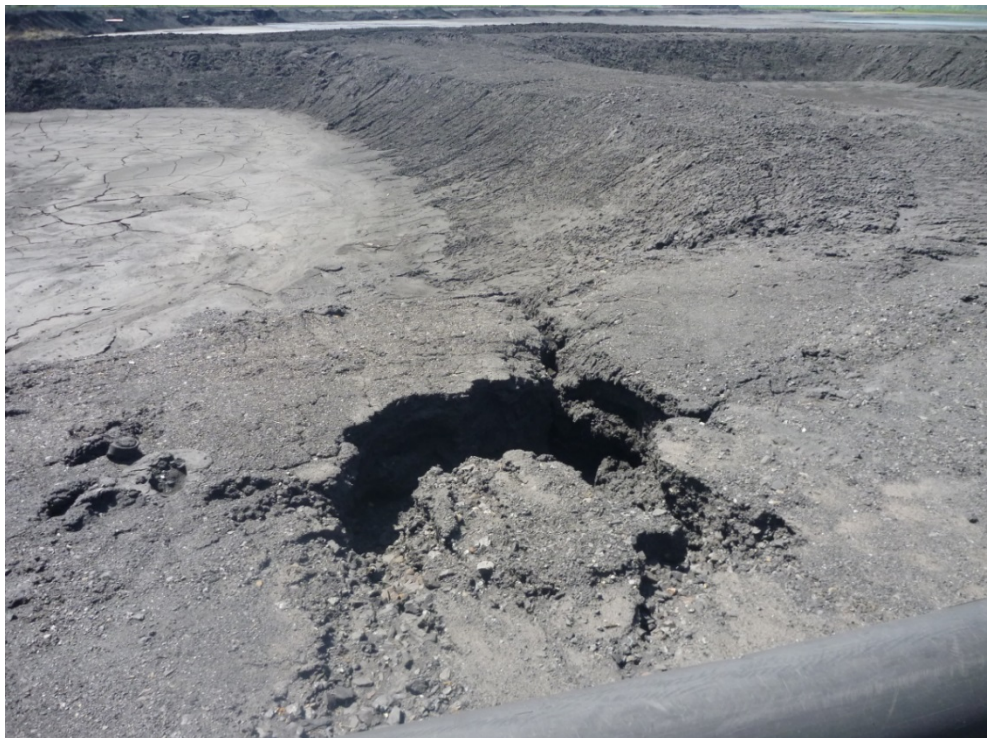
Photograph J - 8: Showing a close-view of a sinkhole within the tailings cell of Lagoon D, looking south. (Photo P1100688, 2017/06/06)

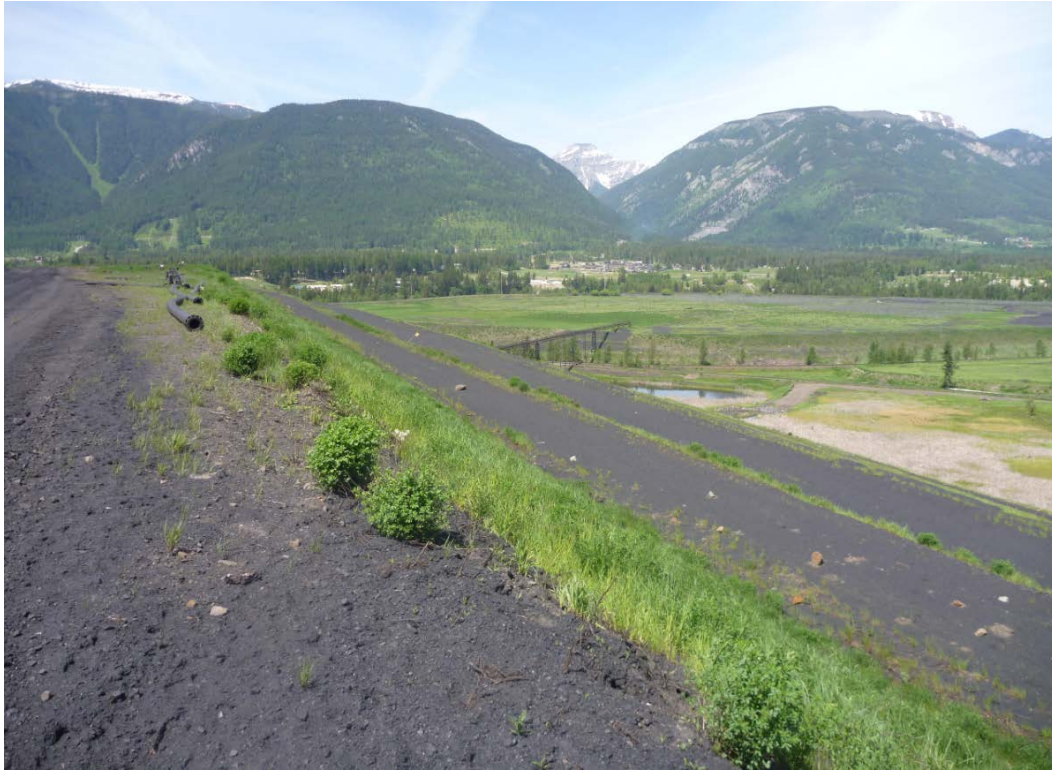
Photograph J - 9: Showing the north crest at east end of Lagoon D, looking west. (Photo P1100689, 2017/06/06)

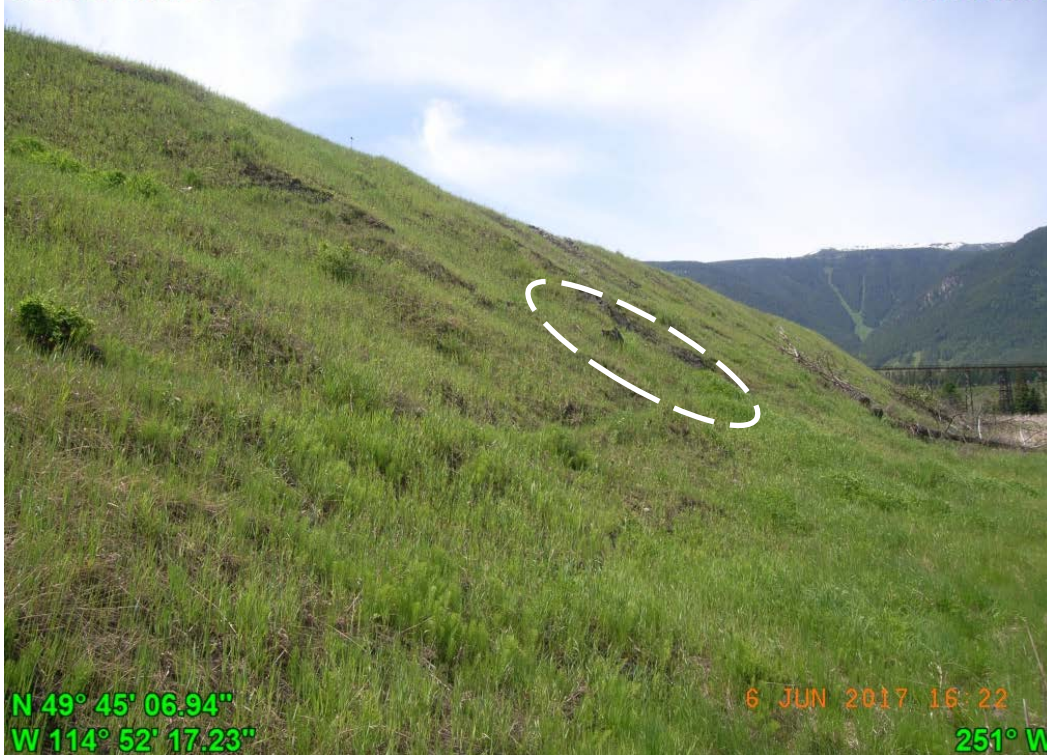
Photograph J - 10: Showing the toe and the 2nd seep area at the east end of North toe of Lagoon D, looking west.

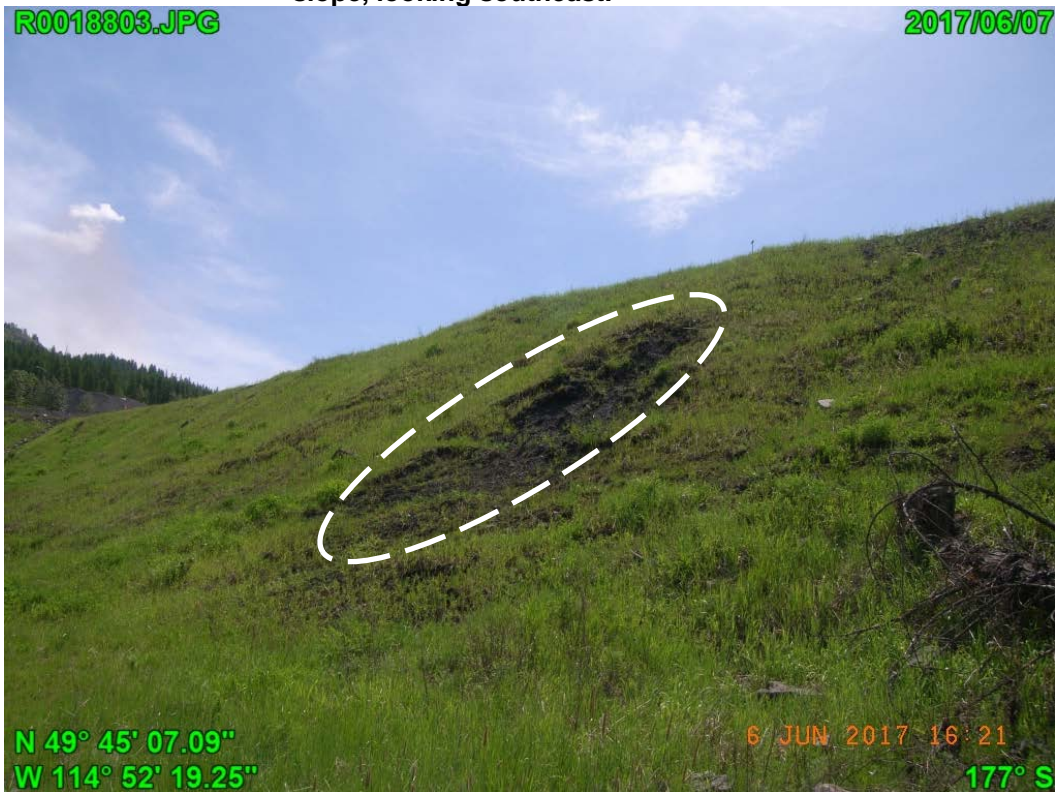
Photograph J - 12: Showing a close-view of the second seep area on the north slope, looking southeast.

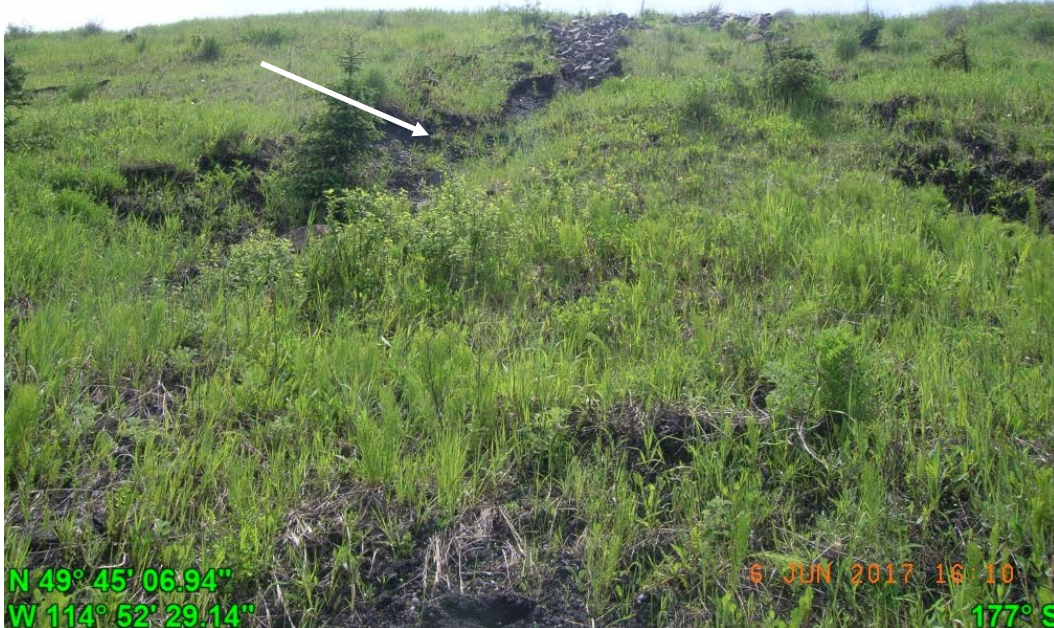
Photograph J - 13: Showing erosion gully at lower north slope, looking south up from the toe.

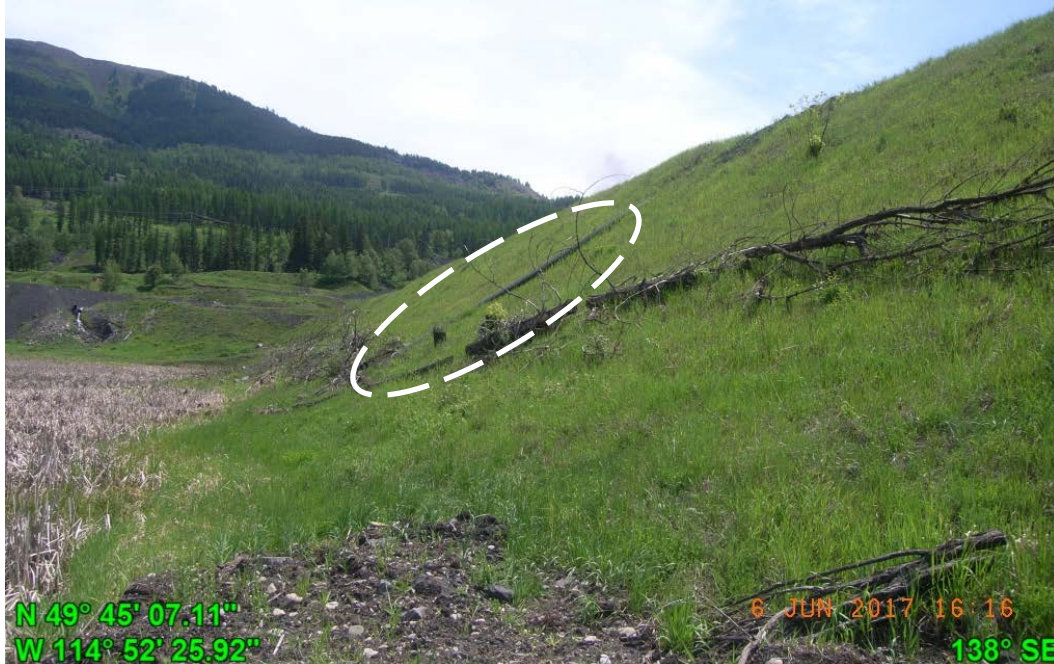
Photograph J - 14: Showing north slope, looking east. Noted the pipe on the lower north slope.
