Teck Coal Limited – Elkview Operations

**Tailings Storage Facilities
West Fork Tailings Facility
and Lagoons A, B, C and D**

2017 Dam Safety Inspection

Final Report

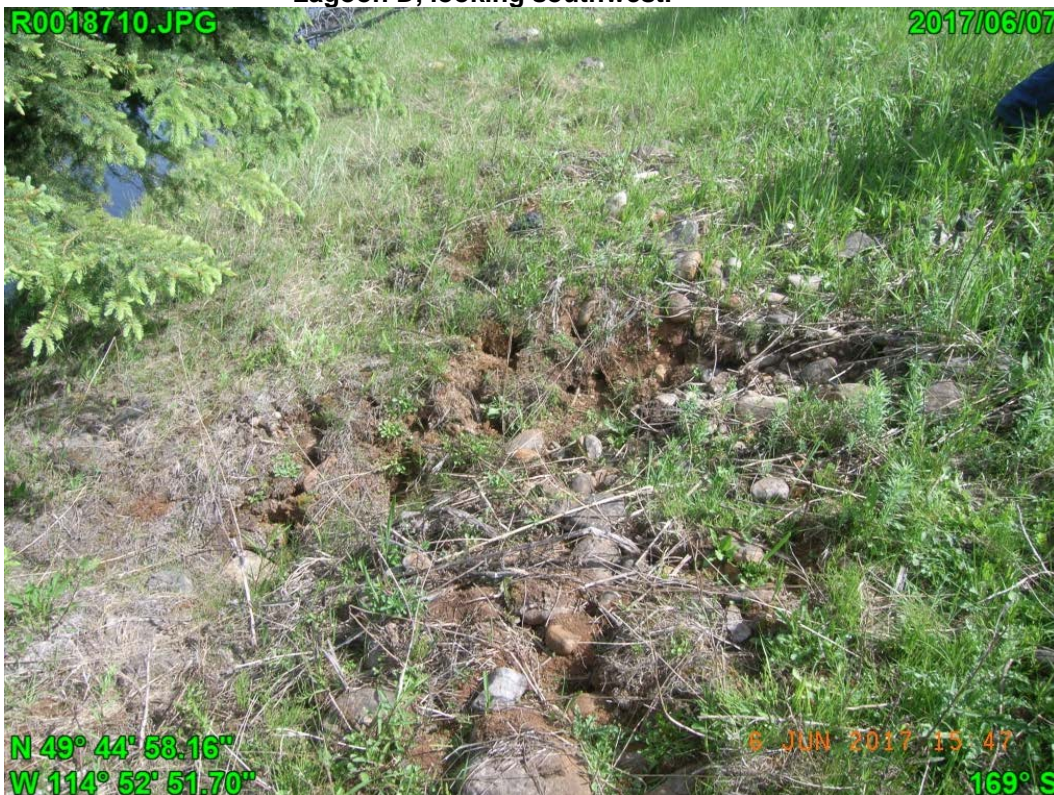
Photograph J - 20: Showing an animal activity at the toe of the north slope of Lagoon D, looking northwest.

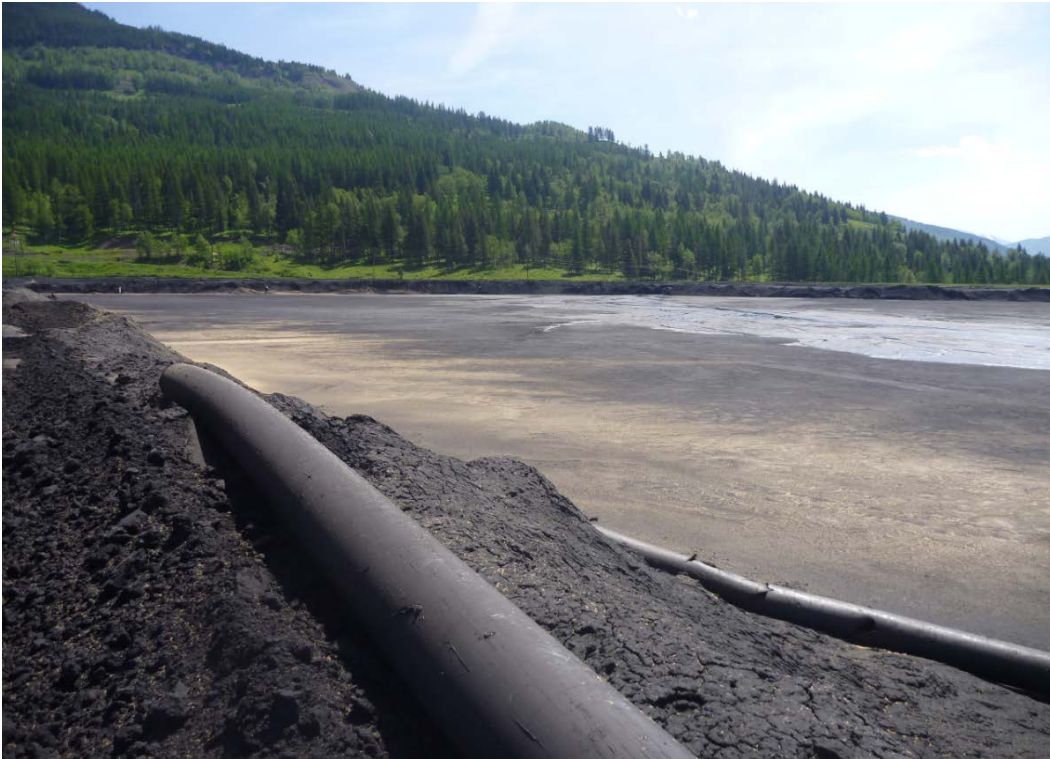
Photograph J - 21: Showing upstream tailings beach at the north section of Lagoon D, looking east. (Photo P1100702, 2017/06/06)

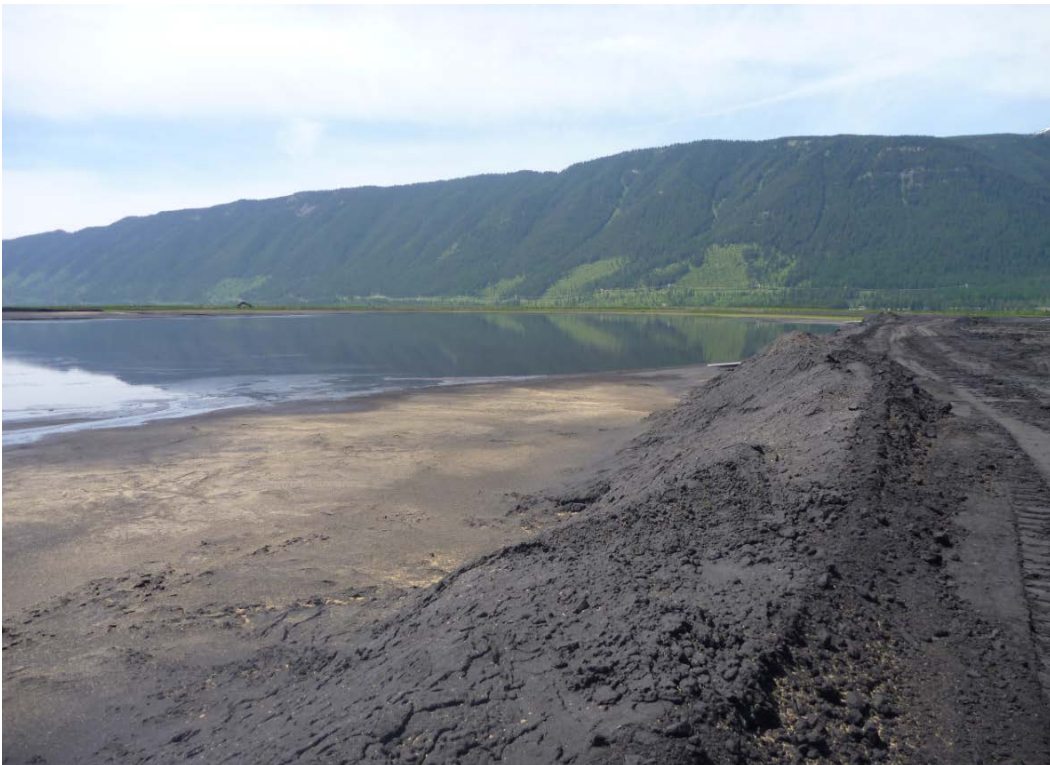
Photograph J - 22: Showing upstream tailings beach at the north section of Lagoon D, looking west. (Photo P1100703, 2017/06/06)

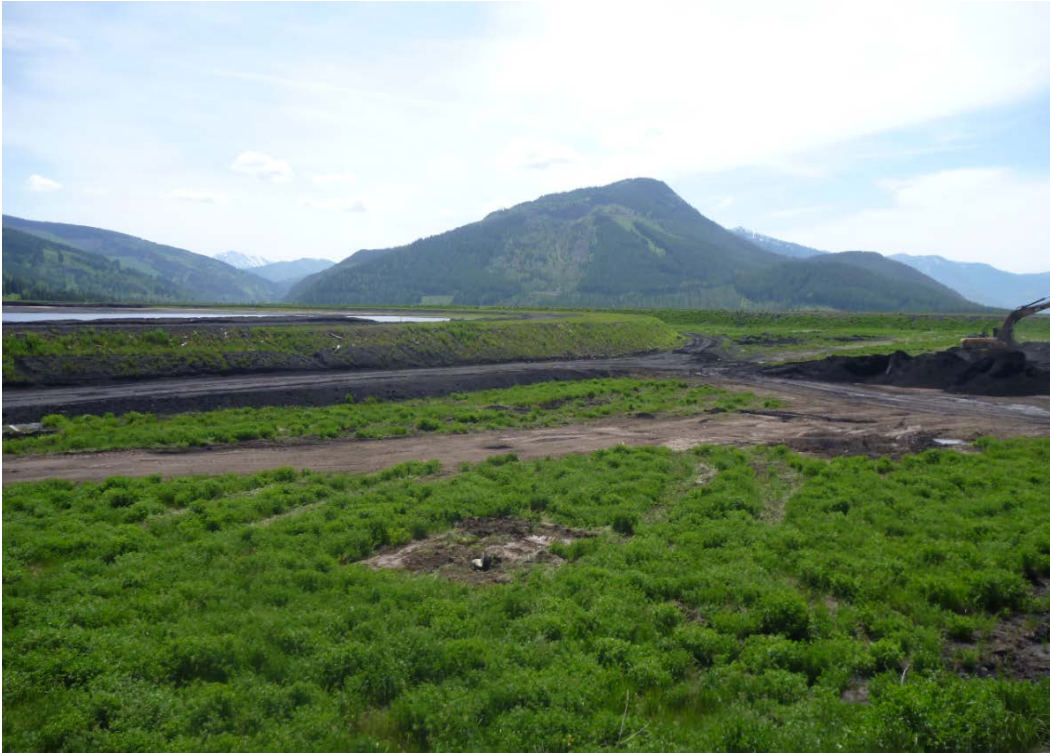
Photograph J - 23: Showing surface of the west corner of Lagoon D, looking south. Noted active tailings deposition on the surface (Photo P1100719, 2017/06/06)

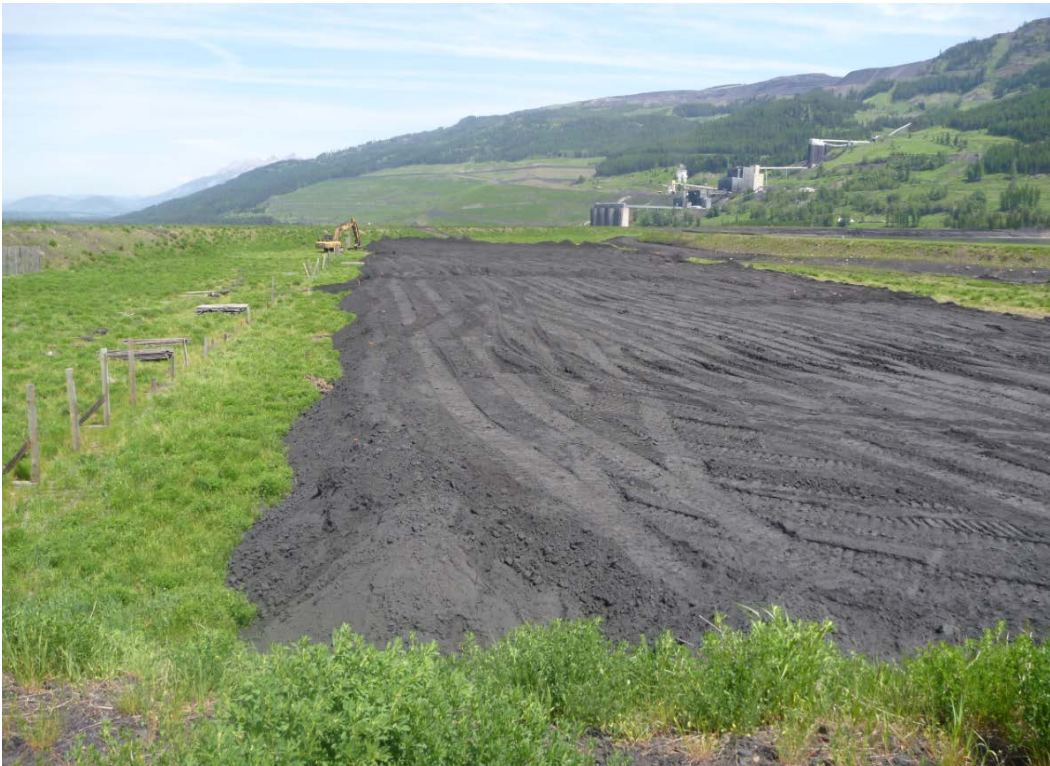
Photograph J - 24: Showing tailings placement on the surface at the west corner of Lagoon D, looking north. (Photo P1100717, 2017/06/06)

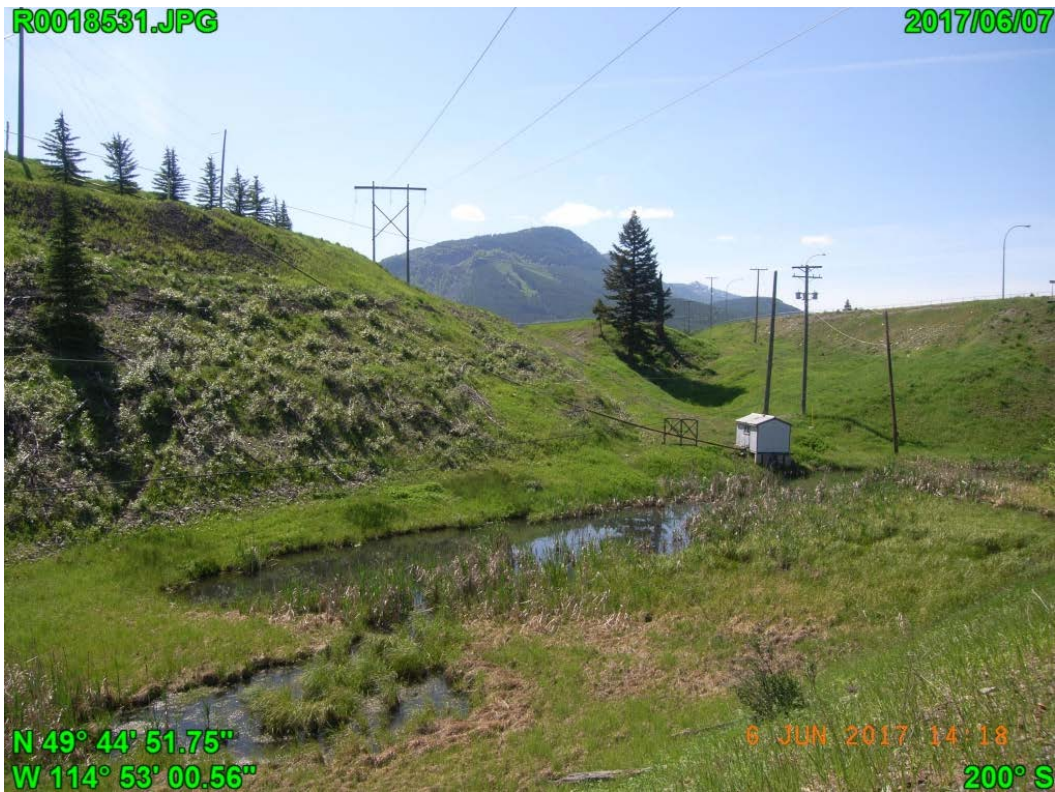
Photograph J - 25: Showing the toe at the west corner of Lagoon D, looking southwest.

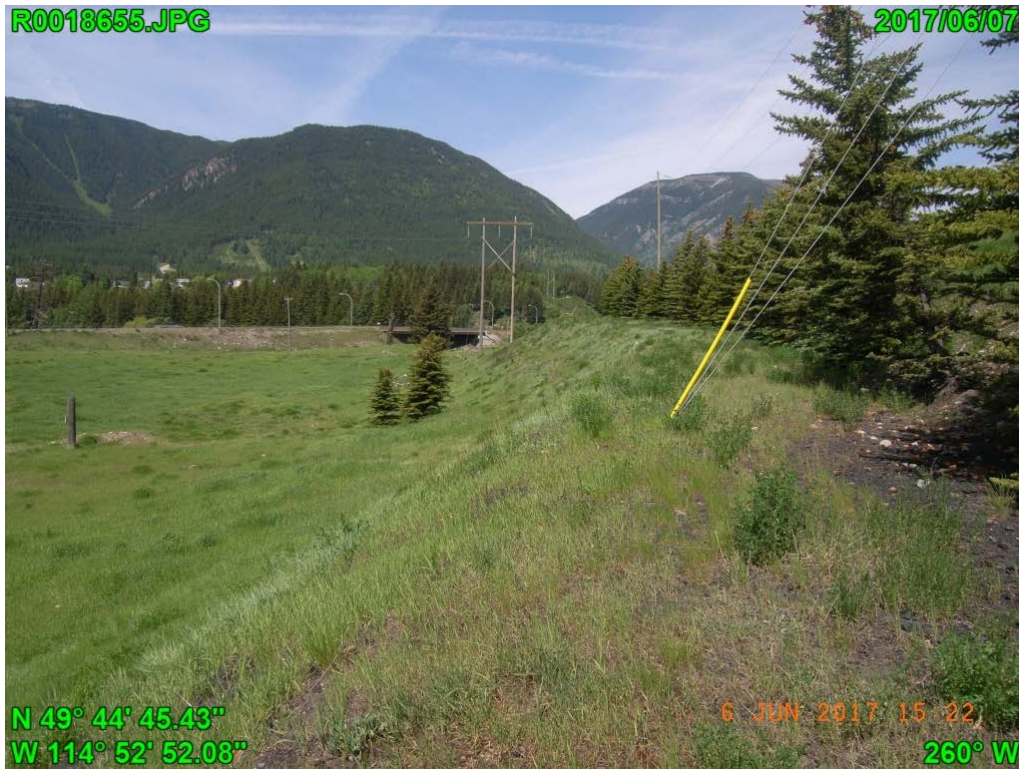
Photograph J - 26: Showing the toe of the dam at west end of Lagoon D, looking northwest.

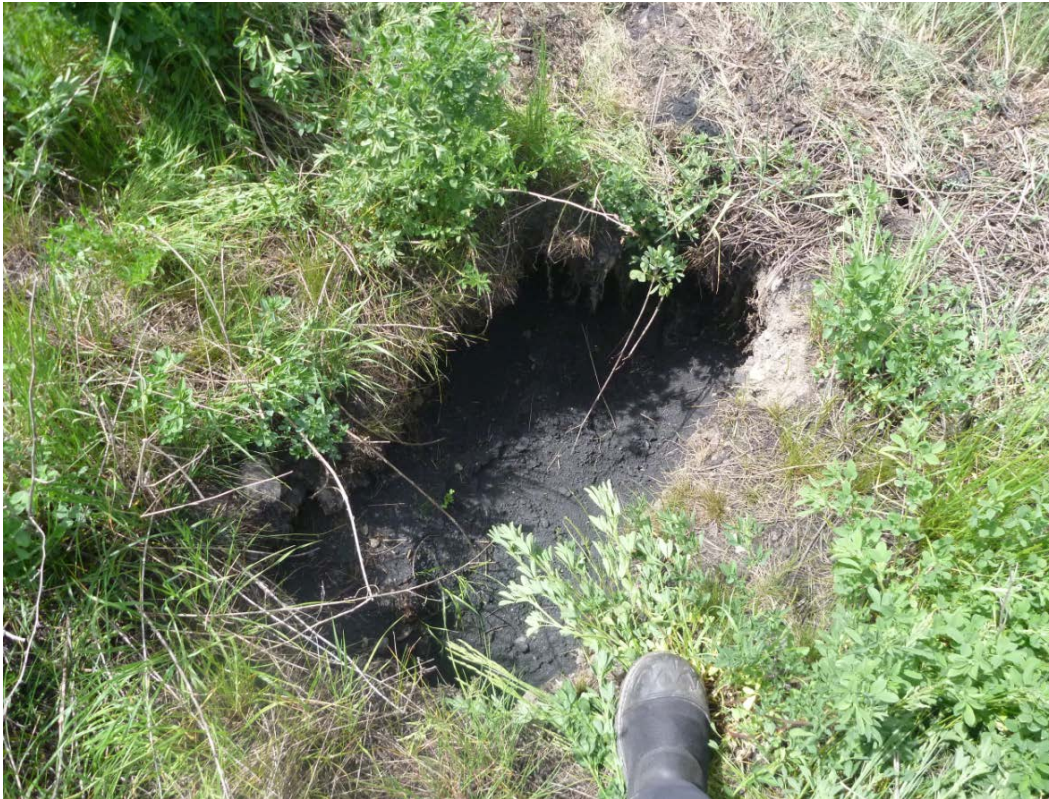
Photograph J - 27: Showing a sinkhole at south west crest of Lagoon D, looking east. (Photo P1100730, 2017/06/06).

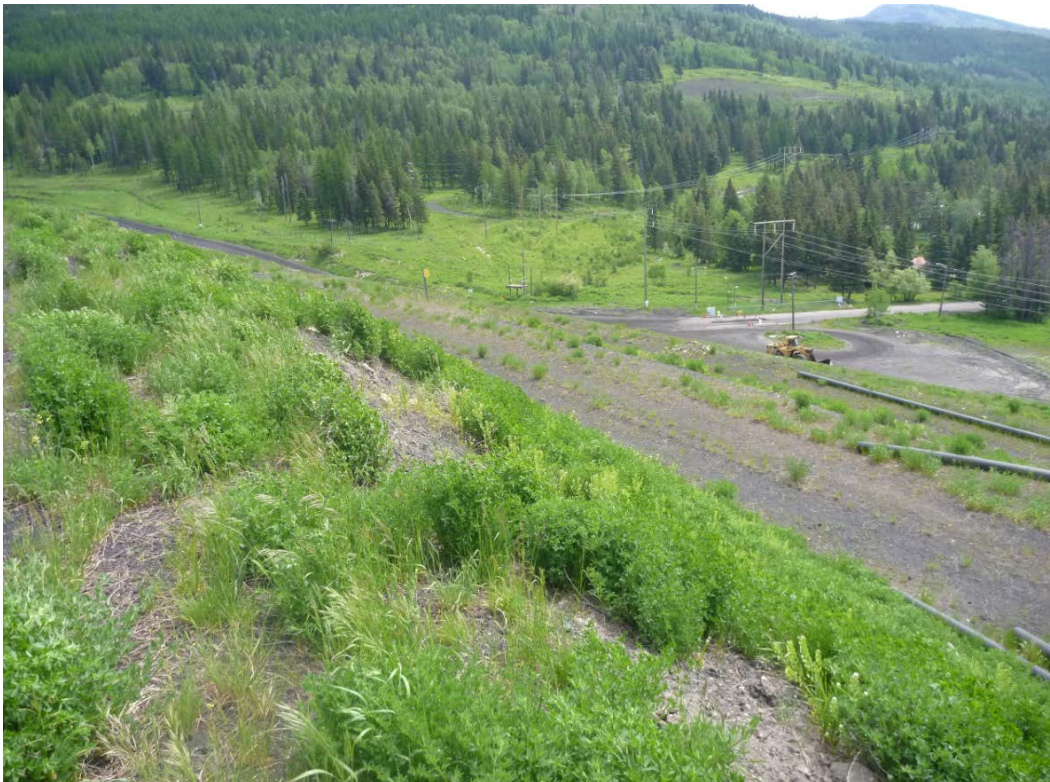
Photograph J - 28: Showing the crest shoulder at the south corner of Lagoon D, looking southeast. (Photo P1100733, 2017/06/07).

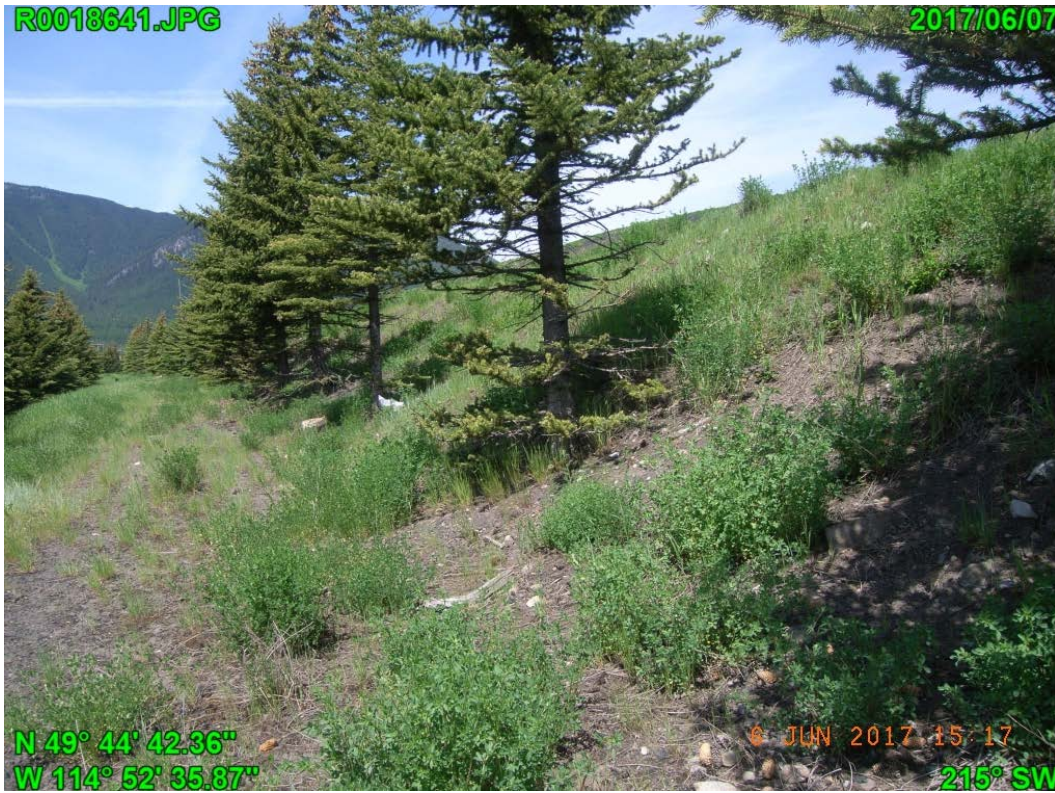
Photograph J - 29: Showing erosion on the south slope of Lagoon D, looking northwest.

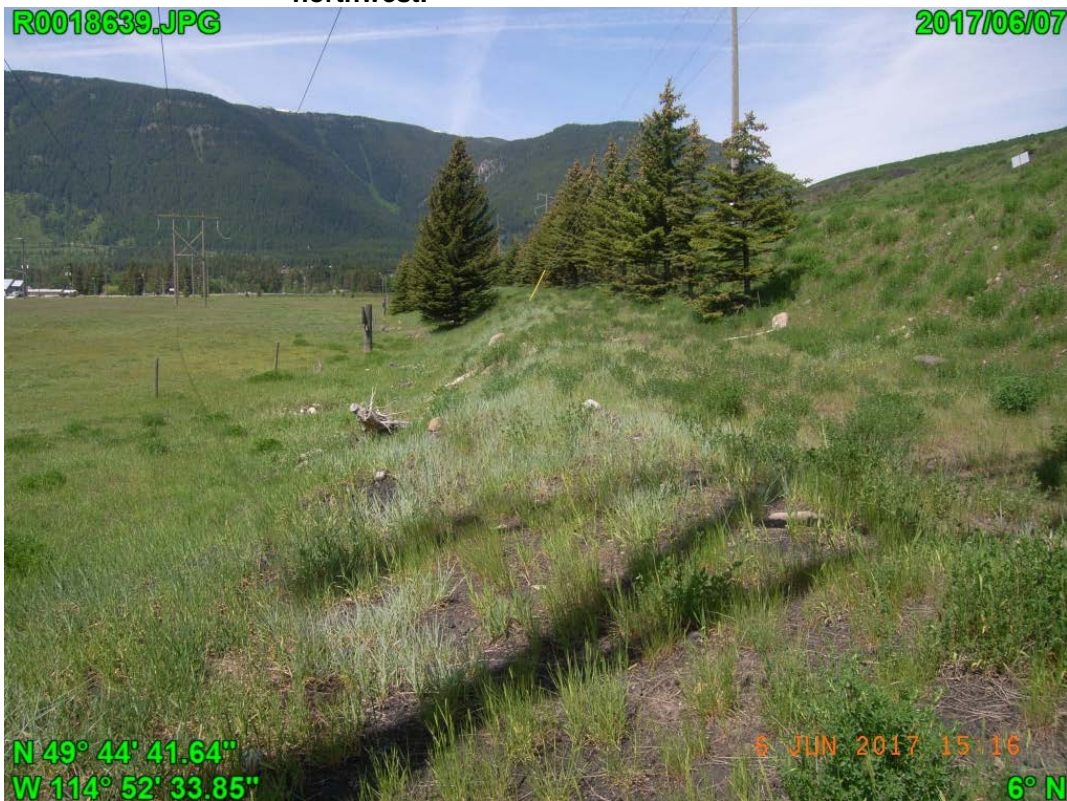
Photograph J - 30: Showing the toe of the south embankment of Lagoon D, looking west.

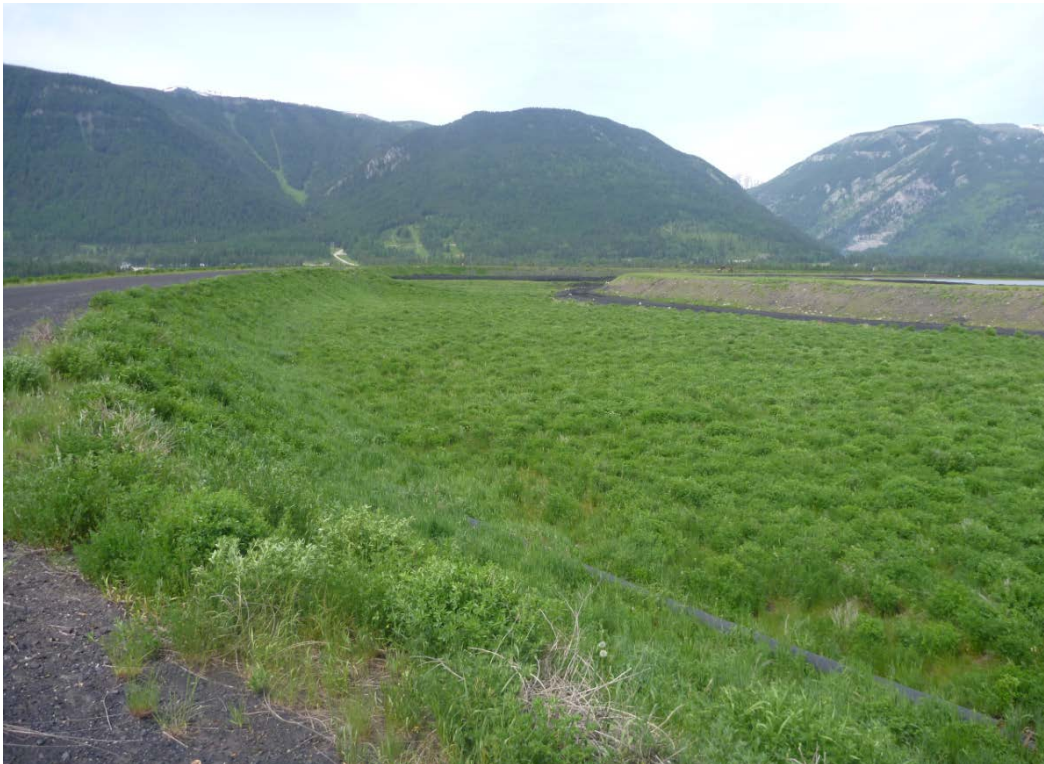
Photograph J - 31: Showing dam crest and upstream surface at the south area of Lagoon D, looking west. (Photo P1100735, 2017/06/07).

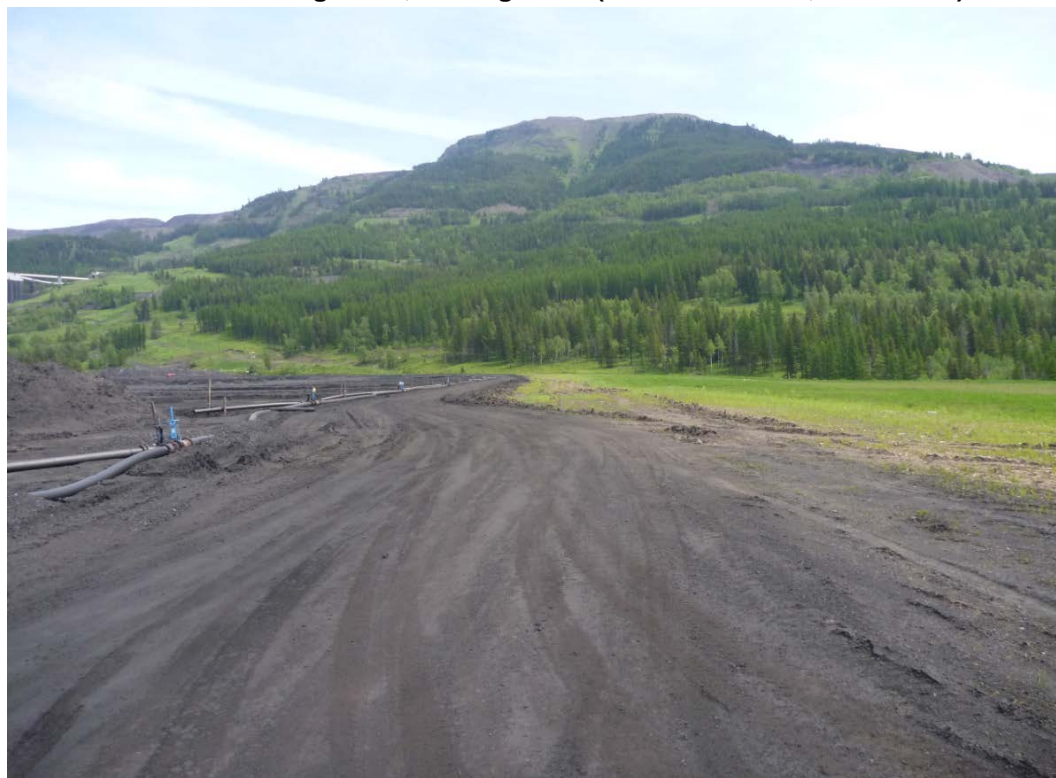
Photograph J - 32: Showing crest and upper south slope of Lagoon D, looking northeast. (Photo P1100736, 2017/06/06)

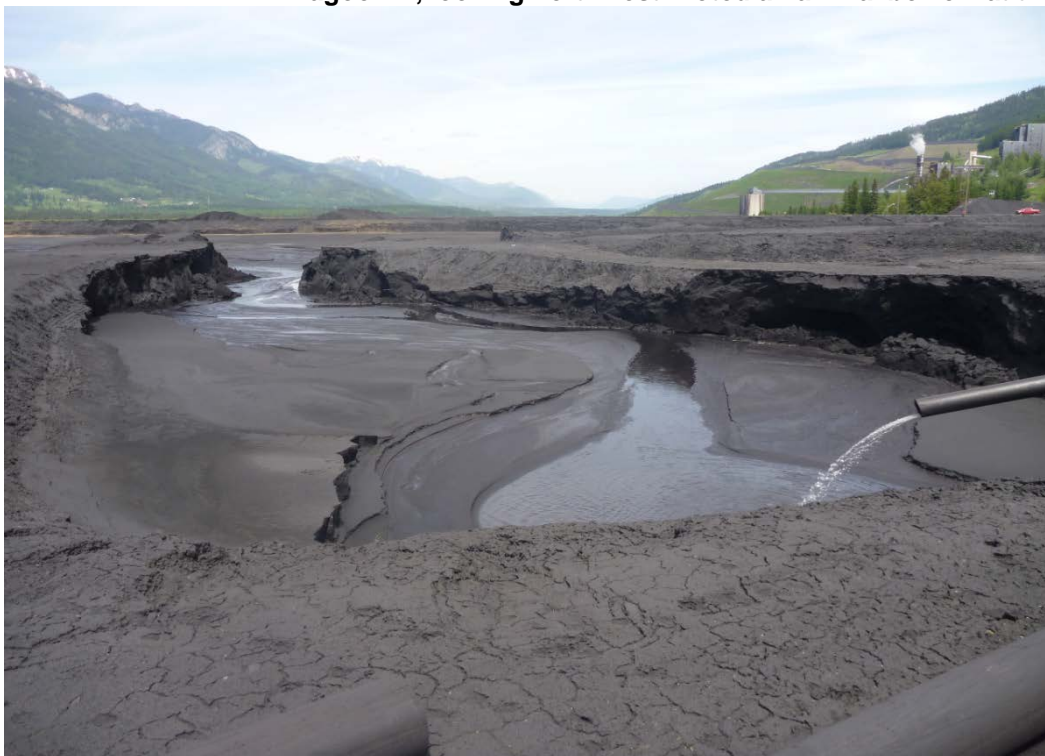
Photograph J - 34: Showing a tailings cell at southeast section of Lagoon D, looking northeast. (Photo P1100742, 2017/06/07)
