Teck Highland Valley Copper Partnership

2017 Dam Safety Inspection Report

Highland Tailings Storage Facility

March 2018

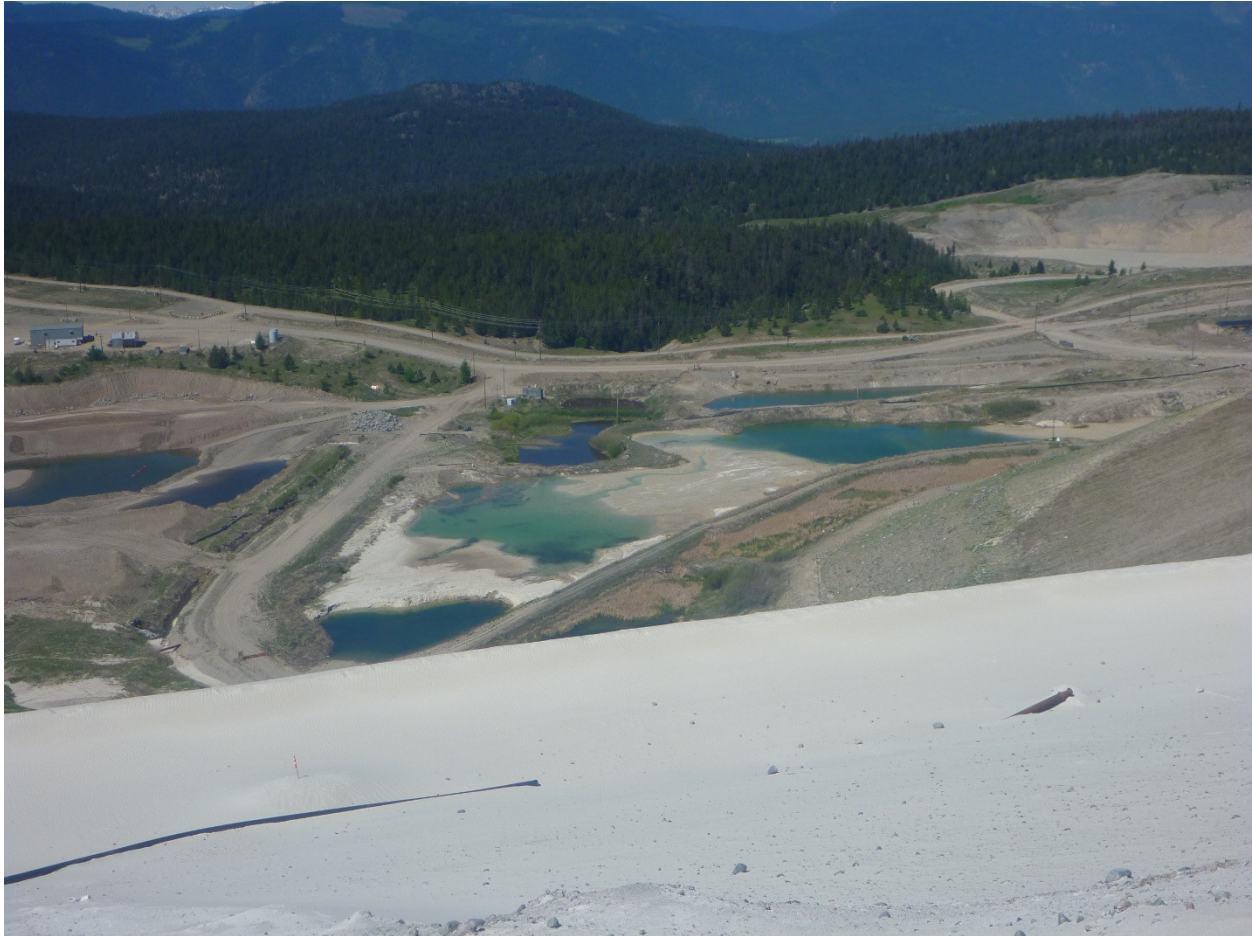
- Higher than normal water level in Slimes Pond 1 due to recent freshet. Freeboard > 5m. (Photo 4)
- Till Core Zone is covered by wind-blown sand making inspection of its condition impossible. (Photo 5)

Photo 4 – Slimes Pond 1

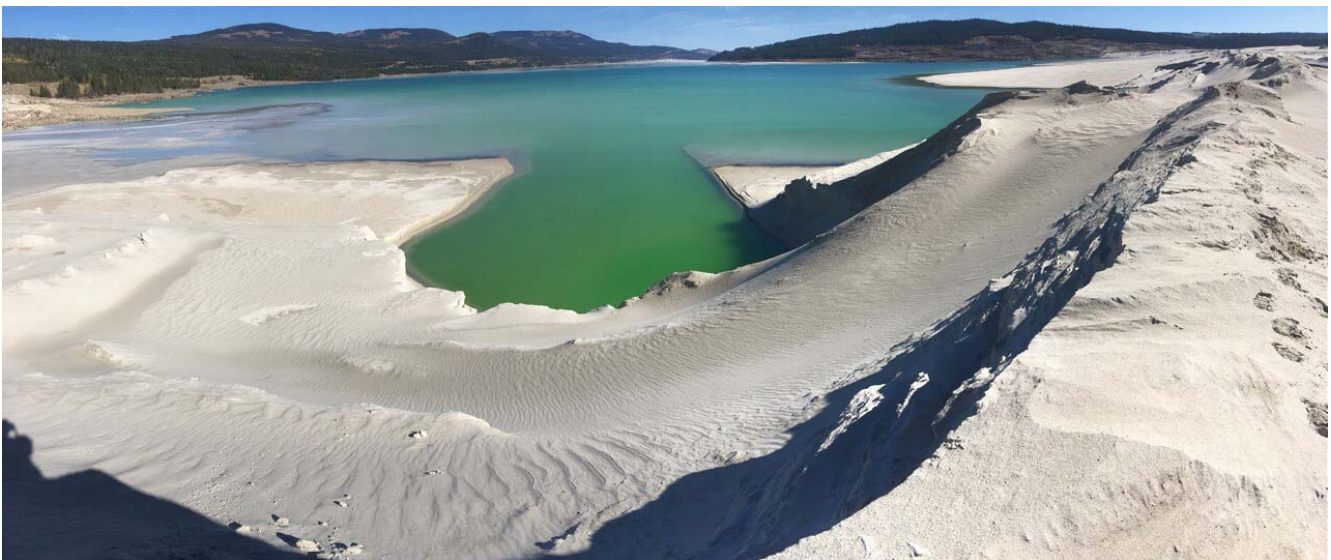
Photo II-A-4 Upstream Dam Face with Undercutting and Overhanging at Old Overflow Discharge Location – Facing East (LL-2017-13)

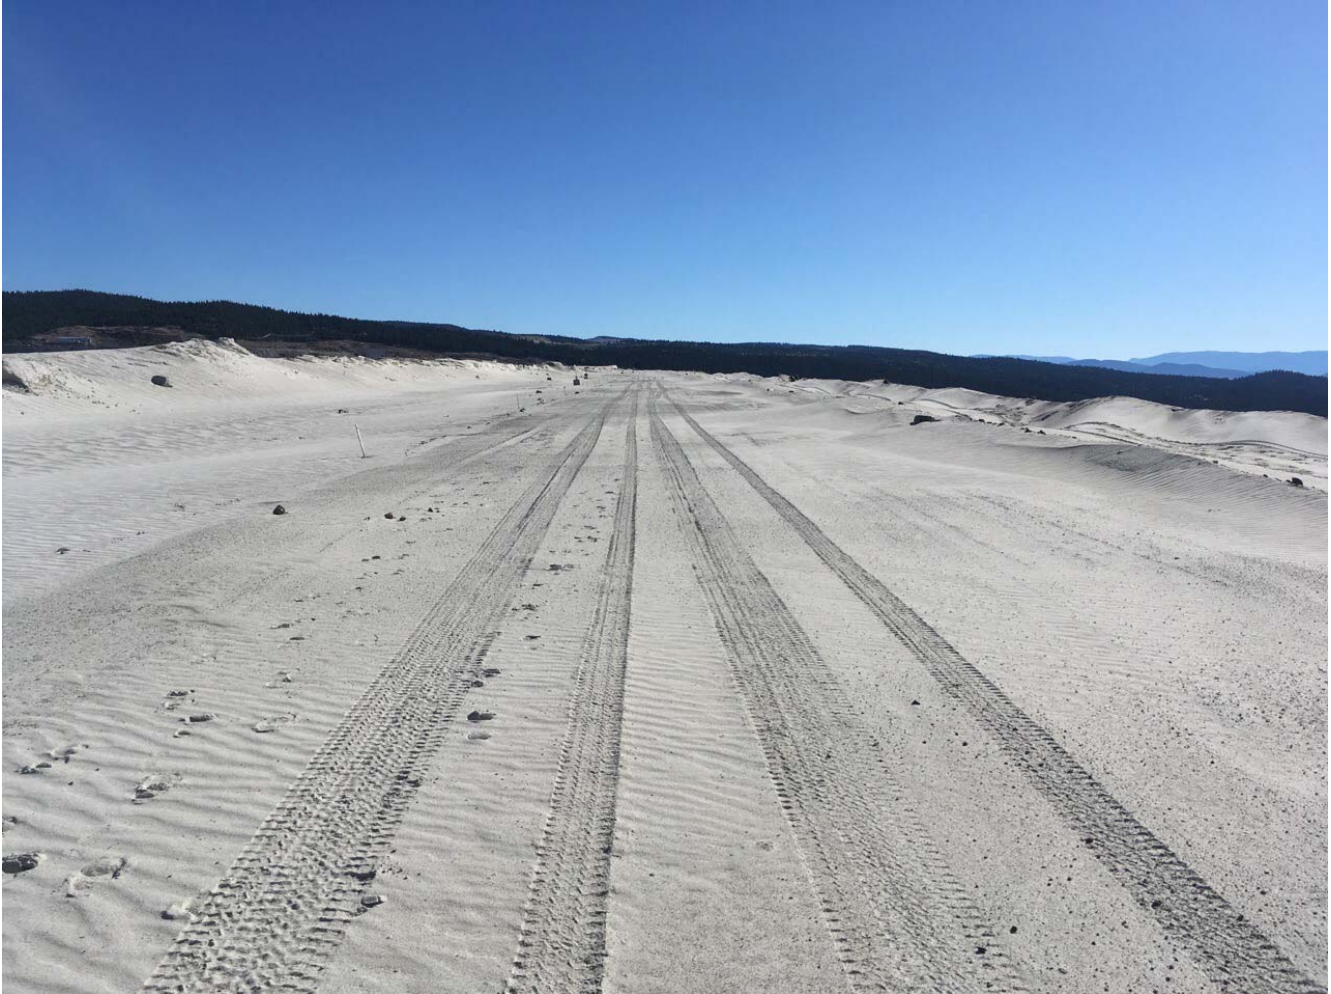
Photo II-A-12 North Dam Till Core Zone – Facing South (LL-2017-15)

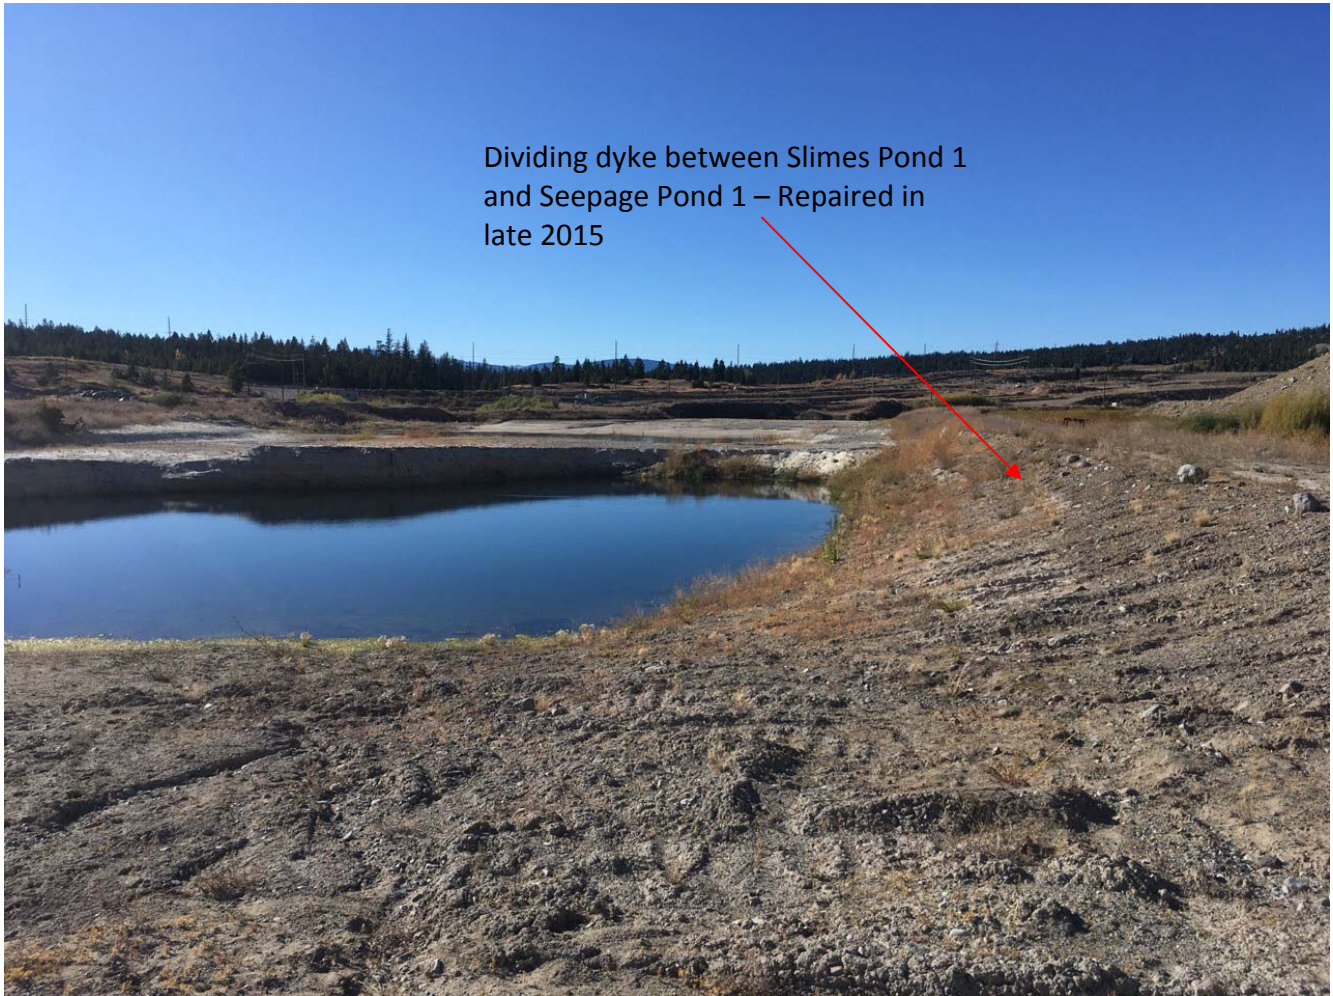
Photo II-C-3 Slimes Pond 1 – Facing Northwest (SS-2017-02)

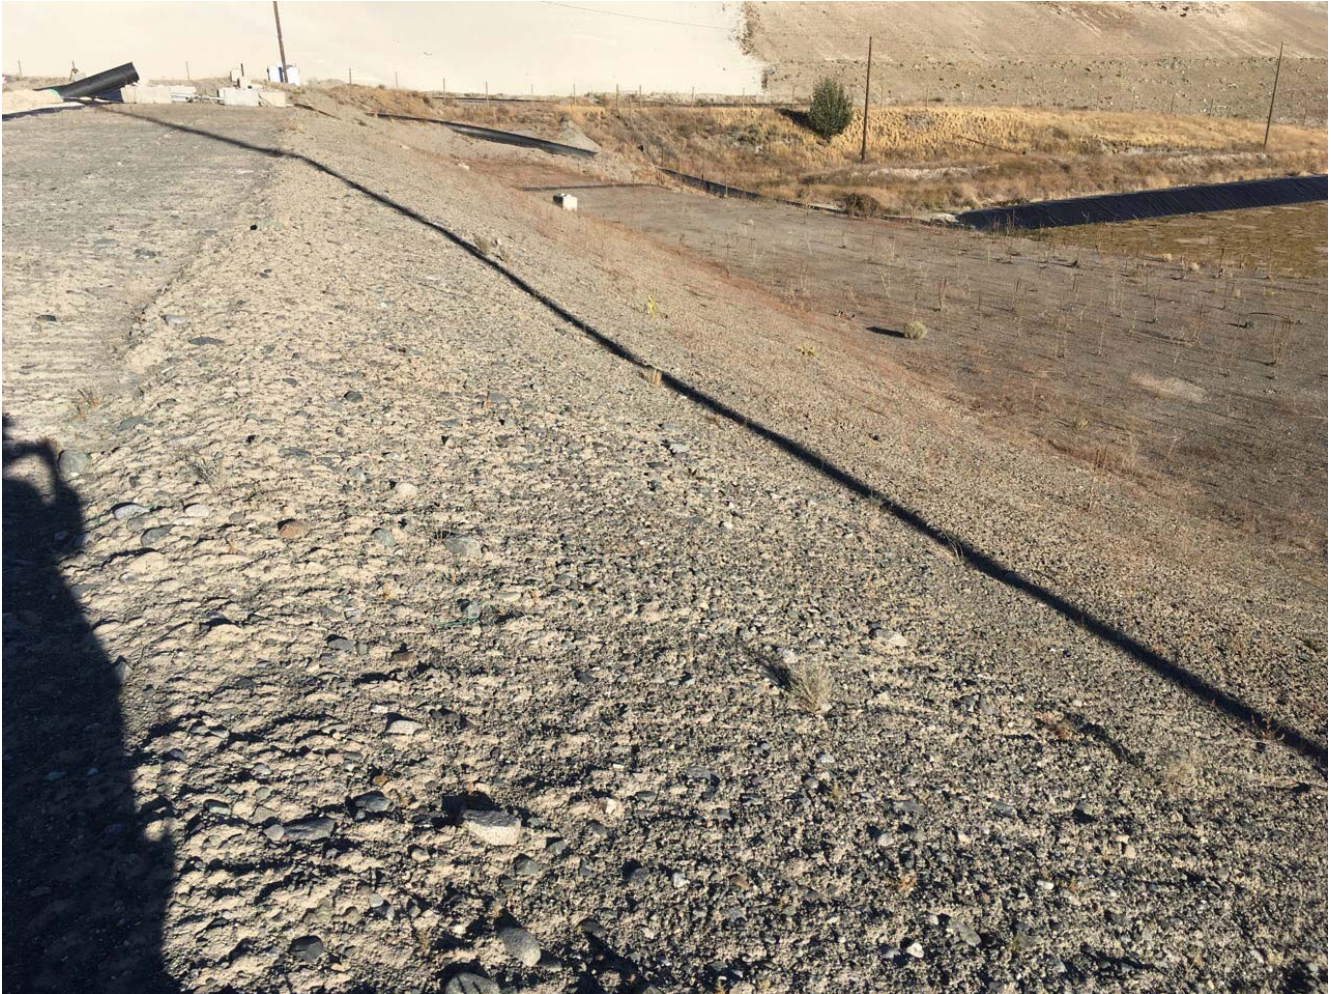
Photo II-C-8 Slimes Pond 2 Downstream Face – Facing East (SS-2017-06)

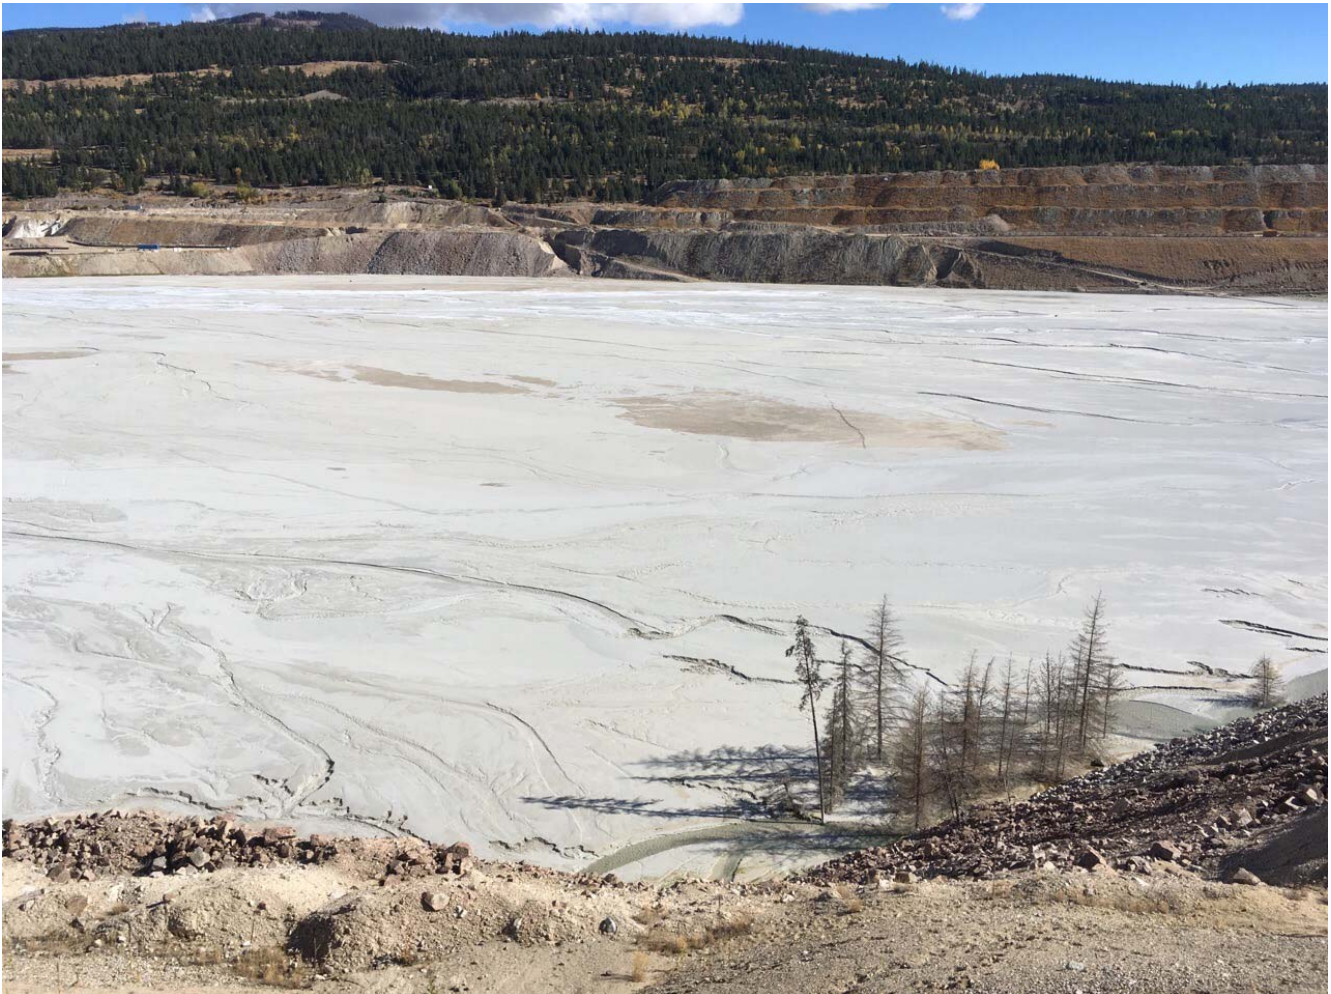
Photo II-D-4 East side of Lake (ML-2017-04)

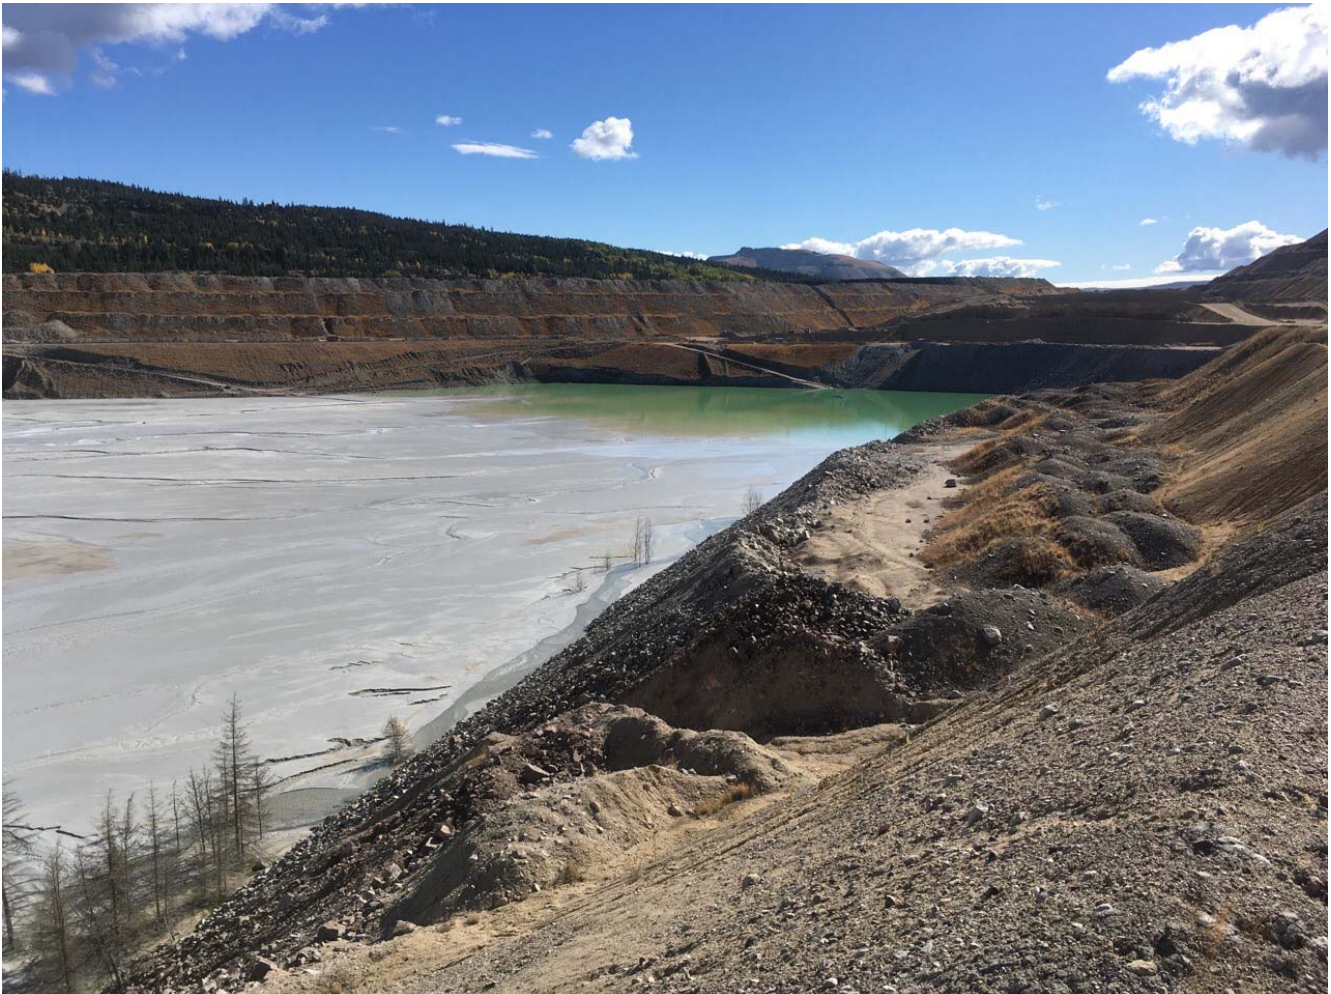
Photo II-D-5 Southeast Side of Lake (ML-2017-01)
