Teck Highland Valley Copper Partnership

2017 Dam Safety Inspection Report

Bethlehem No. 1 Tailings Storage Facility

March 2018

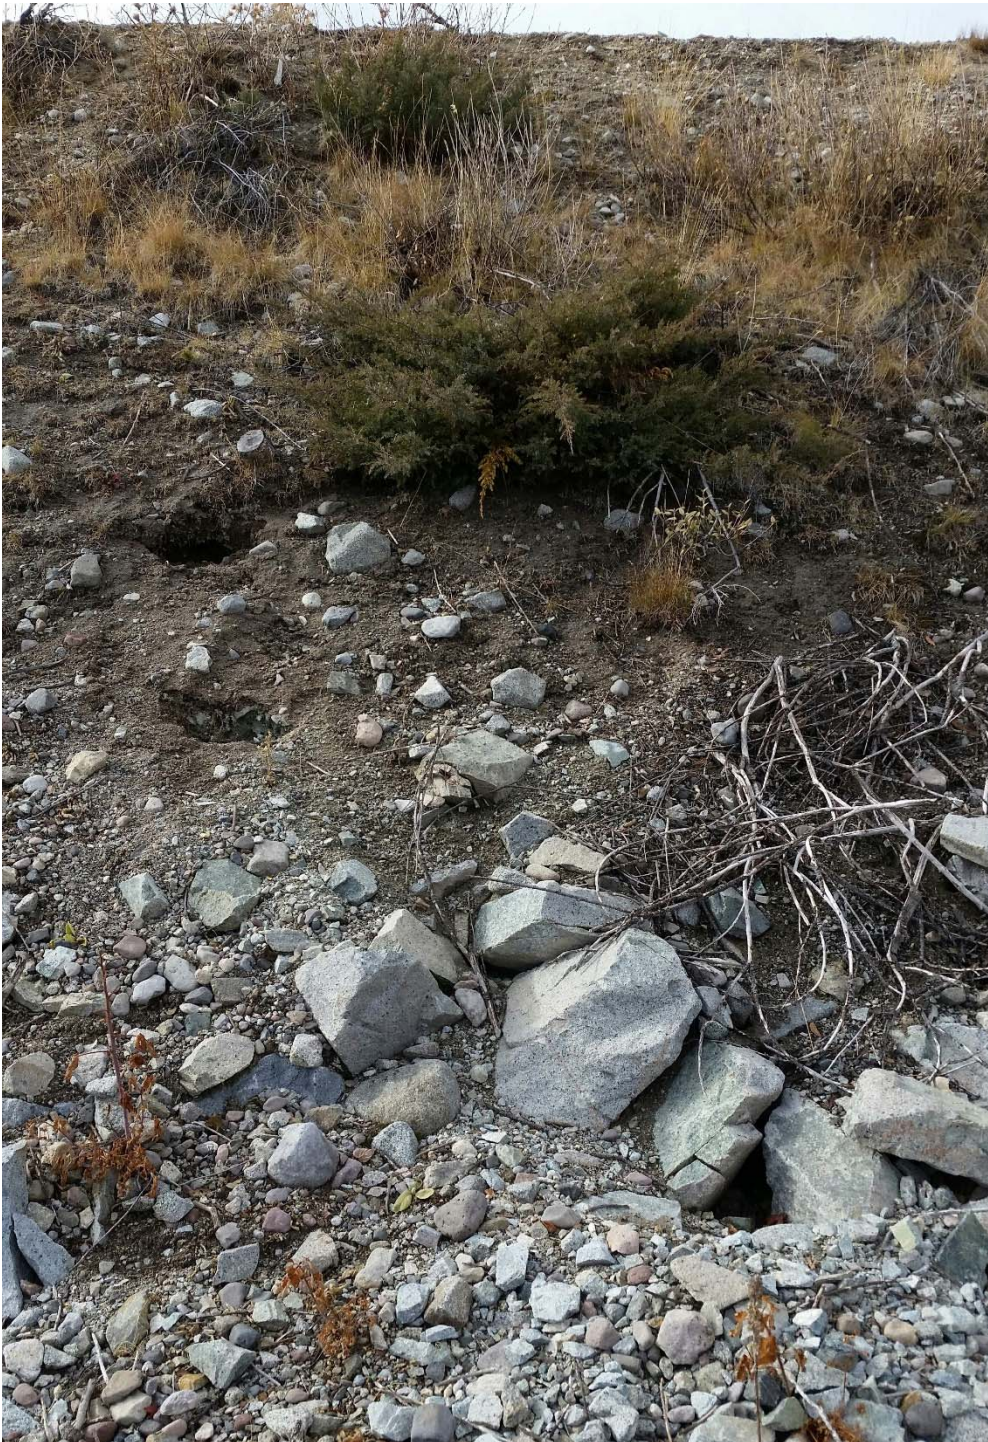
Photo II-B-22 Possible animal burrow site near dam left abutment (BTH-2017-14)

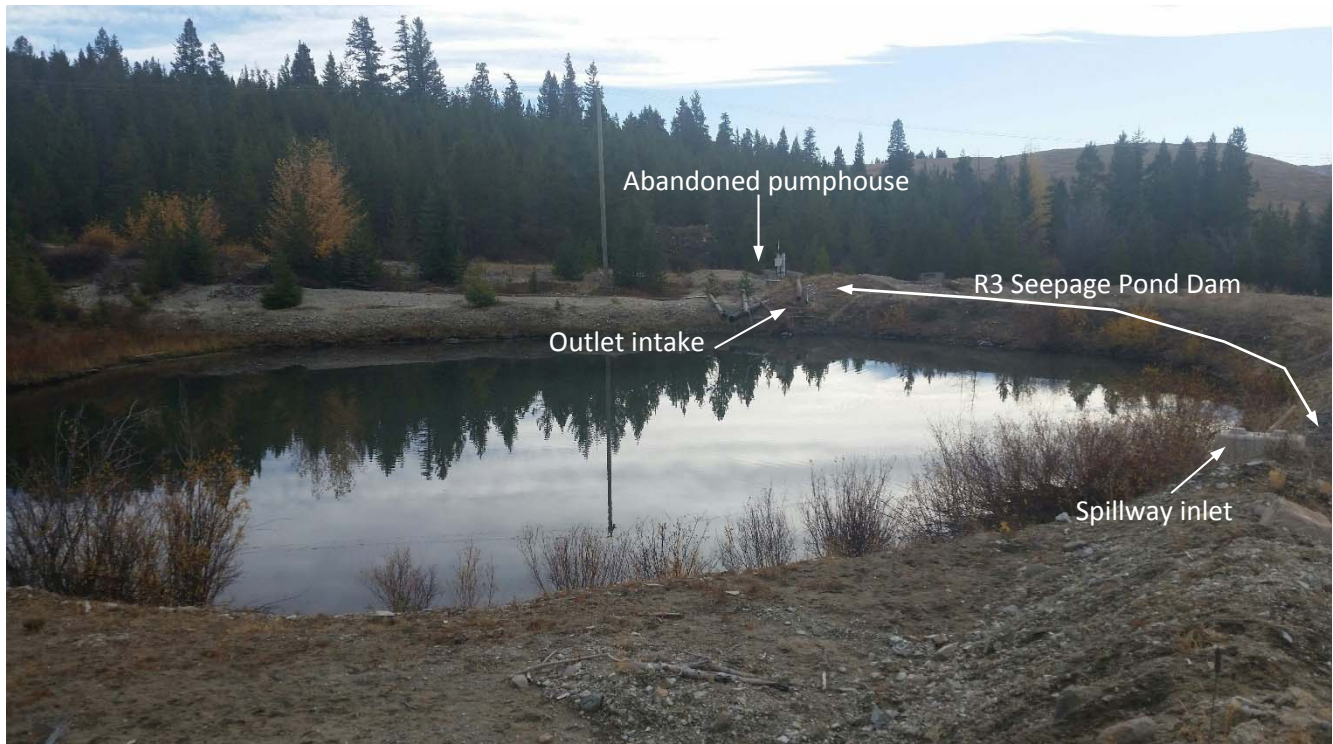
Photo II-C-1 Overview of pond and dam looking south (BTH-2017-23)

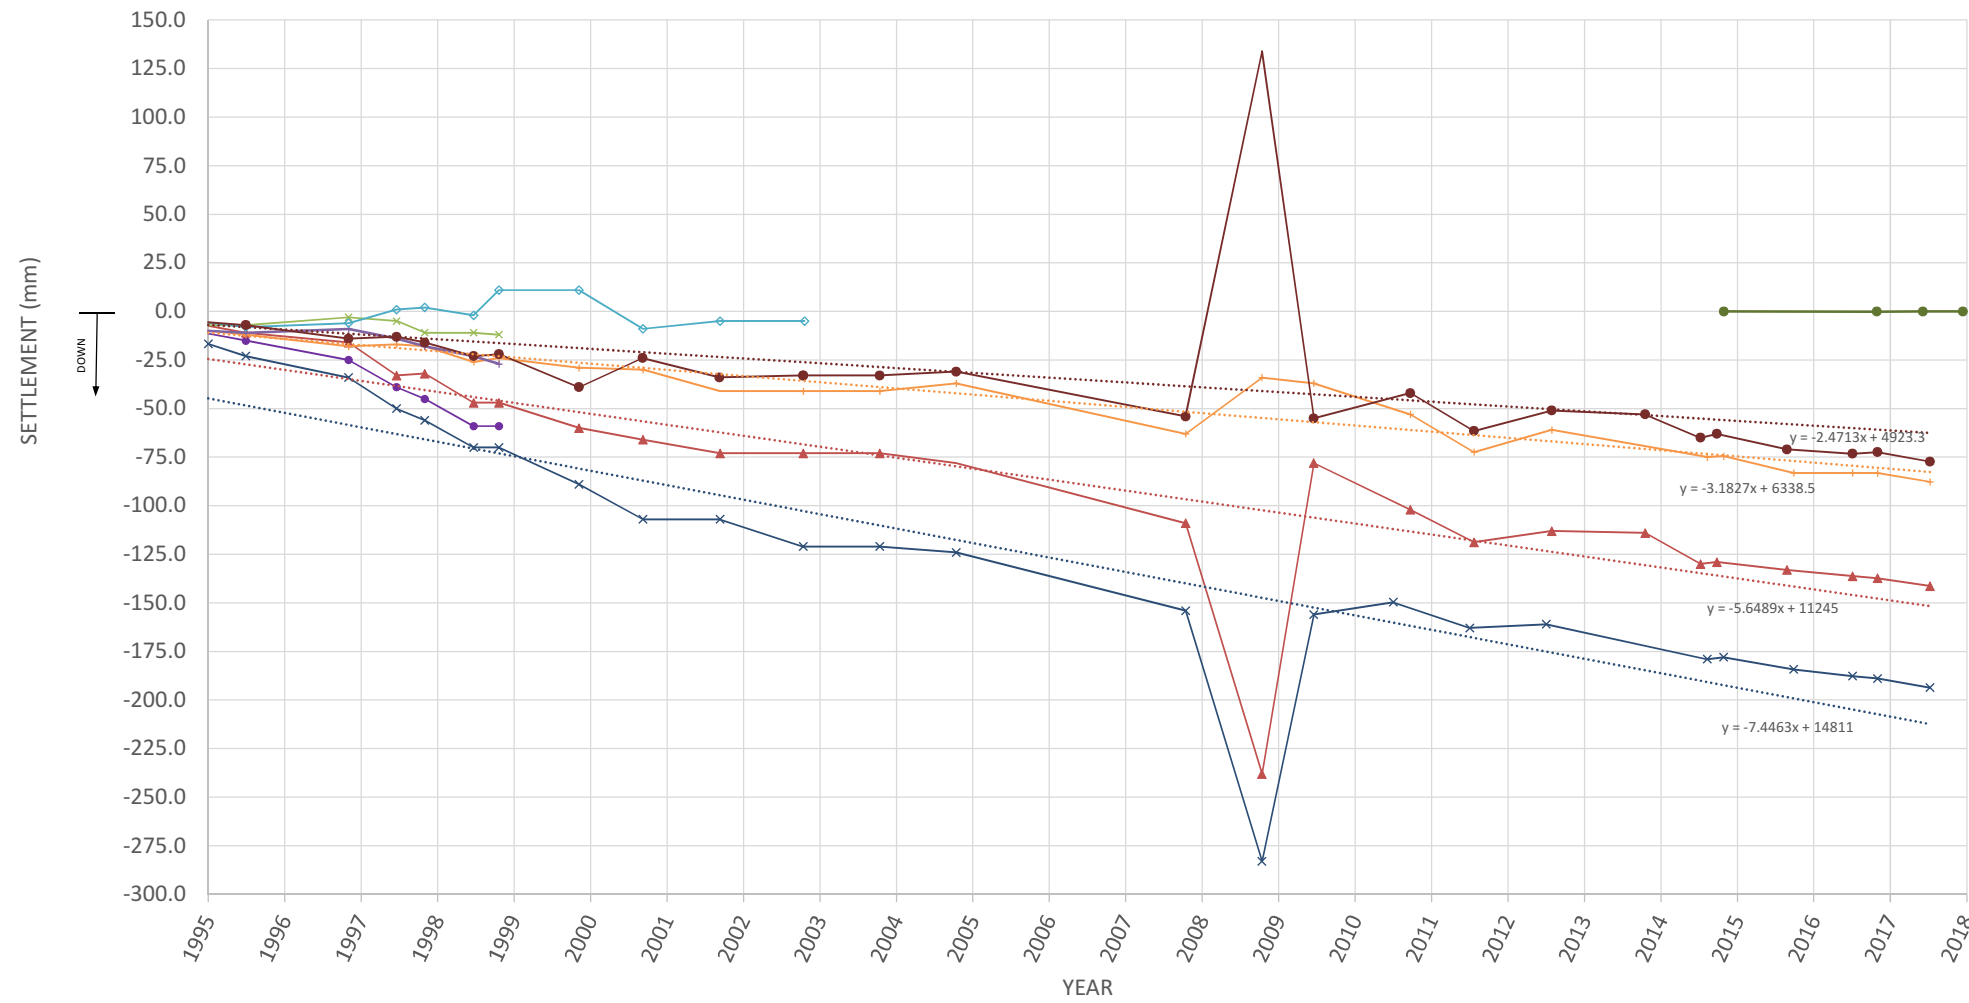
- DAM No. 1 MOVEMENT MONITORING DATA PRIOR TO 1995 NOT SHOWN.
- REFER TO FIGURE 3 FOR MONUMENT LOCATIONS IN PLAN VIEW.
- DM-1, DM-4 AND DM-5 DESTROYED IN 1999.
- DM-6 DESTROYED IN 2002.
