Teck Highland Valley Copper Partnership

2017 Dam Safety Inspection Report

Highmont Tailings Storage Facility

March 2018

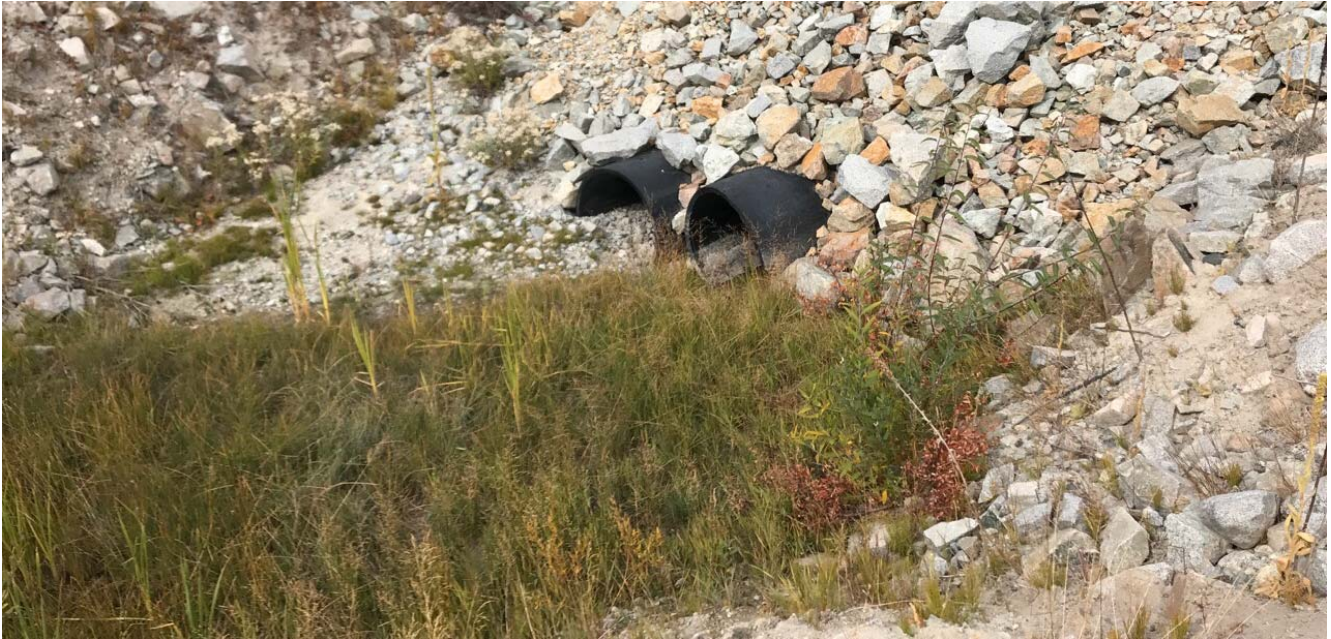
Photo II-A-11 Upstream side of 33" ID spillway road culverts, showing vegetation (HGH-2017-07)

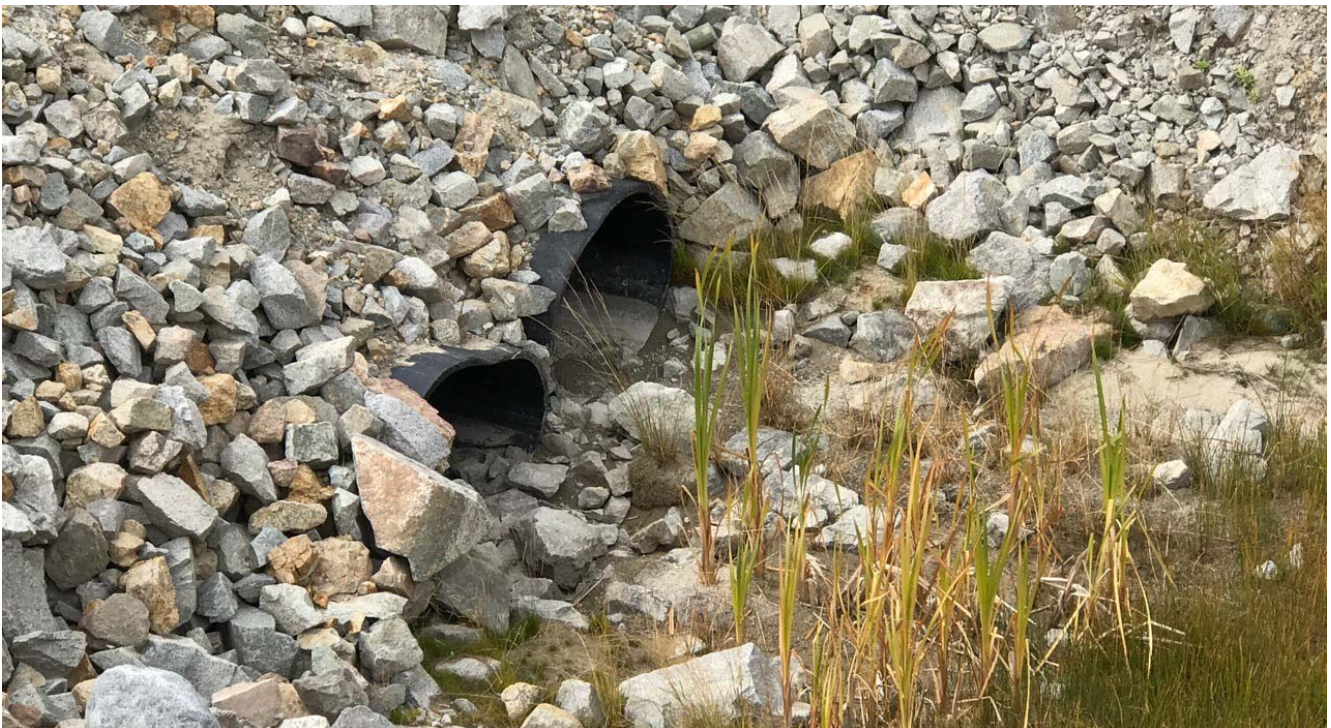
Photo II-A-12 Downstream side of 33" ID spillway road culverts, showing vegetation (HGH-2017-09)
