Teck Highland Valley Copper Partnership

2017 Dam Safety Inspection Report

Trojan Tailings Storage Facility

March 2018

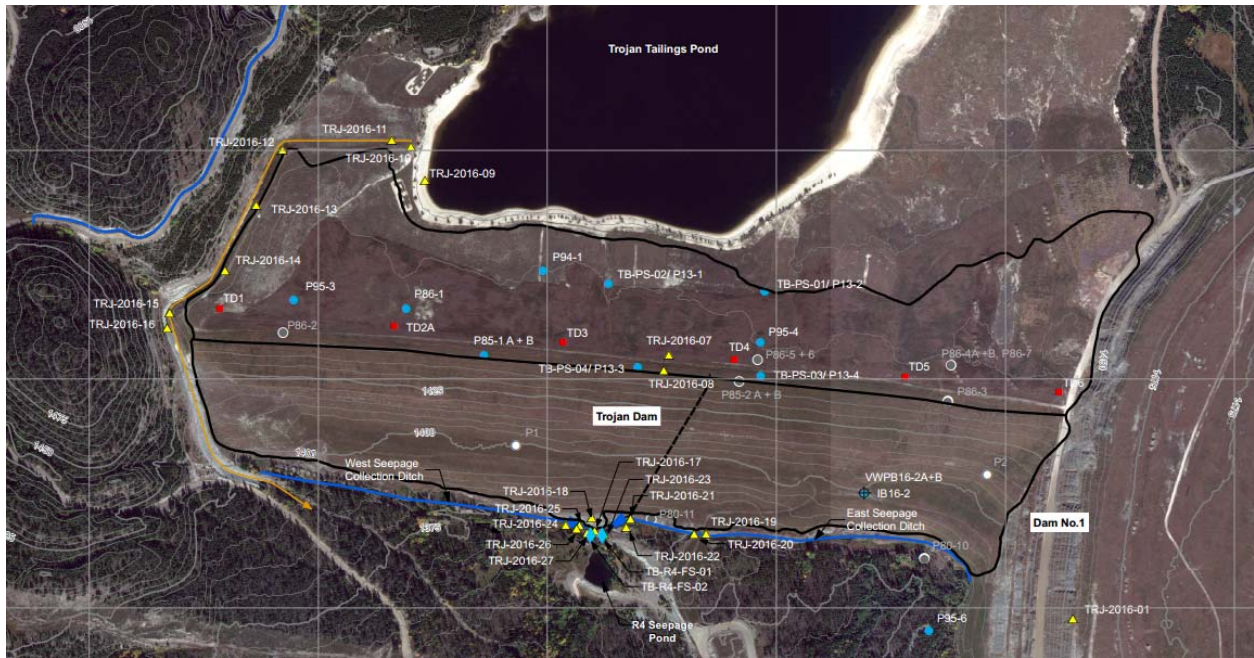
SITE PLAN

- 1) Crest is hummocky due to either differential settlement or formation as part of land reclamation efforts. Does not compromise freeboard and appears to be in the same condition as 2016 inspection.
- 2) High point of tailings beach appears to slope towards access road along left abutment and toe of Bethlehem Dam. Access road lower elevation than crest and under IDF conditions could affect freeboard. Ground survey of this area could resolve these concerns.

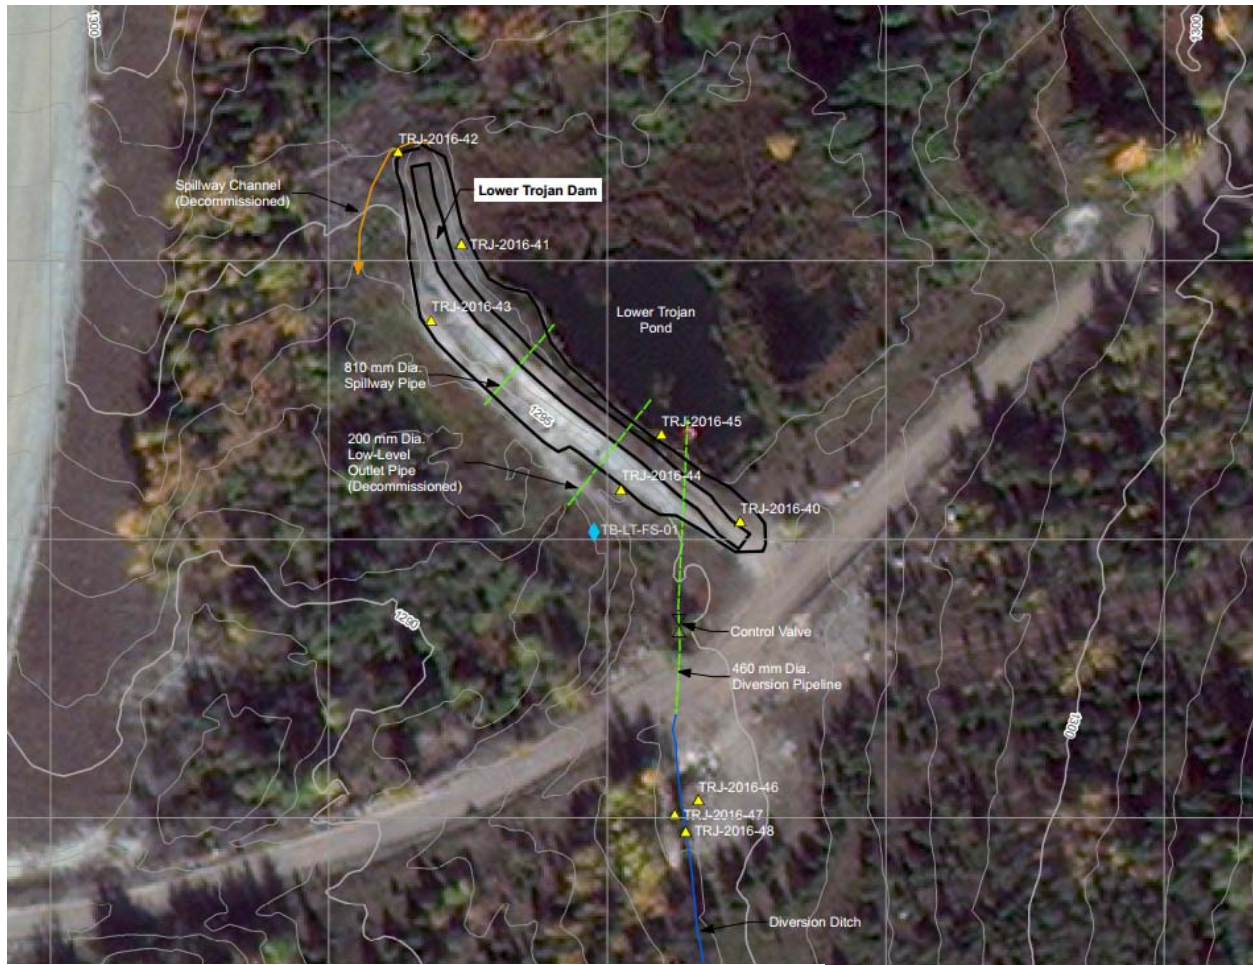
SITE PLAN

- 1) Vegetation growing around catwalk to low-level outlet, continued growth could lead to loss of access to trash rack.
- 2) Upstream slope of dam heavily vegetated and full of debris. This should be monitored and cleared as part of normal operating procedure.

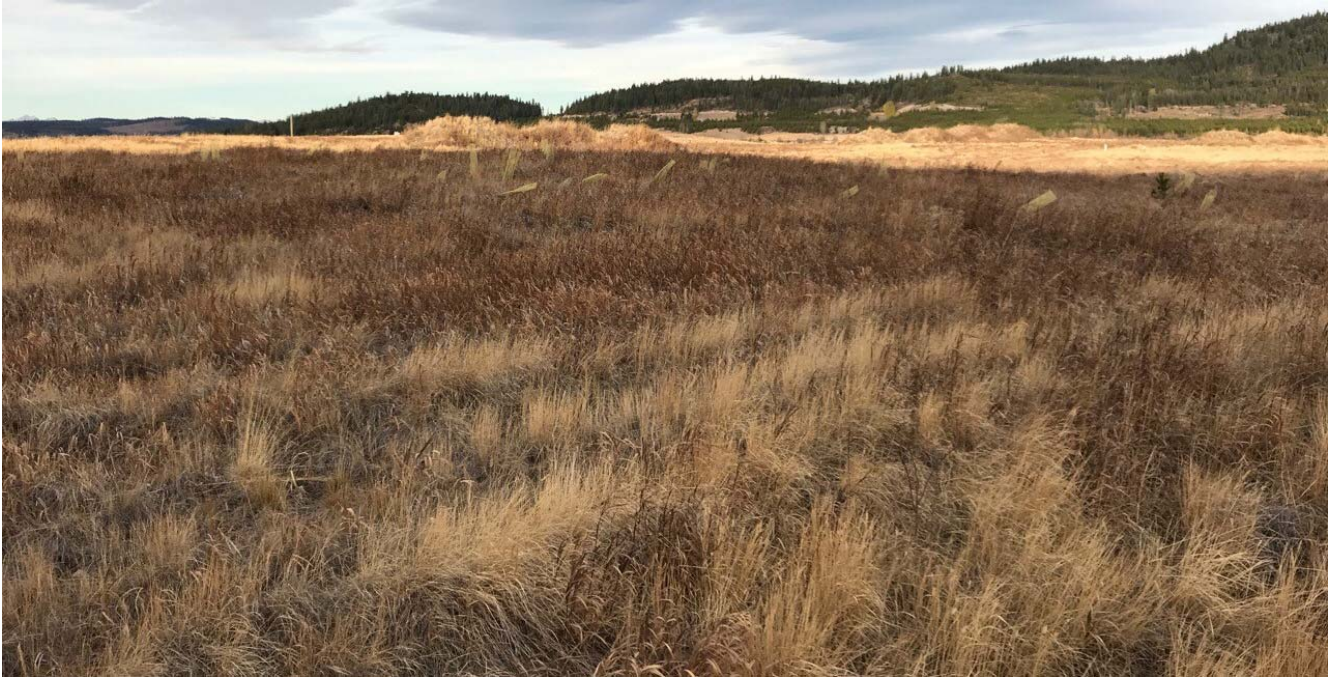
Photo II-A- 6 High point of beach view towards right abutment (TRJ-2017-01)

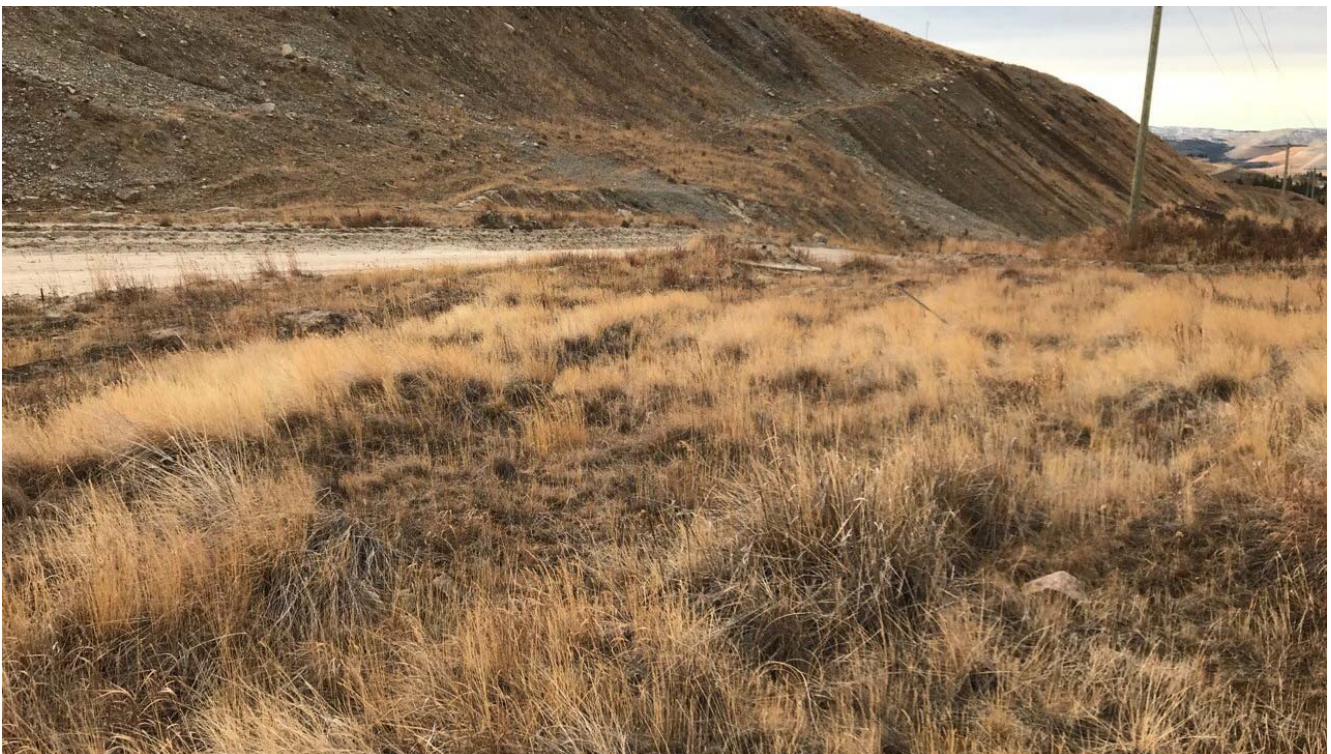
Photo II-A- 7 High point of beach view towards left abutment, ground slopes towards access road which is lower than the crest (TRJ-2017-01)

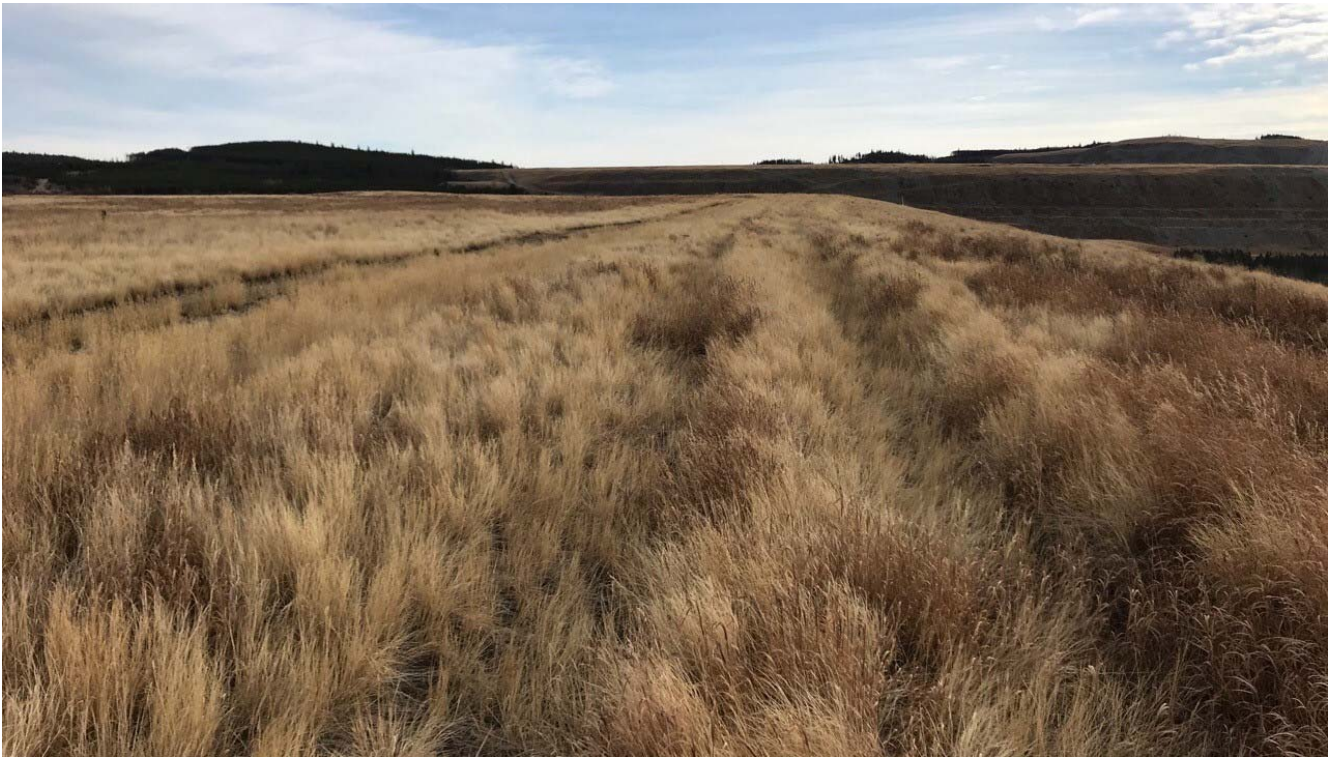
Photo II-A- 8 Vegetated crest view towards left abutment (TRJ-2017-02)

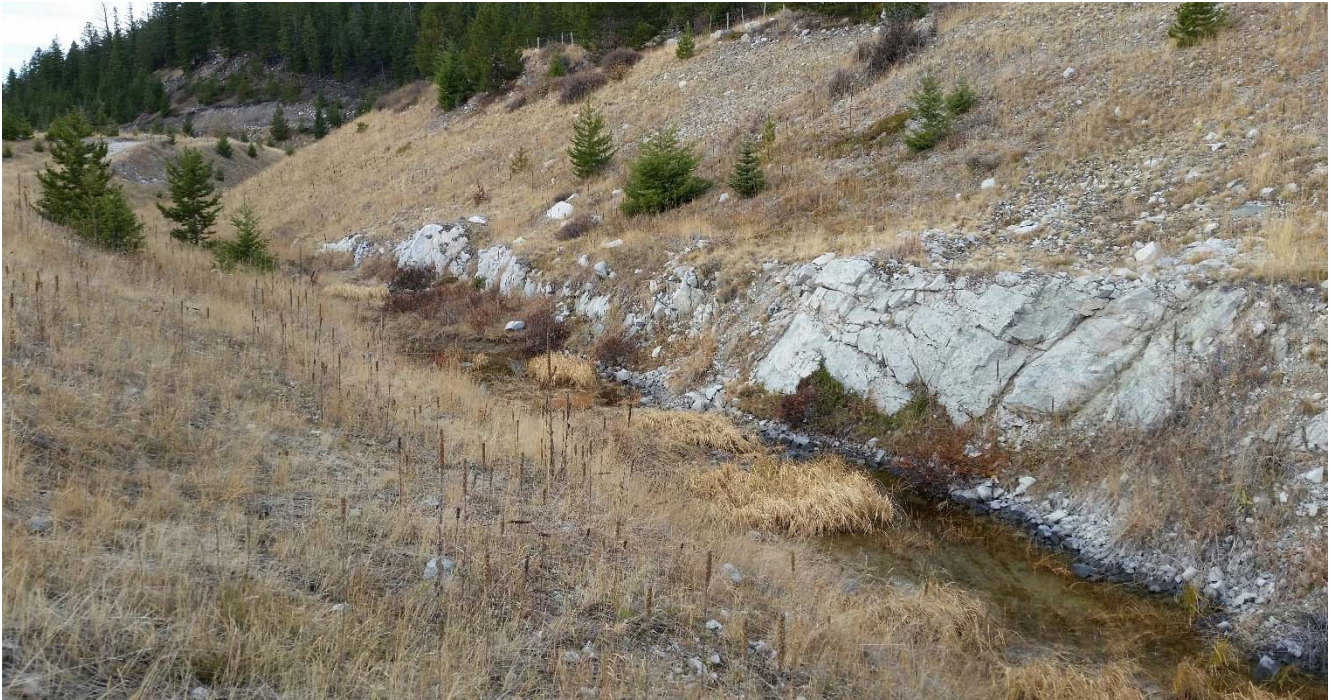
**Photo II-A- 16 Spillway channel with exposed bedrock on righthand side view downstream
(TRJ-2017-09)**

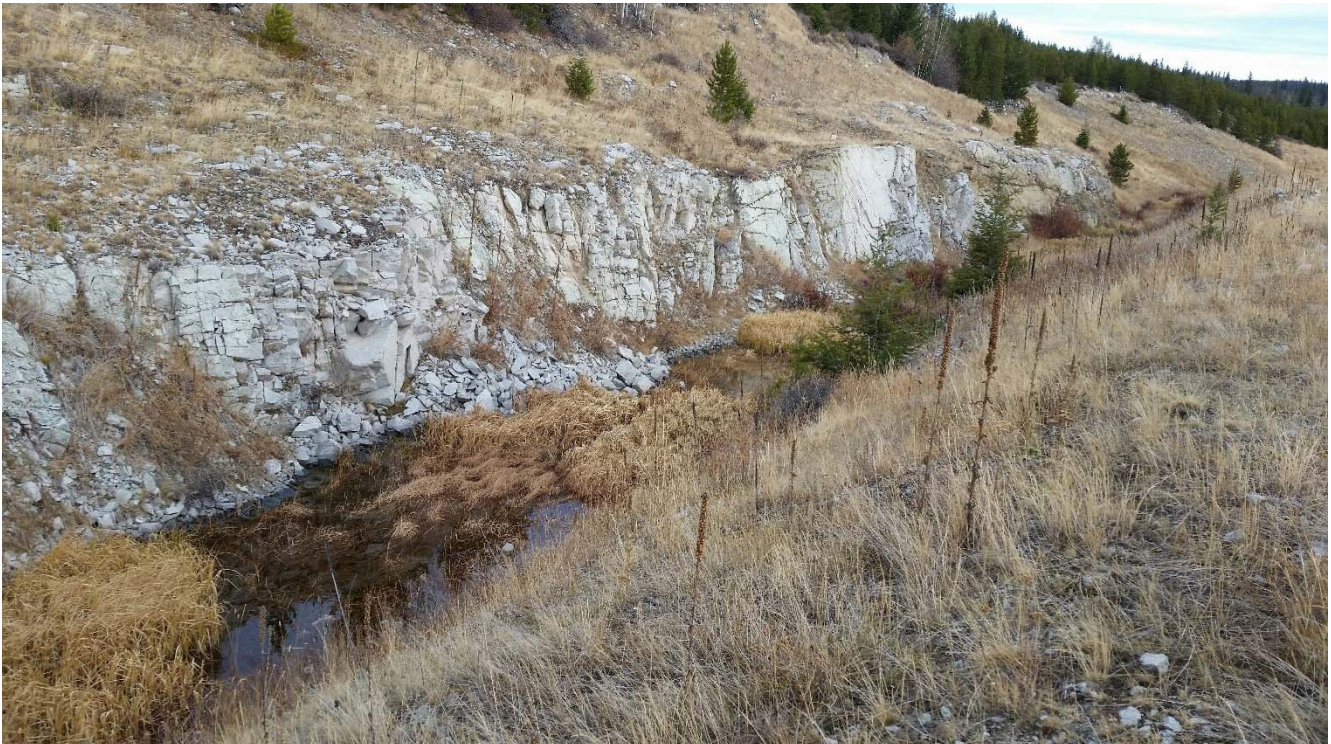
**Photo II-A- 17 Spillway channel with exposed bedrock and pooled water view upstream
(TRJ-2017-09)**

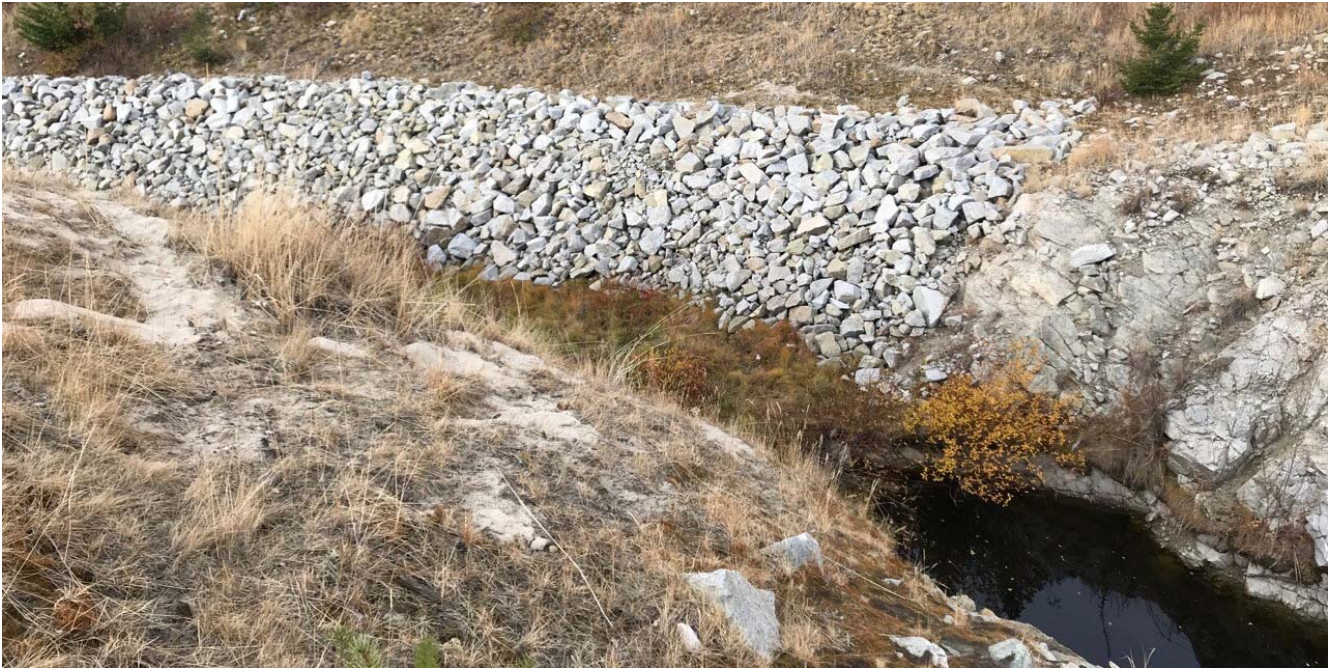
Photo II-A- 20 Spillway channel transition from bedrock to riprap along the toe of the dam, view downstream (TRJ-2017-03)

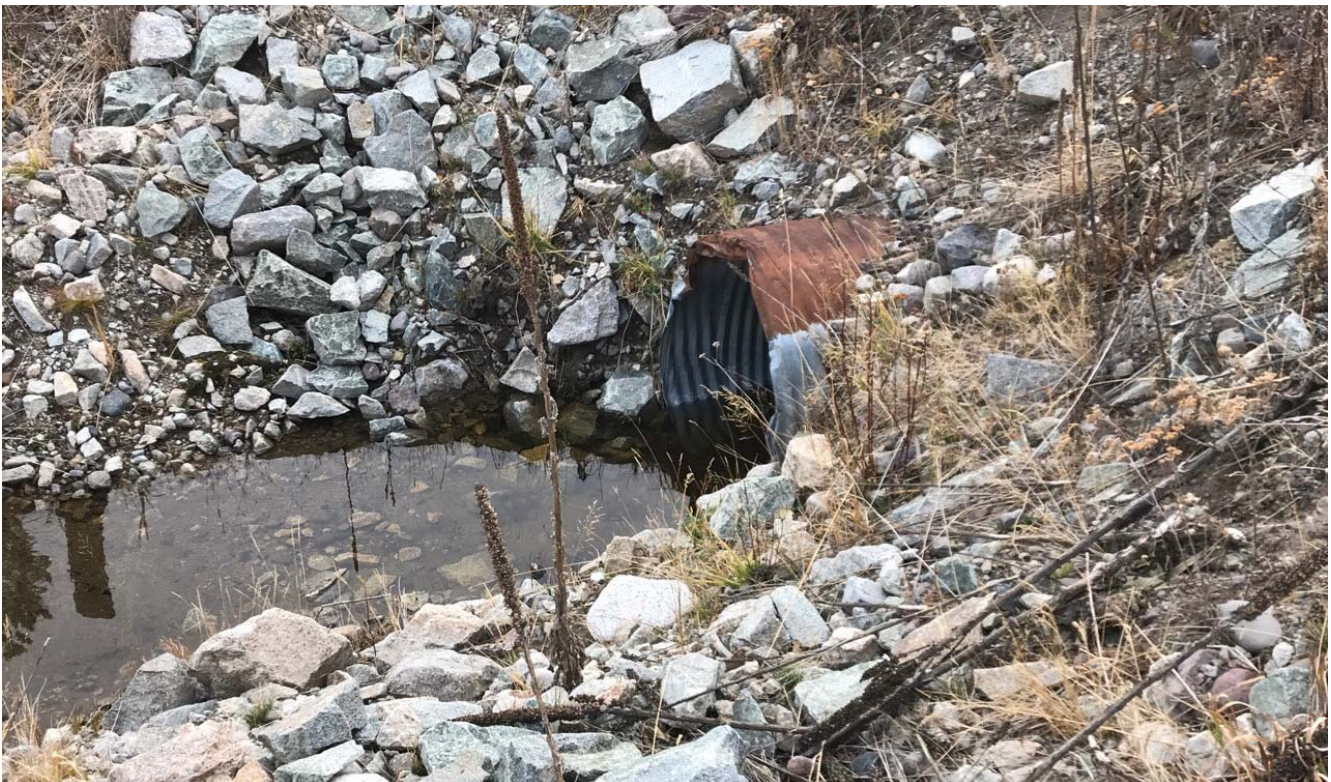
Photo II-A- 32 Diversion channel intersection point, road culvert free of obstructions (TRJ-2017-28)

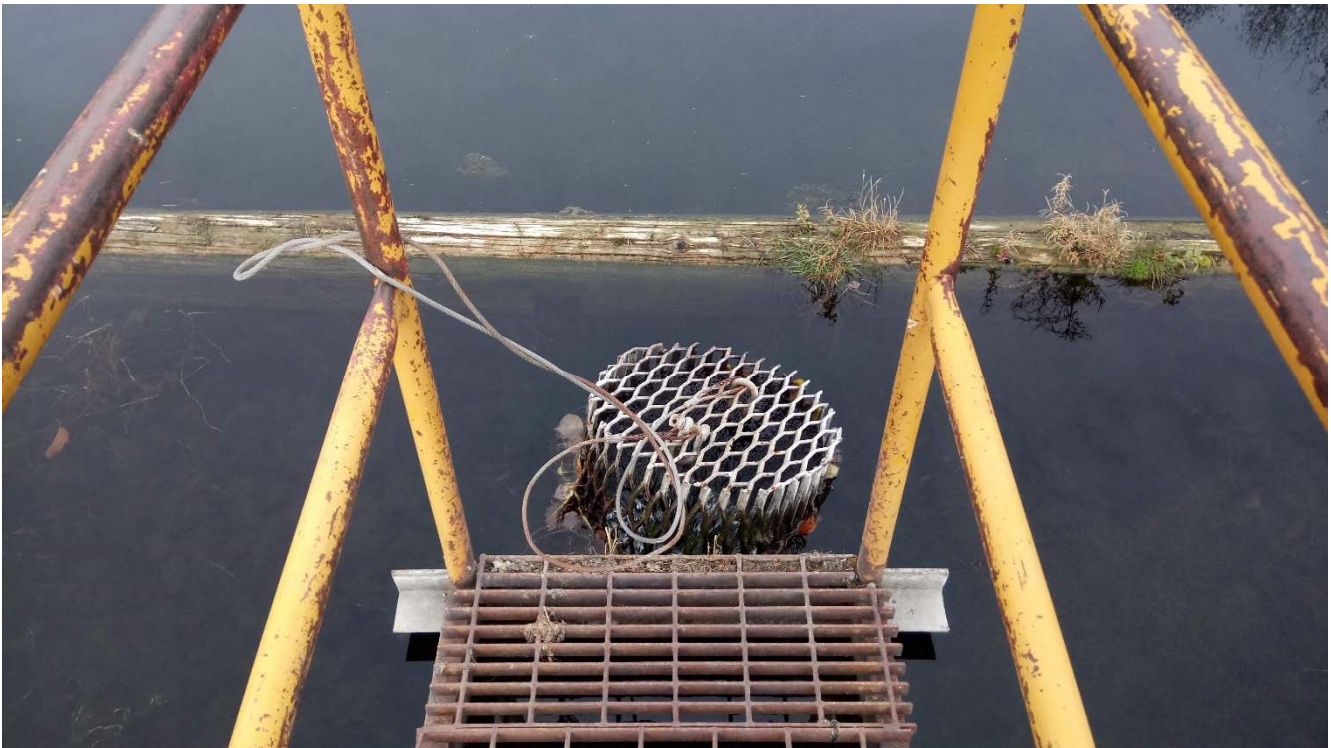
Photo II-B- 3 Low-level outlet to Witches Brook (via Lower Trojan Dam) and wooden debris boom. Debris boom has minimal vegetation, and minor obstructions present in trash rack, therefore material was cleared since 2016 inspection (TRJ-2017-15)

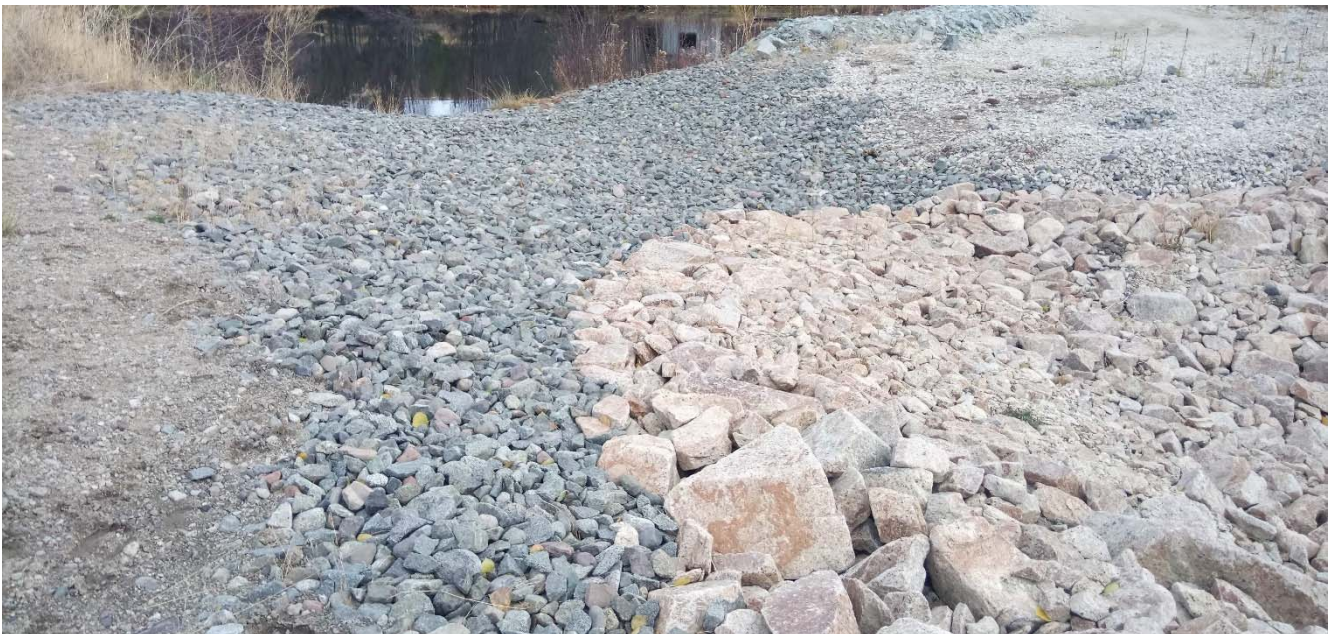
Photo II-B- 6 Dam spillway, no signs of erosion or vegetation present, view downstream (TRJ-2017-18)

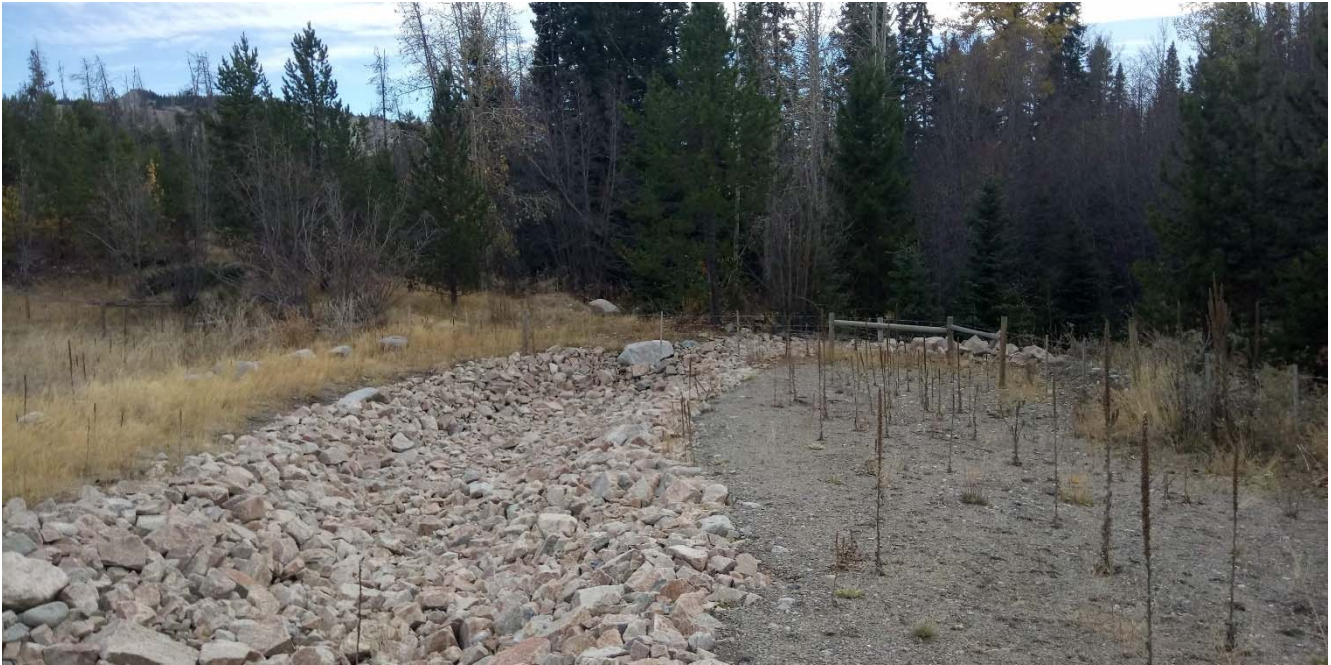
Photo II-B- 7 Final portion of spillway riprap, view downstream towards outfall (TRJ-2017-19)

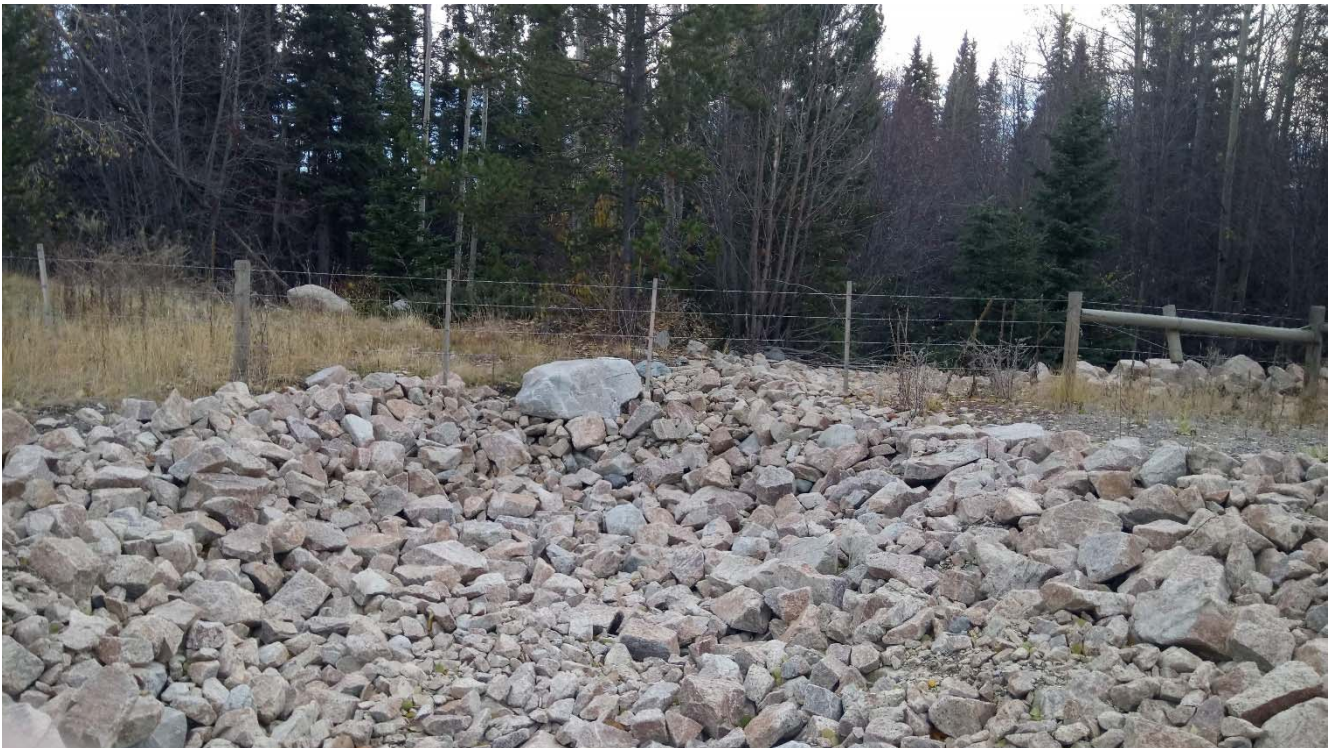
Photo II-B- 8 Riprap coarse material size 35-125mm (TRJ-2017-16)

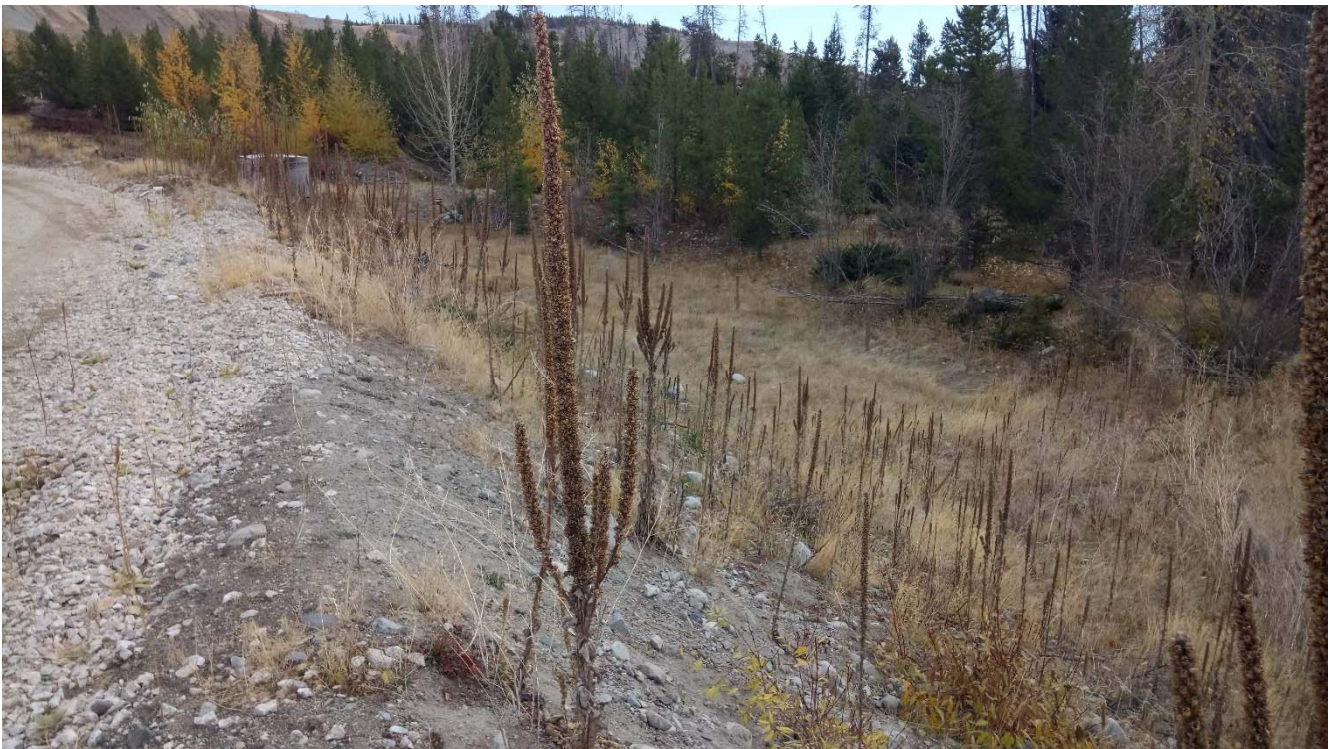
**Photo II-B- 10 East and West toe drain channel outlets and inflow pipe view towards Trojan Dam
(TRJ-2017-15)**

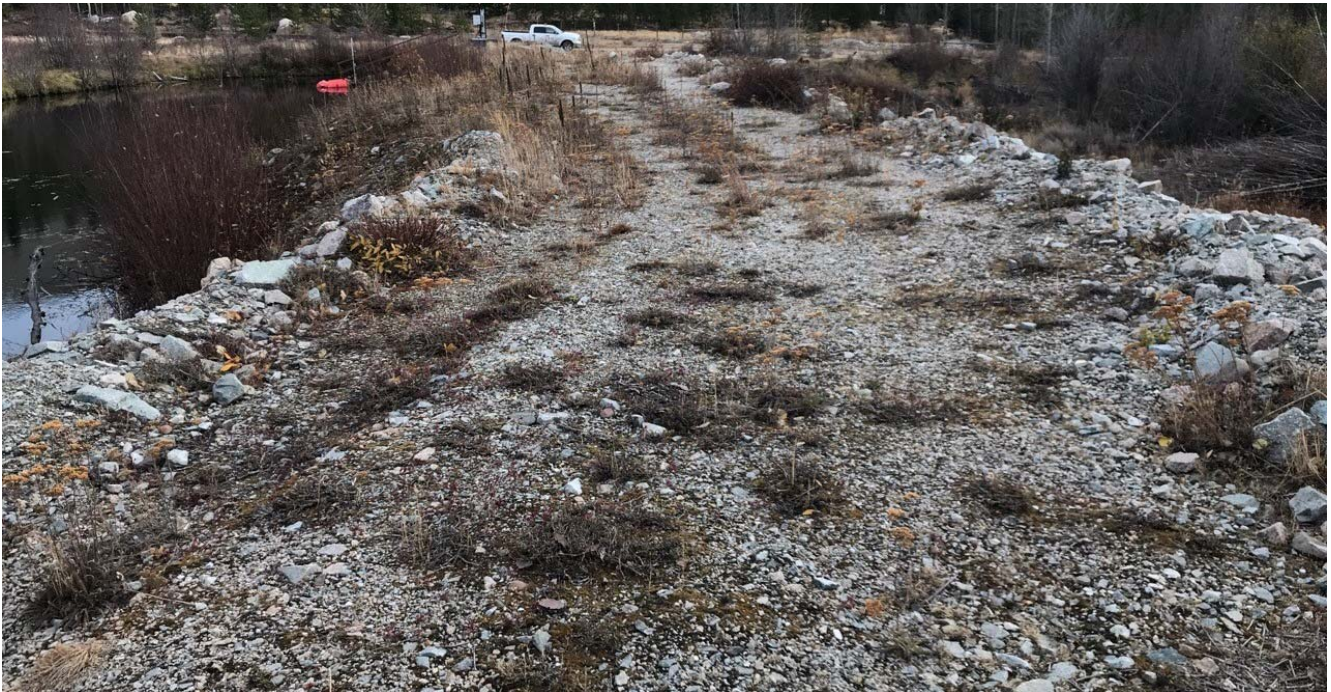
Photo II-C- 3 Overflow near right abutment. Heavy vegetation in front of pipe which could lead to an obstruction. Flow discharges to the dam's right toe (TRJ-2017-23)

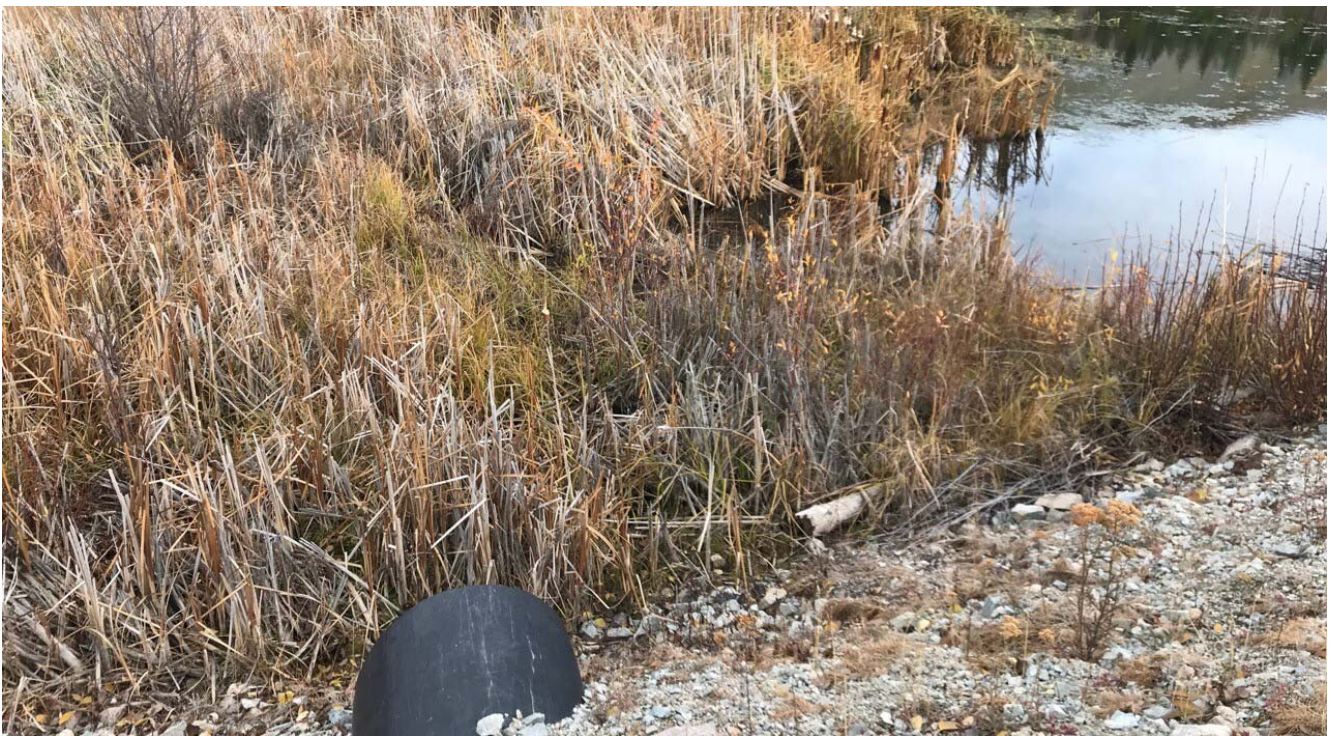
Photo II-C- 4 Dam spillway inlet, extensive vegetation present, and no visible channel (TRJ-2017-24)

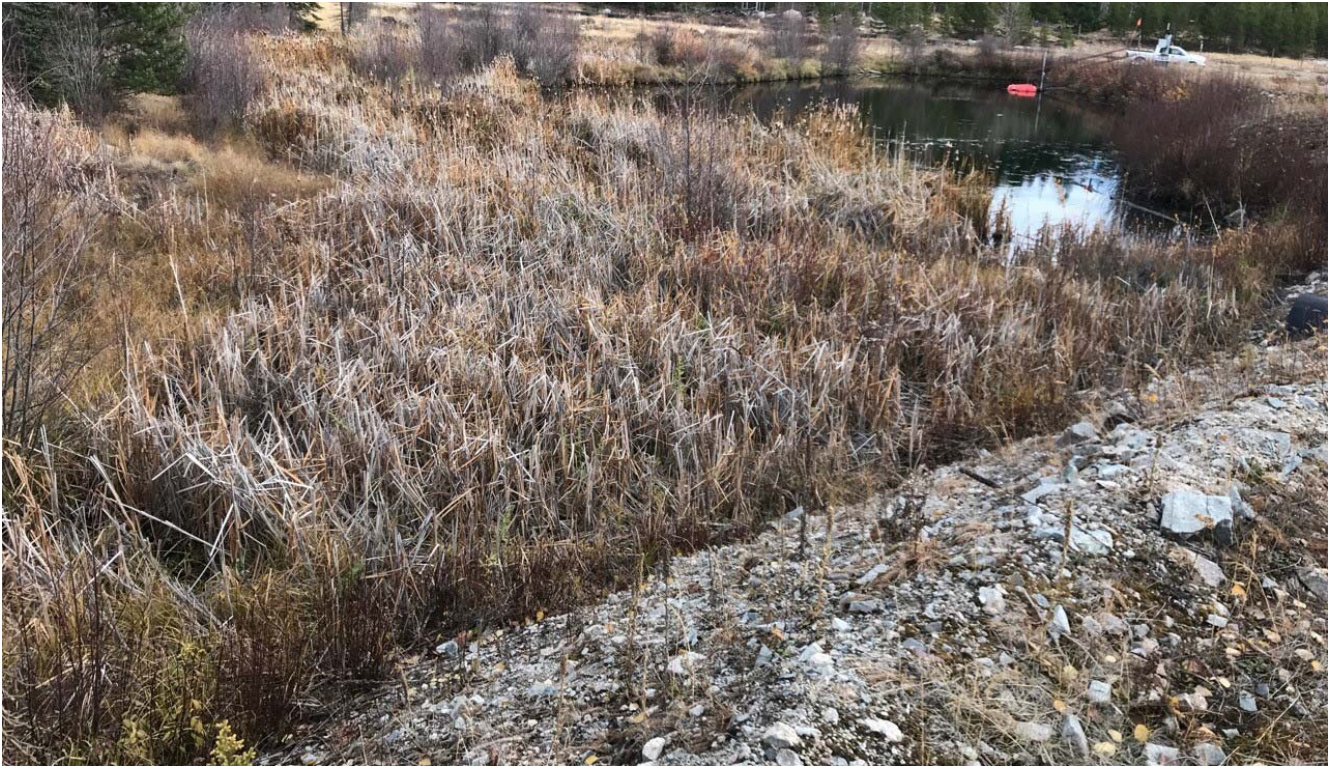
Photo II-C- 5 Spillway route filled with debris, no visible channel or flow path (TRJ-2017-24)

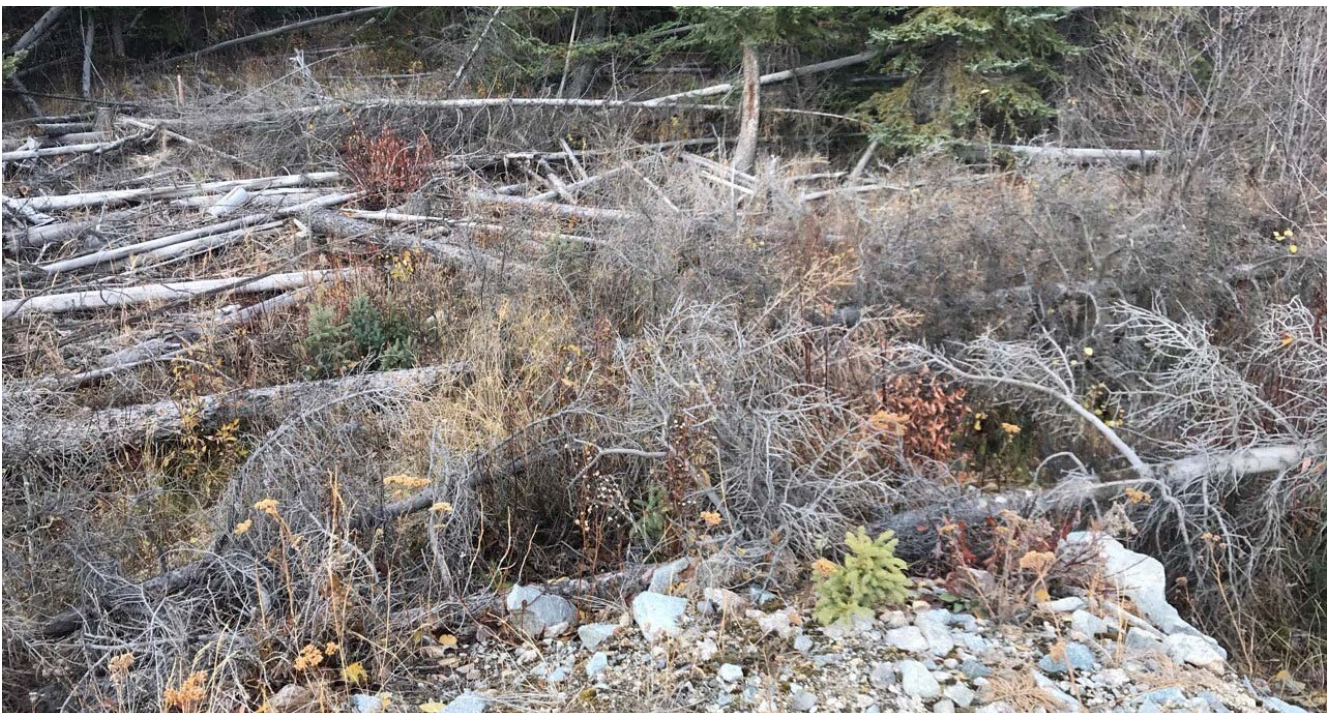
**Photo II-C- 6 Spillway curve around right abutment along the toe of the dam, view downstream.
No visible channel, flow path filled with debris (TRJ-2017-24)**

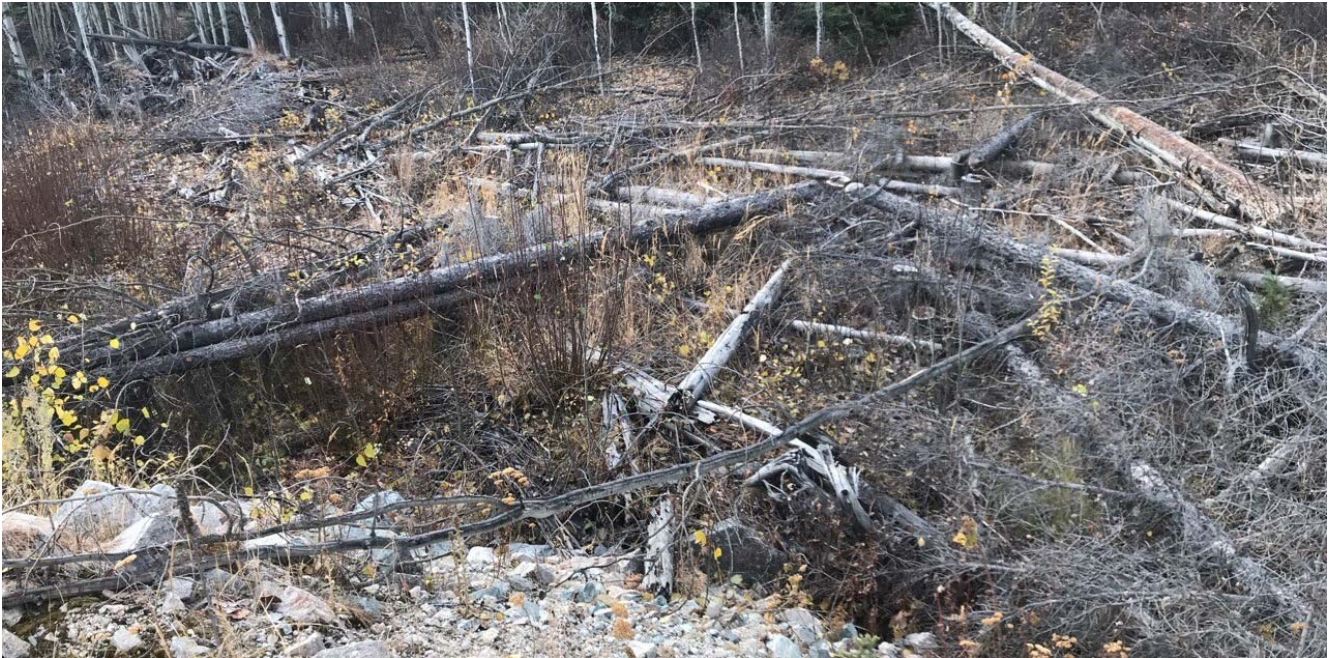
Photo II-C- 7 Dam downstream slope, view towards left abutment (TRJ-2017-22)

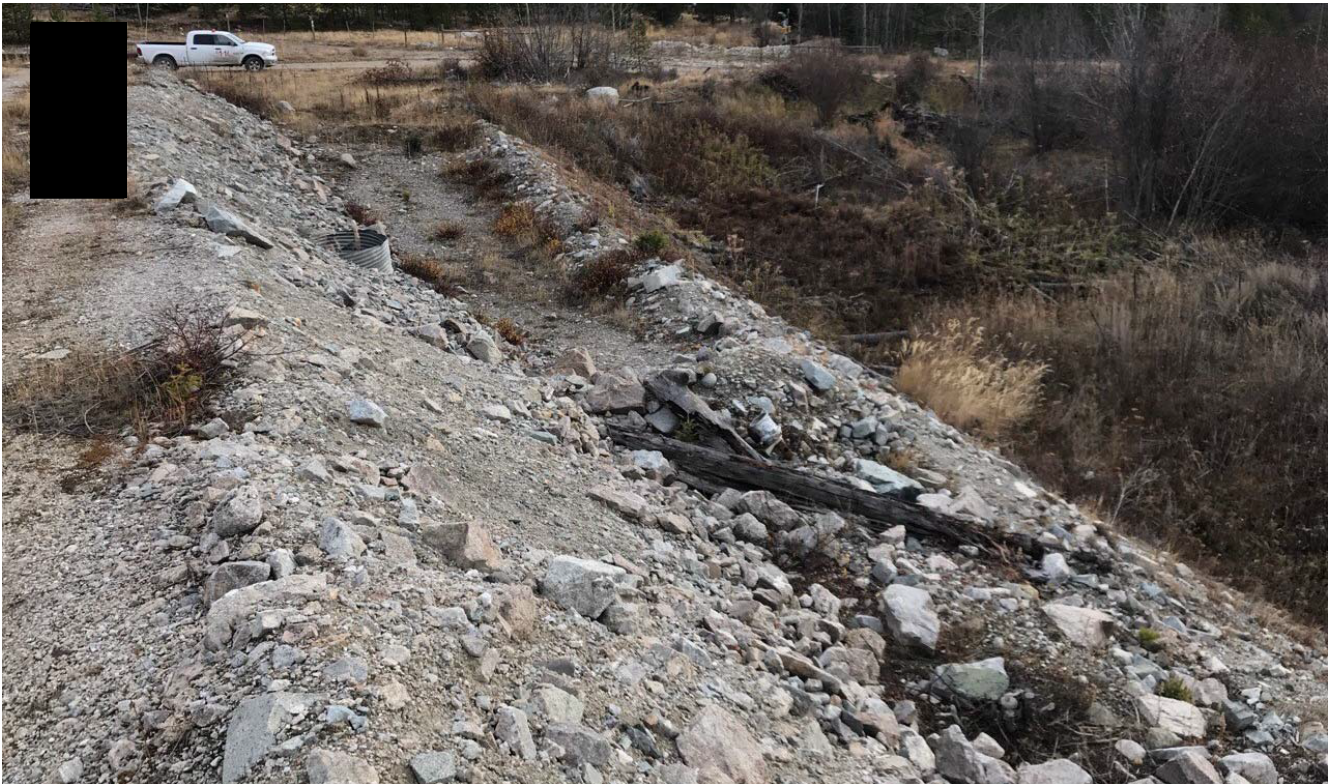
Photo II-C- 8 Dam downstream slope, view towards right abutment and spillway (TRJ-2017-22)

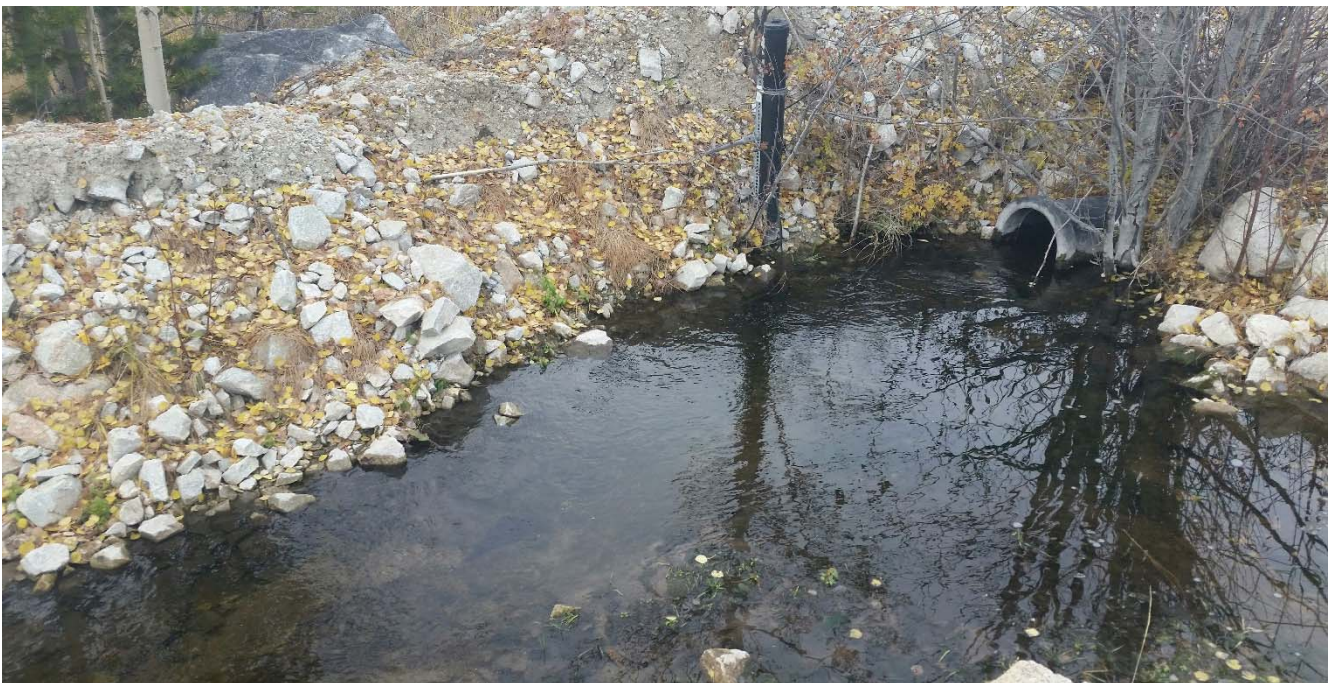
Photo II-C- 12 Inflow culvert from Trojan Diversion Ditch (TRJ-2017-25)

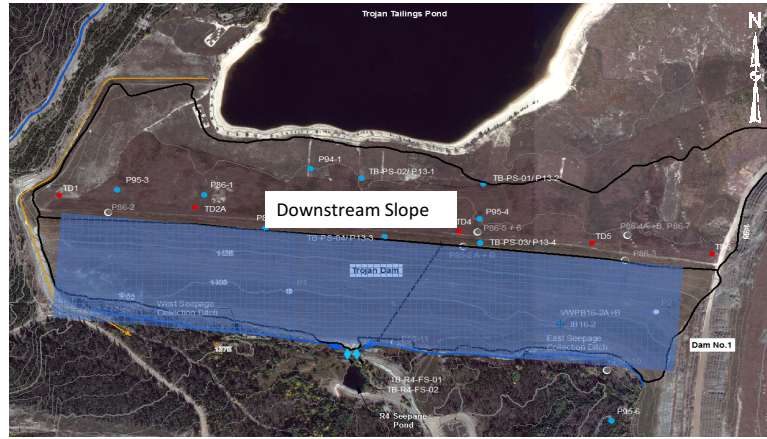
CLIENT TECK HIGHLAND VALLEY COPPER PARTNERSHIP	PROJECT TROJAN TAILINGS STORAGE FACILITY 2017 DAM SAFETY INSPECTION
	TITLE TROJAN DAM PIEZOMETRIC DATA 2007-2017
	PROJECT NO. M02341B26
CREST	
FIG NO. IV-2
