**TECK COAL LIMITED  
FORDING RIVER OPERATIONS**

**2017 Dam Safety Inspection for  
North Tailings Pond and South  
Tailings Pond**

**Reference Number: 1784573-2017-129-R-Rev0-1000**

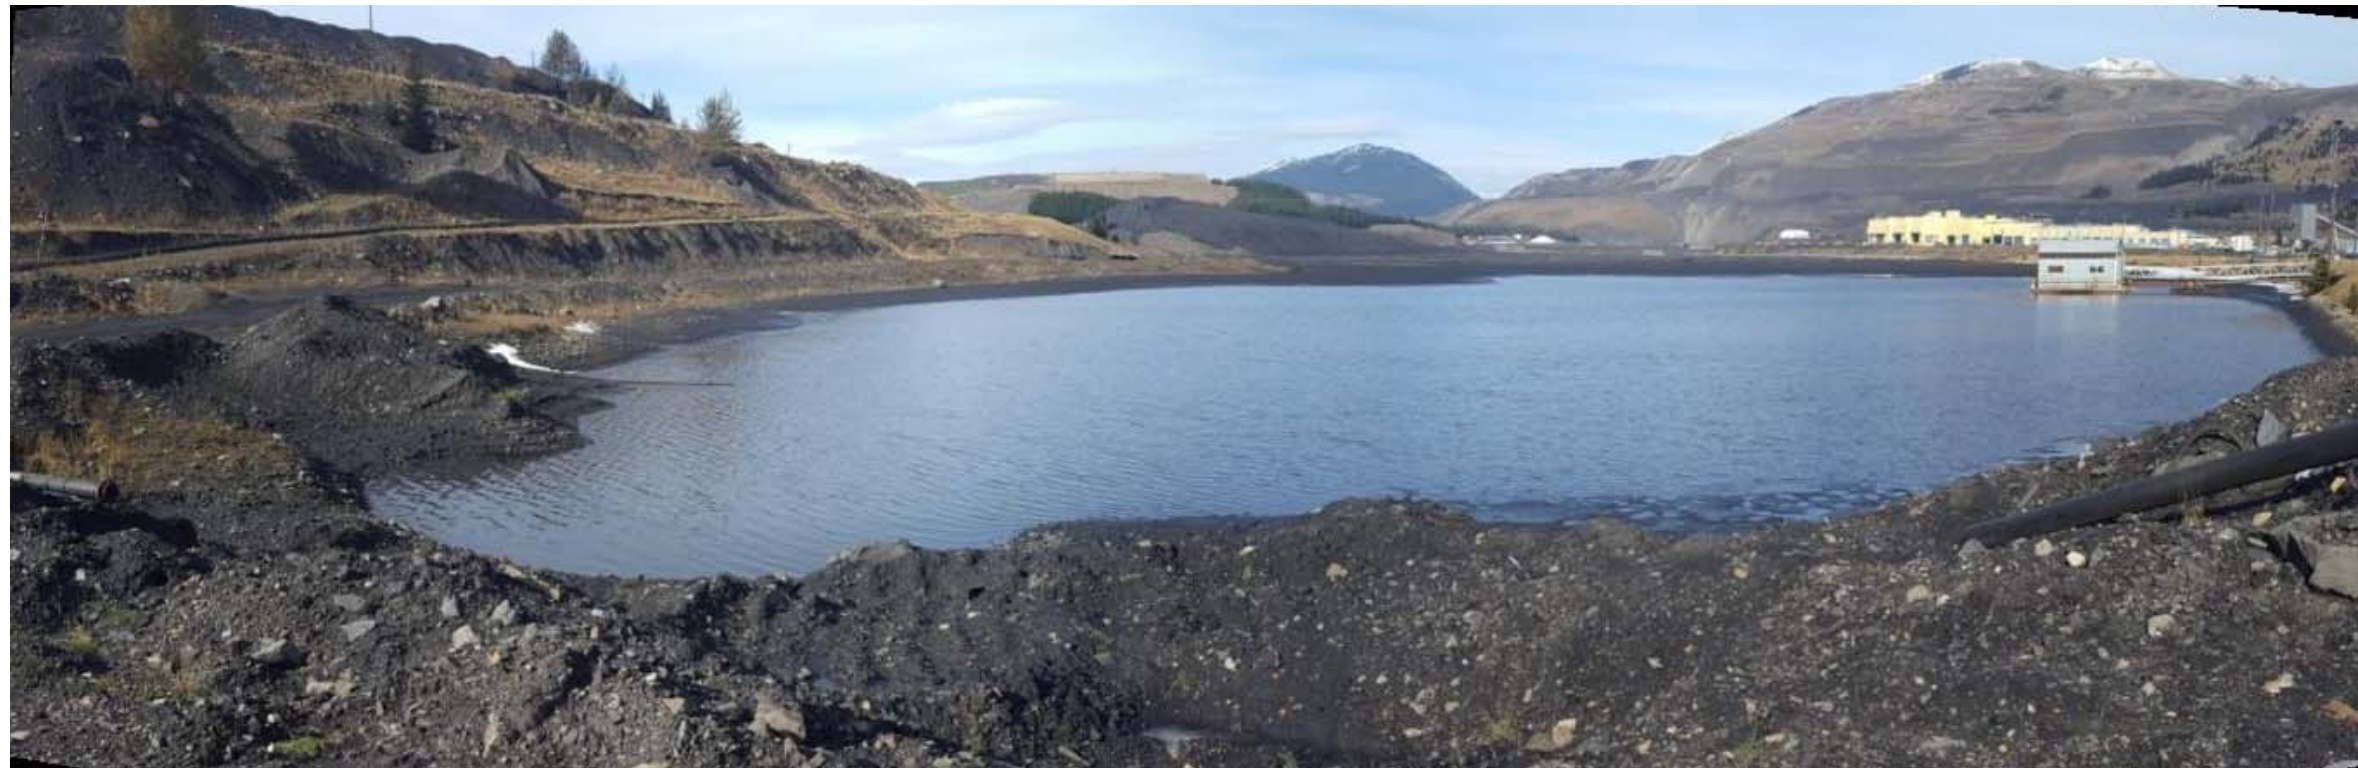
*Photograph 1: North Tailings Pond (NTP) overview from south abutment, looking north. 4 October 2017.*
