Teck Coal Limited

Elkview Operations

West Fork Tailings Facility and Lagoons A, B, C, and D

2022 Annual Facility Performance Report

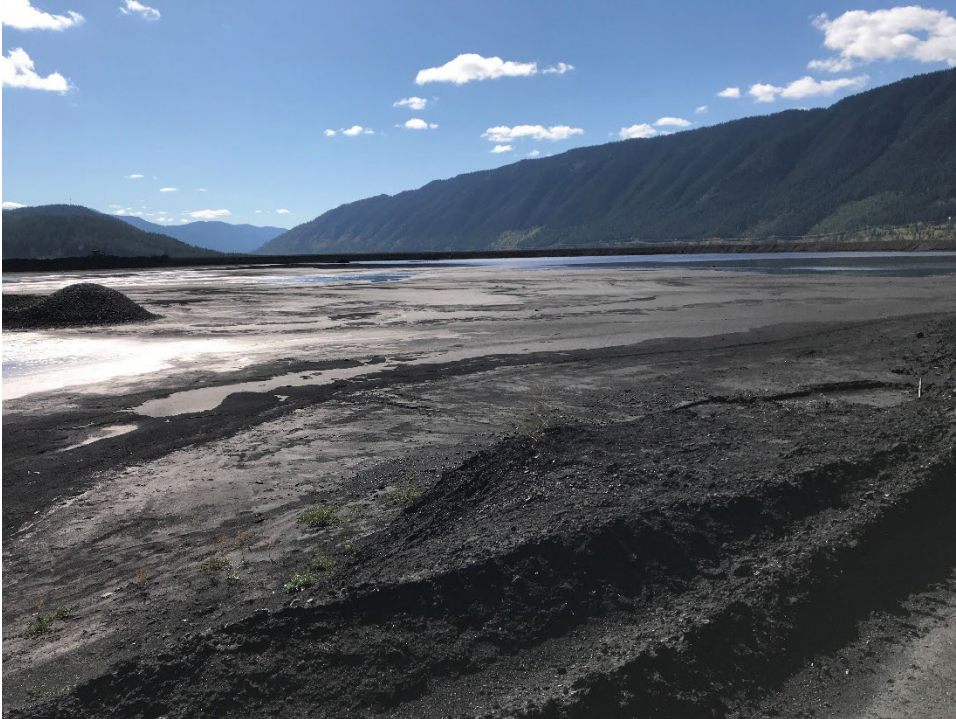
Photo ID-17 Lagoon D tailings beach. (Looking SW– Taken 20 September 2022)

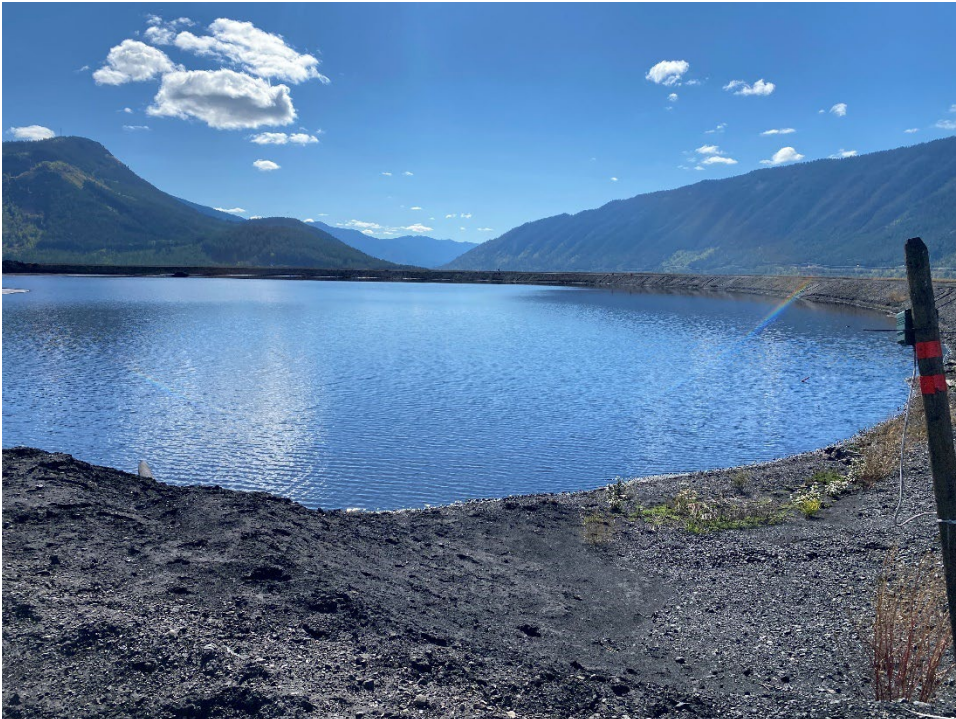
Photo ID-18 Lagoon D pond. (Looking south – Taken 20 September 2022)
