**THURBER ENGINEERING LTD.**

**LINE CREEK OPERATIONS  
TAILINGS STORAGE FACILITIES  
2022 ANNUAL FACILITY PERFORMANCE REPORT**

**Final Report**

Date: March 20, 2023  
File: 31397-3002

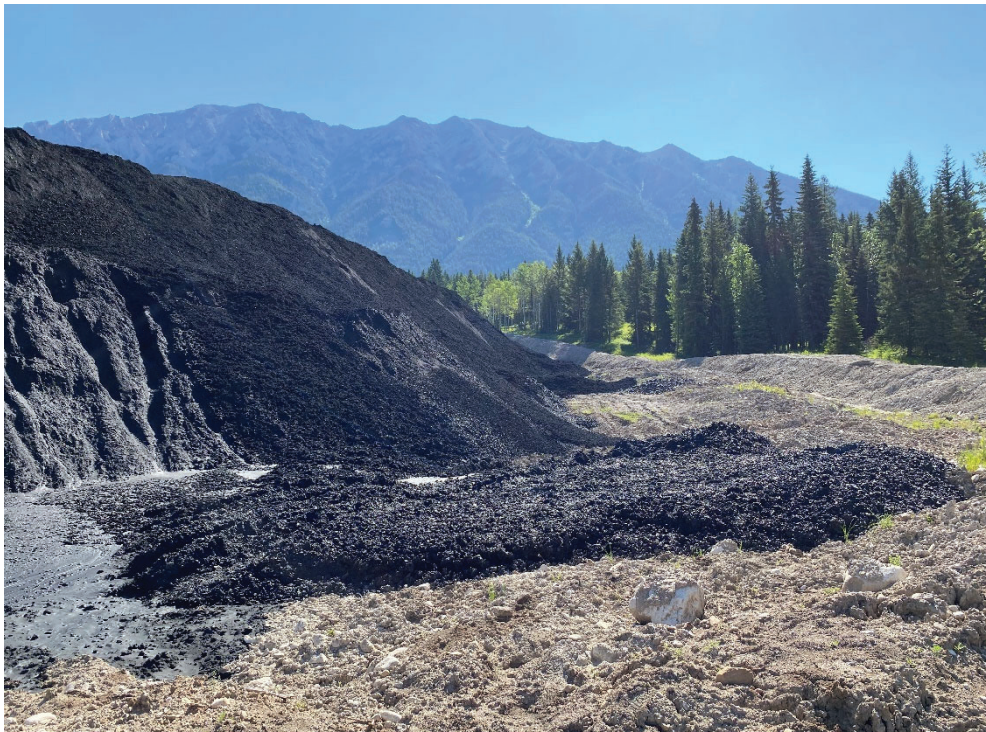
**Photo 16. Soft CCR spoils at June 14, 2022 washout event, looking east**

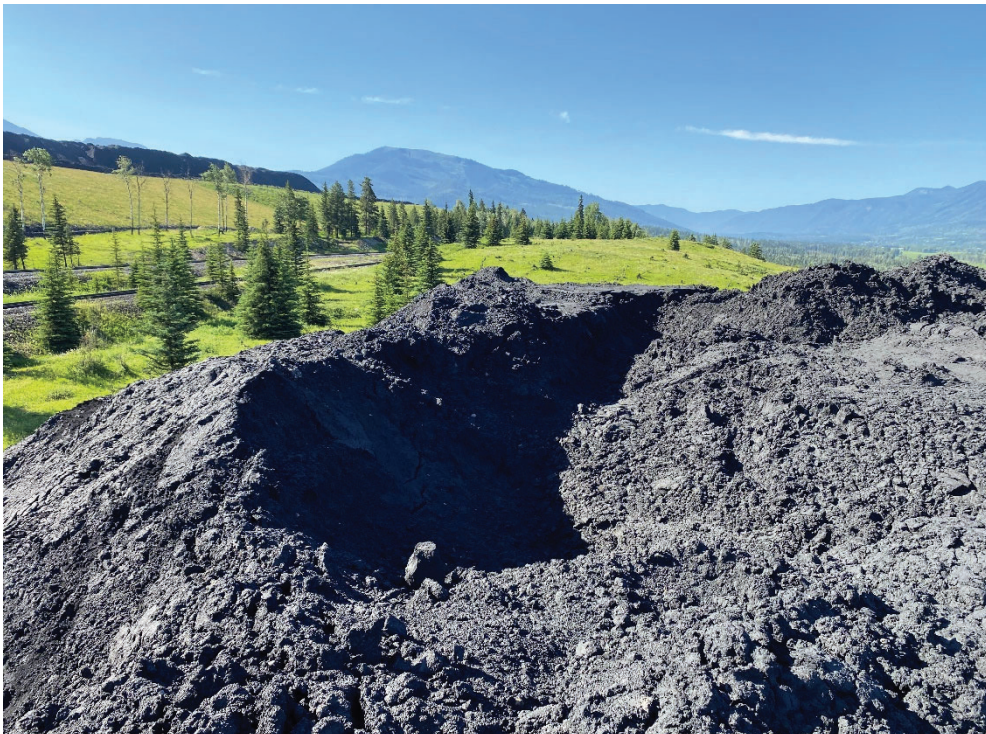
- Deposits of pond fines from the cleanout of the RLP Pond B cleanout in March 2022 were observed to have been dumped on the 1300 m bench. The pond fines were arrayed in standing dump piles and appeared to have dewatered since deposition (Photos 50 to 60). No post dump handling or compaction efforts were evident. It is recommended that no additional material be deposited in the PFD until a stability analysis and design are developed and approved by the EoR.

**Photo 57. Pond fines deposited on the Upper Bench, looking south**

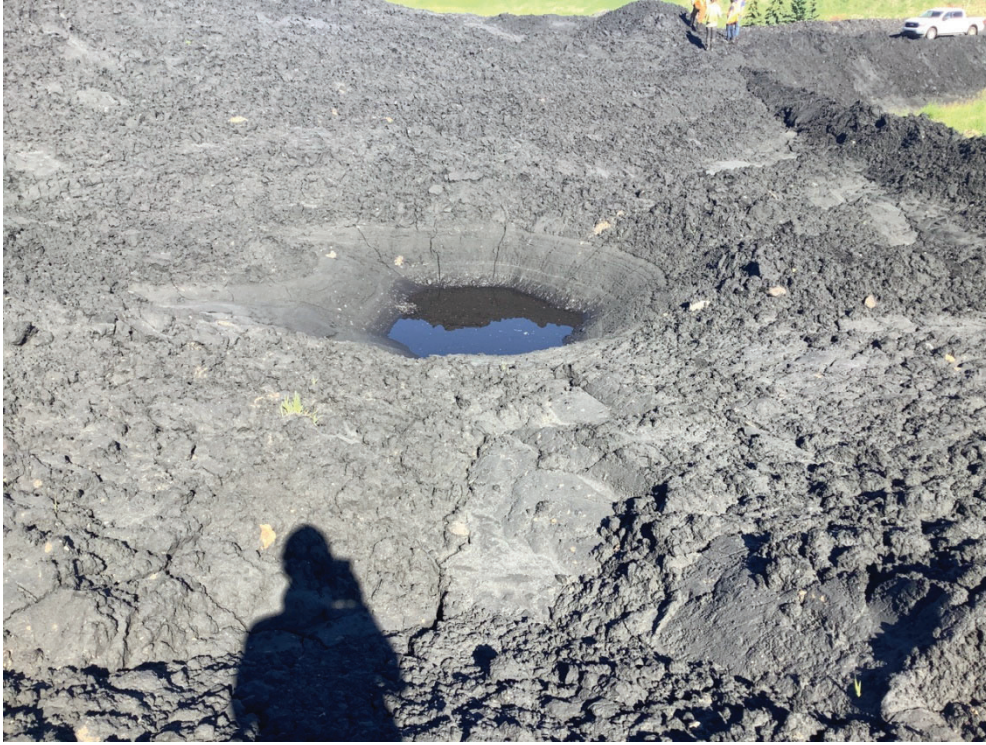
**Photo 58. Pond fines deposited on the Upper Bench, looking west**

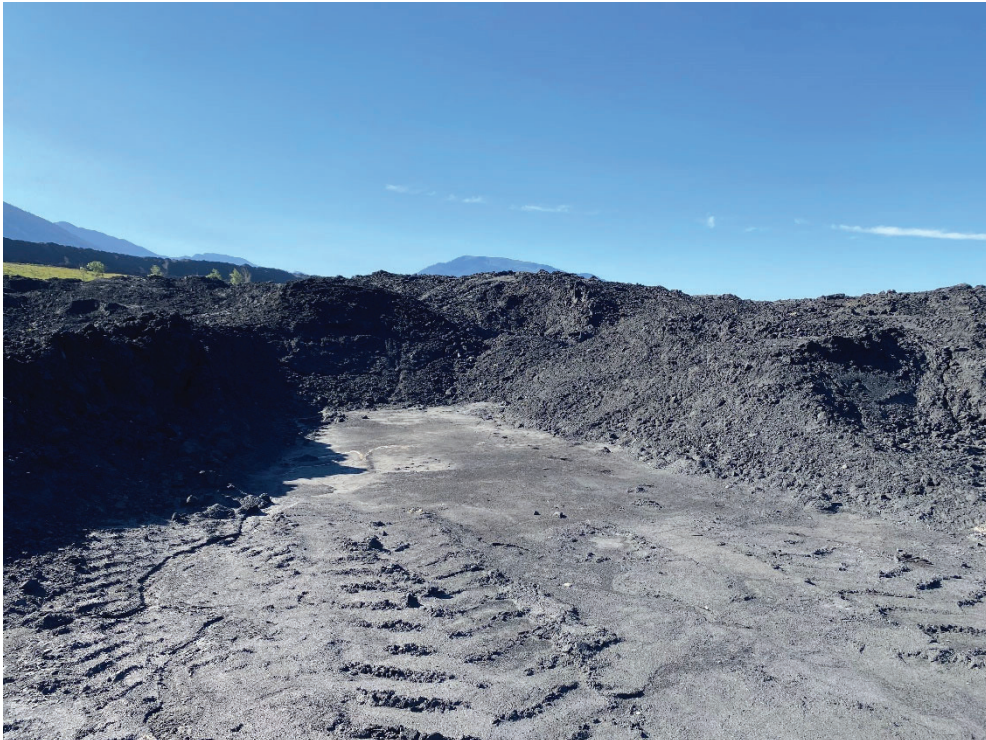
**Photo 59. Pond fines deposited on the Upper Bench, looking south**

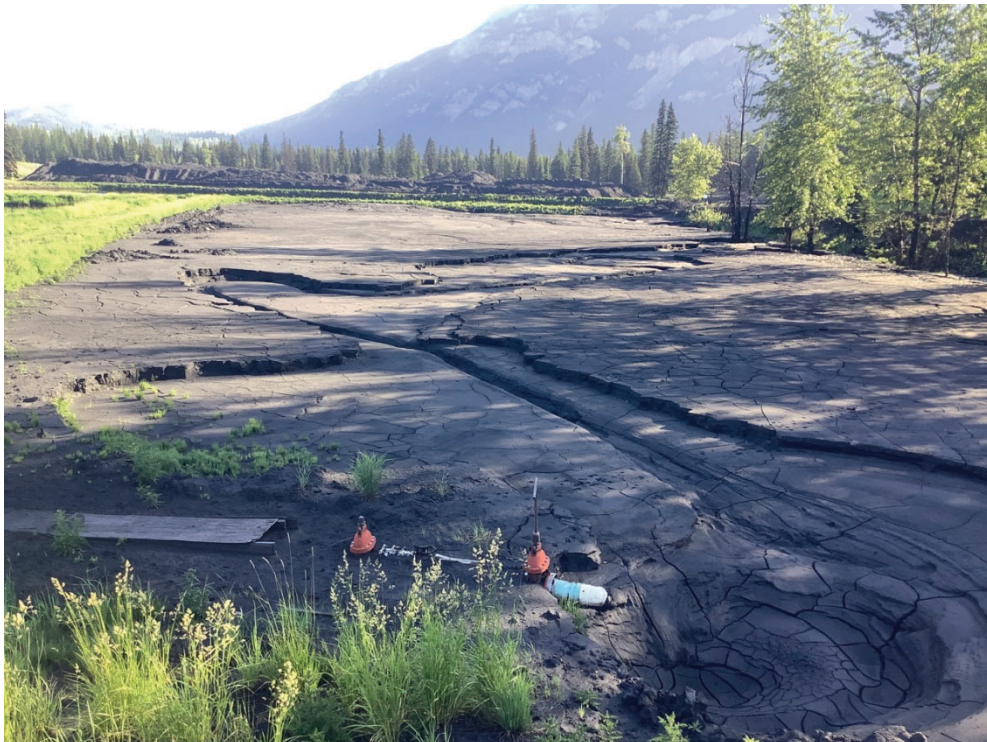
- The discharge pipe crossing of the Pond A/B internal berm limits equipment access to the berm to the northeast (Photos 62 and 63). If the discharge piping were to be relocated, equipment would have multiple point of access and egress along the berm to facilitate maintenance and response to emergencies.

**Photo 62. Pond A discharge spigot location, looking north**
