2022 Annual Facility Performance Report

Red Dog Tailings Storage Facility

Red Dog Mine, Alaska

31404122.007-002-R-Rev0

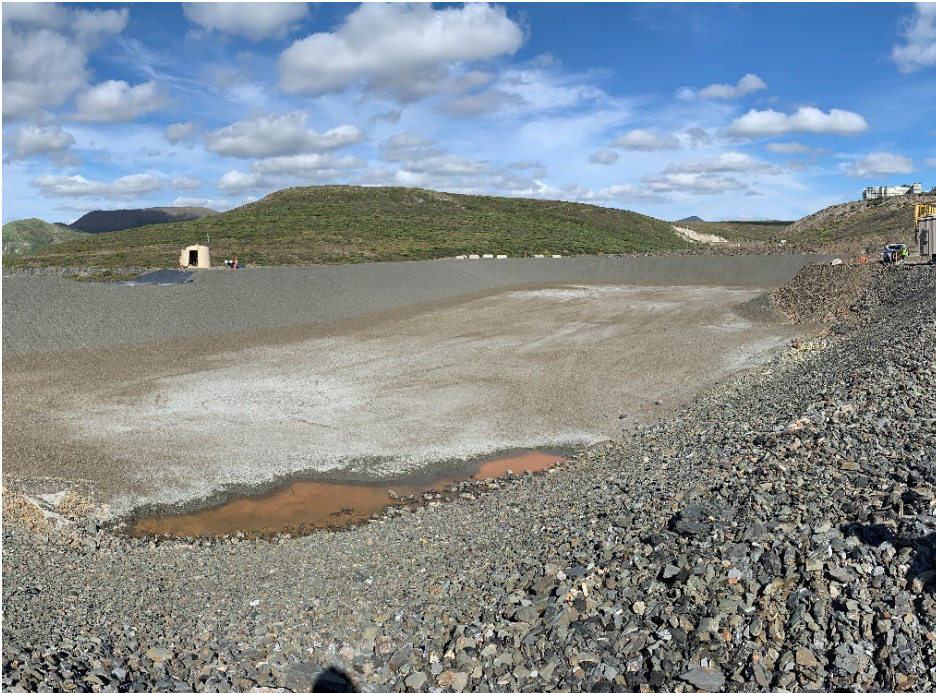
The Seepage Collection Pond and Dam crest, upstream and downstream slopes, and spillway appeared to be in satisfactory physical condition with no signs of damage, settlement, cracking, or instability (see Photos 8 to 11). The bottom of the Seepage Collection Pond had divots in the protective soils covering the geomembrane liner at the east side of the pond bottom (see Photo 9), which should be inspected to assess there is no damage to the liner and protective cover soil replaced. Ponding water was also observed at the base of the Embankment bench fill (see Photo 8), which may be an indicator that additional protective cover soil may be required in those areas.

Photo 8: Seepage Collection Pond with Visible Pooled Water

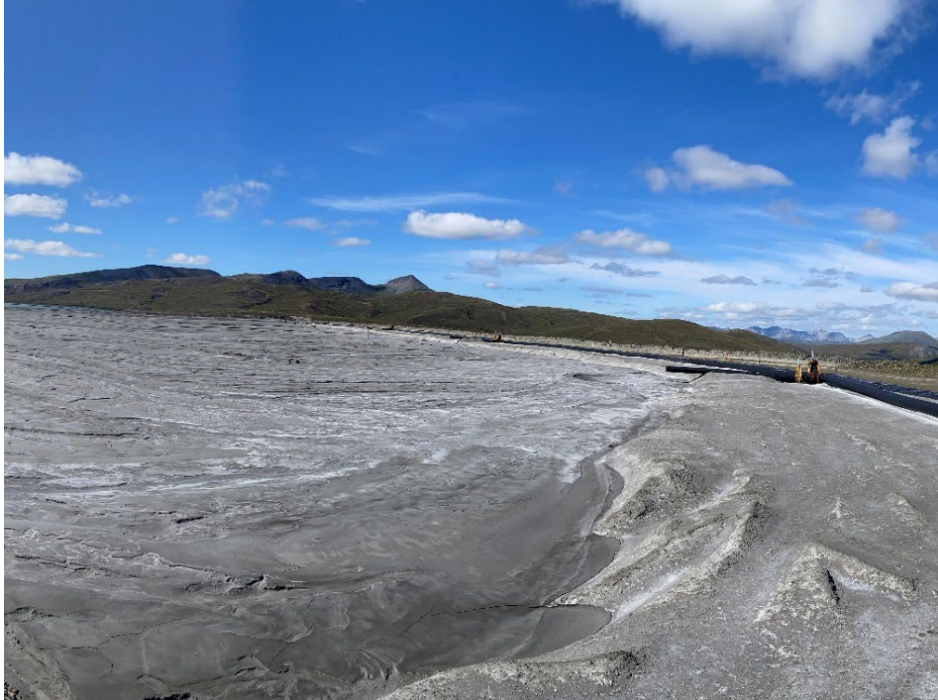
Upstream slope of Embankment and Wing Wall appeared to be in satisfactory physical condition with no indications of liner damage, displacement, or other signs of instability (see Photos 2, 3, and 15). A satisfactory subaerial tailings beach that appeared to meet the minimum target widths was observed at the Embankment and Wing Wall (see Photos 19 and 20). No piping or sinkholes were observed in the subaerial tailings beach.

Photo 19: Subaerial Tailings Beach at Embankment

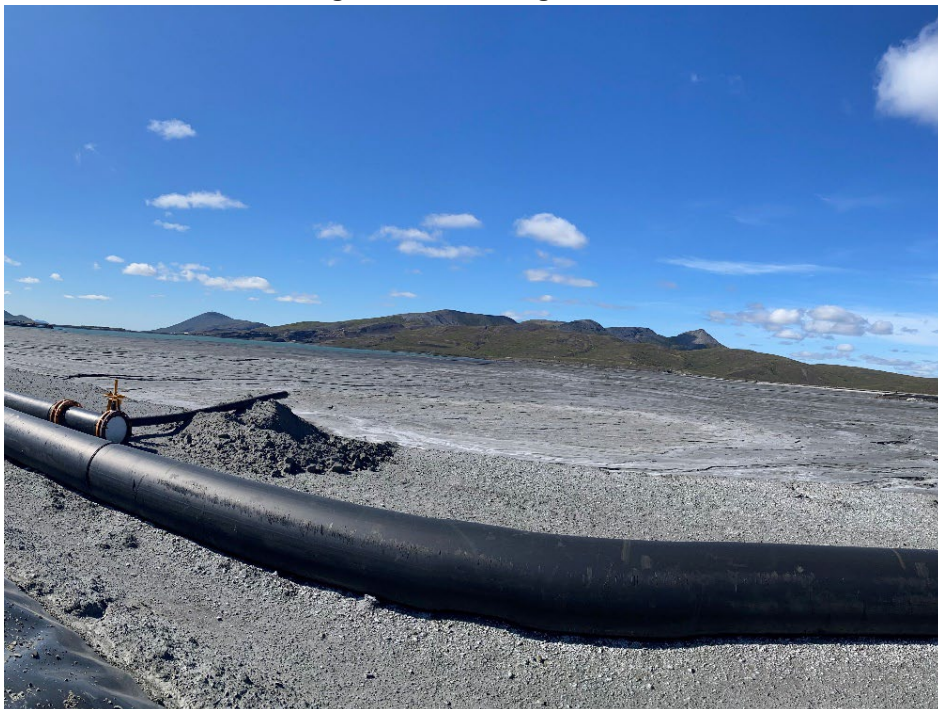
Photo 20: Subaerial Tailings Beach at Wing Wall
