**Teck Metals Ltd.**

**Sullivan TSF 2022**

***Annual Summary of Tailings Facility  
Performance Report***

A05807A22

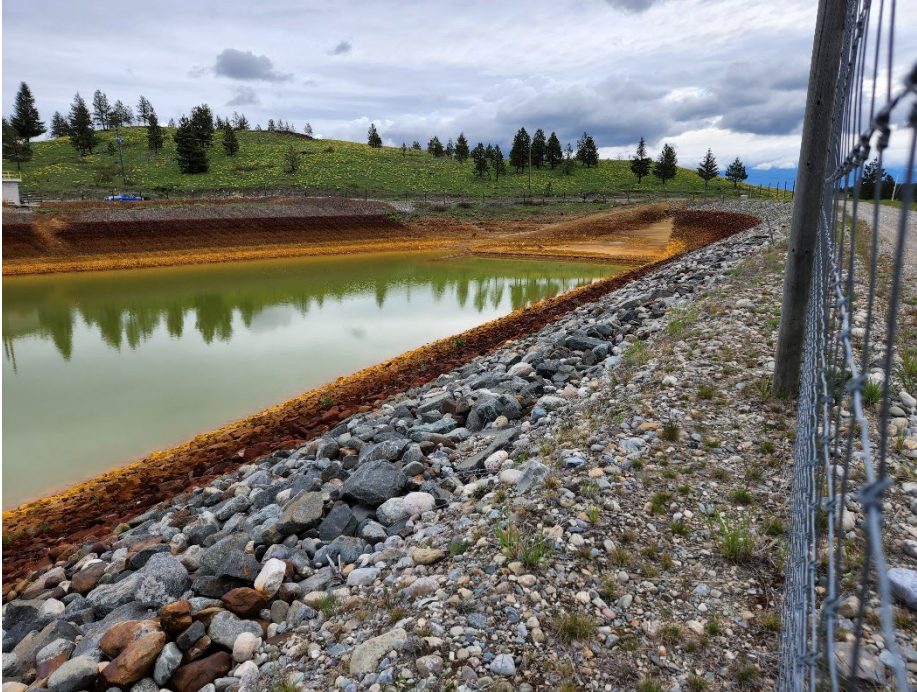
**Photo II.1 ARD South Dam Upstream Slope**

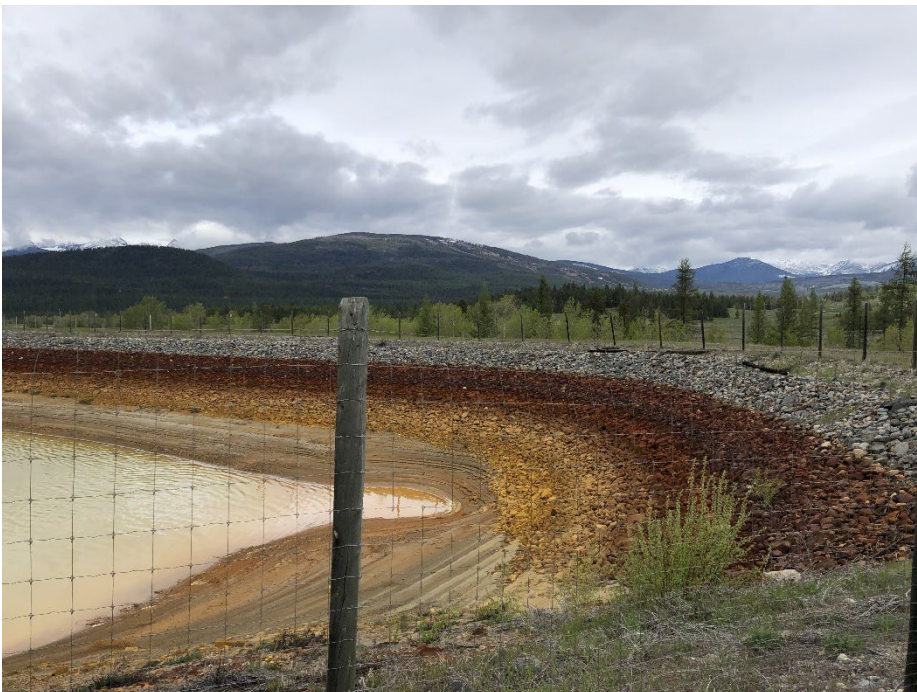
**Photo II.2 North Dam Upstream Slope**

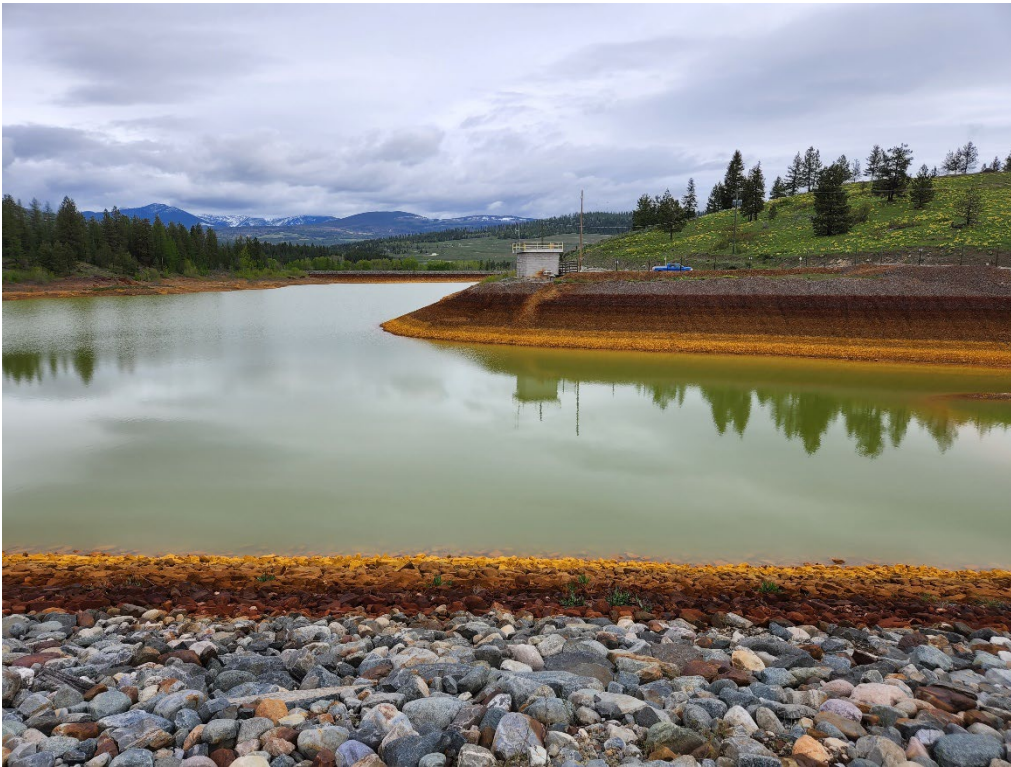
**Photo II.3 Erosion adjacent to pumphouse**

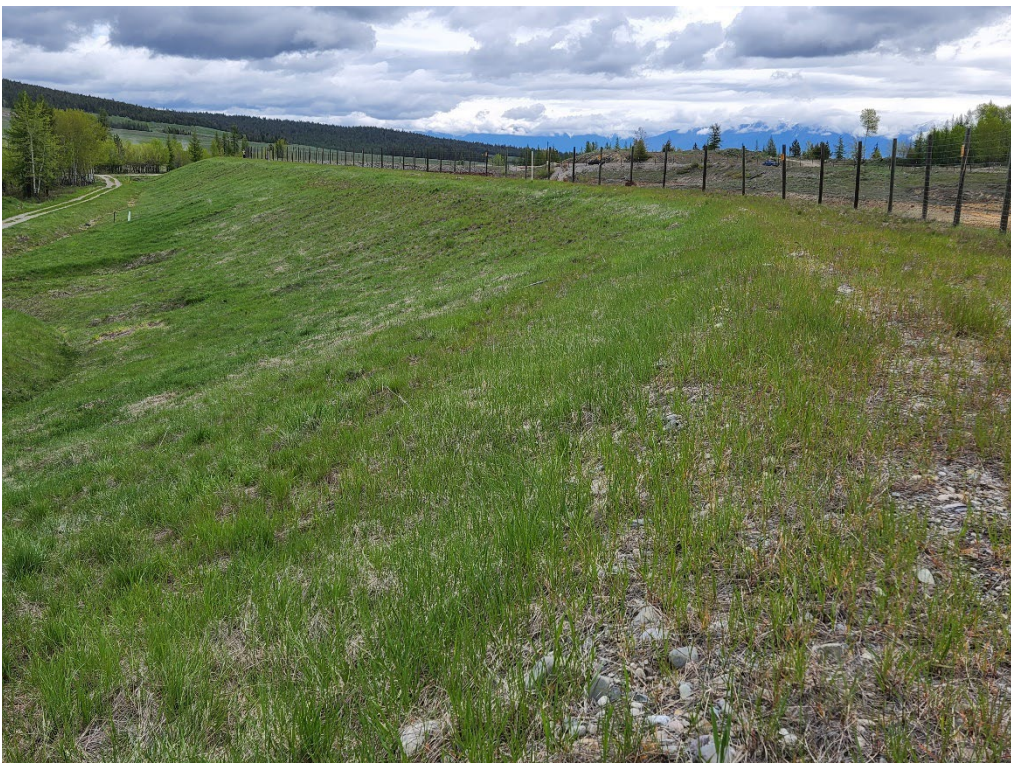
**Photo II.4 ARD North Dam Downstream Slope**

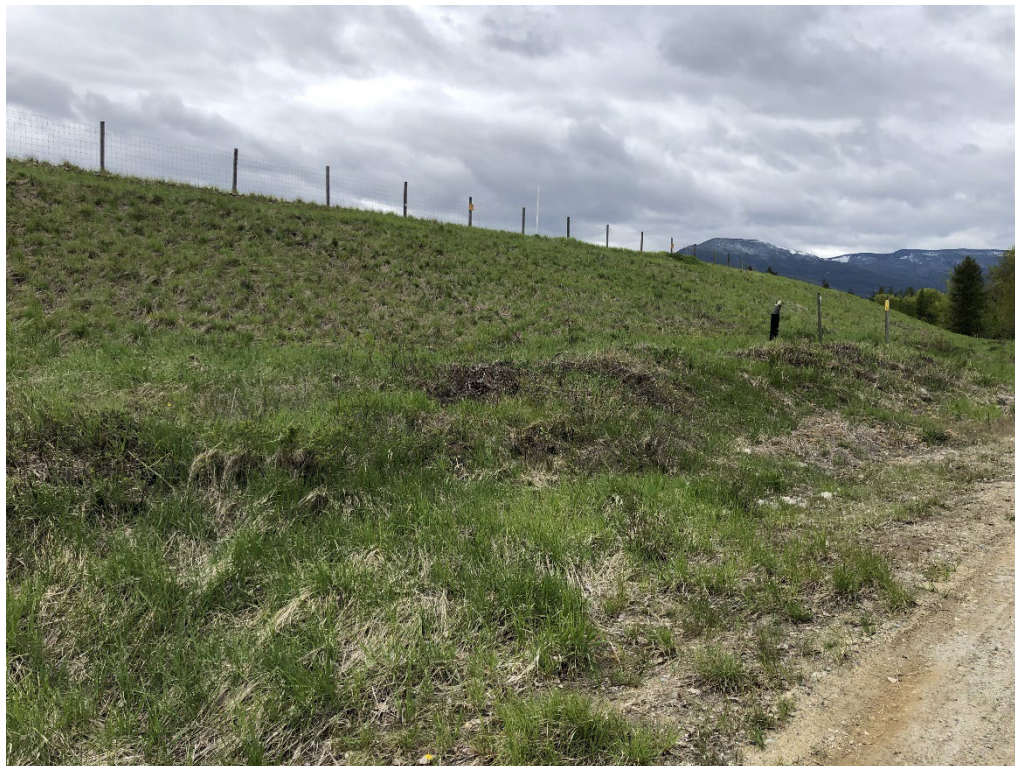
**Photo II.5**      **Vegetation at toe of North Dam**

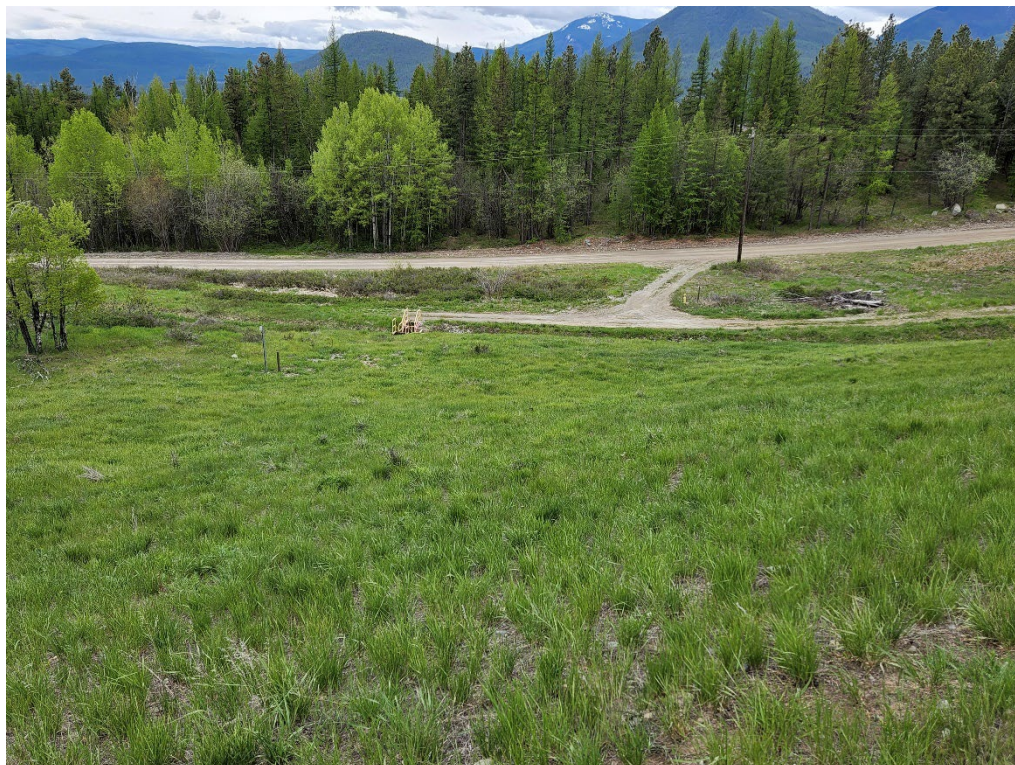
**Photo II.6**      **South Dam Downstream Slope**

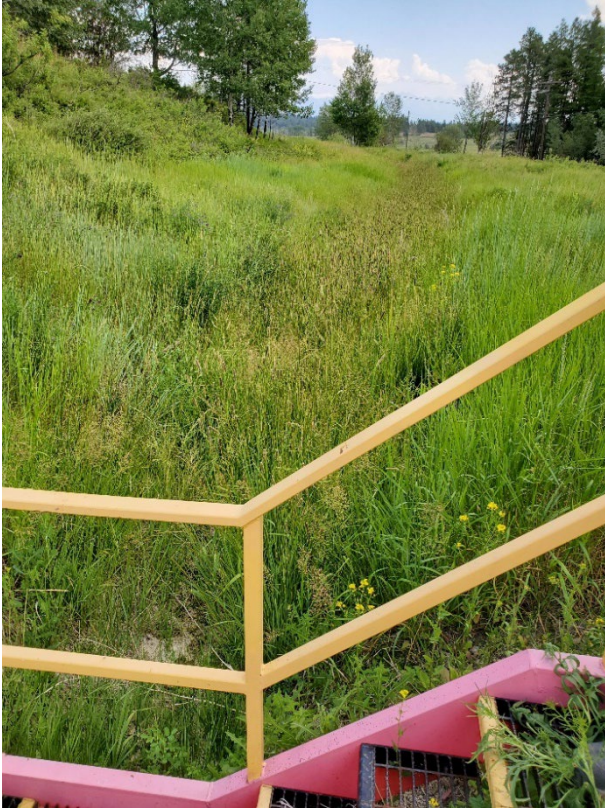
**Photo II.7 Weir 1 downstream ditch**

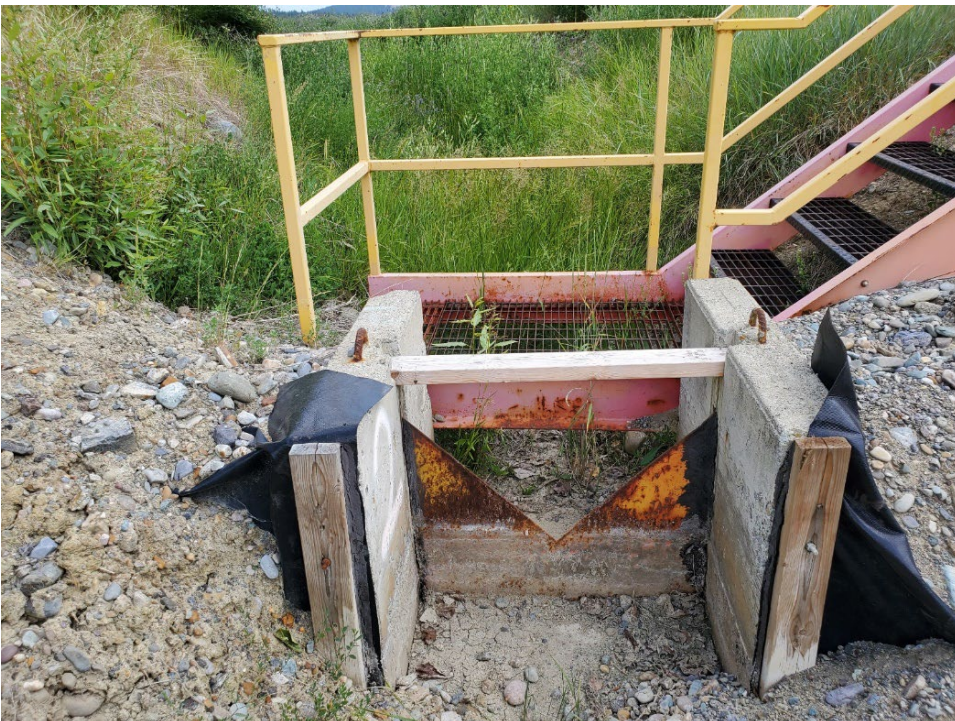
**Photo II.8 Weir 2 – AIPWU**

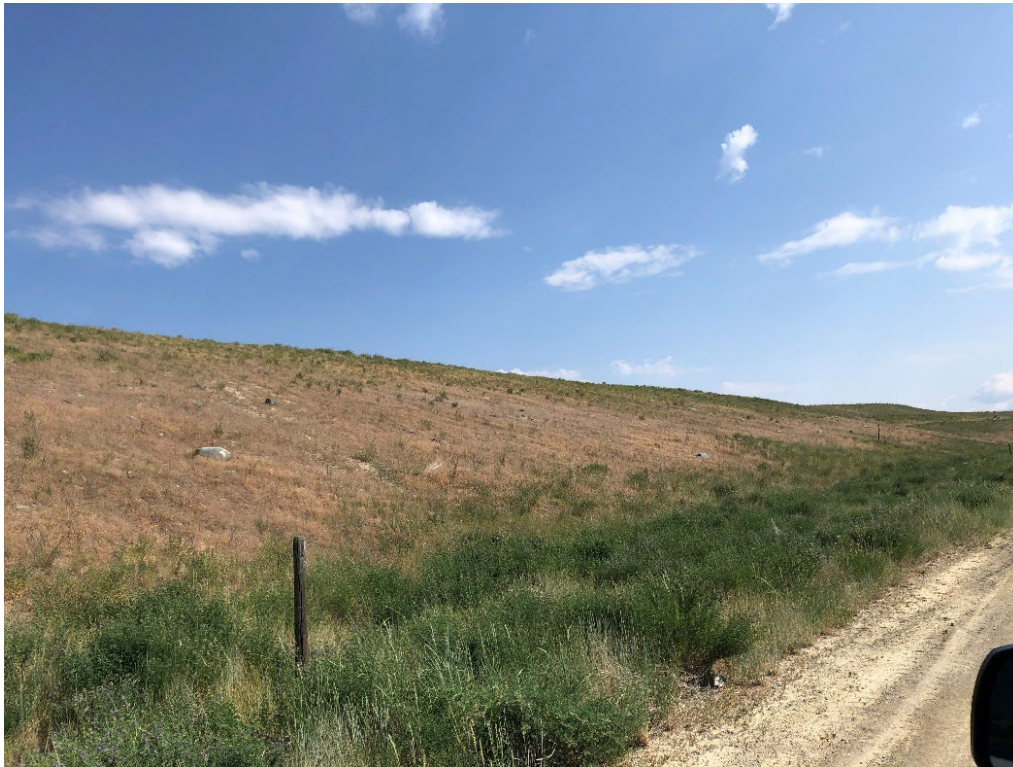
**Photo II.9 Iron Dike Downstream Slope**

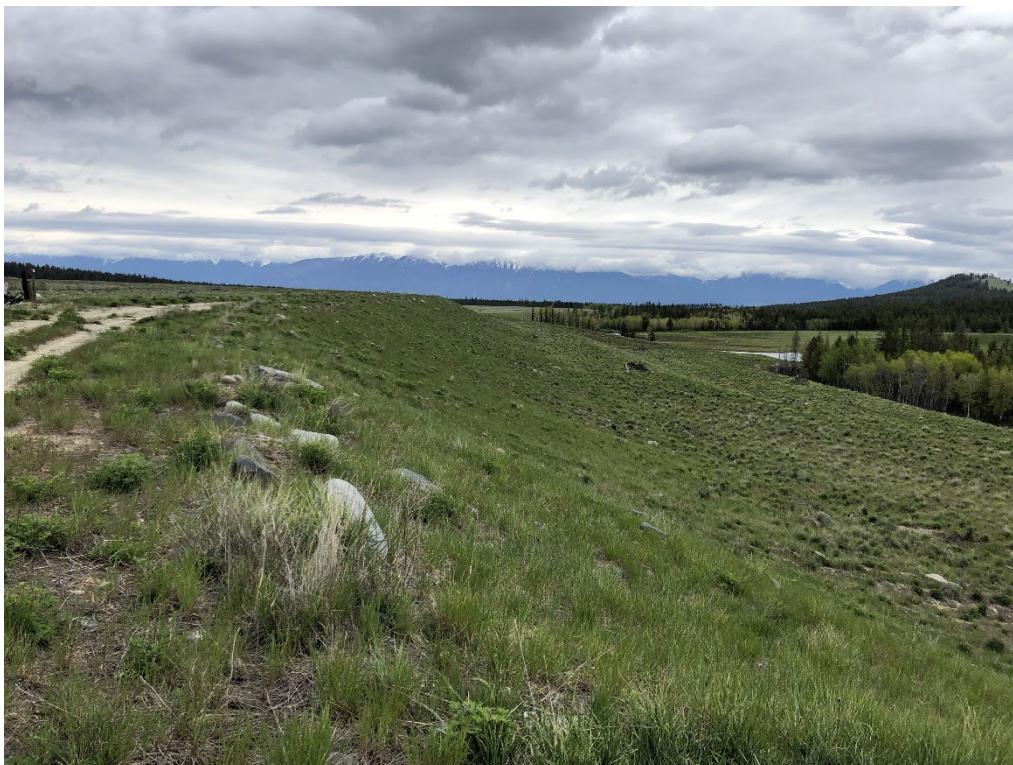
**Photo II.10 Iron Dike Crest and Crest of Toe Berm**

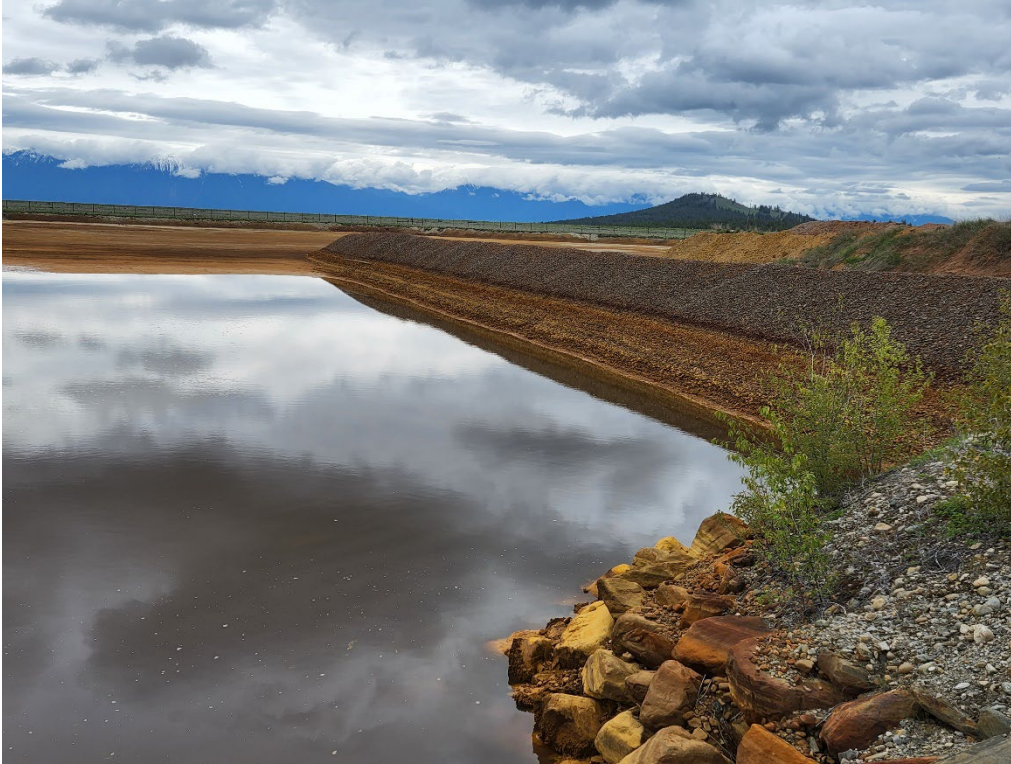
**Photo II.11 Overview of Iron Pond**

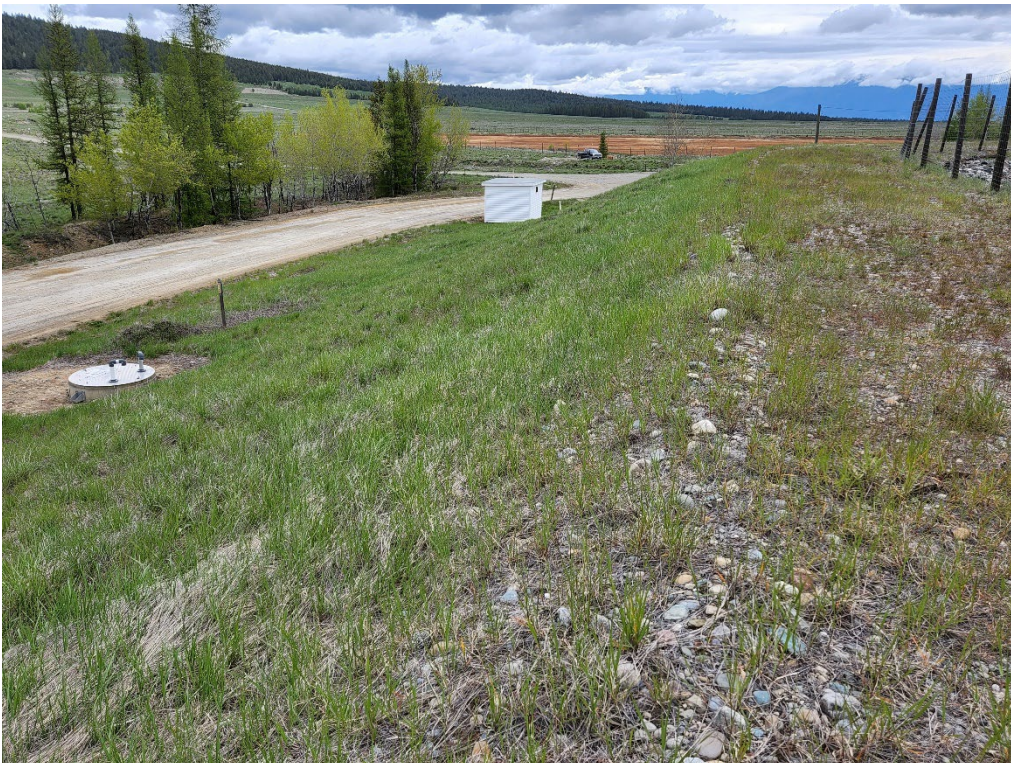
**Photo II.12 Overview of Iron TSF looking towards Iron Pond**

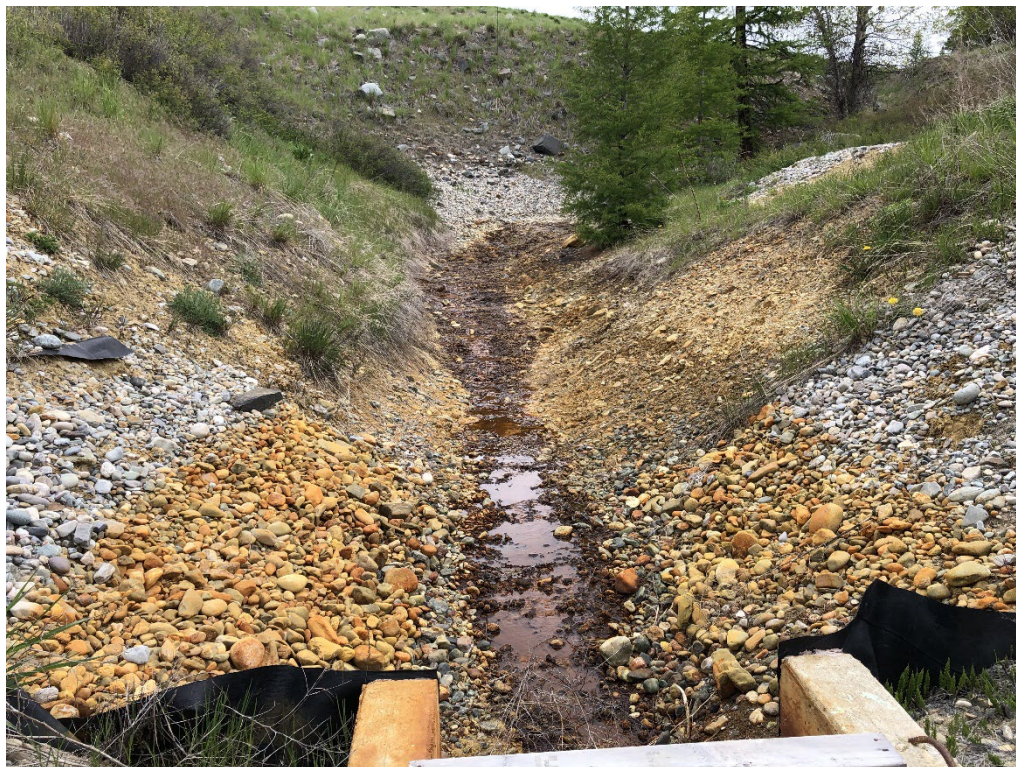
**Photo II.14 Channel Upstream of Weir #3**

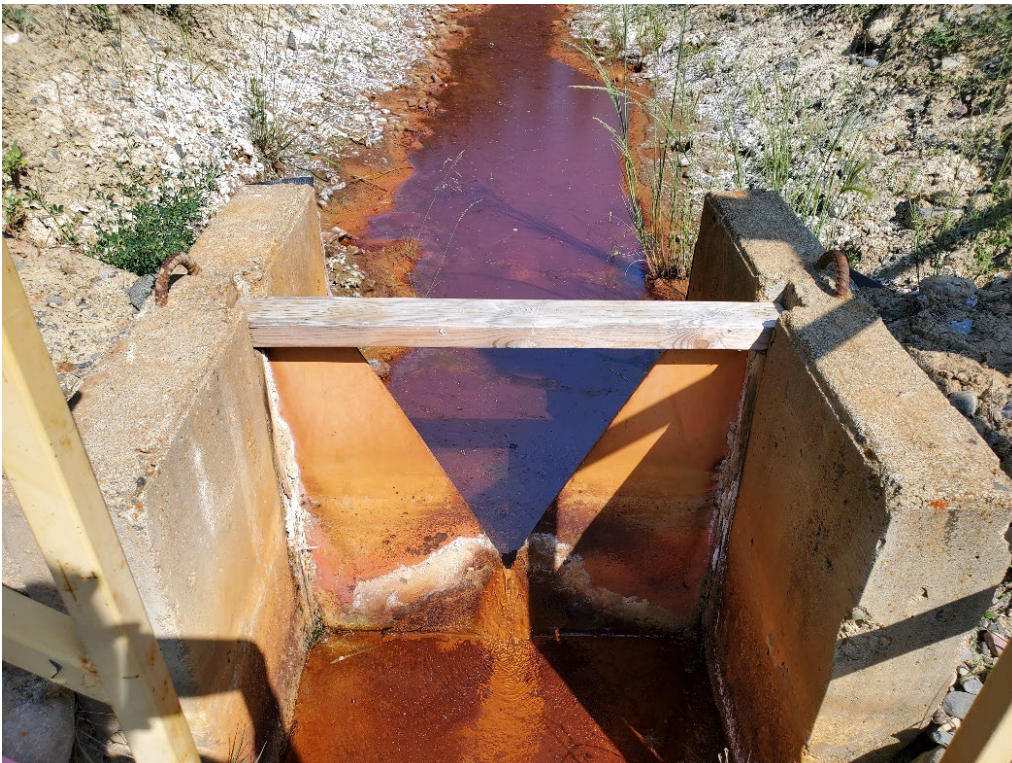
**Photo II.16 Weir #4 worn notch**

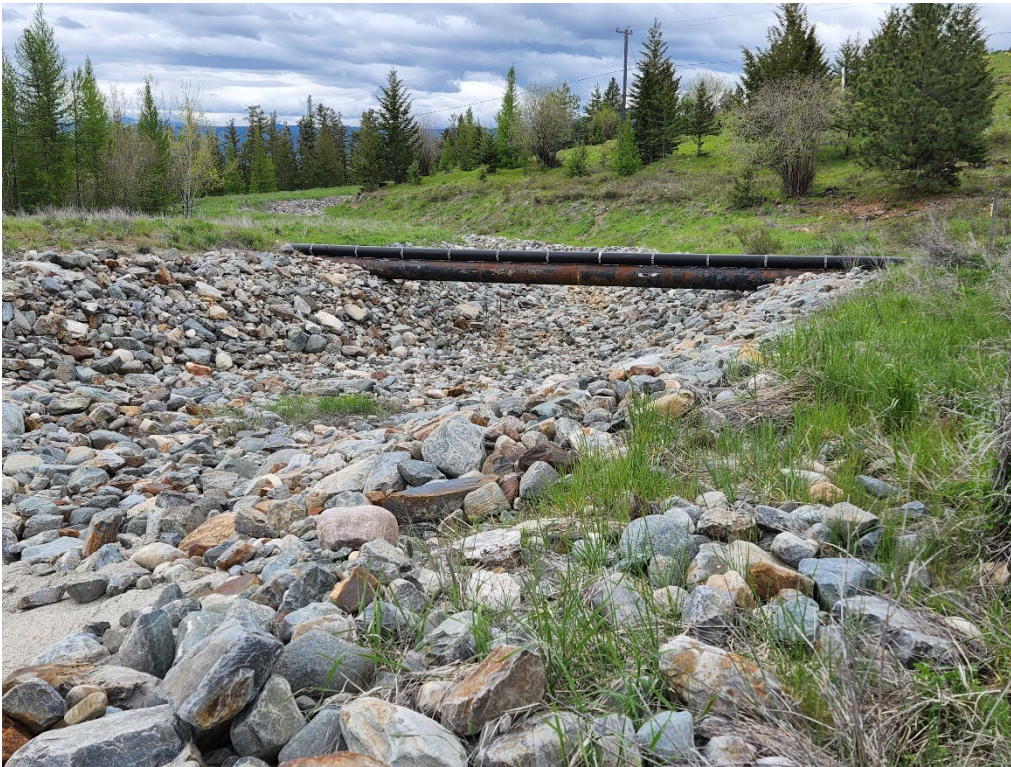
**Photo II.17 Emergency Spillway Channel Inlet**

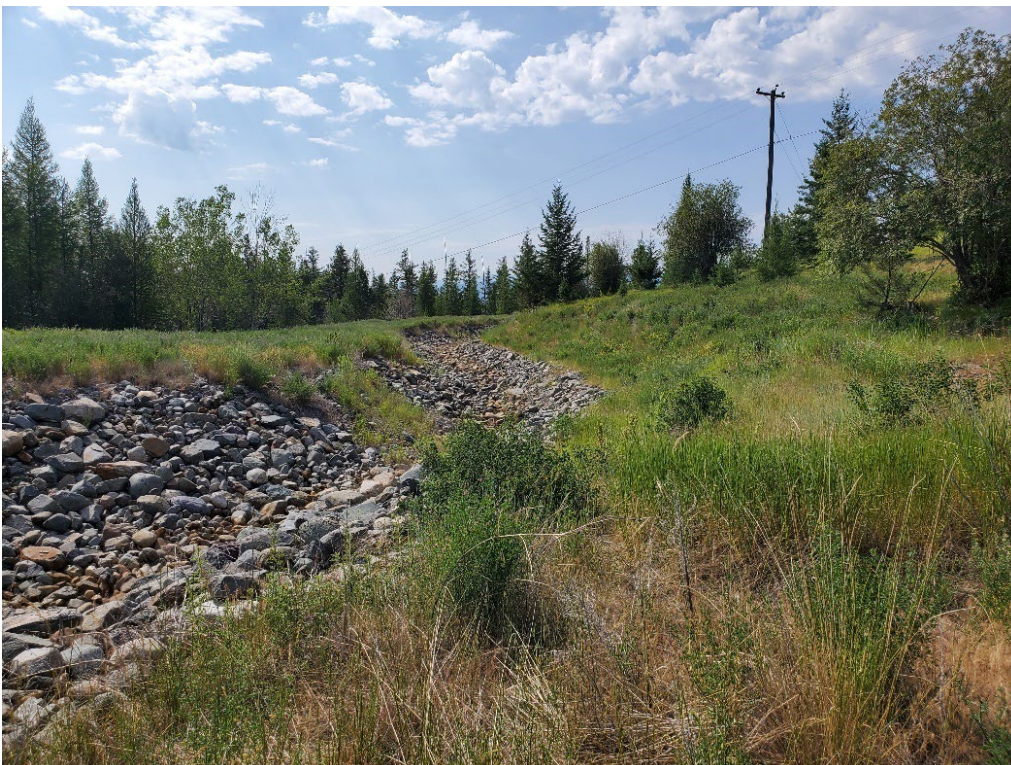
**Photo II.18 Emergency Spillway Channel upper section looking downstream from inlet**

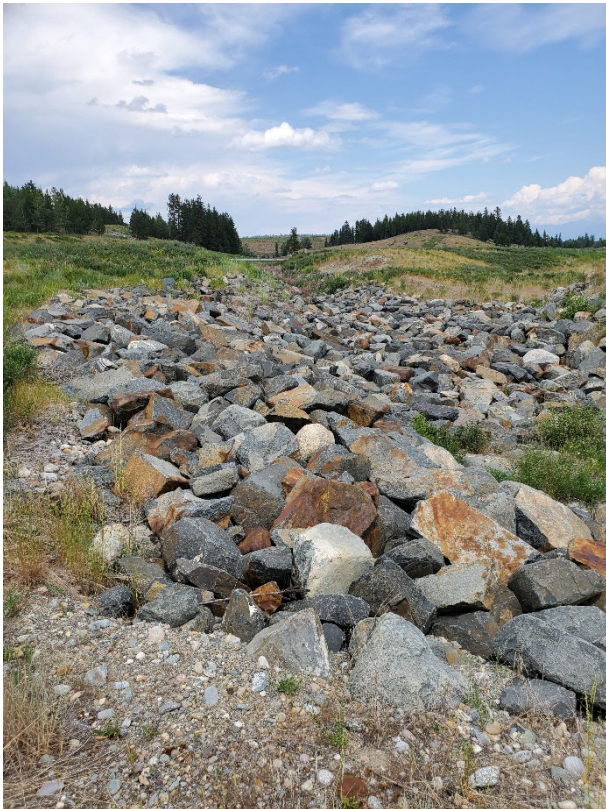
**Photo II.19 Emergency Spillway Channel looking upstream from connection to West Gypsum TSF**

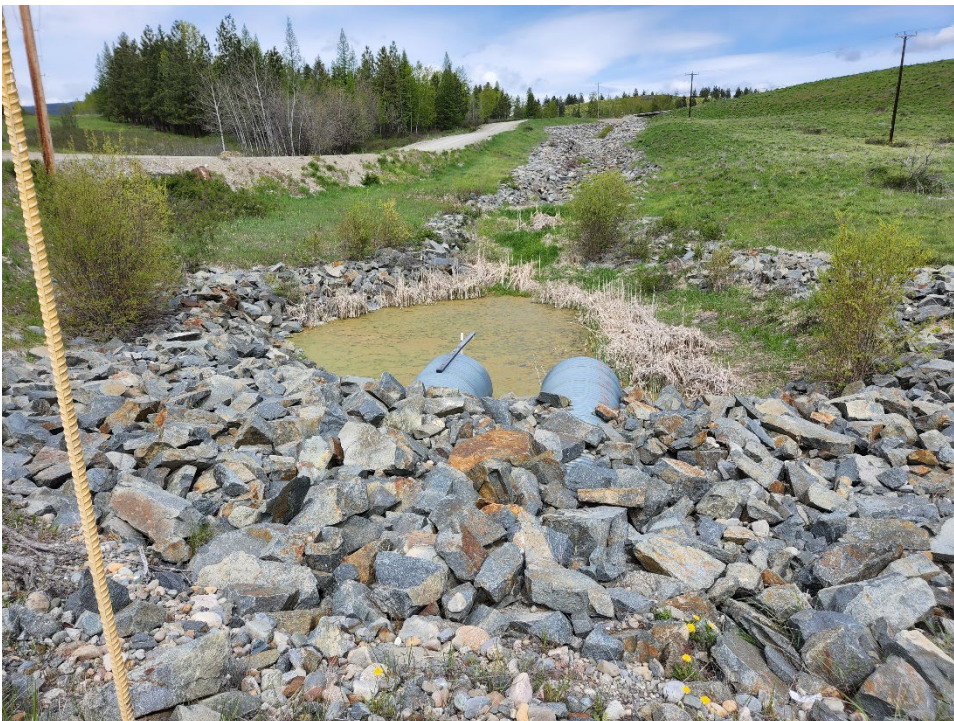
**Photo II.20 Emergency Spillway Channel outlet to Cow Creek**

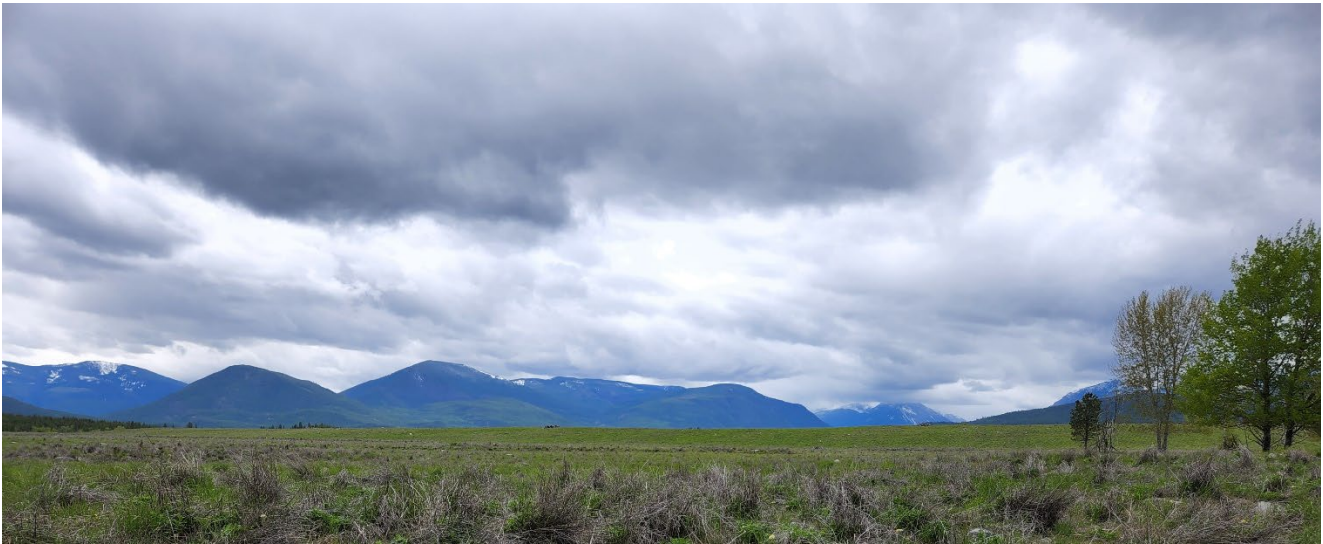
**Photo II.21 No. 1 Siliceous Dike Downstream Slope**

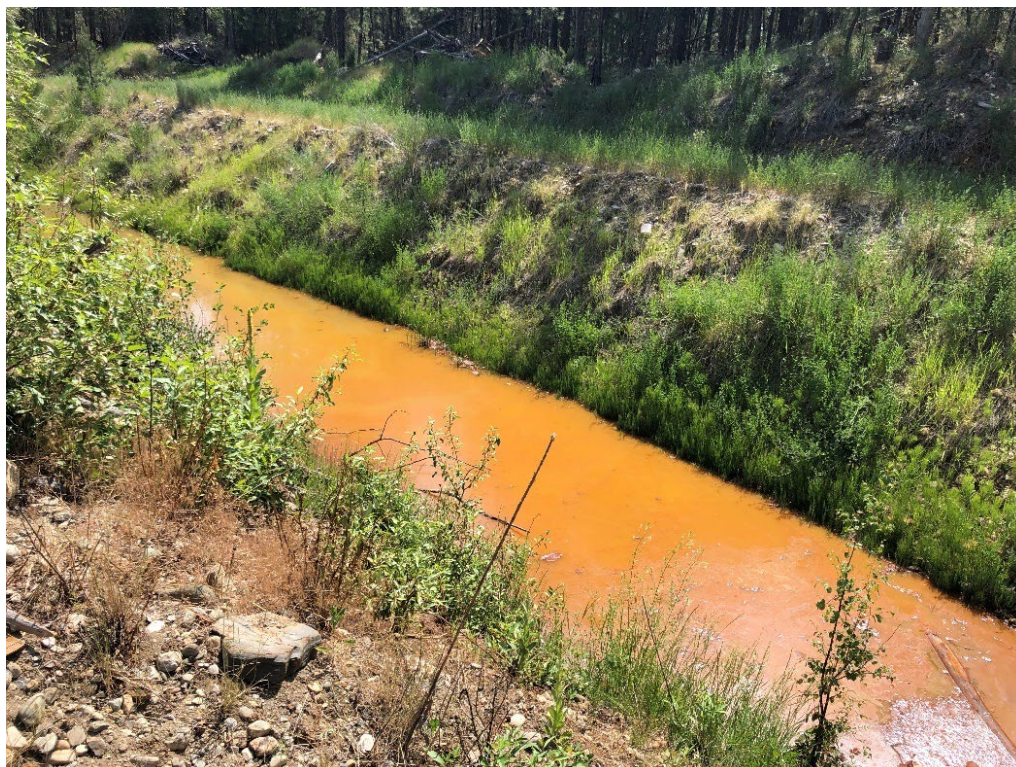
**Photo II.24 Seepage downstream of No. 2 Siliceous Dike**

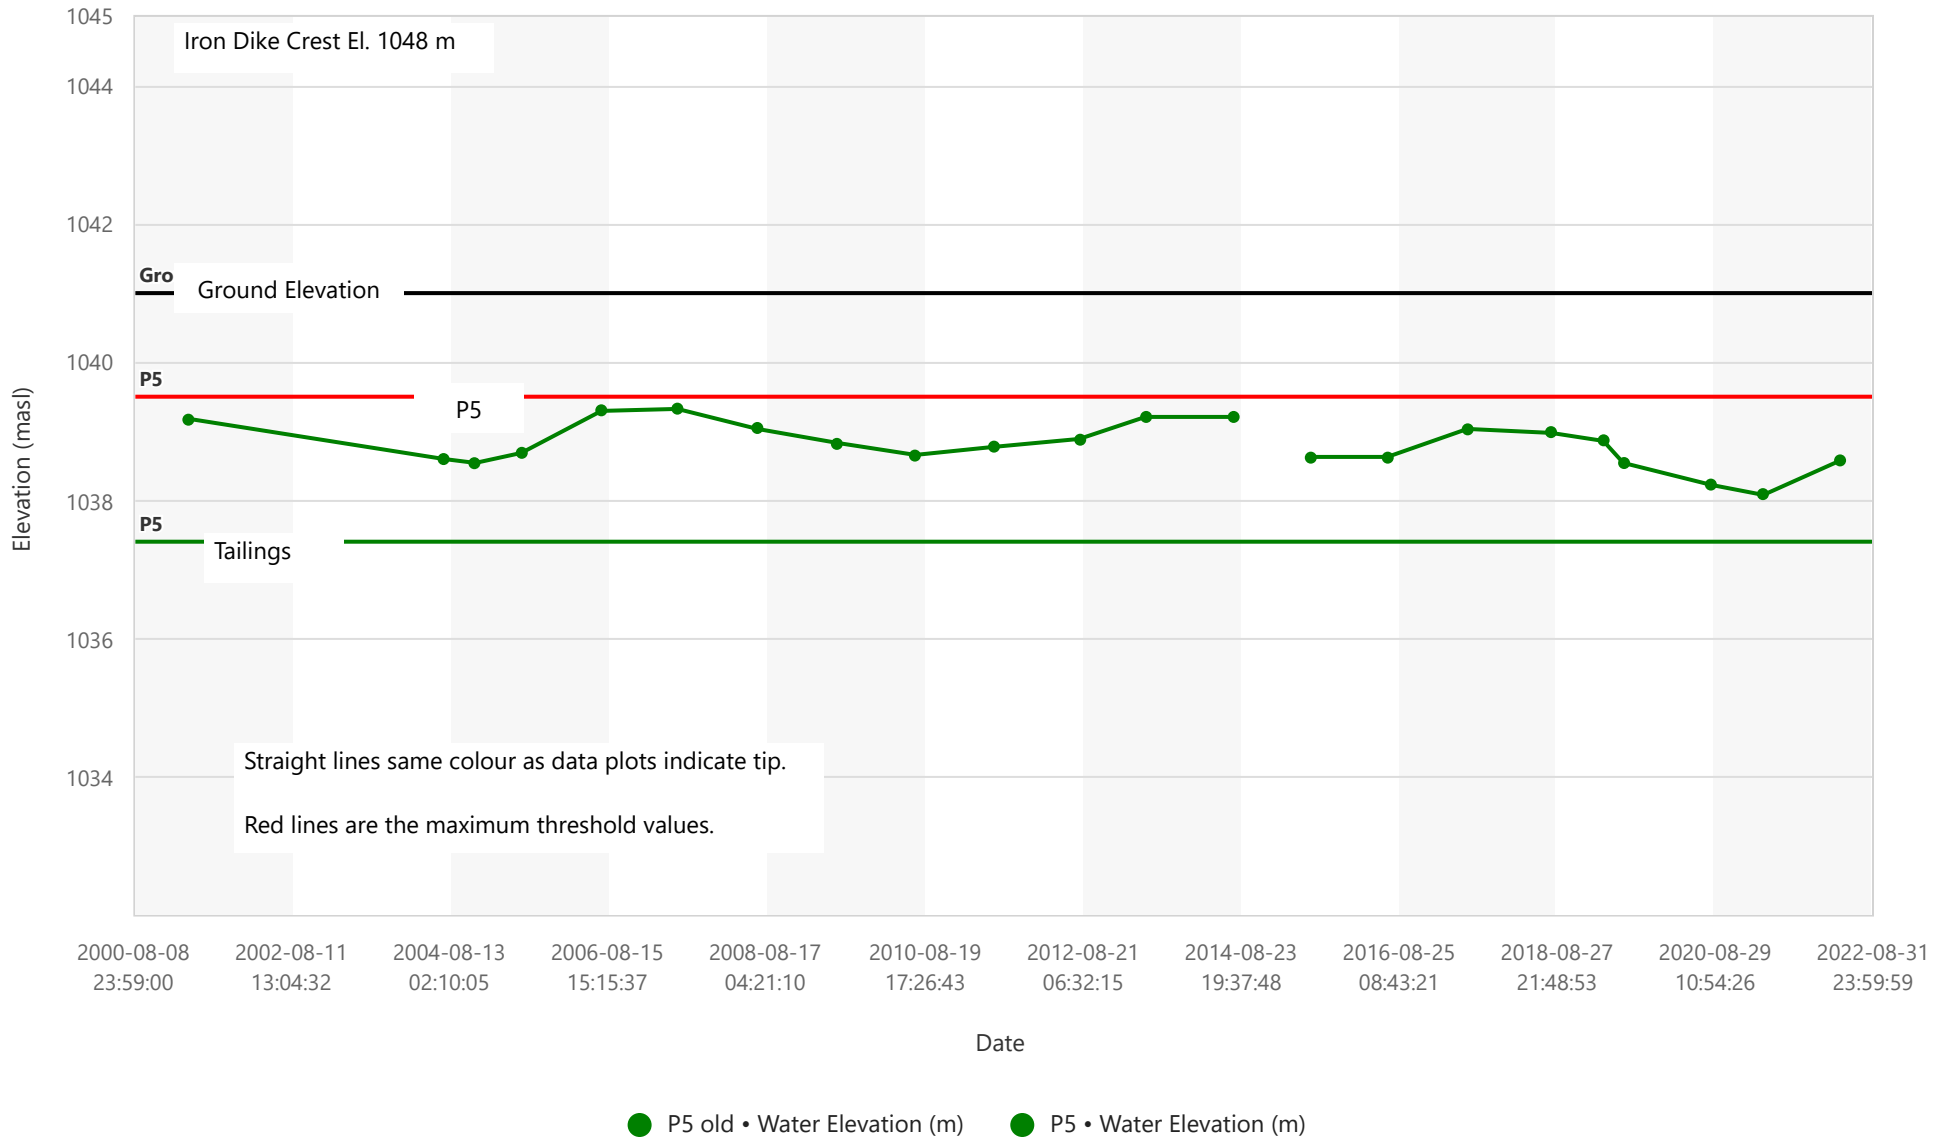
Figure IV-9 Line 54+00

Standpipe piezometers were flushed in July/August 2014. Not all sediment was removed and some casings also cut or extended/repared at this time. Therefore a new top of casing and new depth to bottom of standpipe was recorded for many instruments. Older data will appear below tip elevation if previously read "dry" or if previous top of casing elevation was incorrect due to damage.
