Teck Coal Limited – Elkview Operations

**Tailings Storage Facilities
West Fork Tailings Facility
and Lagoons A, B, C and D**

2017 Dam Safety Inspection

Final Report

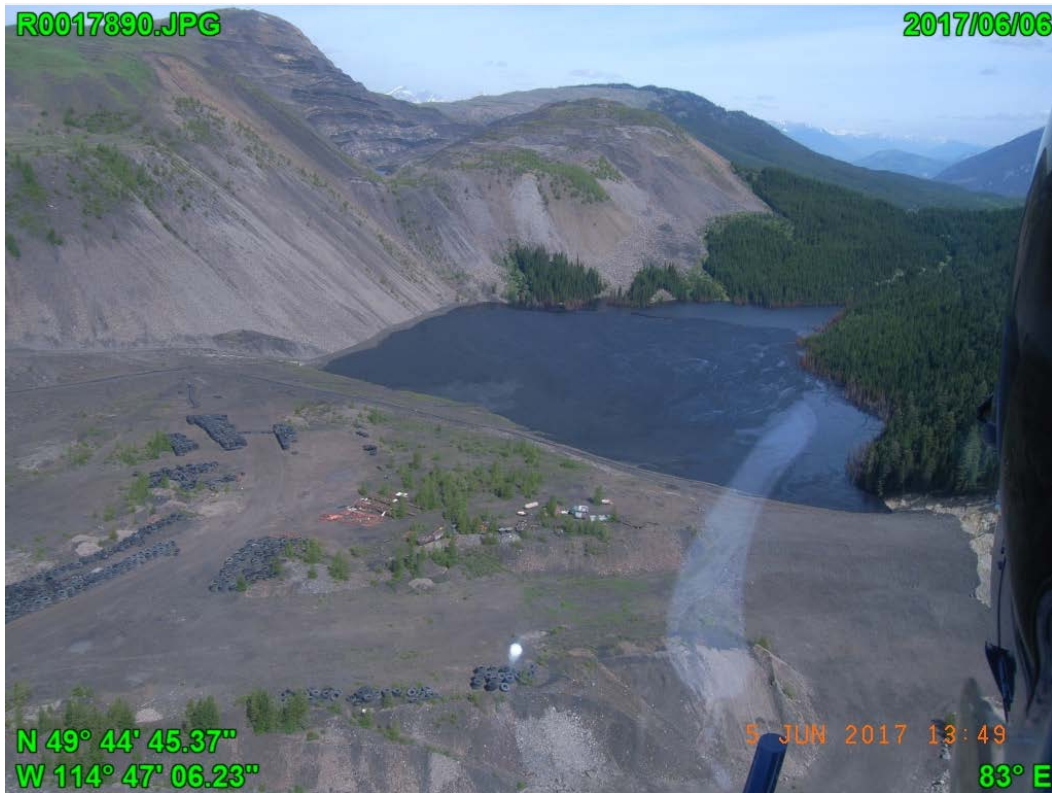
Photograph F - 1: Showing aerial overview of WFTF, looking north.

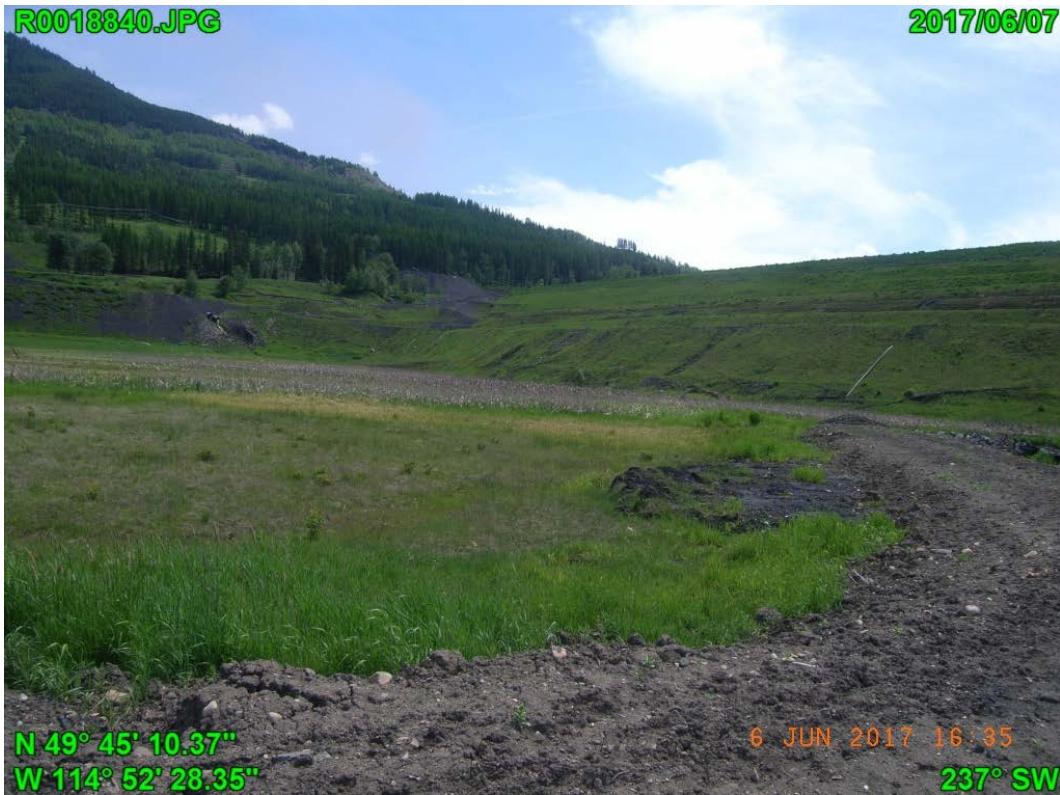
Photograph G - 3: Showing the south side of Lagoon A, looking southeast.

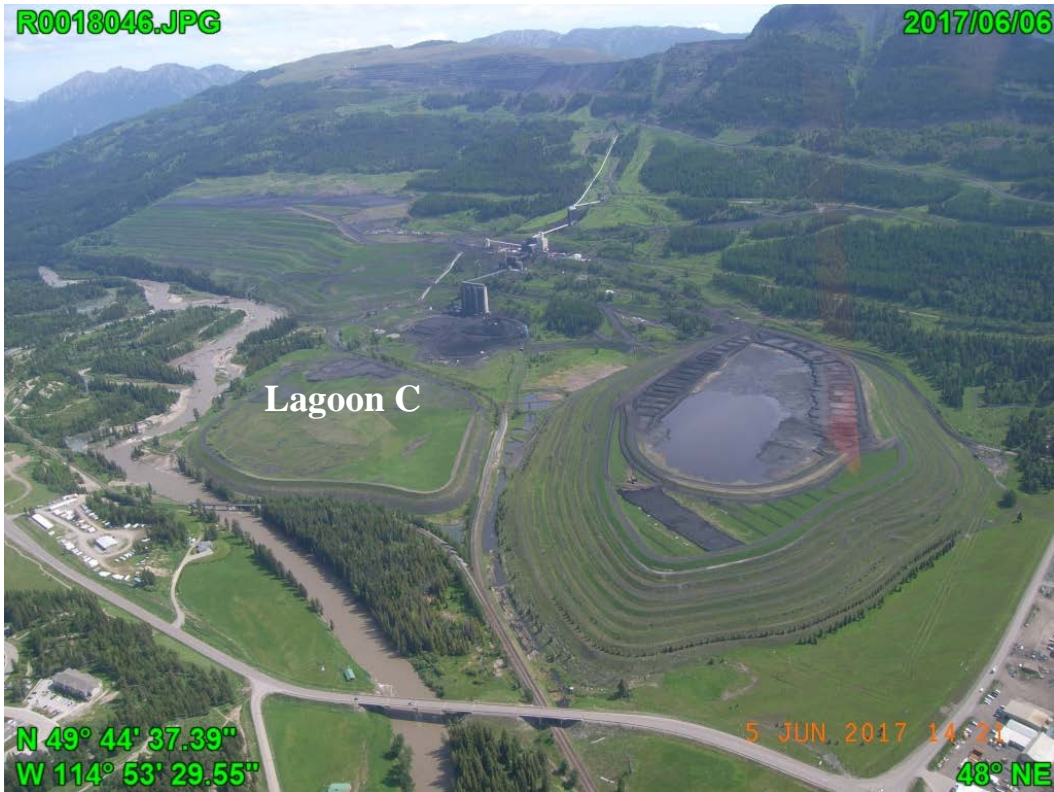
Photograph I - 1: Showing aerial overview of Lagoon C, looking northeast.

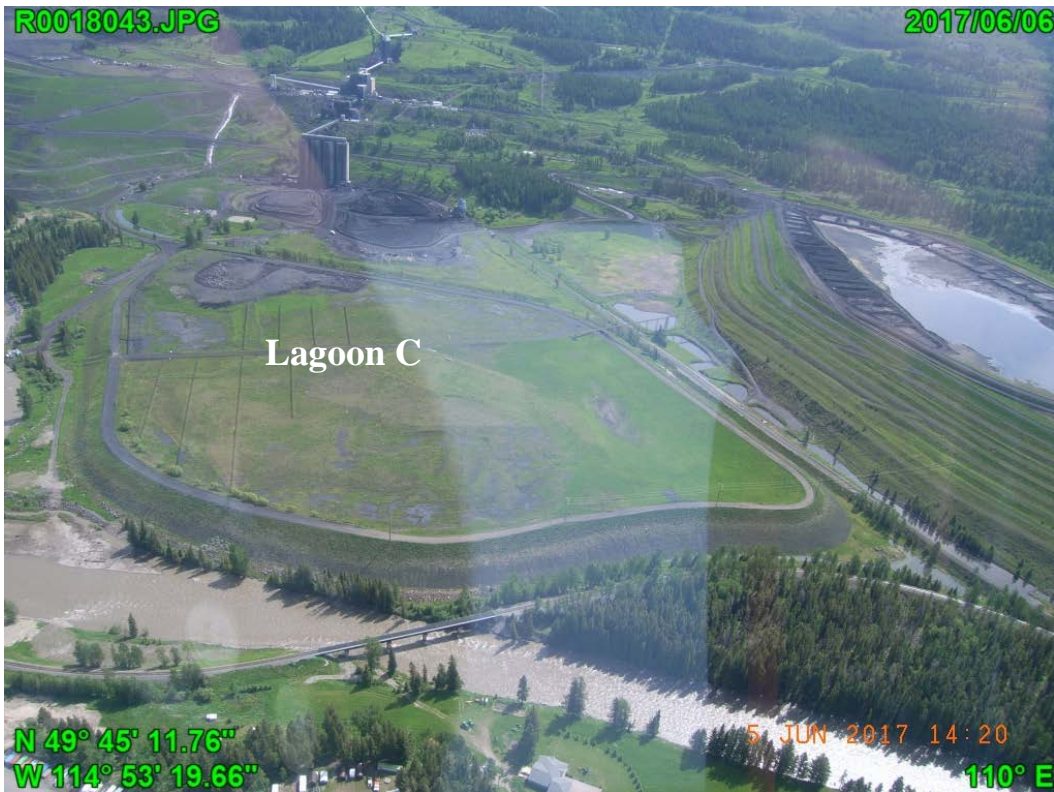
Photograph I - 2: Showing aerial overview of Lagoon C, looking east.

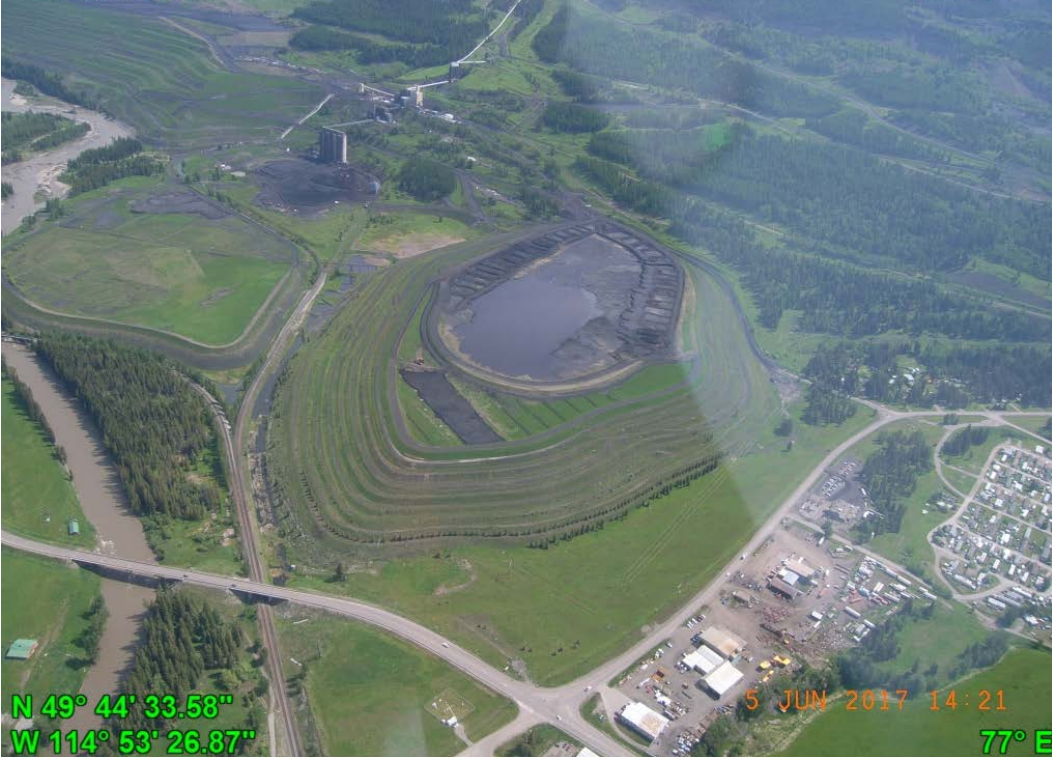
Photograph J - 2: Showing an aerial overview of Lagoon D, looking northeast.
